# ENGINEERING INVESTIGATIONS AT INACTIVE HAZARDOUS WASTE SITES

## PHASE II INVESTIGATION

### SNYDER TANK CORPORATION

Site No. 915049  
Hamburg, New York  
Erie County

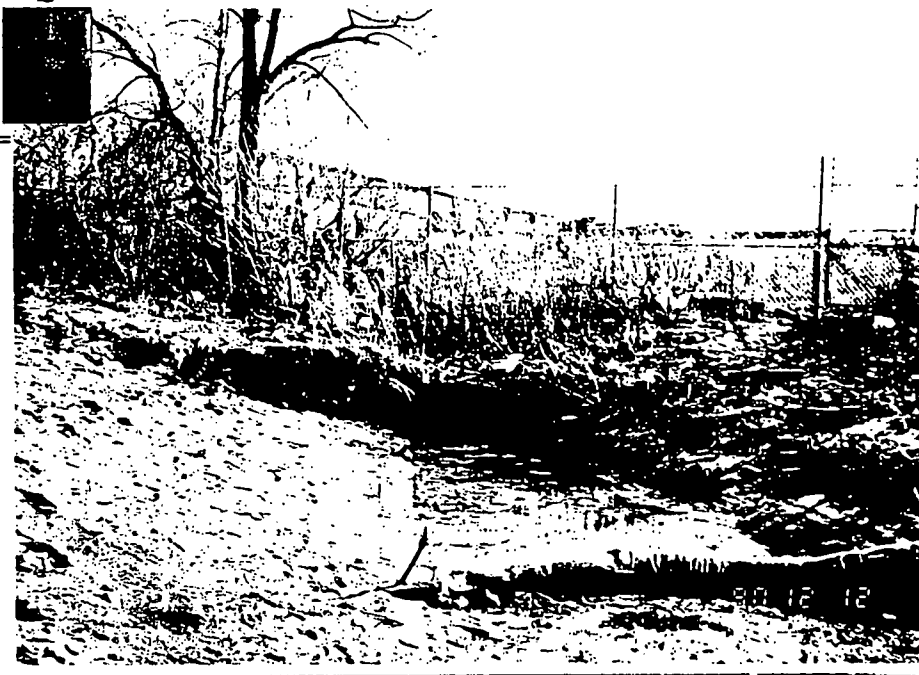
6

An unsecured baffle exists at SW-1 to absorb outflowing products from the facility.  
Reference #7 (Photos 5,6, and 8), pgs.1 and 2

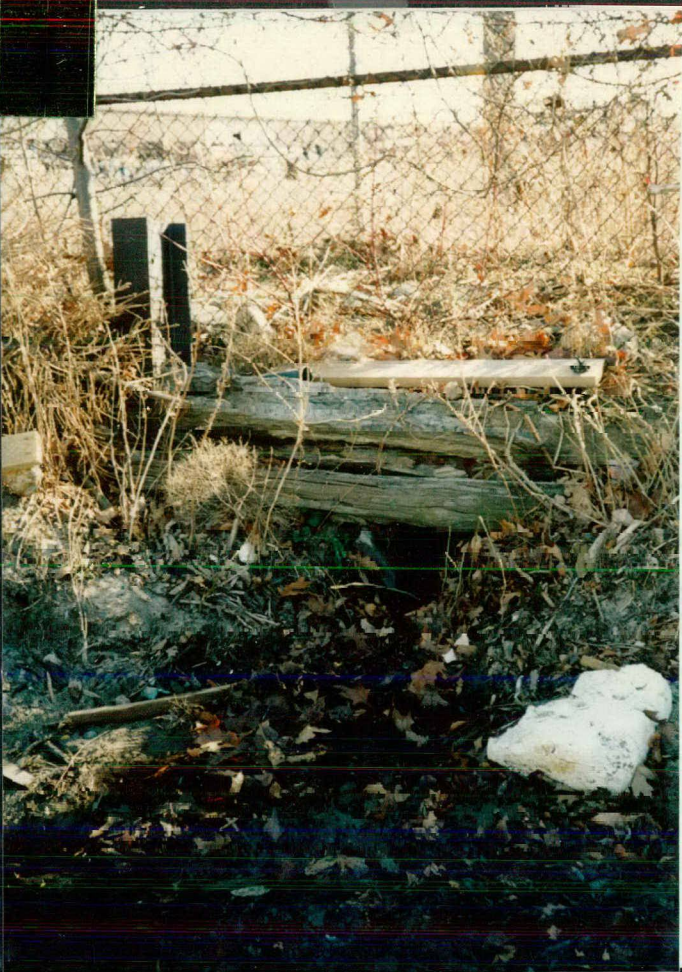
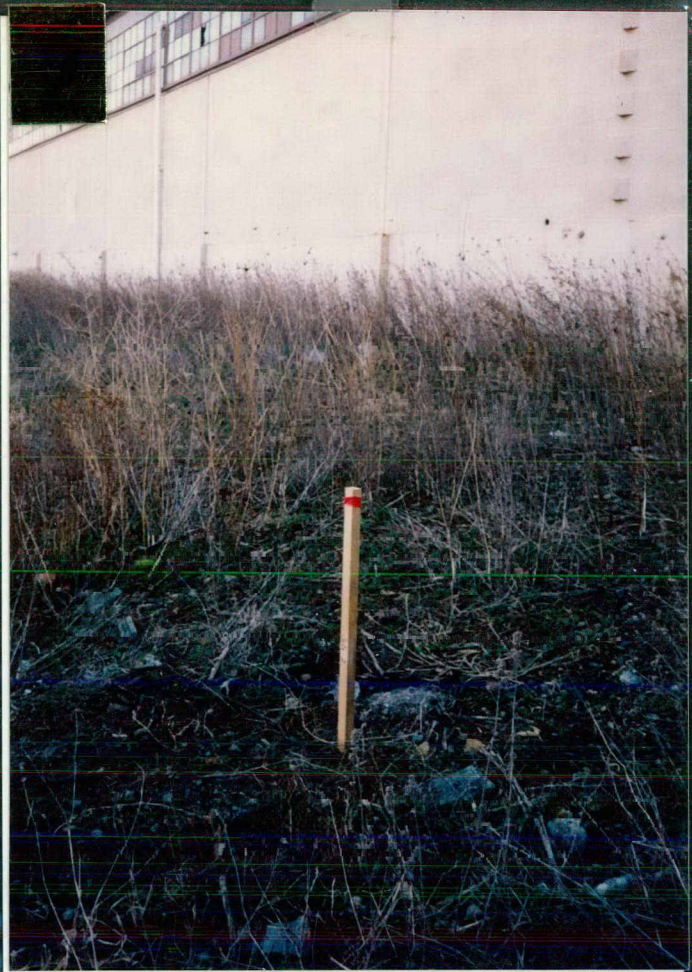
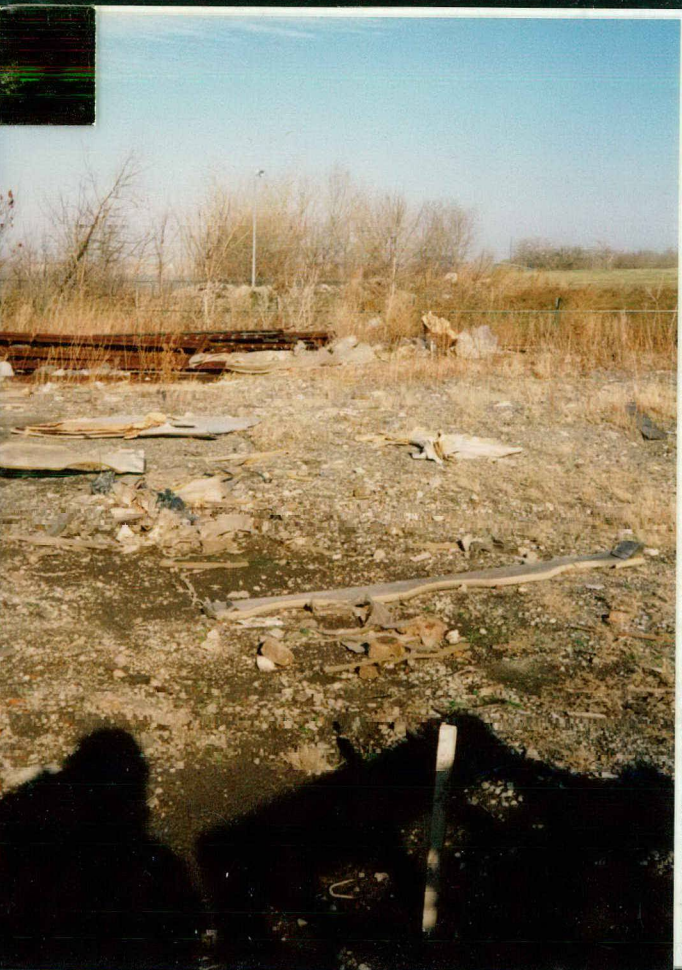
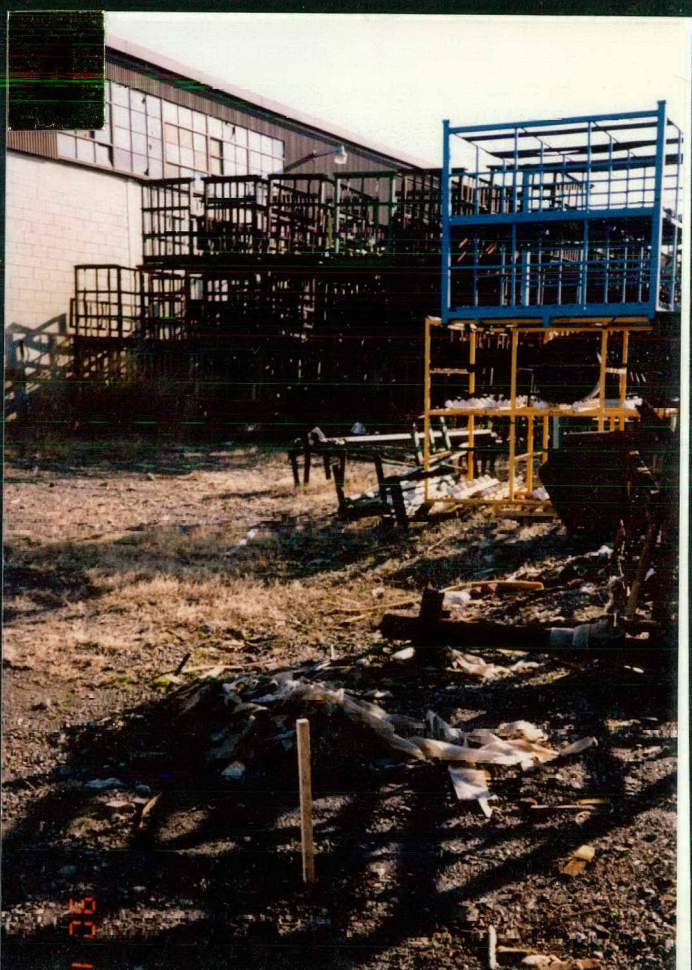
Surface soil sample  
location SS-3.

Three surface soil samples (SS-1, SS-2, and SS-3) and one subsurface split spoon/cuttings sample (SPGW-2) were collected from the site. The three surface soil samples were collected from three different areas where staining was noted by the YEC sampling team (Figure 1.2 and Plate A). The auger cuttings sampled were collected from borehole GW-2 where an HNU reading exceeded 10 units. These samples were analyzed for TCL organic compounds and TAL metals and cyanide. The analytical results are listed in Tables 1.4 and 1.5.
