report.HW915049 2008 -03-26 PHASE I & II INVESTIGATIONS.pdf

**3773-3774 Lake Shore Road  
Snyder Tank  
915049**

- i) Phase I Environmental Site Assessments,  
by Great Lakes Environmental & Safety  
Consultants, June, 2005**
- ii) Phase II Investigation, by Bench Mark,  
May, 2006.**
- iii) Phase I Environmental Assessment  
by Hazard Evaluation, October, 2006**
- iv) Phase II Investigation – Area C,  
by Bench Mark, March 26, 2008.**

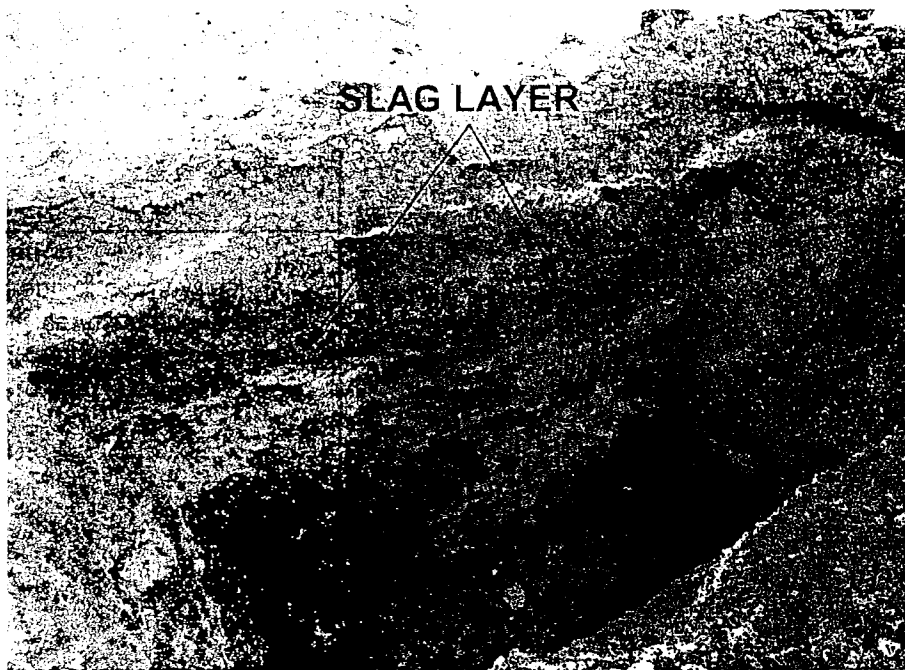
| <b>Photo No.</b><br>6 | <b>Date</b><br>04/12/06 | |

| <b>Description:</b><br>Photograph of geophysical anomaly identified during test pit TP-3 excavation. Determined to be a hard slag layer. | | |

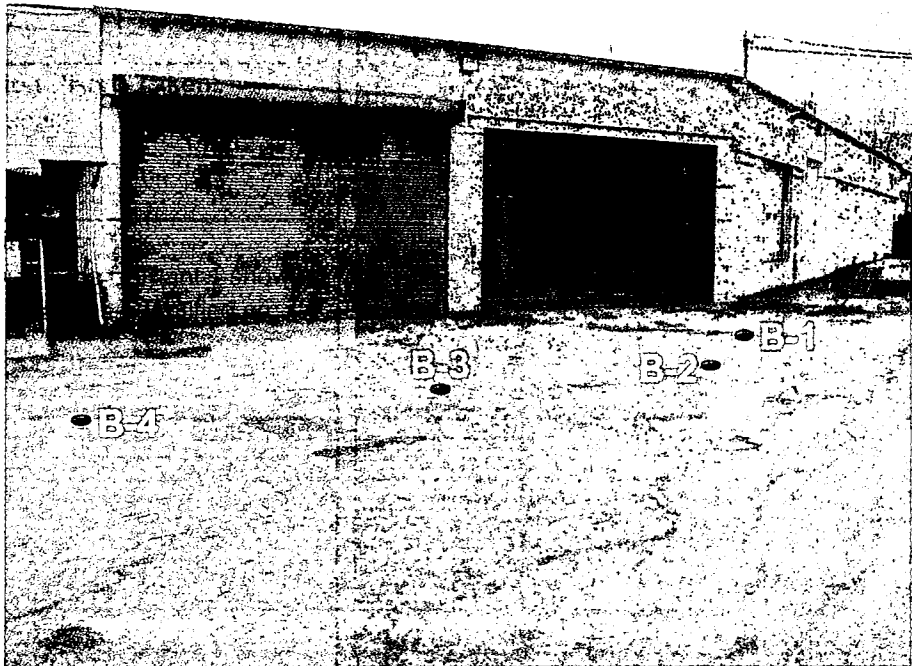
| <b>Photo No.</b><br>7 | <b>Date</b><br>04/12/06 | | |

| <b>Description:</b><br>"Cut-Out" Area of Plant 1 showing boring locations (identified on photo). | | | |

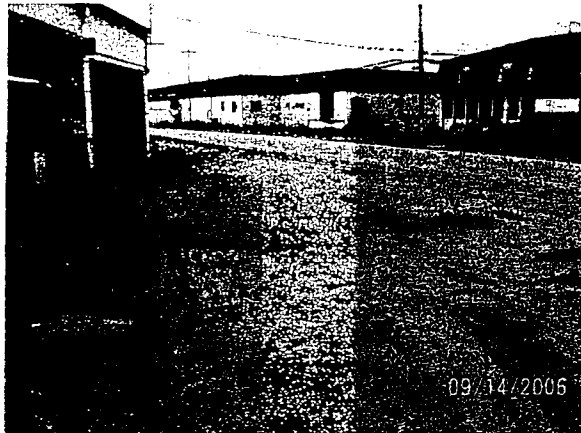
**Photo 6:**

Photo 6: Area of reportedly closed UST, Plant #1 building to left.

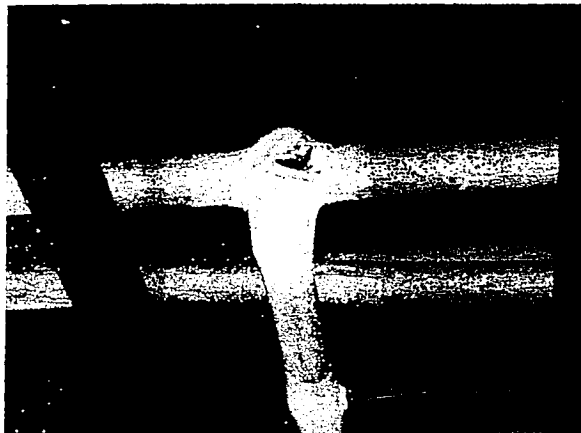
**Photo 13:**

Photo 13: Possible asbestos pipe insulation. Basement of former office building.
