Re: 3773 Lake Shore Road, Blasdell, NY
 Area A – Underground Storage Tank
 Remedial Measures Summary Report

SITE PLAN
AREA A - UNDERGROUND STORAGE TANK
 3773 LAKE SHORE ROAD SITE
 HAMBURG, NEW YORK
 PREPARED FOR
 3773 LAKESHORE ROAD, INC.

POST-EXCAVATION SAMPLE LOCATIONS
AREA A - UNDERGROUND STORAGE TANK

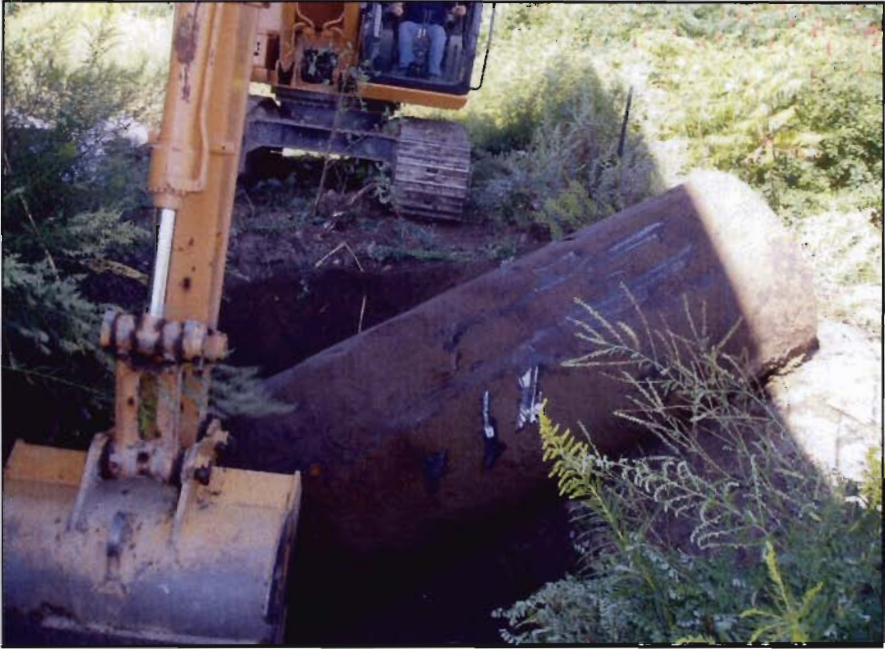
Client Name: Harter, Secrest & Emery		Site Location: 3773 Lake Shore Road	Project No.: 0109 - 001 - 101
Photo No. 1	Date 09/02/08

Direction Photo Taken: South			
Description: Toluene Tank removal, tank is 13 feet long x 4 feet wide.

Soil/fill overlying the majority of the UST had previously been removed and staged adjacent to the excavation. Accordingly, removal work was initiated by lifting the UST from the excavation and staging it on poly sheeting. Benchmark personnel measured the UST dimensions at approximately 13 feet in length and 4 feet in diameter. The excavated tank was cut open and approximately 5 cubic yards of sand

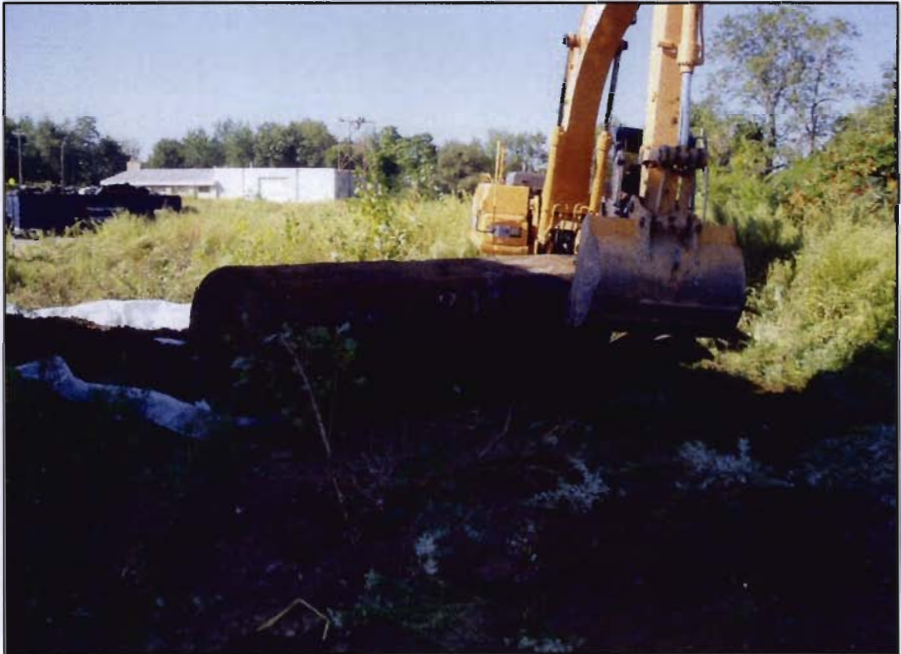
Photo No. 2	Date 09/02/08

Direction Photo Taken: South		
Description: Placing Toluene tank onto poly.

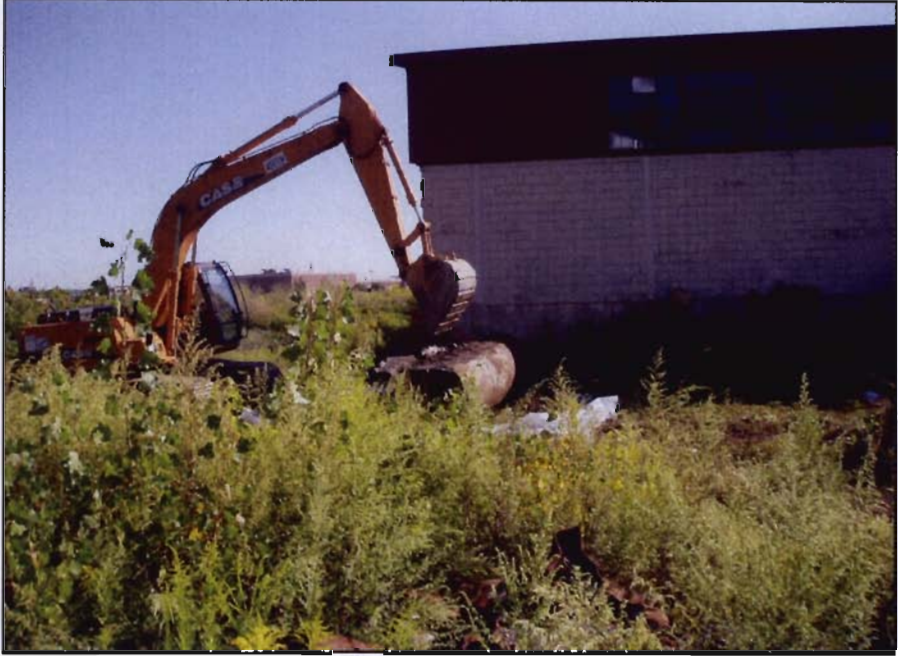
Client Name: Harter, Secret & Emery		Site Location: 3773 Lake Shore Road	Project No.: 0109 - 001 - 101
Photo No. 3	Date 09/02/08

Direction Photo Taken: North			
Description: Removing tank contents.

were removed and staged on poly sheeting near the excavation. The tank was subsequently cleaned in preparation for off-site steel scrap recycling. No liquids or sludges were present.

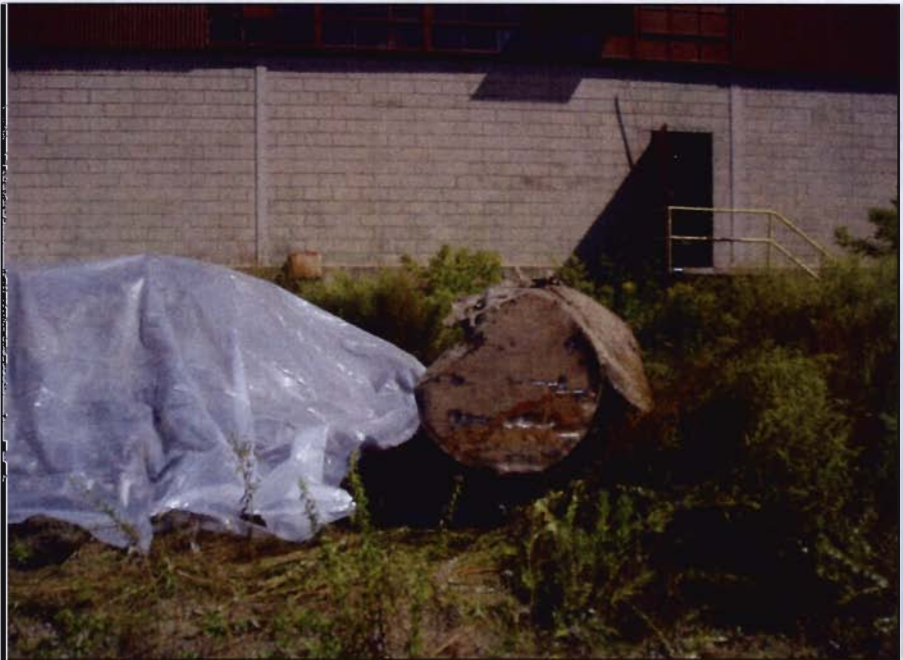
Photo No. 4	Date 09/02/08

Direction Photo Taken: North		
Description: Empty tank on poly next to covered pile of excavated soil/fill.

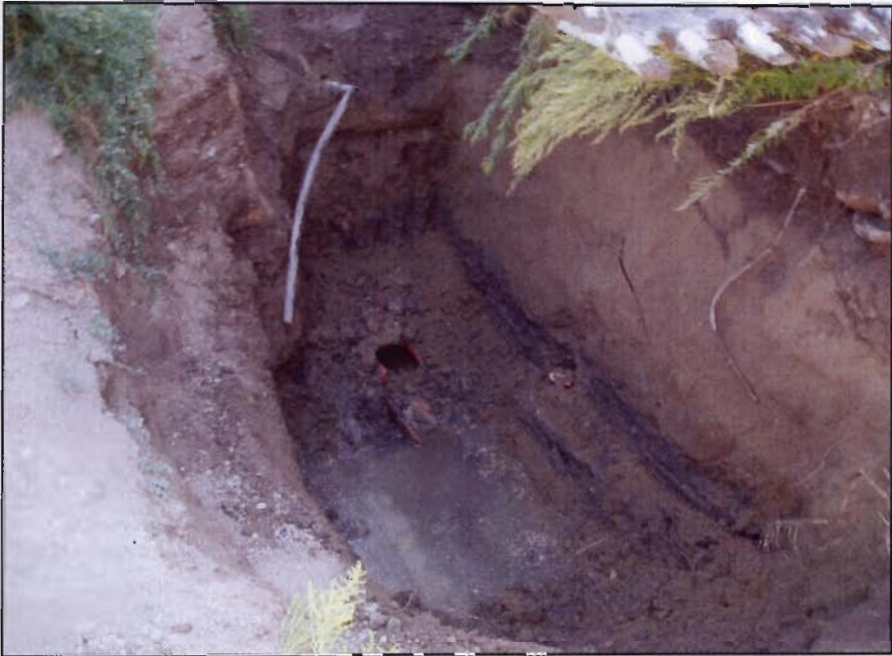
Client Name: Harter, Secrest & Emery		Site Location: 3773 Lake Shore Road	Project No.: 0109 - 001 - 101
Photo No. 5	Date 09/02/08

Direction Photo Taken: North			
Description: Tank excavation, bottom of excavation ~10.5 fbg's at bottom 15-inch drain line flowing north to south.

During soil/fill excavation, a 15-inch diameter vitrified clay pipe (VCP) was encountered running in a north-south direction approximately 3 feet beneath the bottom of the UST. Based on facility utility drawings, this pipe was identified as a facility storm sewer. The pipe was not installed on bedding material, nor did Benchmark personnel observe any breaks, leaks or other indications of openings in the piping. However, because impacted soil/fill appeared to extend beneath the sewer it was necessary to remove an approximate 12-foot section of the VCP piping to facilitate the excavation work. (This section was later replaced with a new length of 15-inch PVC piping as described below).

The final excavation area measured approximately 22.5 feet in length by 11 feet wide at grade, and tapered inward to a depth of approximately 10.5 feet below ground surface (fbgs) (see Figure 2). Approximately 50 cubic yards of impacted soil/fill was stockpiled on poly sheeting with the sand removed from the UST, separate from the clean overlying soil/fill material previously removed. Other than a small amount of storm water from the removed pipe section, the excavation remained dry throughout the period.

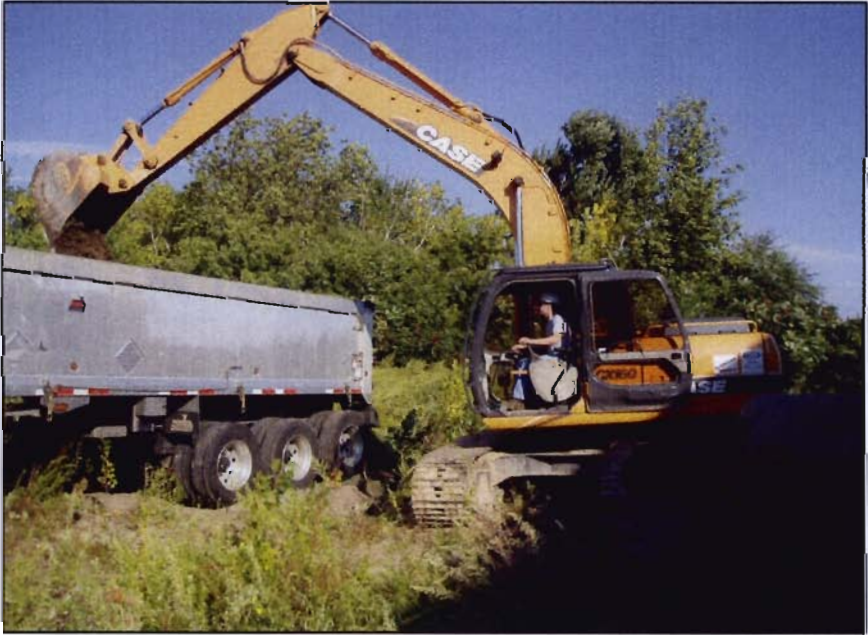
Photo No. 6	Date 09/05/08

Direction Photo Taken: West		
Description: Disposal of excavated soil/fill.

On September 5, 2008, the staged impacted soil/fill and sand pile from the UST excavation was loaded into dump trailers provided by Waste Management, and transported to the Waste Management Model City (Subtitle C) Landfill for disposal. The 12-foot section of VCP was also disposed at the Model City facility. Concurrently, two soil/fill piles, intermingled with empty 55-gallon drums, were excavated to native soil. The drums were segregated, crushed and shipped off-site for steel scrap recycling with the UST. The soil/fill material intermingled with the drums was shipped off-site to Waste Management's Model City with the impacted soil/fill and sand from the UST removal. Attachment 3 includes a copy of scale tonnage receipts. A total of 81.44 tons of soil/fill and sand were disposed.

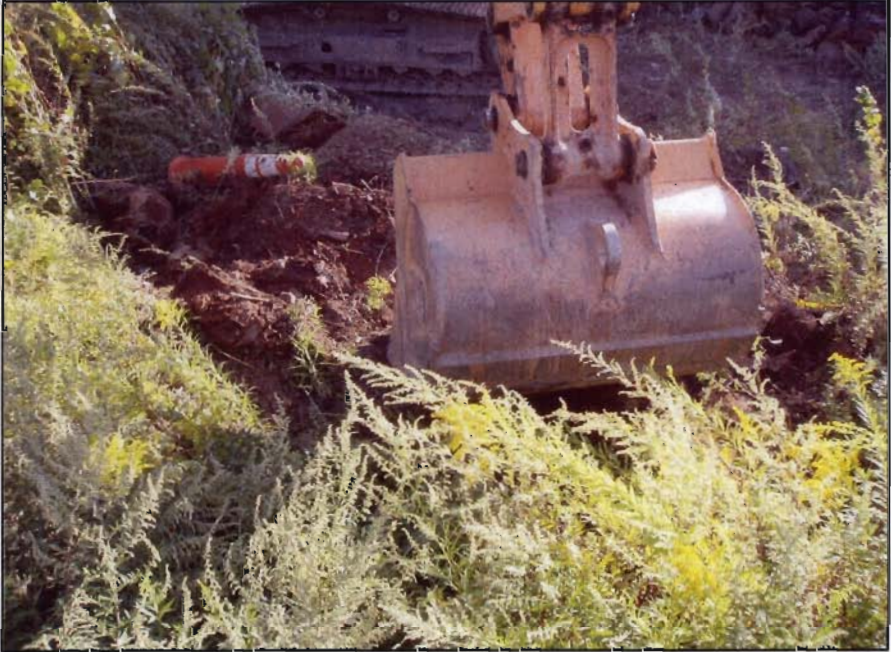
Client Name: Harter, Secret & Emery		Site Location: 3773 Lake Shore Road	Project No.: 0109 - 001 - 101
Photo No. 7	Date 09/05/08

Direction Photo Taken: West			
Description: Removal of drum of northern drum and soil pile.

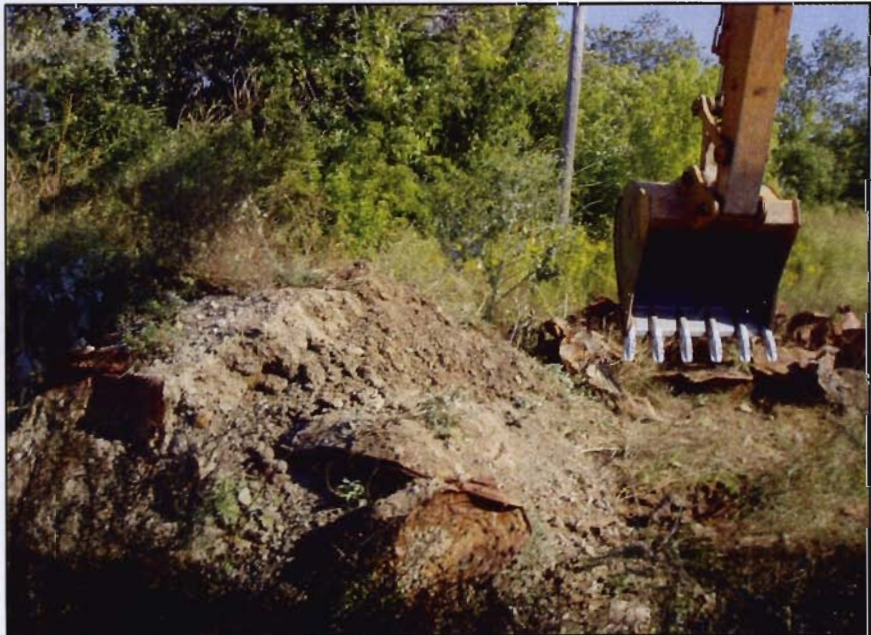
Photo No. 8	Date 09/05/08

Direction Photo Taken: West			
Description: Removal of southern drum and soil pile.

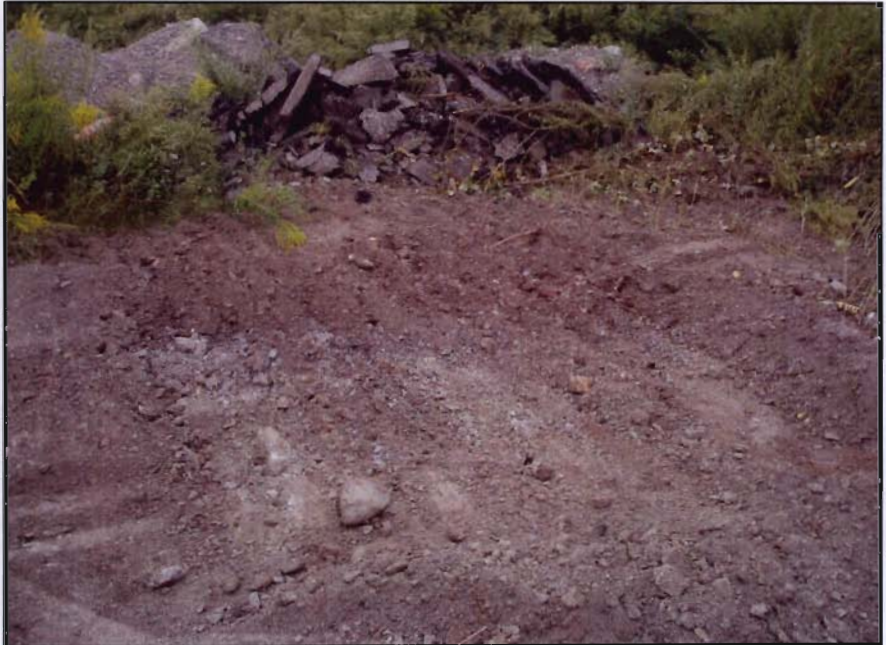
Client Name: Harter, Secrest & Emery		Site Location: 3773 Lake Shore Road	Project No.: 0109 - 001 - 101
Photo No. 9	Date 09/05/08

Direction Photo Taken: South			
Description: Northern drum pile after removal.

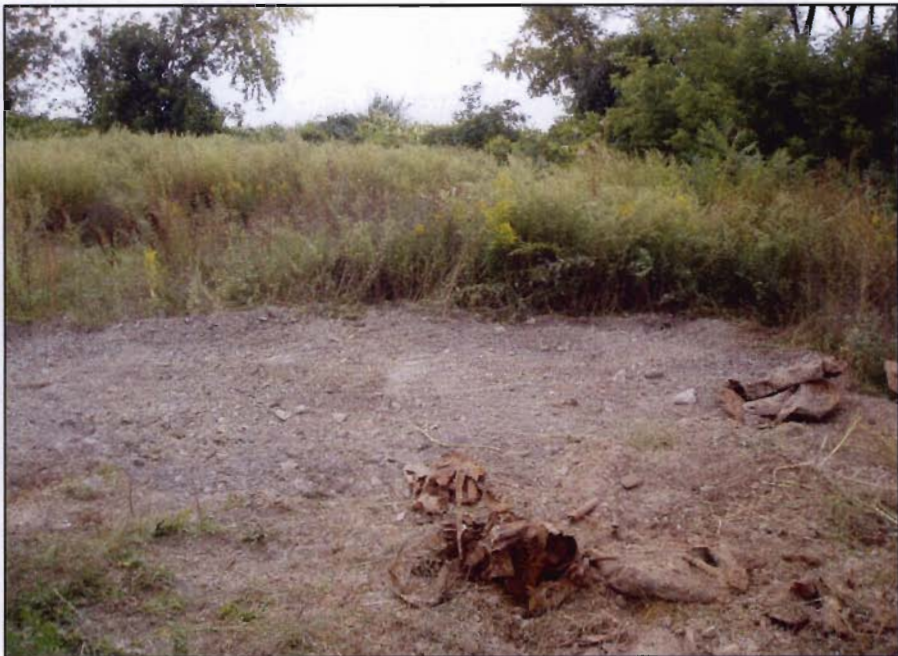
Photo No. 10	Date 09/05/08

Direction Photo Taken: South		
Description: Southern drumpile after removal.

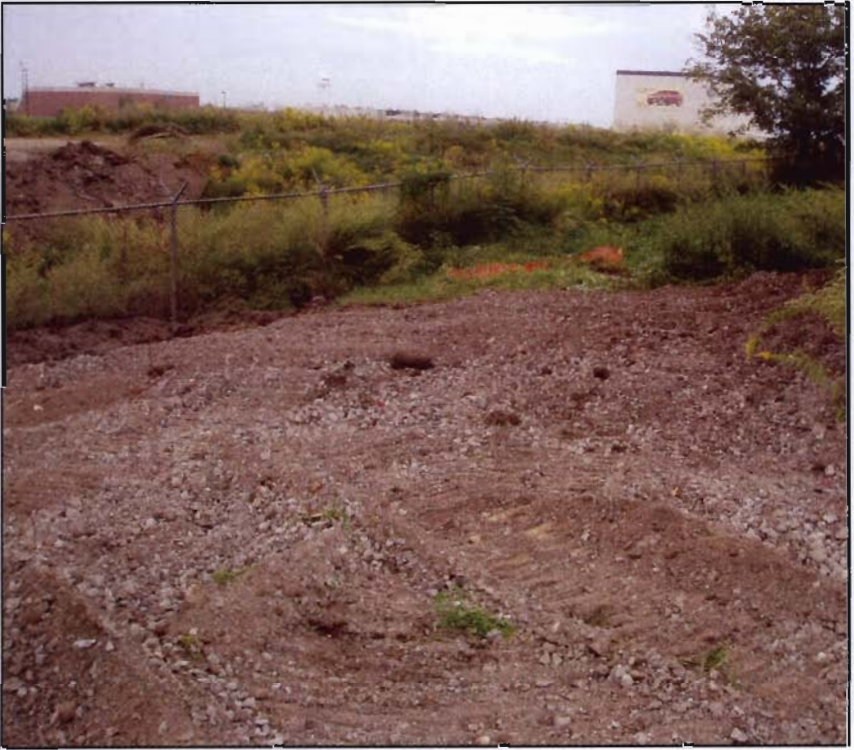
Client Name: Harter, Secret & Emery		Site Location: 3773 Lake Shore Road	Project No.: 0109 - 001 - 101
Photo No. 11	Date 09/05/08

Direction Photo Taken: North			
Description: Toluene tank excavation backfilled.

On September 5, 2008, Benchmark and AAA Environmental replaced the removed VCP piping with a new length of 15-inch diameter PVC storm water pipe. The new section was coupled to the existing storm water pipe with Fernco adaptors. Backfill activities were also completed at this time. Crushed concrete backfill, furnished by Swift River Associates under NYSDEC Beneficial Use Determination 278-9-15, was initially used to carefully surround the new section of pipe. The remainder of the excavation was backfilled with approximately 35 cubic yards of this same material and soil previously overlying the UST. Per our December 19 Work Plan, Benchmark had previously collected four samples of the soil/fill that was overlying the UST for analysis of toluene (see analytical data in Attachment 2). Since this material exhibited non-detectable toluene concentrations, it was deemed acceptable for reuse as backfill material in the excavation. Backfill material was placed into the excavation, compacted in 2-foot lifts using the excavator, and smoothed with the excavator bucket to match final grade and minimize settling.
