Final IRM Report for Operable Unit 2

**Spaulding Composites Site
Tonawanda, Erie County, New York
Site Number 9-15-050**

**March 2007
Revised July 2008**

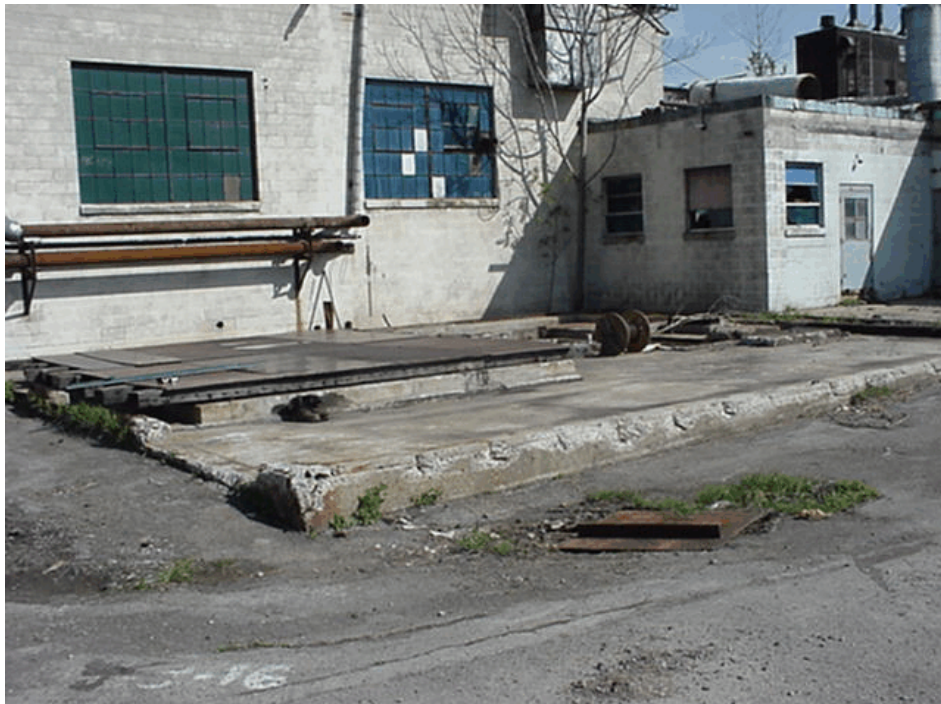
Figure 2-2. Photograph showing the Therminol (behind rolloff) and Baghouse Dust (2-story structure) buildings prior to demolition. View looking northwest. Photograph taken by Brian Hutzler on January 28, 2004.

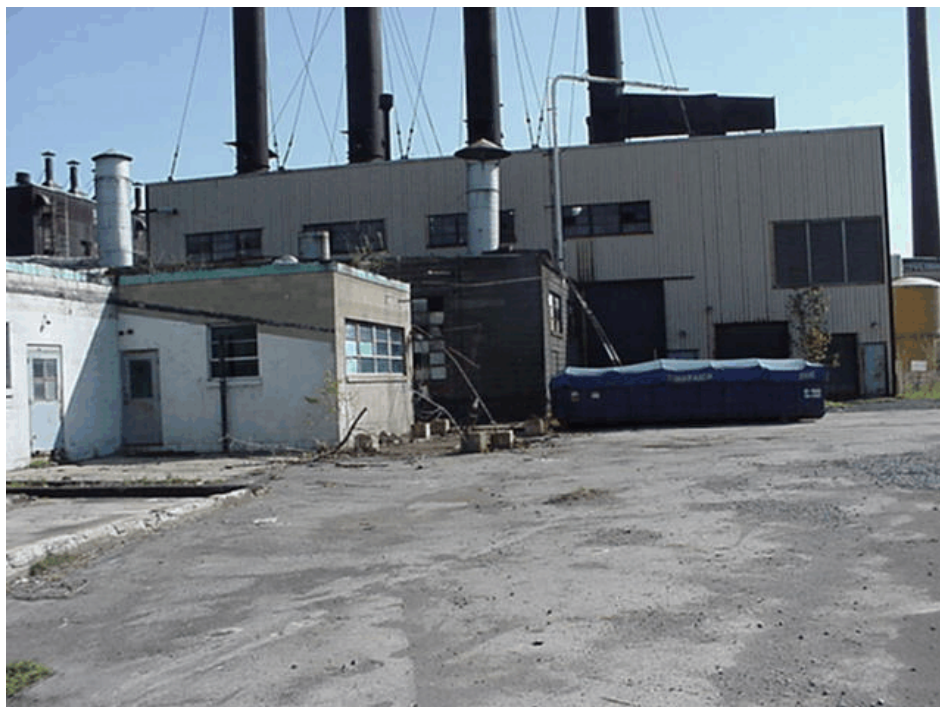
Figure 2-4. Photograph showing the Baghouse Dust Building prior to demolition. View looking north. Photograph taken by Glenn May on March 4, 2004.

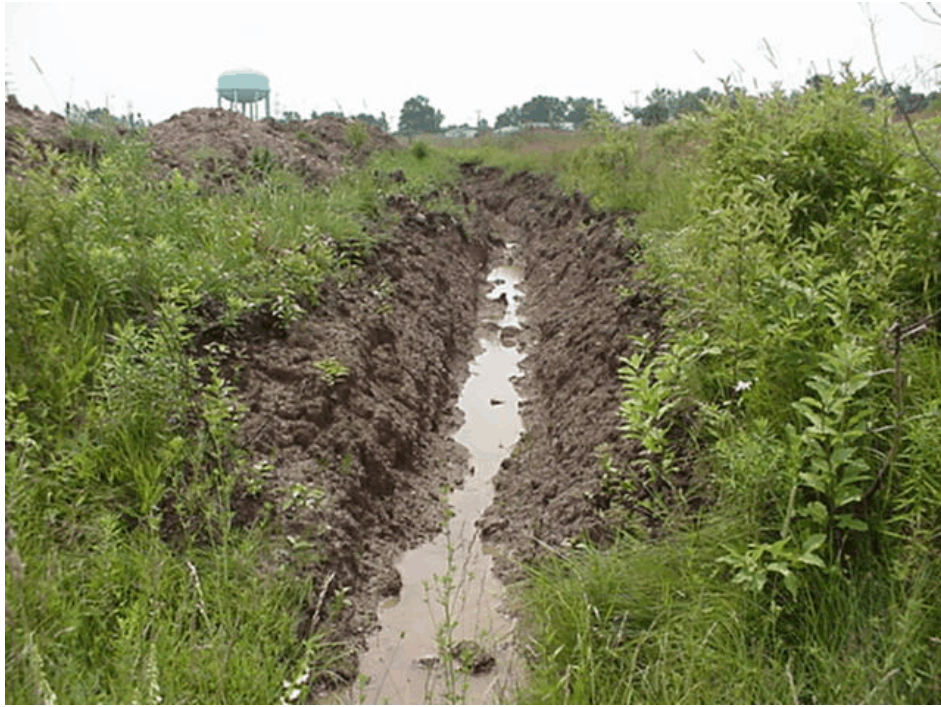
Figure 2-8. Photograph showing the new drainage ditch excavated around SWMU 12. View looking southeast. Photograph taken by Glenn May on July 20, 2004.

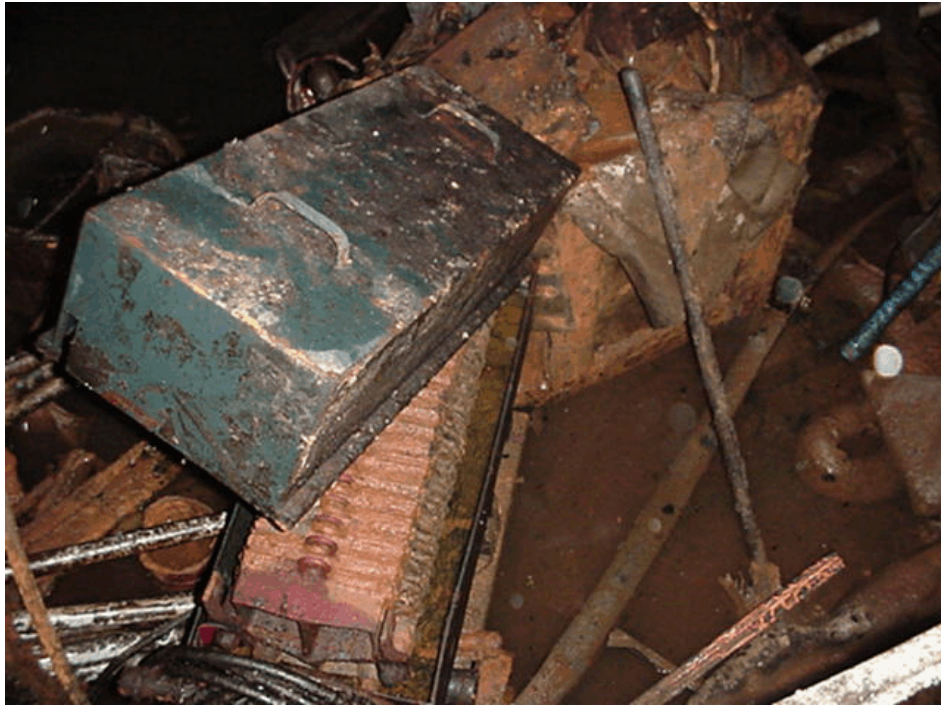
Figure 2-10. Photograph showing the debris in the Spauldite Sheet basement prior to remediation. View from inside the basement. Photograph taken by Ron Huntington on May 6, 2004.

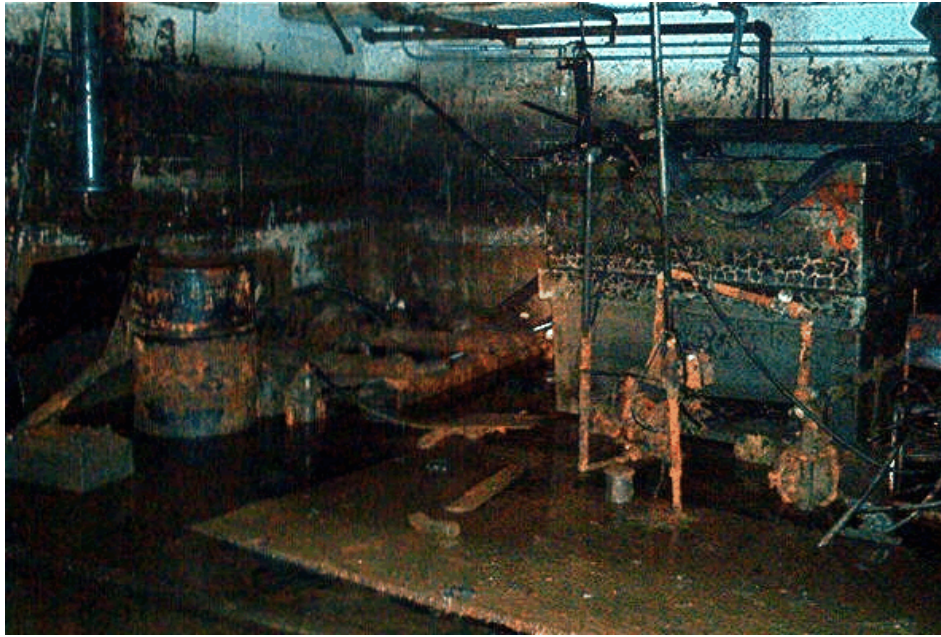
Figure 2-11. Photograph showing the debris in the Spauldite Sheet basement prior to remediation. View from inside the basement. Photograph taken by Ron Huntington on May 6, 2004.

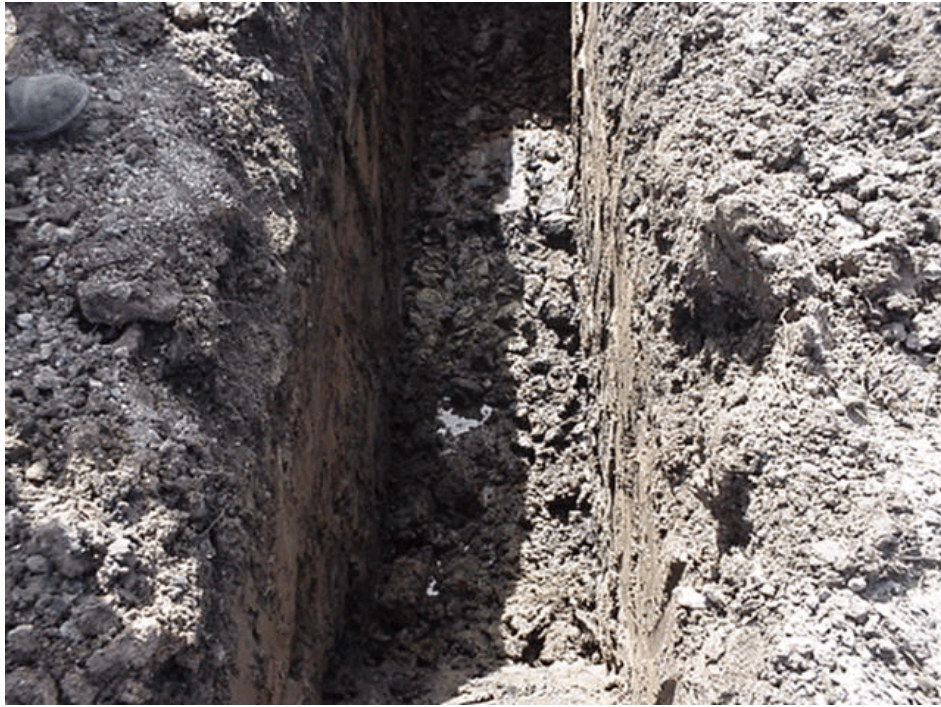
Figure 2-14. Photograph showing the test trench excavated across the south arm of the “U” shaped Settling Lagoon (SWMU 12). View looking southeast. Photograph taken by Ron Huntington on May 6, 2004.

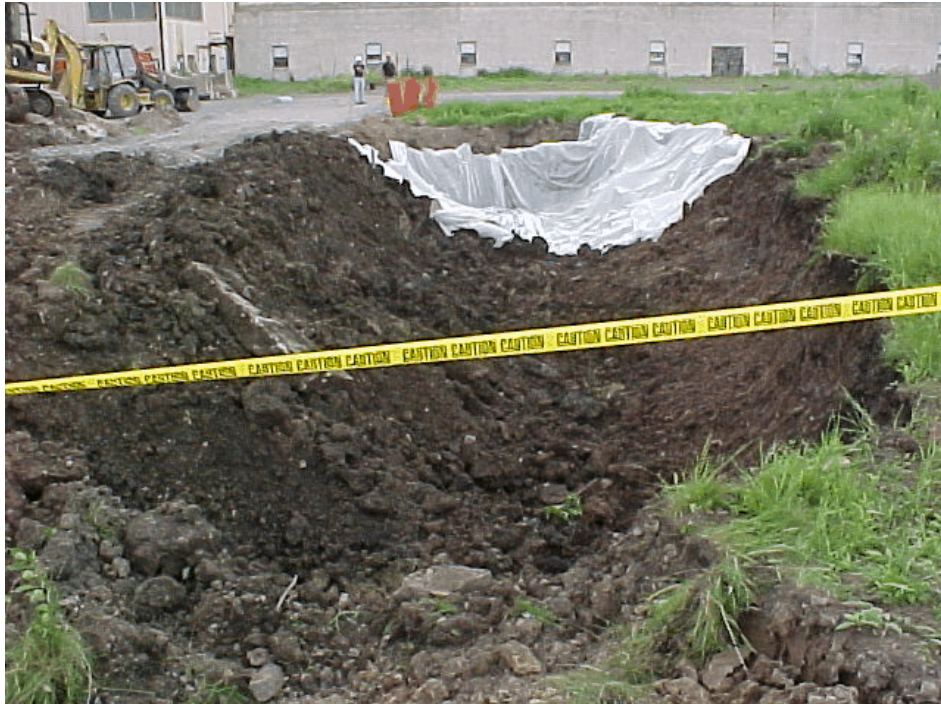
Figure 2-17. Photograph showing the SWMU 12 excavation (north arm). View looking northeast from the base of the lagoon. Photograph taken by Glenn May on July 23, 2004.

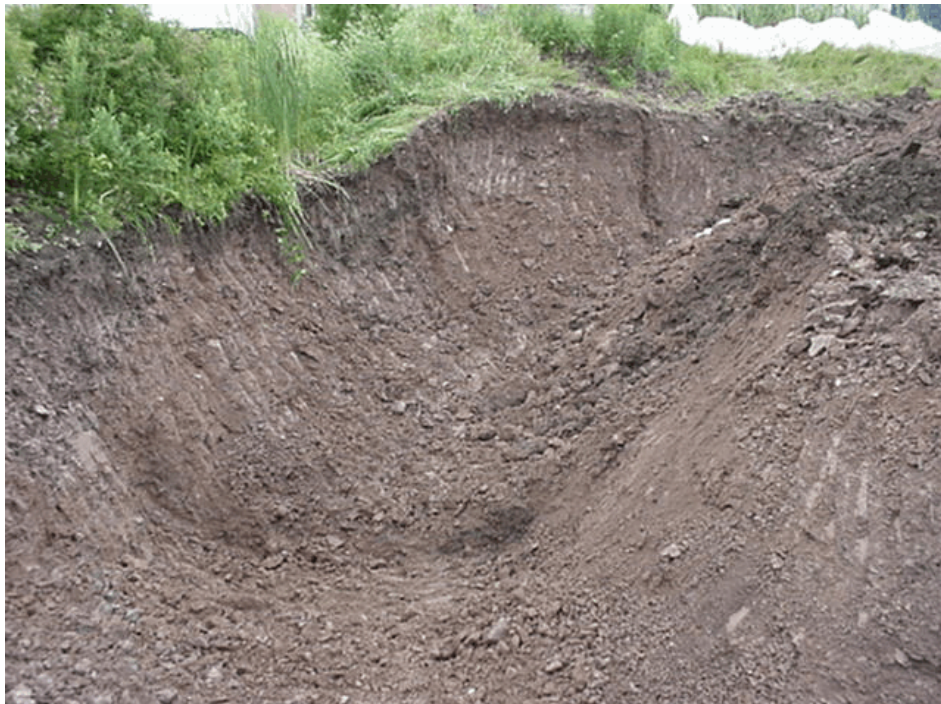
Figure 2-18. Photograph showing the SWMU 12 excavation (base). View looking northwest from the south arm of the lagoon. Photograph taken by Glenn May on July 27, 2004.

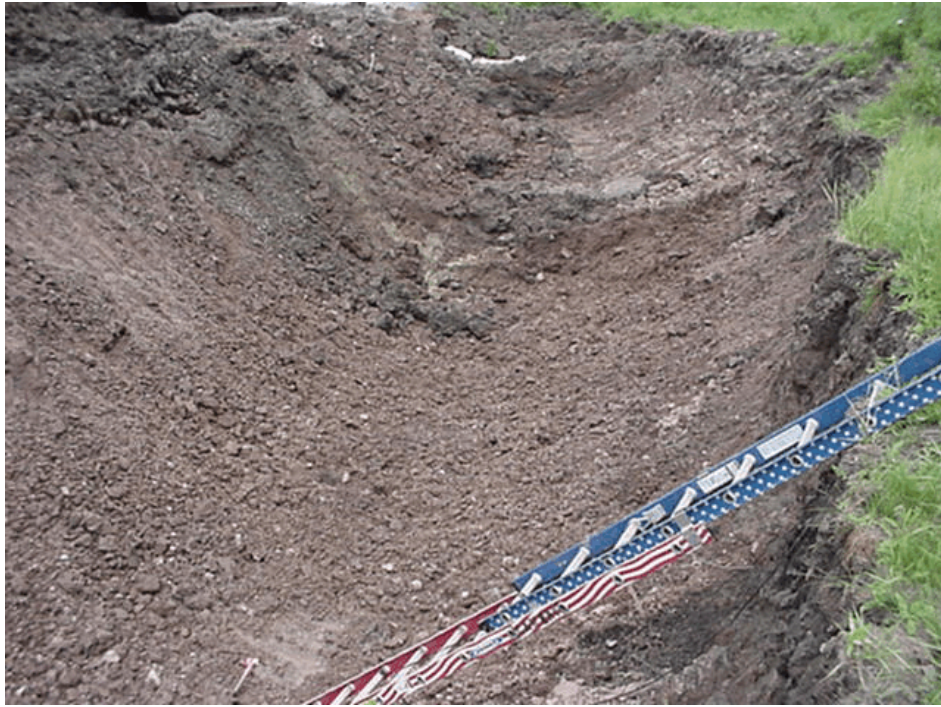
Figure 2-19. Photograph showing the SWMU 12 excavation (south arm). View looking northeast from the base of the lagoon. Photograph taken by Glenn May on July 28, 2004.

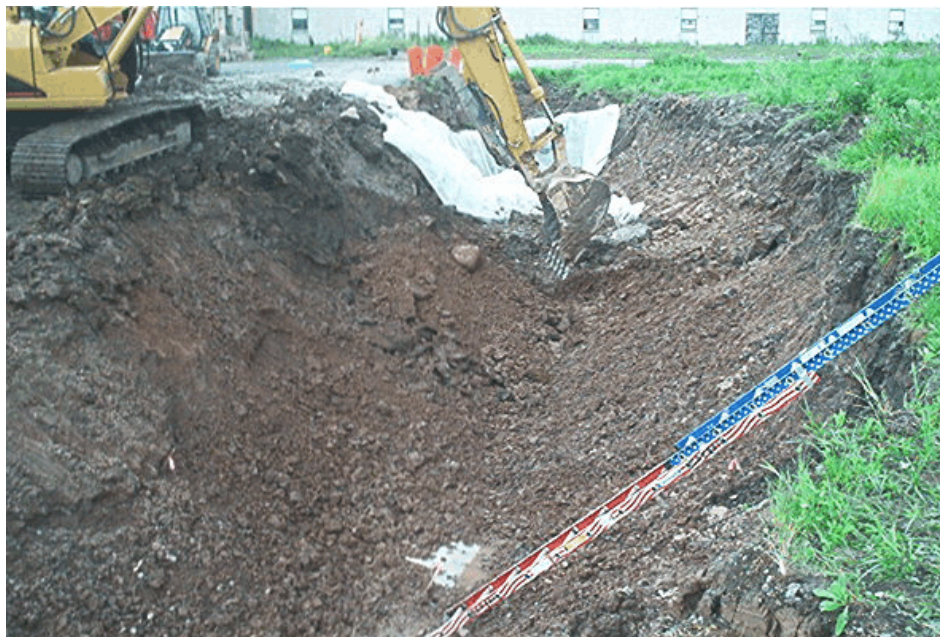
Figure 2-20. Photograph showing the SWMU 12 excavation (north arm). View looking northeast from the base of the lagoon. Photograph taken by Glenn May on July 28, 2004.

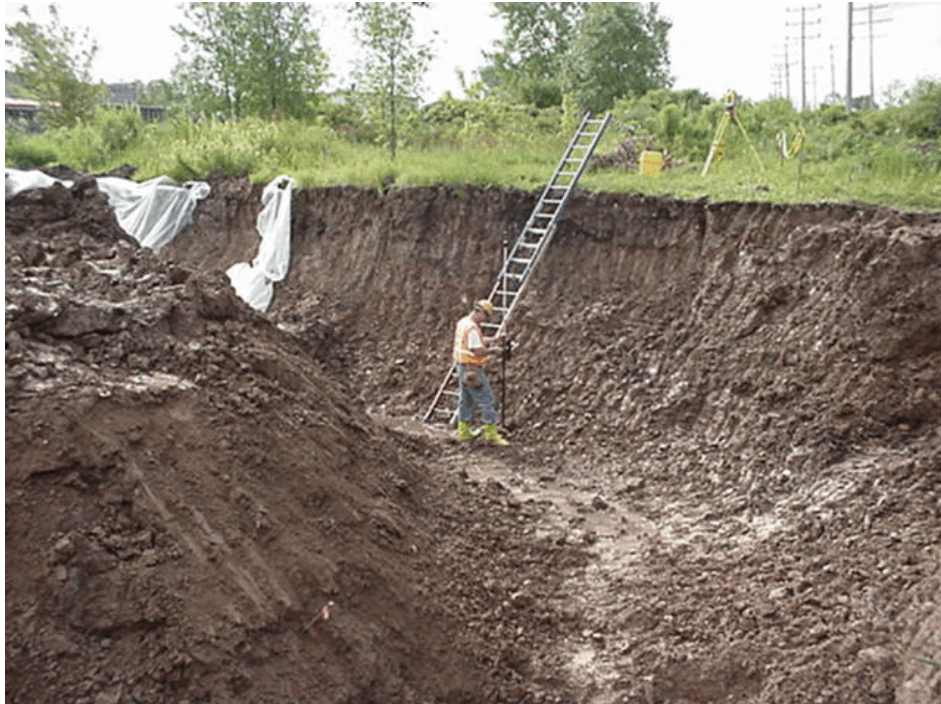
Figure 2-21. Photograph showing the SWMU 12 surveying activities. View looking southwest from the base of the lagoon toward the south arm. Photograph taken by Glenn May on July 28, 2004.

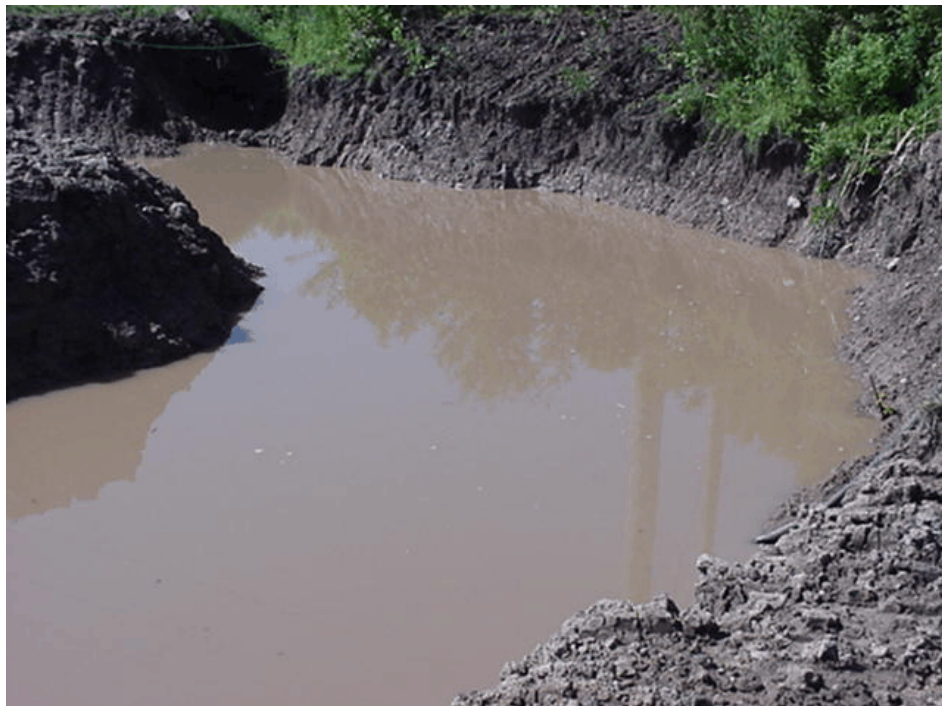
Figure 2-22. Photograph showing the "U" shaped Settling Lagoon (SWMU 12) following heavy rainfall over the previous weekend. Note the high water mark approximately 2 feet below the surface. View looking south. Photograph taken by Glenn May on August 2, 2004.

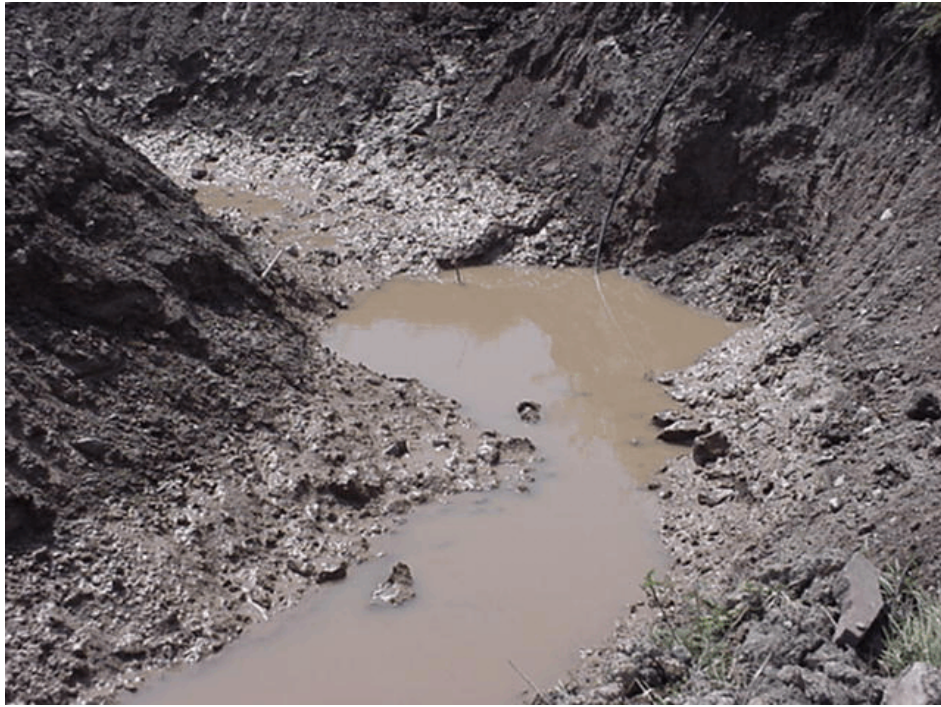
Figure 2-23. Photograph showing the “U” shaped Settling Lagoon (SWMU 12) after being pumped almost dry. View looking south. Photograph taken by Glenn May on August 3, 2004.

When C&W personnel arrived at the Site on Monday morning, August 2nd, they observed that water had filled the excavation to within 2 feet of the ground surface (Figure 2-22). Pumping of this water to the Spauldite Sheet basement began immediately. A check of the rain gauge on site revealed that 2.05 inches of rain had fallen over the weekend. The excavation was essentially pumped dry by the following afternoon (Figure 2-23).

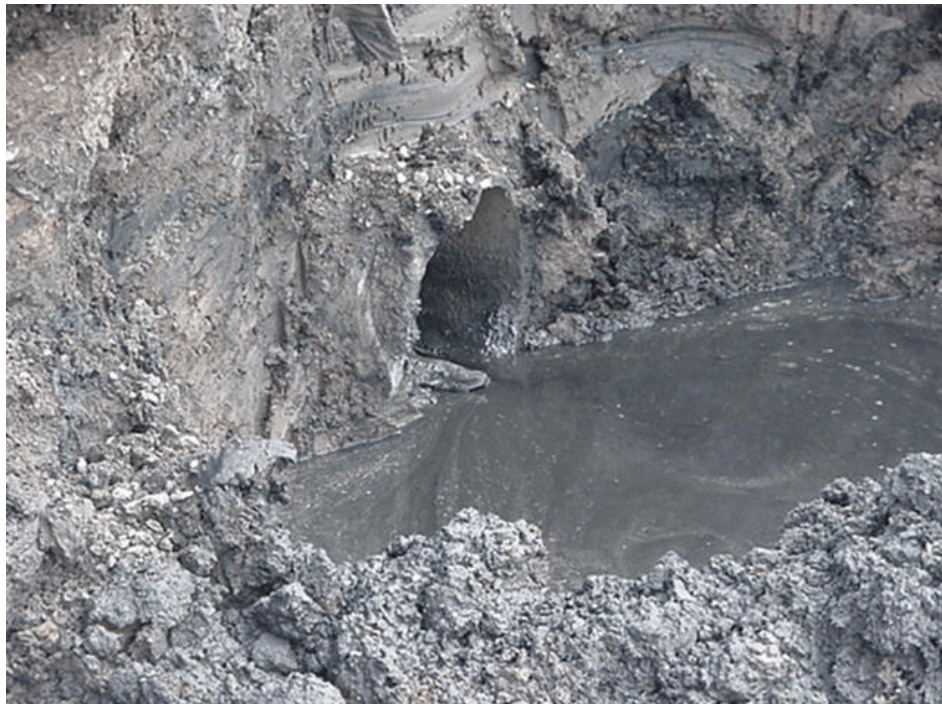
Figure 2-24. Photograph showing the inflow pipe to the north arm of the “U” shaped Settling Lagoon (SWMU 12). View looking east. Photograph taken by Glenn May on August 6, 2004.

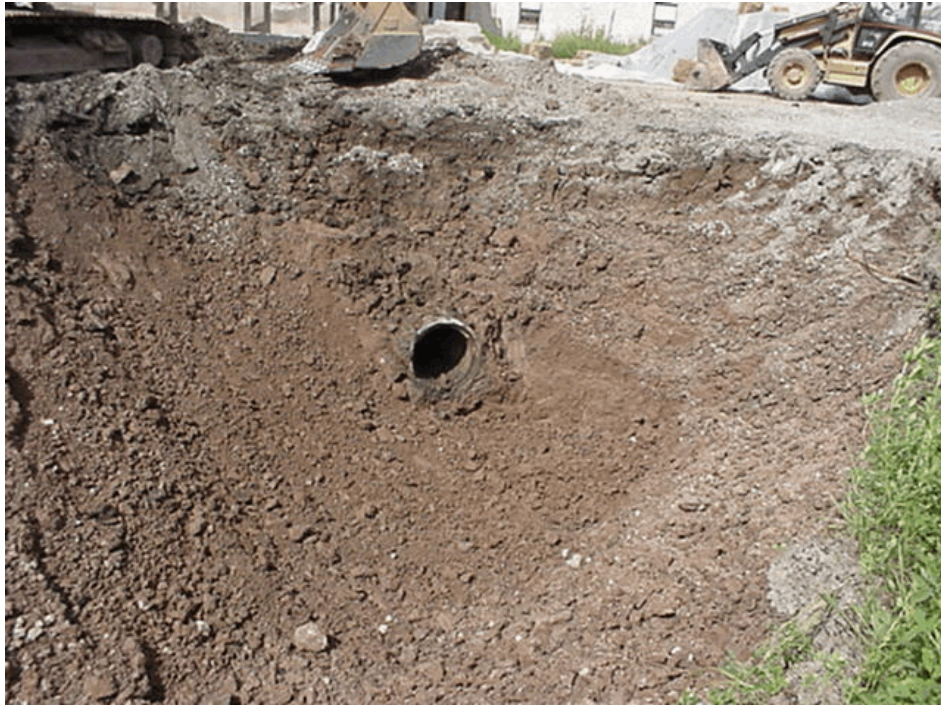
Figure 2-25. Photograph showing the outflow pipe from the south arm of the “U” shaped Settling Lagoon (SWMU 12) to the K-Line sewer. View looking north. Photograph taken by Glenn May on August 6, 2004.

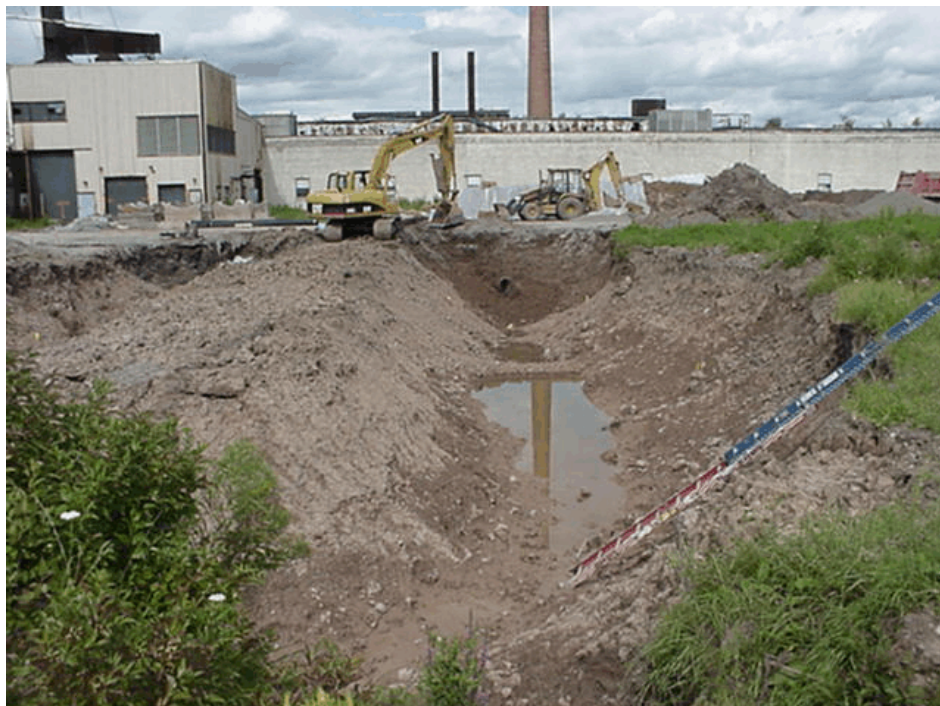
Figure 2-26. Photograph showing the completed SWMU 12 excavation (south arm). View looking northeast. Photograph taken by Glenn May on August 6, 2004.

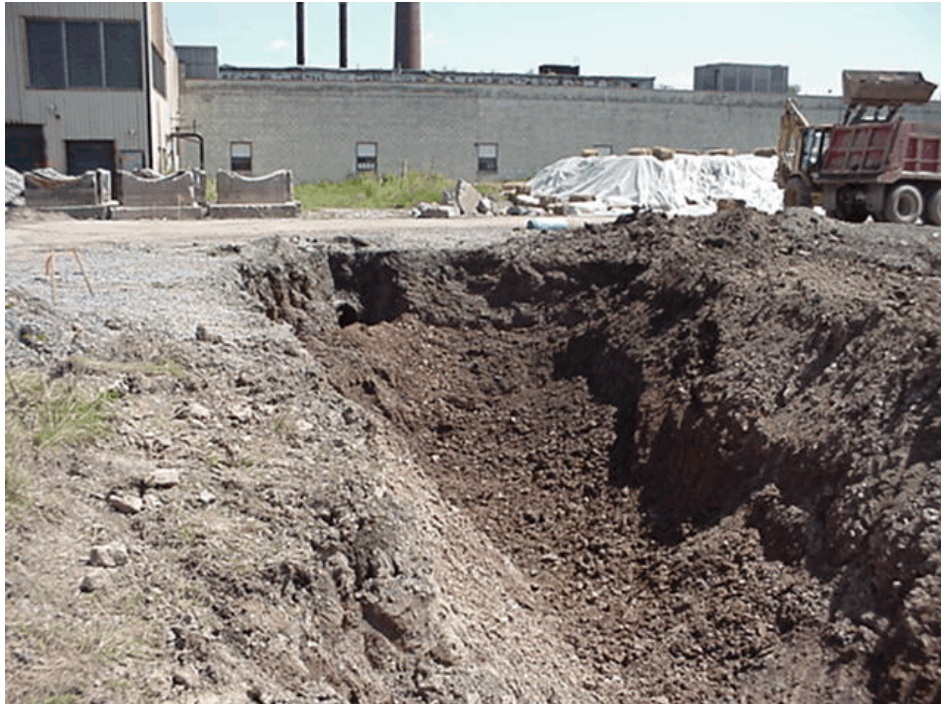
Figure 2-27. Photograph showing the completed SWMU 12 excavation (north arm). View looking northeast. Photograph taken by Glenn May on August 9, 2004.

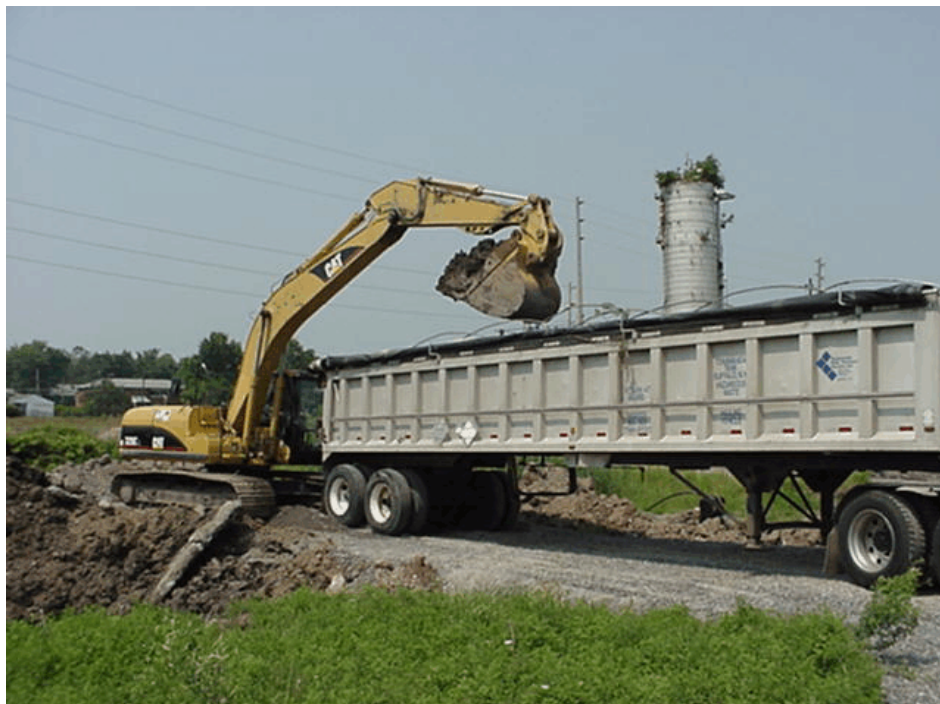
Figure 2-28. Photograph showing the direct loading of trucks during the initial excavation of SWMU 12. View looking northwest. Photograph taken by Glenn May on July 21, 2004.

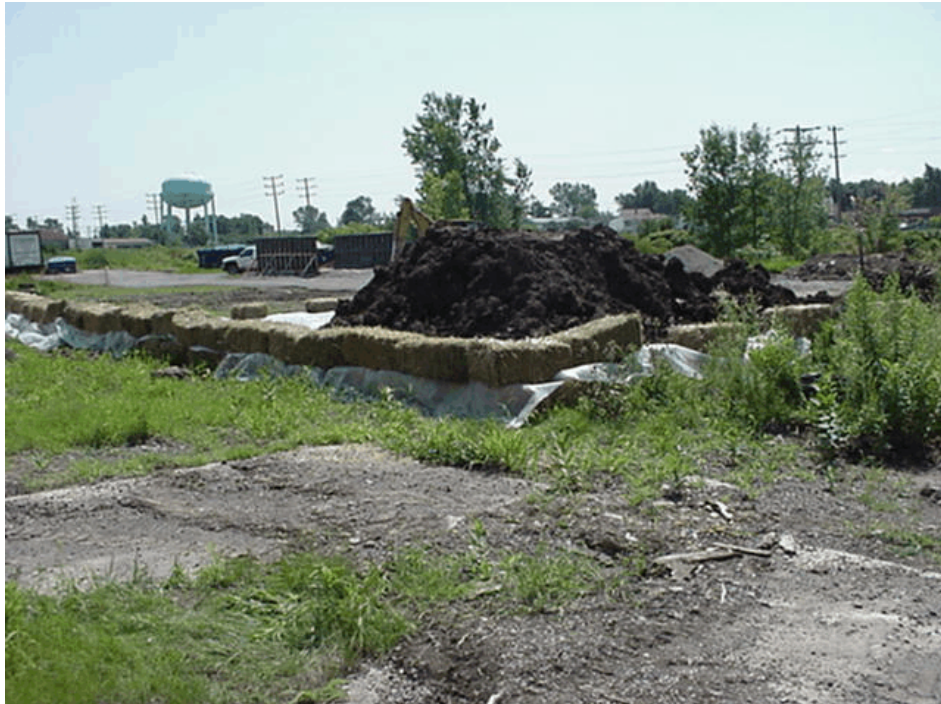
Figure 2-29. Photograph showing the soil staging pad being constructed over the SWMU 23 area. View looking south. Photograph taken by Glenn May on August 3, 2004.

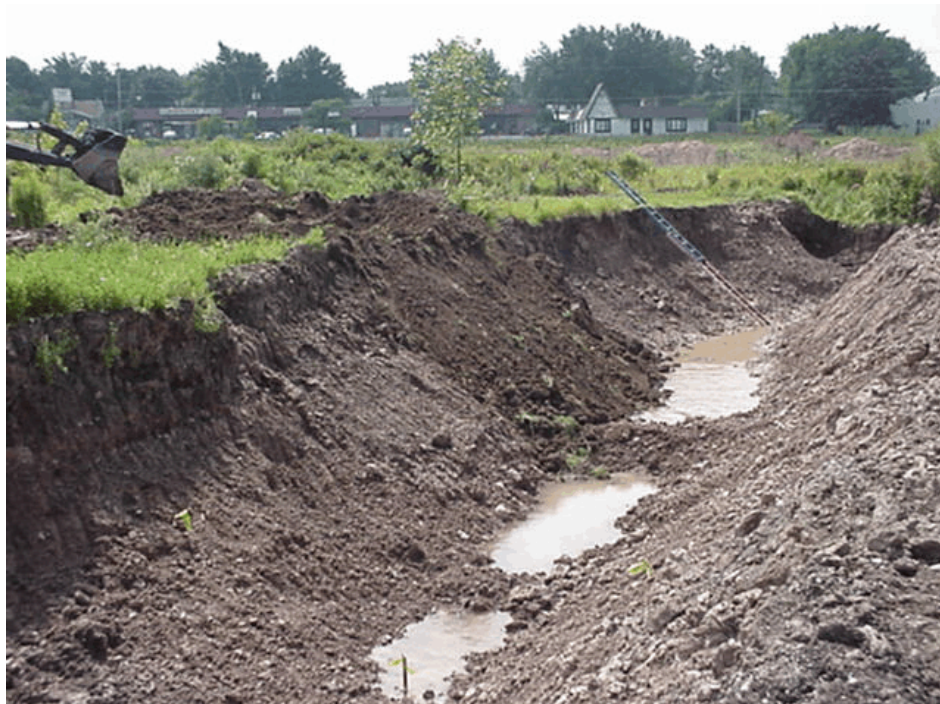
Figure 2-30. Photograph showing the start of backfilling activities at SWMU 12 (south arm). View looking southwest. Photograph taken by Glenn May on August 10, 2004.

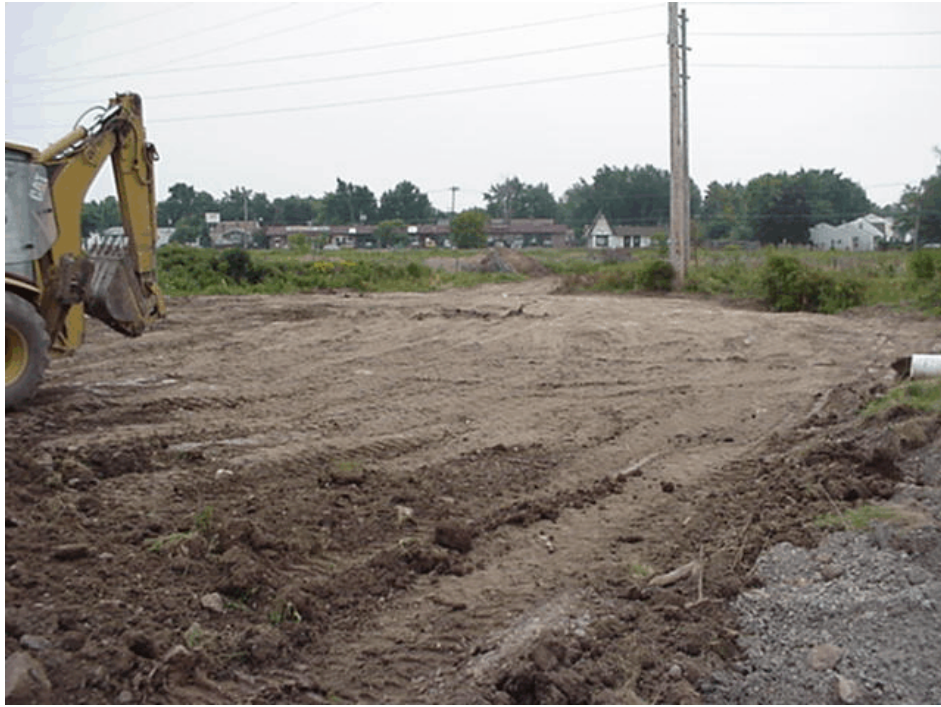
Figure 2-31. Photograph showing the completed backfilling of SWMU 12. View looking southwest. Photograph taken by Glenn May on August 26, 2004.

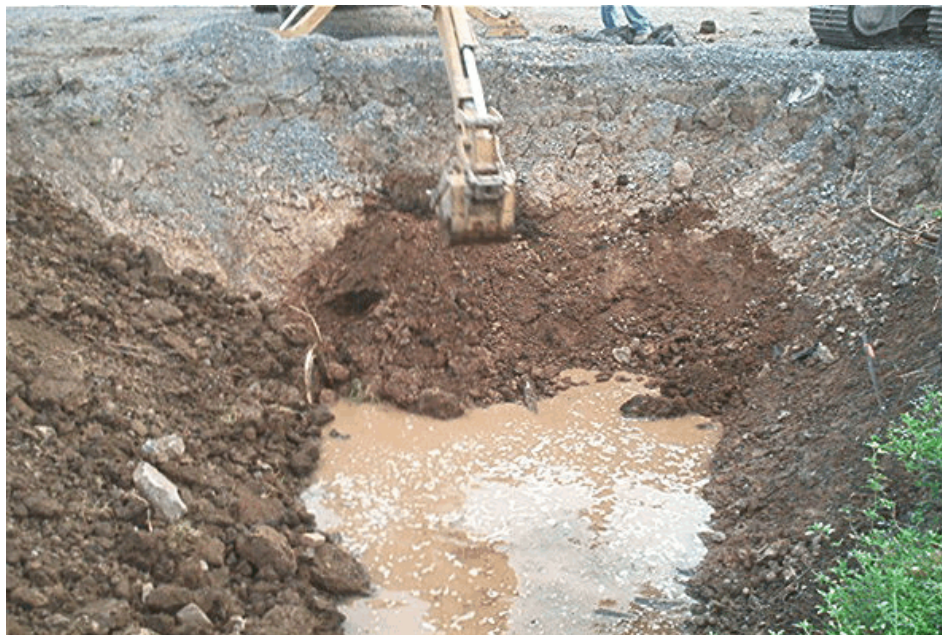
Figure 2-32. Photograph showing the outflow pipe from the south arm of the “U” shaped Settling Lagoon (SWMU 12) being plugged with native silty clay. View looking northeast. Photograph taken by Glenn May on August 27, 2004.

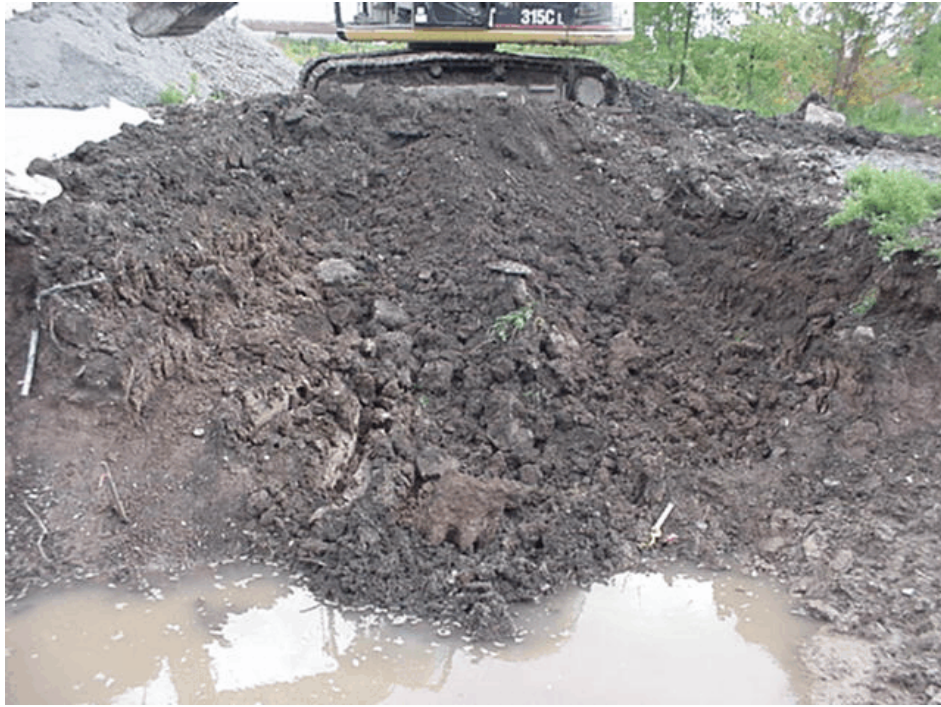
Figure 2-33. Photograph showing the initial excavation of the Southeast Ditch. View looking southeast. Photograph taken by Glenn May on August 31, 2004.

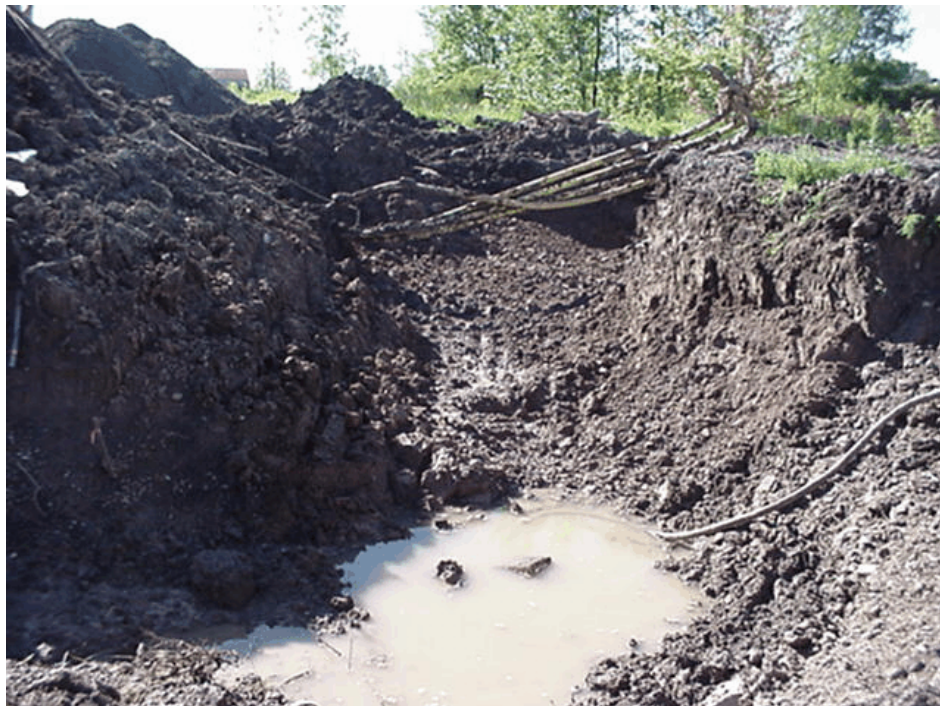
Figure 2-34. Photograph showing the continued excavation of the Southeast Ditch. The pipes in the background conveyed fuel oil from a tank farm located to the right of this photo to the Boiler House. View looking southeast. Photograph taken by Glenn May on September 1, 2004.

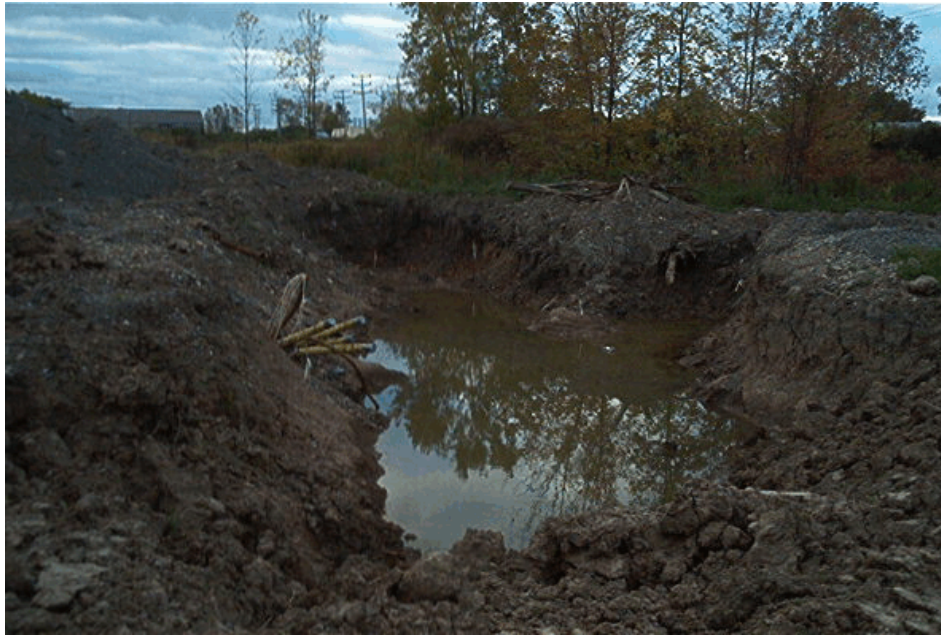
Figure 2-35. Photograph showing the final excavation of the Southeast Ditch. Note that the pipes have been cut and capped. View looking southeast. Photograph taken by Glenn May on October 11, 2004.

On Monday, September 20, 2004 C&W utilized a vac truck to remove petroleum and water from the four lines. The water was drained into the Spauldite Sheet basement for eventual treatment through the temporary water treatment system, while the petroleum was placed into drums for future disposal. The pipes were cut off with a reciprocating saw near the sidewall of the excavation and sealed with duct tape (Figure 2-35).

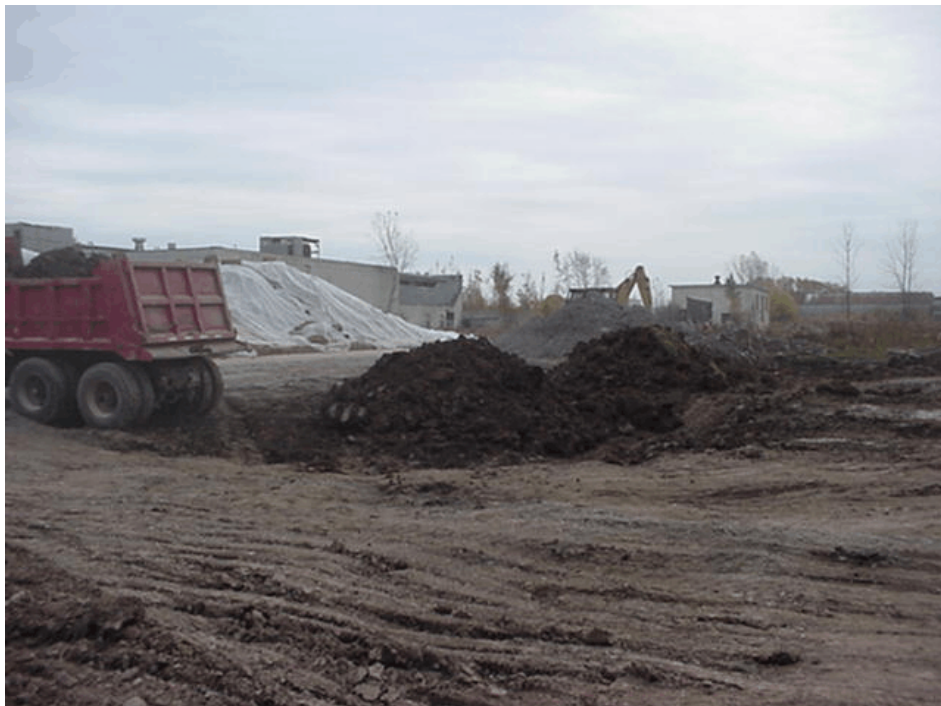
Figure 2-36. Photograph showing the backfilling of the Southeast Ditch. View looking southeast. Photograph taken by Glenn May on October 29, 2004.

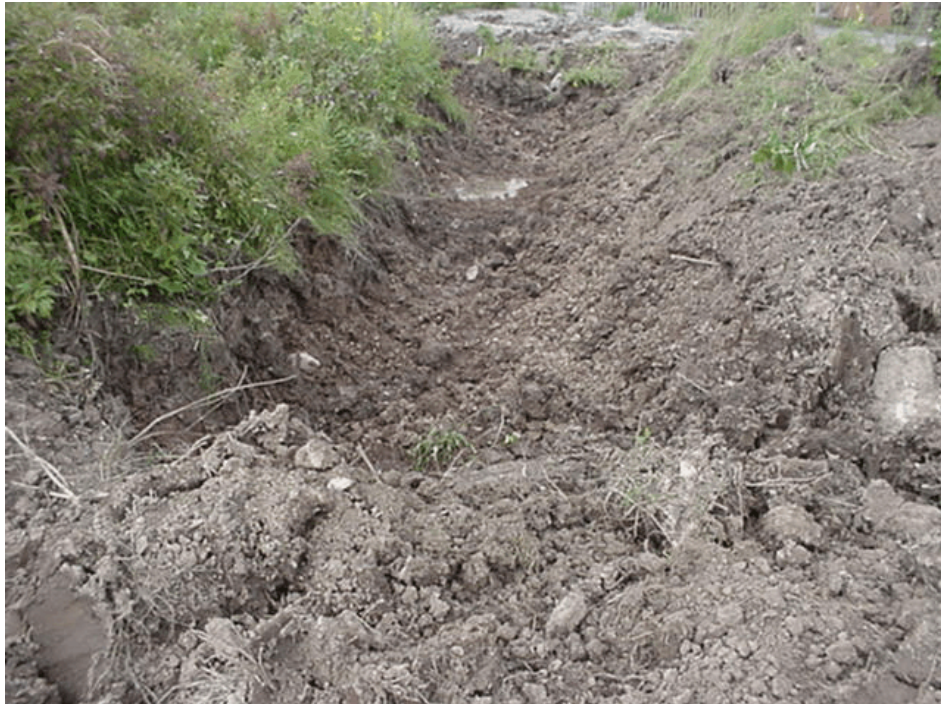
Figure 2-38. Photograph showing the initial excavation of the Northwest Ditch. View looking southeast. Photograph taken by Glenn May on August 31, 2004.

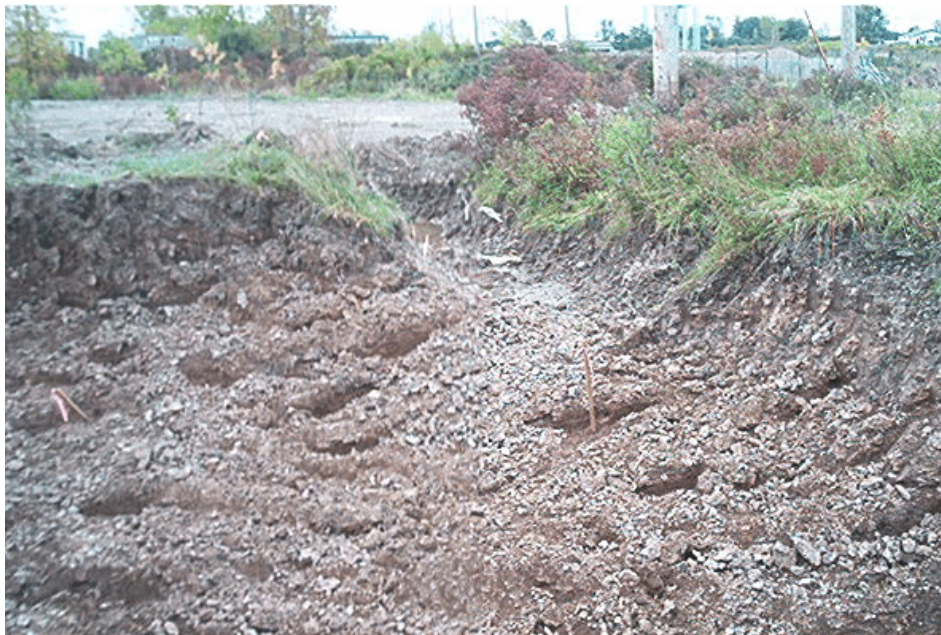
Figure 2-39. Photograph showing the final excavation of the Northwest Ditch. View looking southeast. Photograph taken by Glenn May on October 11, 2004.

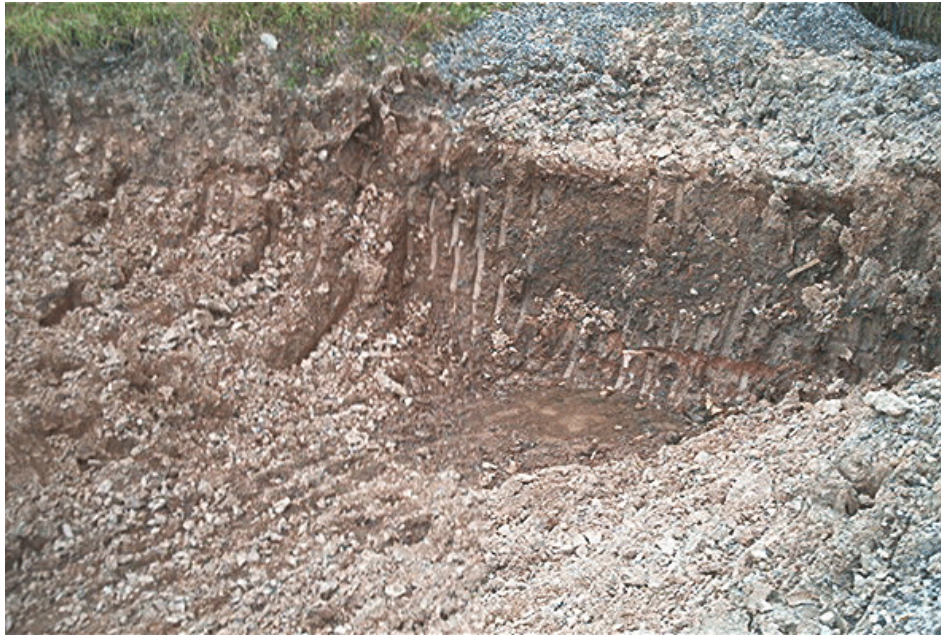
Figure 2-40. Photograph showing the grinding waste (rusty color approximately 1 foot above the floor of the excavation) left in the Roadway Ditch due to the presence of the field trailers. View looking southwest. Photograph taken by Glenn May on October 11, 2004.

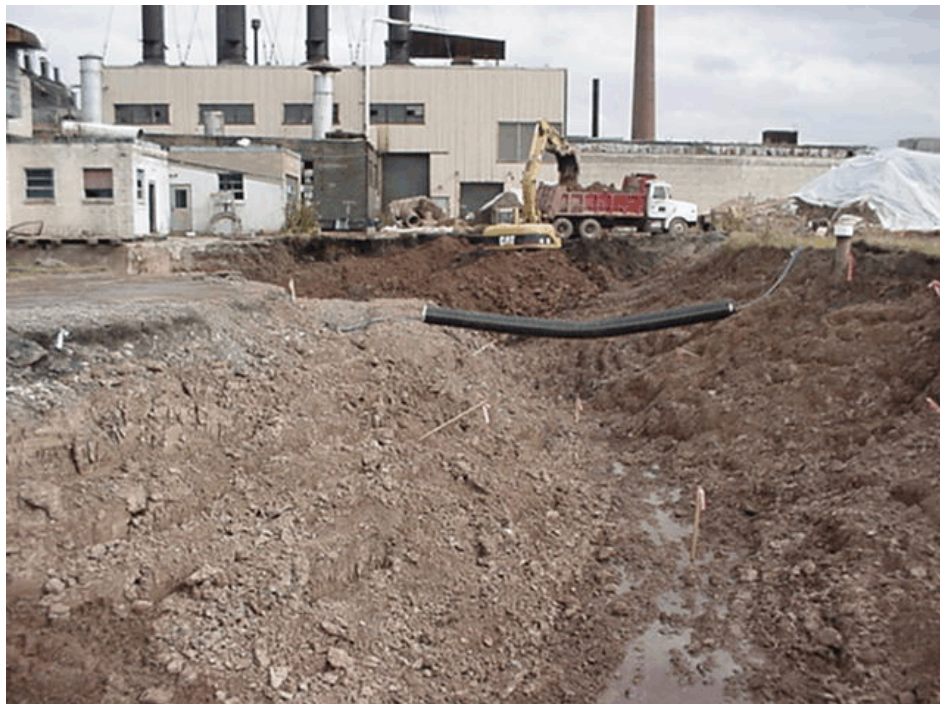
Figure 2-41. Photograph showing the merger of the Roadway Ditch excavation with the SWMU 38 (Therminol Building) excavation. View looking northeast. Photograph taken by Glenn May on October 15, 2004.

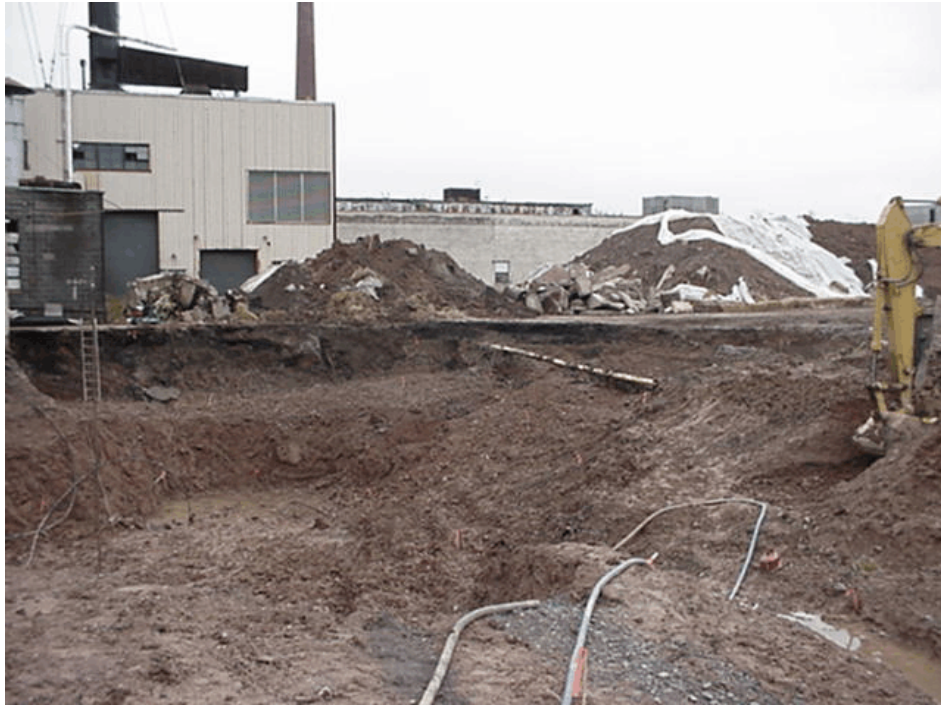
Figure 2-42. Photograph showing the excavation of the trench as part of the Roadway Ditch remediation. The SWMU 38 excavation is located to the left of the excavator, while the contaminated soil stockpile can be observed in the background. View looking east. Photograph taken by Glenn May on October 22, 2004.

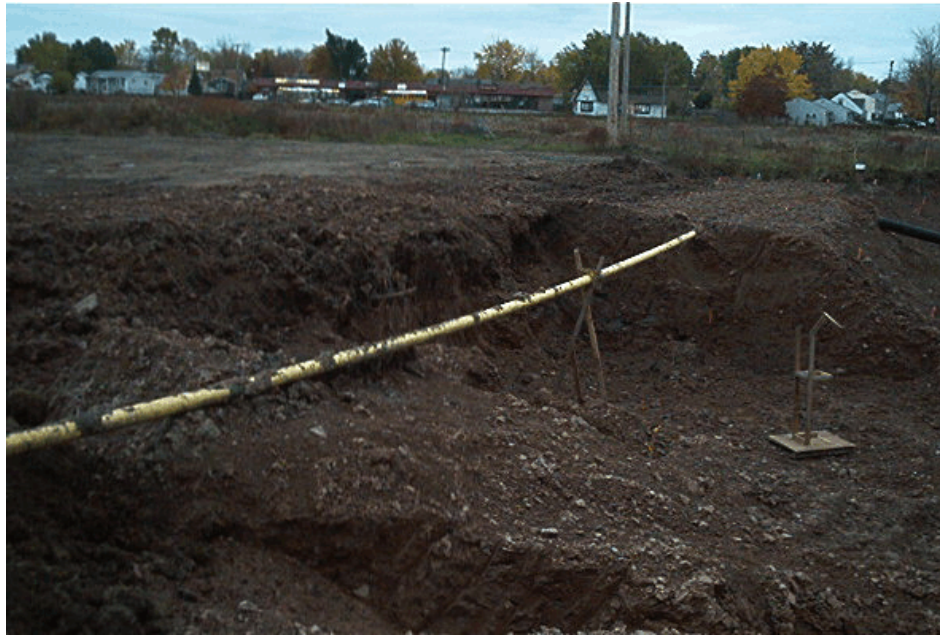
Figure 2-43. Photograph showing the final excavation of the trench associated with the Roadway Ditch. Note the bracing utilized to support the high pressure natural gas pipeline. View looking southwest. Photograph taken by Glenn May on November 1, 2004.
