Final IRM Report for Operable Unit 2

**Spaulding Composites Site
Tonawanda, Erie County, New York
Site Number 9-15-050**

**March 2007
Revised July 2008**

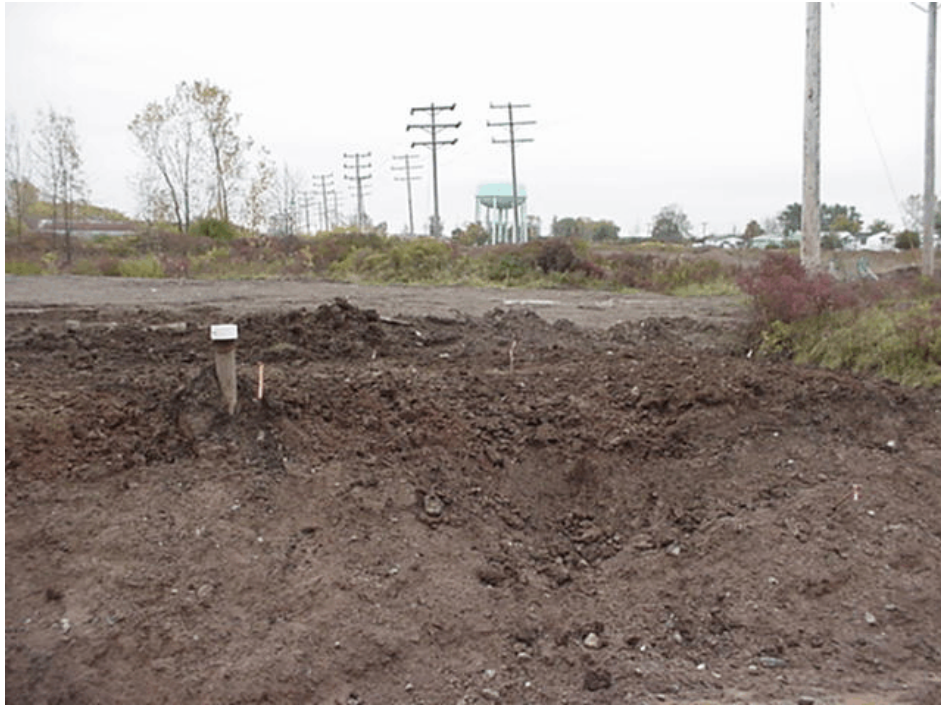
Figure 2-44. Photograph showing the initial excavation of the berm located between the Roadway Ditch (foreground) and SWMU 12 (background). View looking south. Photograph taken by Glenn May on October 22, 2004.

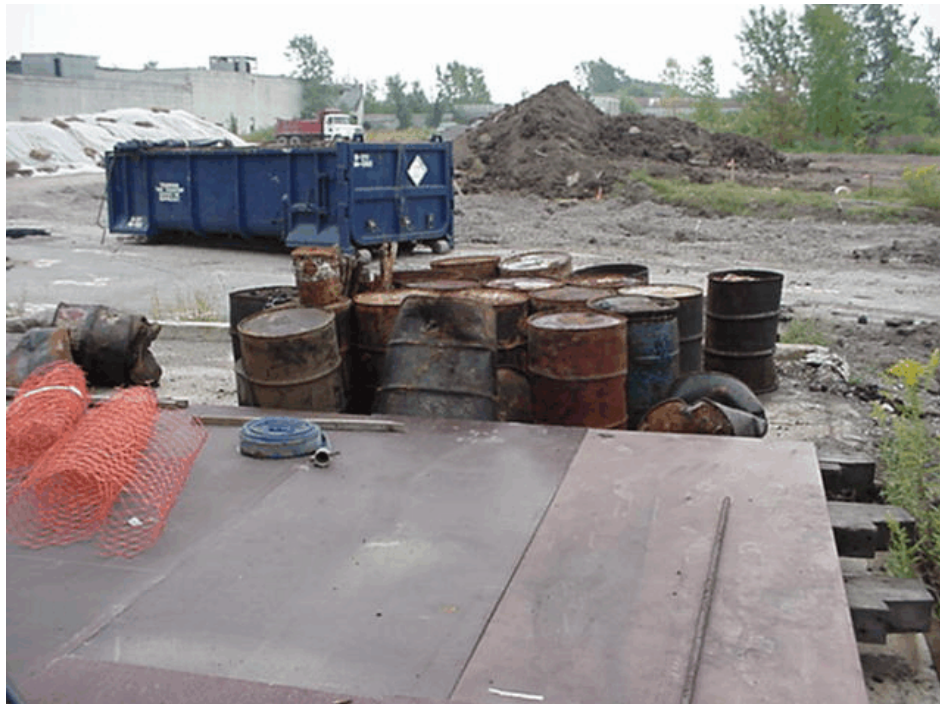
Figure 2-45. Photograph showing the drums removed from the Spauldite Sheet basement during remediation. View looking southeast. Photograph taken by Glenn May on August 27, 2004.

On Friday, August 27, 2004 a full crew of laborers worked in the basement removing most of the remaining equipment, drums and debris. One rolloff was filled, with the remaining material staged near the Therminol Building until additional rolloffs were brought to the Site (Figures 2-45 and 2-46). Sludge from the basement was also staged in this area.

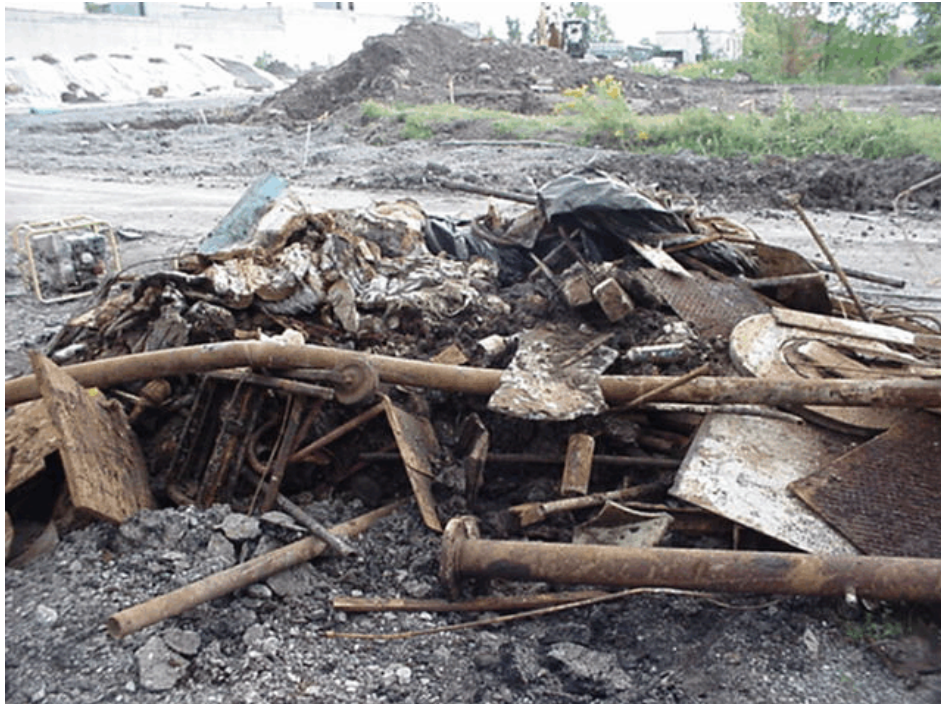
Figure 2-46. Photograph showing some of the debris removed from the Spauldite Sheet basement during remediation. View looking southeast. Photograph taken by Glenn May on August 31, 2004.

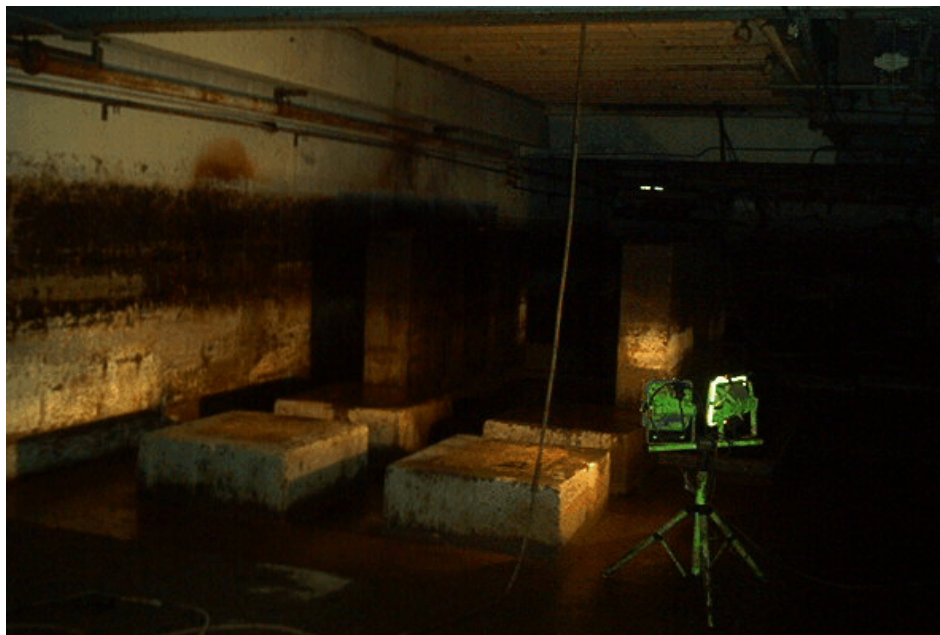
Figure 2-47. Photograph showing the remediated Spauldite Sheet basement. View from inside the basement. Photograph taken by Glenn May on September 8, 2004.

When C&W personnel arrived at the Site on Monday morning, August 30th, they observed that the basement contained 17 inches of water that had accumulated from the heavy rains over the weekend. As a result, work in the basement ceased until Thursday, September 2nd when the water was pumped down enough for work to resume. This work consisted of the removal of the remaining piping, debris and sludge. Sludge from seven sumps was also removed with a vac truck, which was emptied onto the contaminated soil stockpile. All work in the basement was completed on Wednesday, September 8, 2004 (Figure 2-47).

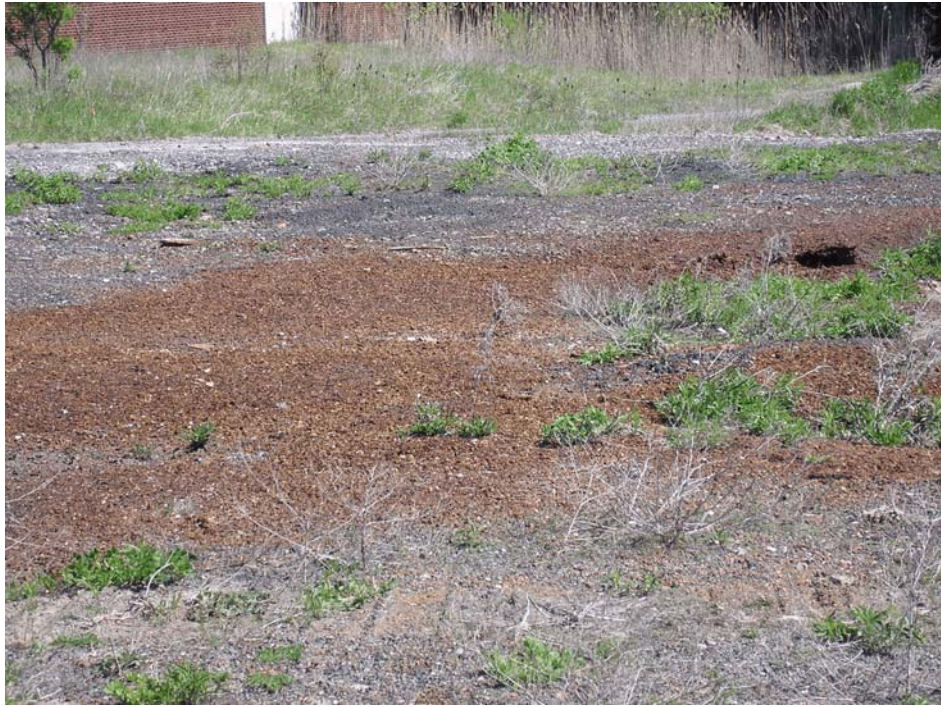
Figure 2-49. Photograph showing the button ash that was encountered under the clean soil stockpile. View looking north. Photograph taken by Glenn May on May 2, 2006.

When removing soil from the clean soil stockpile, button ash was observed across the surface

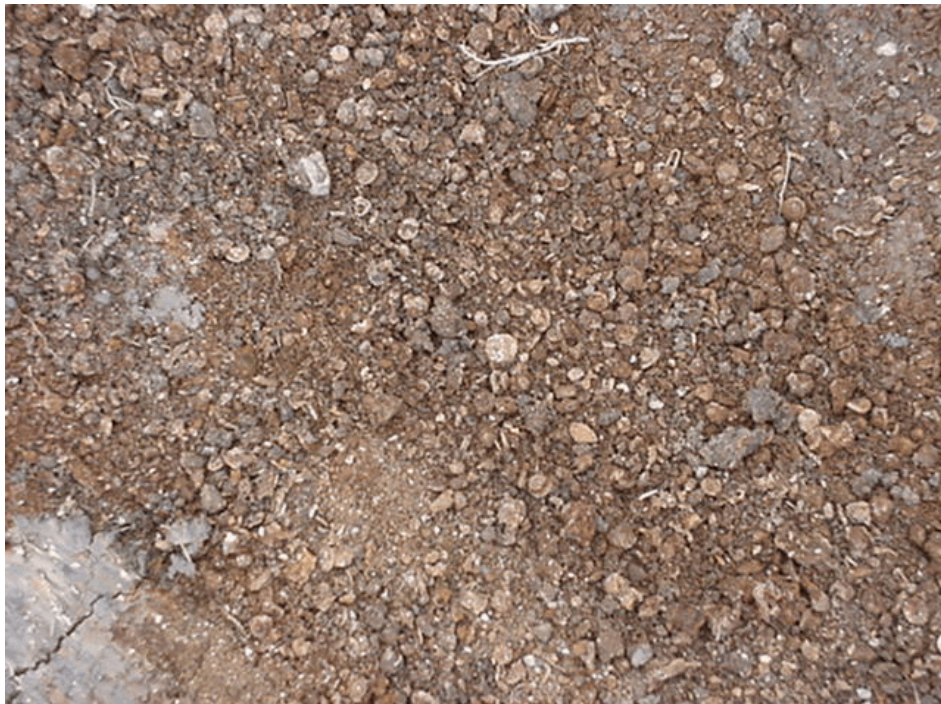
When removing soil from the clean soil stockpile, fill material was observed across the surface of the entire area (Figure 2-49). This fill material consisted predominantly of rust colored ash containing numerous buttons with some fibre fragments and black coal ash (Figure 2-50). On Friday, August 27, 2004 this fill material was scraped down to the native silty clay soil to the extent practicable with a backhoe and stockpiled in this area of the Site (Figure 2-51). On September 14, 2004 one composite sample of the button-ash stockpile was collected and sent to PSC for analysis to determine the nature of contamination in this material. The analytical results from this sample are discussed in Section 3.5.2.

Figure 2-50. Photograph showing a closeup of the button ash underlying the clean soil stockpile. Photograph taken by Glenn May on August 26, 2004.

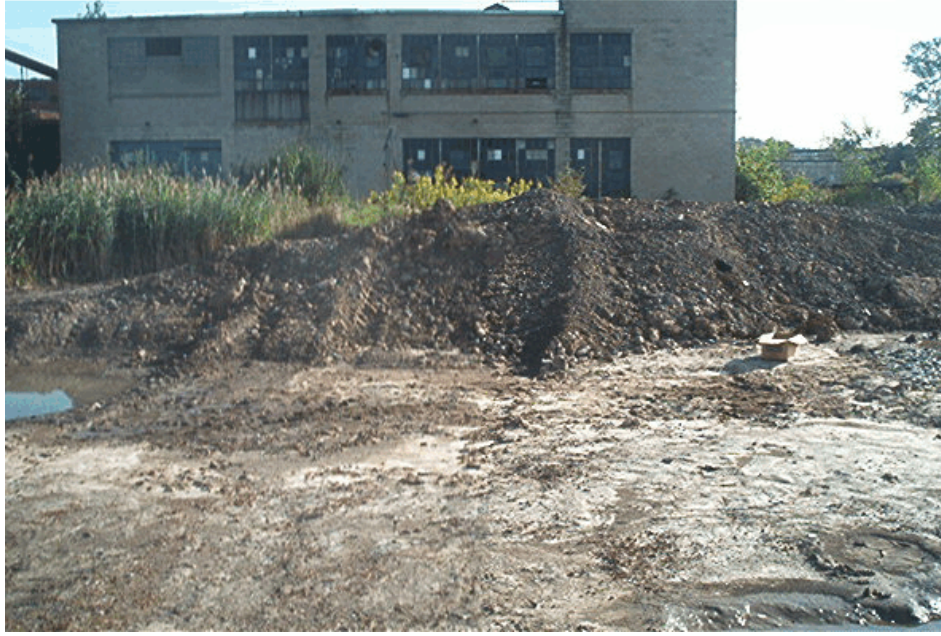
Figure 2-51. Photograph showing the stockpiled bottom ash. View looking northeast. Photograph taken by Glenn May on September 14, 2004.

of the entire area (Figure 2-49). On Friday, August 27, 2004 this fill material was scraped down to the native silty clay soil to the extent practicable with a backhoe and stockpiled in this area of the Site (Figure 2-51). On September 14, 2004 one composite sample of the button ash stockpile was collected and sent to PSC for analysis of TCL volatiles using USEPA Method 8260, TCL semivolatiles using USEPA Method 8270, TCL pesticides using USEPA Method 8081, TCL PCBs using USEPA Method 8082 and TAL metals using USEPA Method 6010.

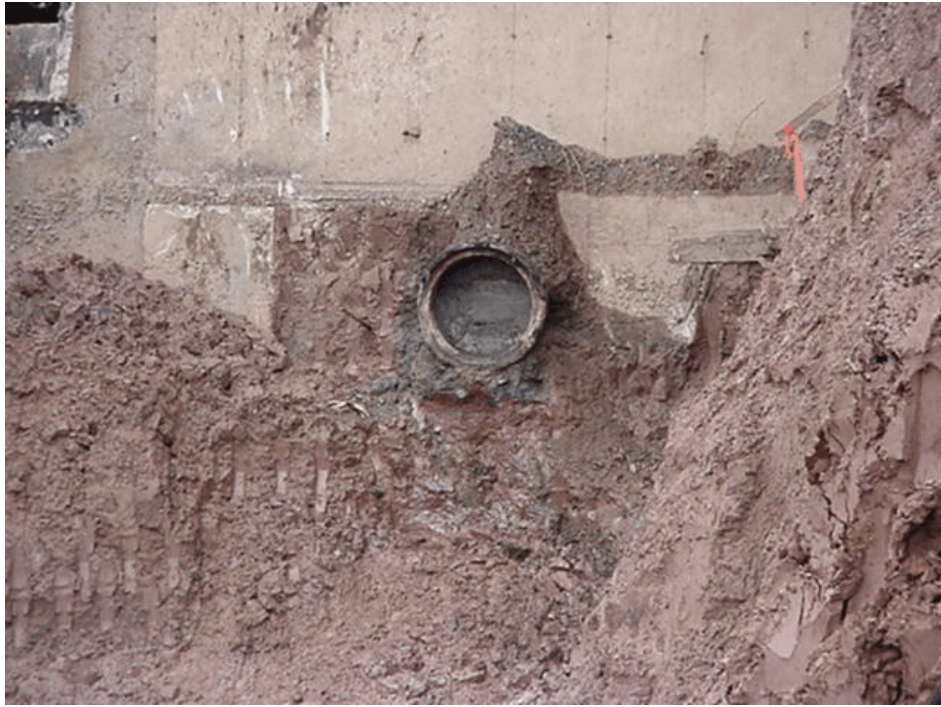
Figure 2-54. Photograph showing the K-Line storm sewer near the former Therminol Building after it was plugged with bricks and mortar. View looking northwest. Photograph taken by Glenn May on October 21, 2004.

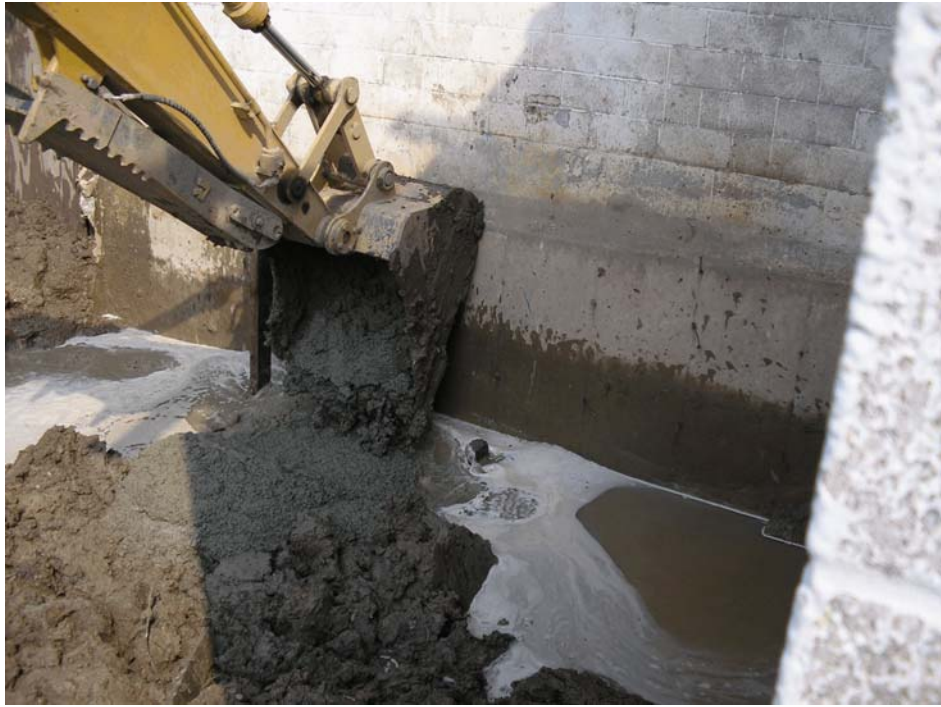
Figure 2-56. Photograph showing the concrete being poured into the form around the K-Line storm sewer. View looking northwest. Photograph taken by Glenn May on June 10, 2005.

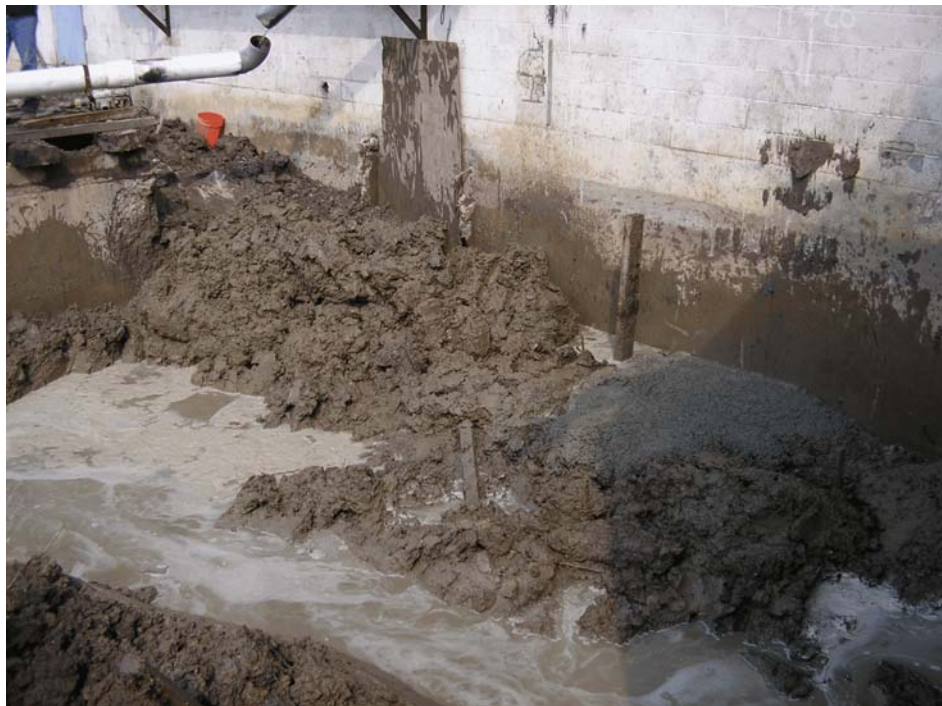
Figure 2-57. Photograph showing the completed concrete plug around the K-Line storm sewer near the former Therminol Building. View looking northwest. Photograph taken by Glenn May on June 10, 2005.

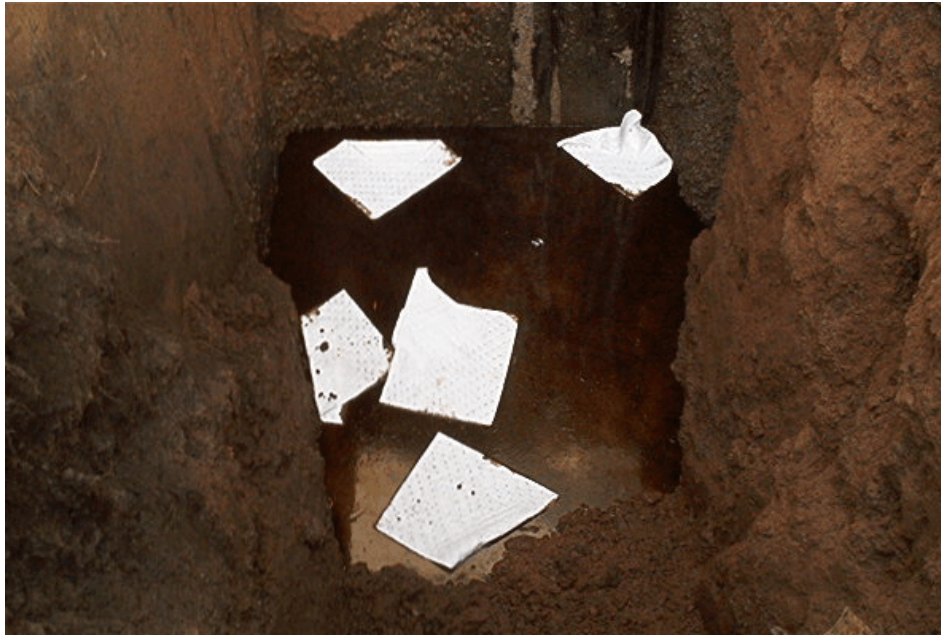
Figure 2-58. Photograph showing the NAPL encountered along the outside wall of the Spauldite Sheet basement. View looking northwest. Photograph taken by Glenn May on September 28, 2004.

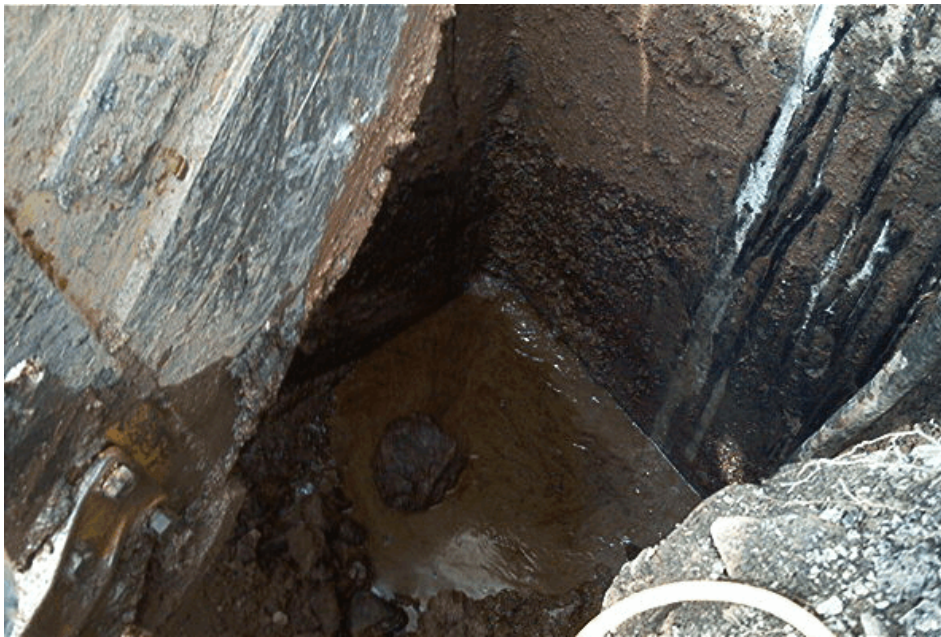
Figure 2-59. Photograph showing the NAPL encountered along the outside wall of the Spauldite Sheet basement. View looking west. Photograph taken by Glenn May on September 28, 2004.

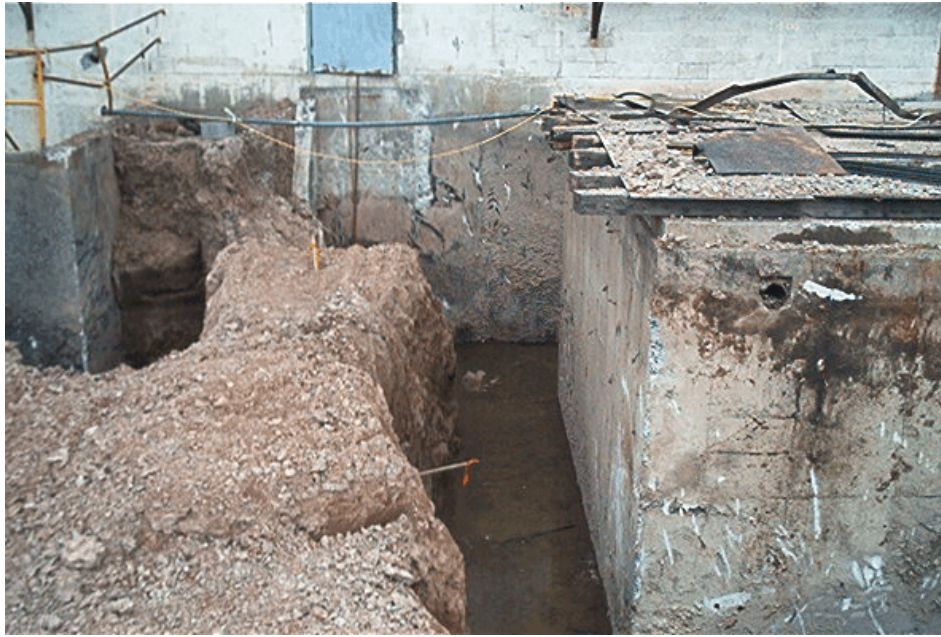
Figure 2-60. Photograph showing the final excavation along building foundations. View looking northwest. Photograph taken by Glenn May on October 11, 2004.

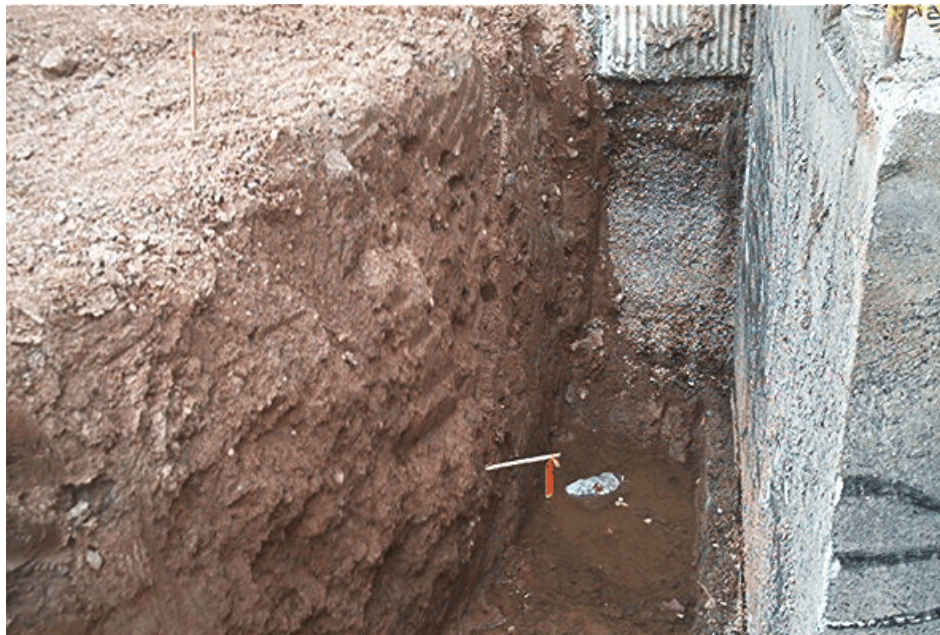
Figure 2-61. Photograph showing the final excavation along the Spauldite Sheet basement stairwell. The crushed stone in the background contains NAPL, but could not be removed during the Phase 1 IRM due to an adjacent building. View looking west. Photograph taken by Glenn May on October 11, 2004.

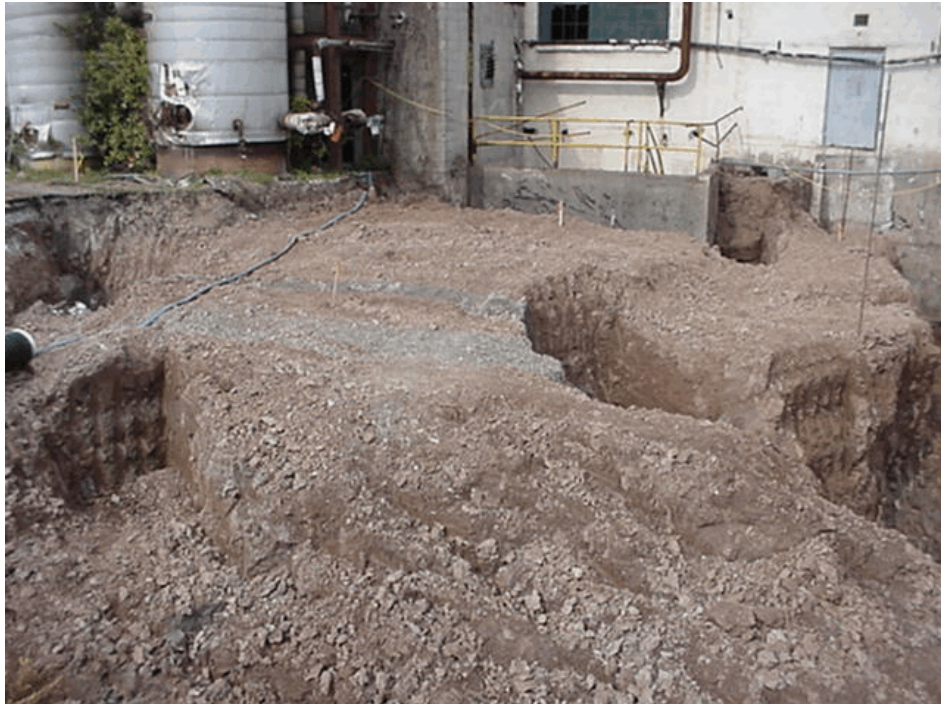
At this point excavation progressed to the south with the stripping off of approximately one foot of fill material overlying the native silty clay (Figure 2-62). At the same time excavation of backfill along the west wall of the Therminol Building sump was also removed down to the native silty clay. Excavation continued in a southward direction until the Roadway Ditch was encountered (Figure 2-41). Confirmatory samples TS-13 thru TS-15 (Figure 2-37) were collected from this area and submitted to PSC for analysis. The analytical results from these samples are discussed in Section 3.12.

Figure 2-62. Photograph showing the final excavation of the western portion of the Therminol Building area. View looking northwest. Photograph taken by Glenn May on October 15, 2004.

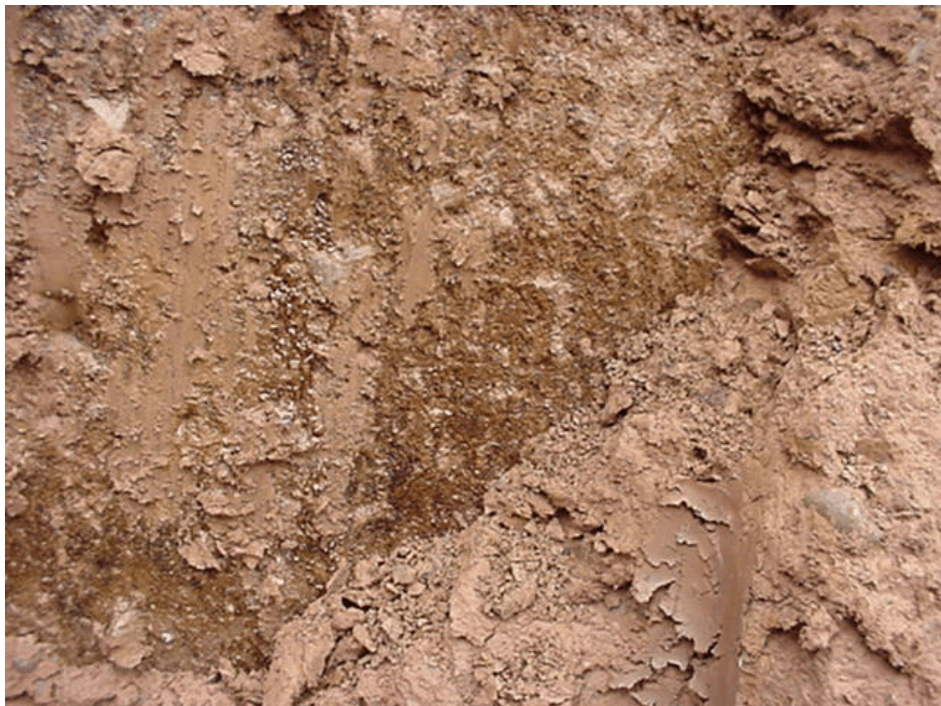
Figure 2-63. Photograph showing NAPL in a vertical dessication crack. View looking northeast. Photograph taken by Glenn May on October 21, 2004.

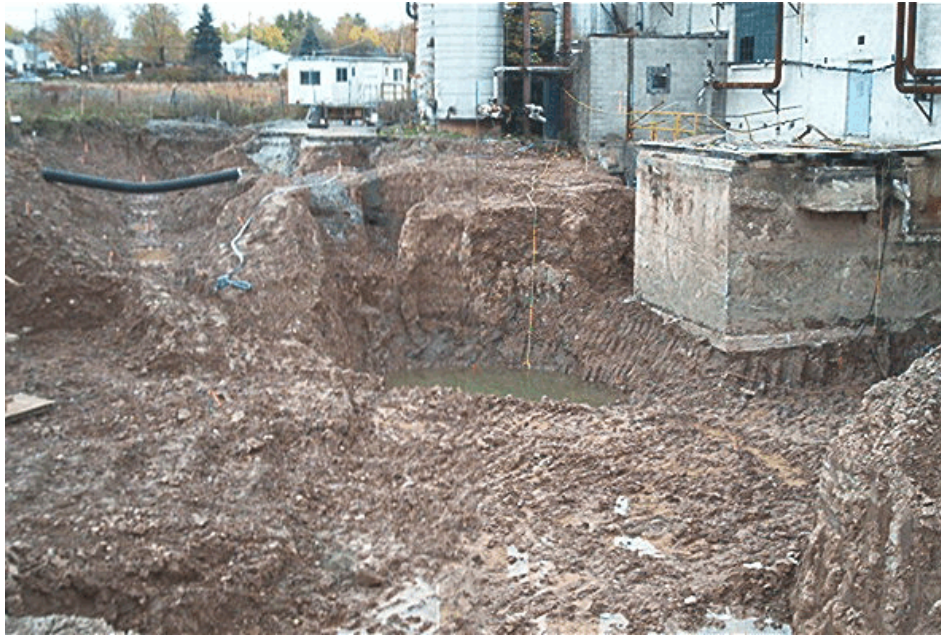
Figure 2-64. Photograph showing the deep excavation centered on former manhole MHE-2. The Therminol Building sump is to the immediate right, while the Roadway Ditch excavation is to the left. View looking west. Photograph taken by Glenn May on November 1, 2004.

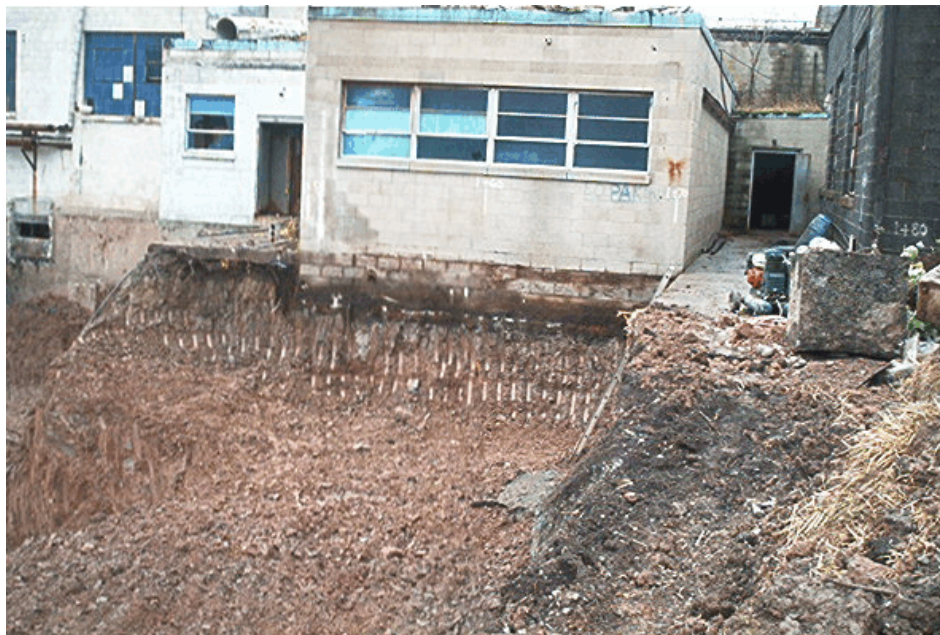
Figure 2-65. Photograph showing the final excavation of the Therminol Building area in front of the Cafeteria. View looking northwest. Photograph taken by Glenn May on October 22, 2004.

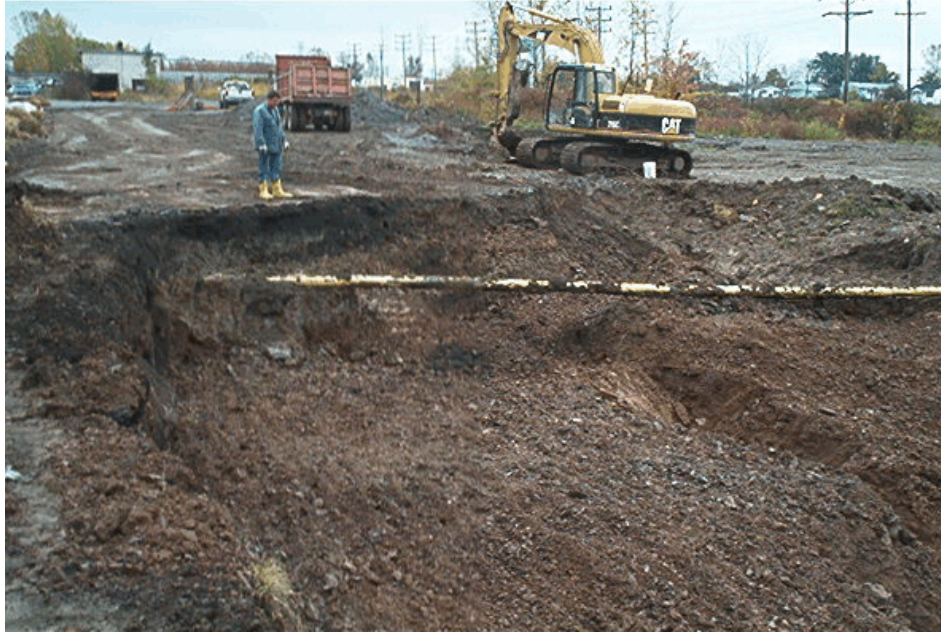
Excavation of the Therminol Building area continued toward the east with the floor of the excavation at a depth of about 15 feet bgs (Figures 2-37 and 2-64). The excavation sloped upward toward the south where it commingled with the Roadway Ditch excavation, and stepped up to a depth of approximately 8 feet bgs in front of the Cafeteria (Figures 2-37 and 2-65). The excavation remained at this depth from the Cafeteria southward to the 24-inch inflow pipe that connected the small Settling Lagoon (SWMU 11) with the “U” shaped Settling Lagoon (SWMU 12). Removal of this pipe began on Thursday, October 21, 2004 and was completed the following day. This became the southern limit of the Therminol Building excavation (Figure 2-66). Confirmatory

Figure 2-66. Photograph showing the southeastern limit of the Therminol Building excavation. Note the black cinders and ash underlying the roadway. View looking southeast. Photograph taken by Glenn May on October 22, 2004.

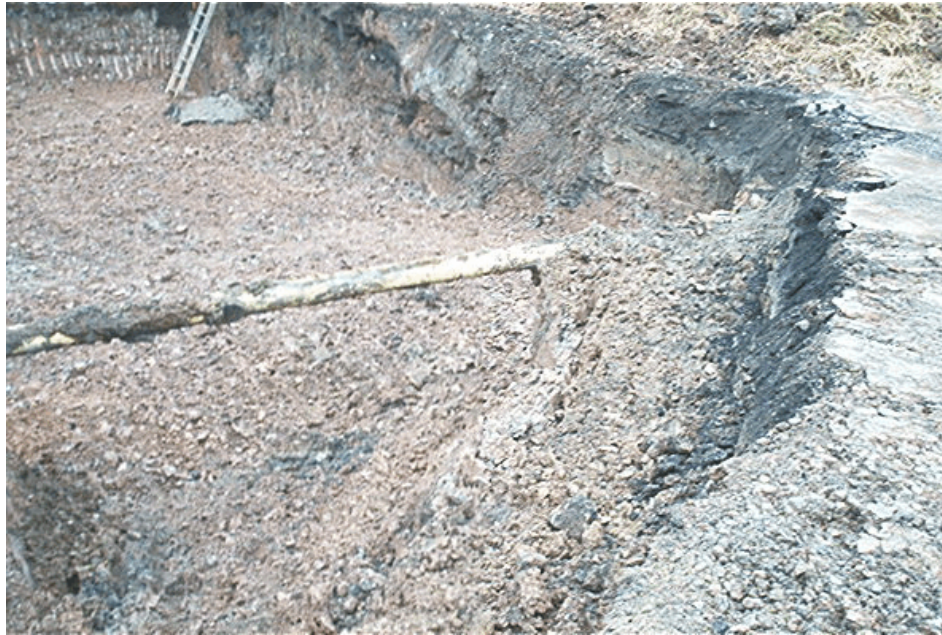
The east wall of the excavation contained grinding waste associated with SWMU 11 (Figure 2-67). Black cinders and ash were also observed (Figures 2-66 and 2-67). Although these wastes would be excavated during Phase 2 of the OU2 IRM, samples of each waste type were collected and submitted to PSC for analysis to determine the nature of contamination in these materials. The analytical results from these samples are discussed in Section 3.5.1.

Figure 2-67. Photograph showing the fill material in the east wall of the Therminol Building excavation. This fill is associated with the SWMU 11 Settling Lagoon. View looking north. Photograph taken by Glenn May on October 22, 2004.

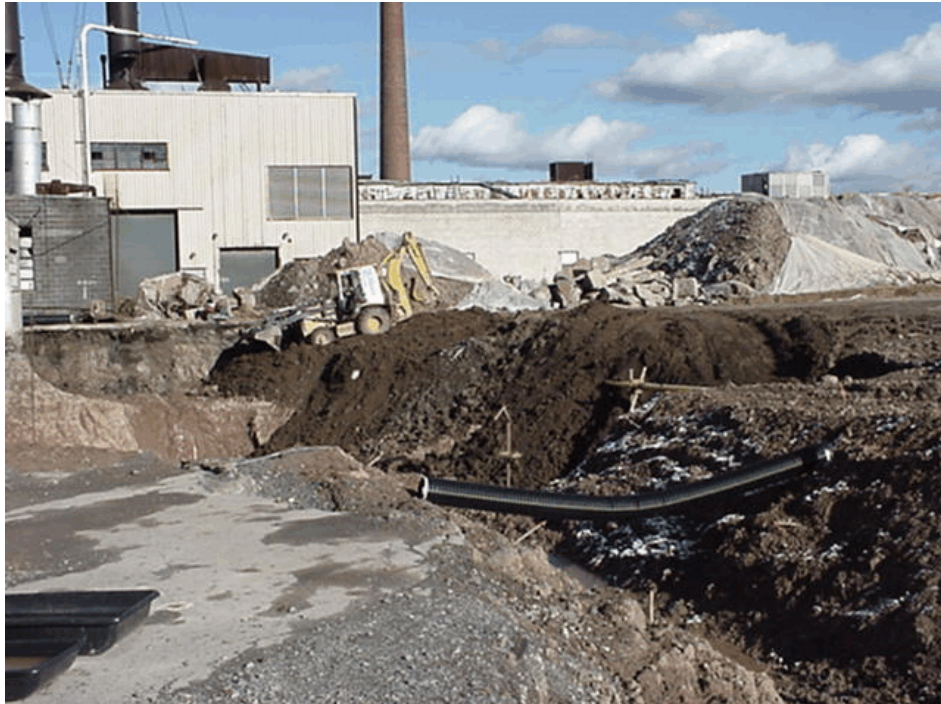
Figure 2-68. Photograph showing the start of backfilling activities at SWMU 38 and the Roadway Ditch. View looking northeast. Photograph taken by Glenn May on November 9, 2004.

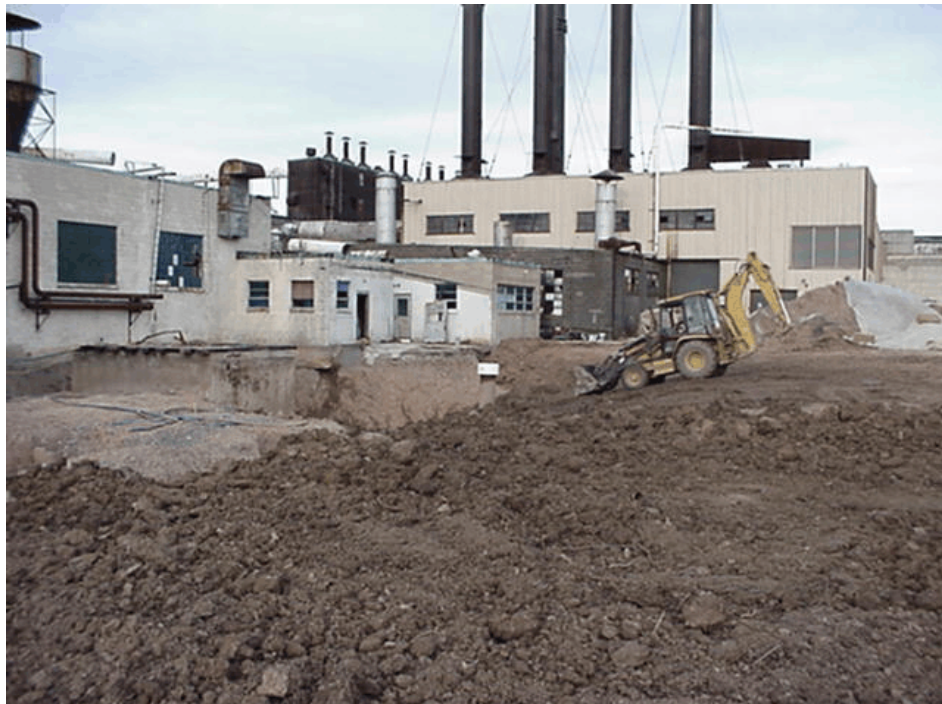
Figure 2-69. Photograph showing backfilling activities at SWMU 38 and the Roadway Ditch. View looking north. Photograph taken by Glenn May on November 15, 2004.

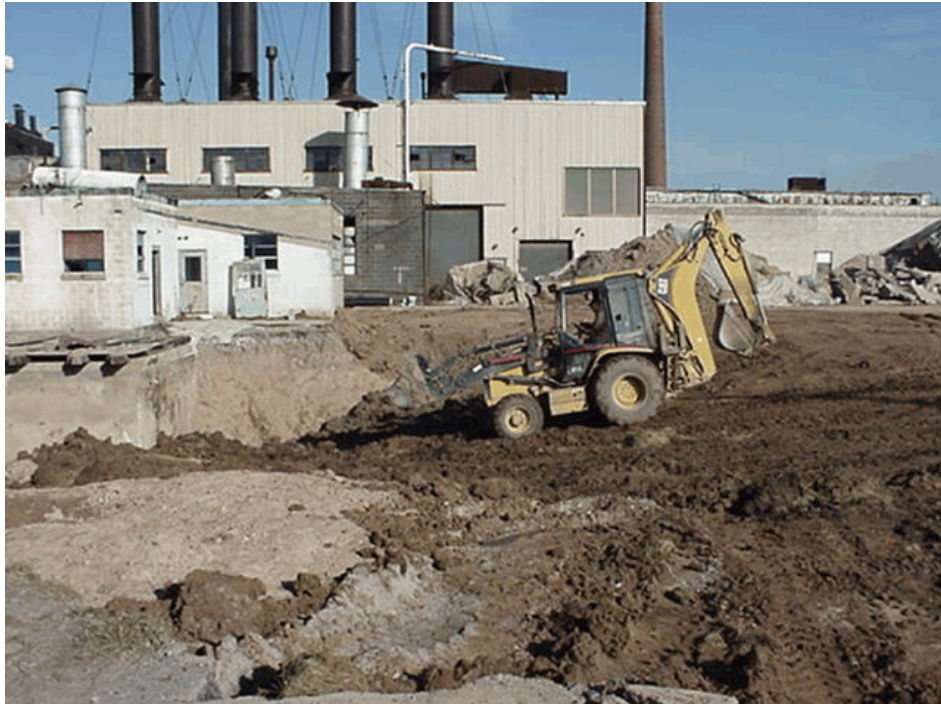
Figure 2-70. Photograph showing backfilling activities at SWMU 38 and the Roadway Ditch. View looking northeast. Photograph taken by Glenn May on November 16, 2004.

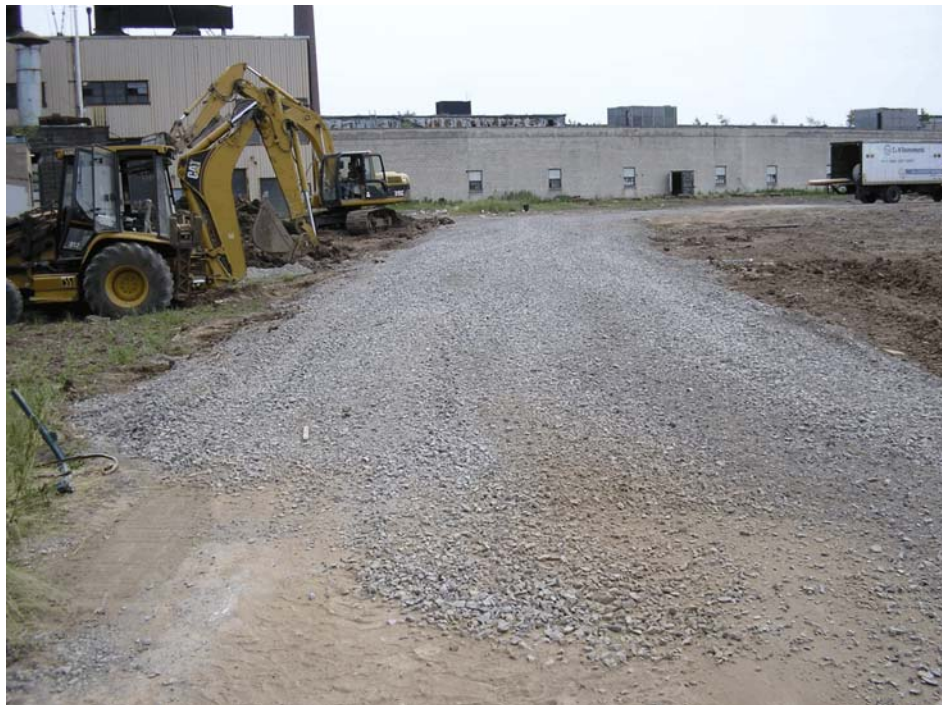
Figure 2-71. Photograph showing the replaced roadway across the SWMU 38 and Roadway Ditch areas. View looking east. Photograph taken by Glenn May on June 9, 2005.

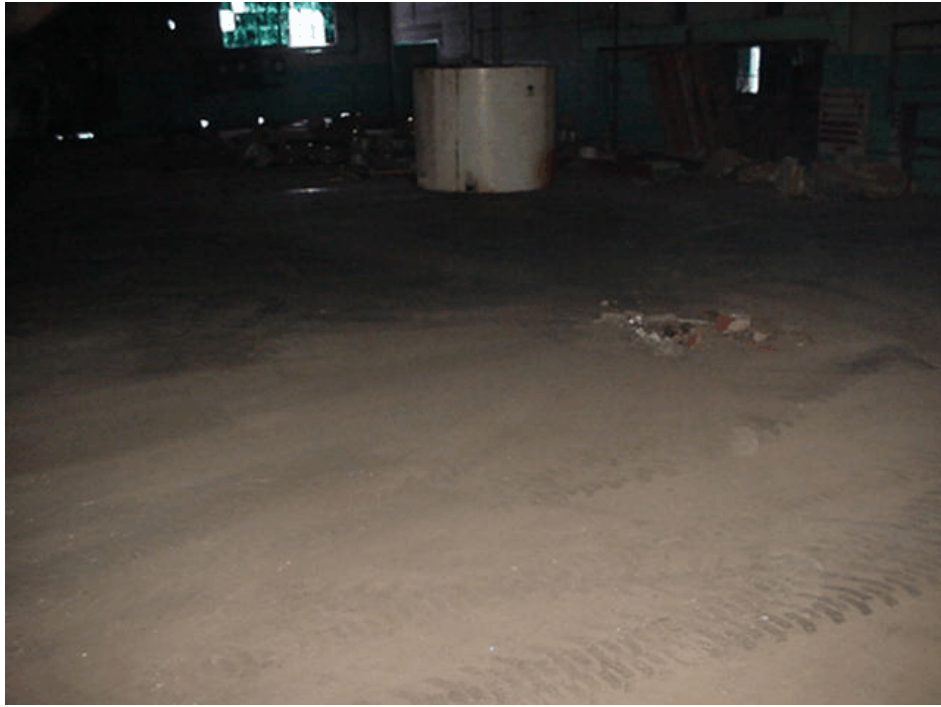
Figure 2-72. Photograph showing the inside of the Spauldite Sheet Building following the removal of spent carbon. View looking south. Photograph taken by Glenn May on February 4, 2005.

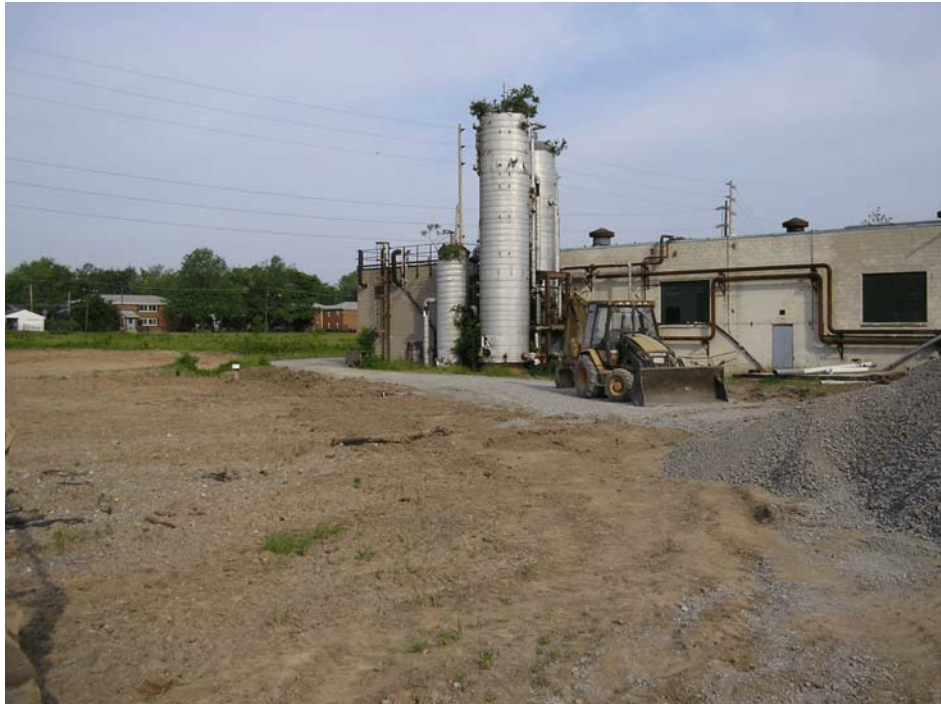
Figure 4-1. Photograph showing the three Supertherm Tanks prior to removal. View looking northwest. Photograph taken by Ron Huntington on June 8, 2005.

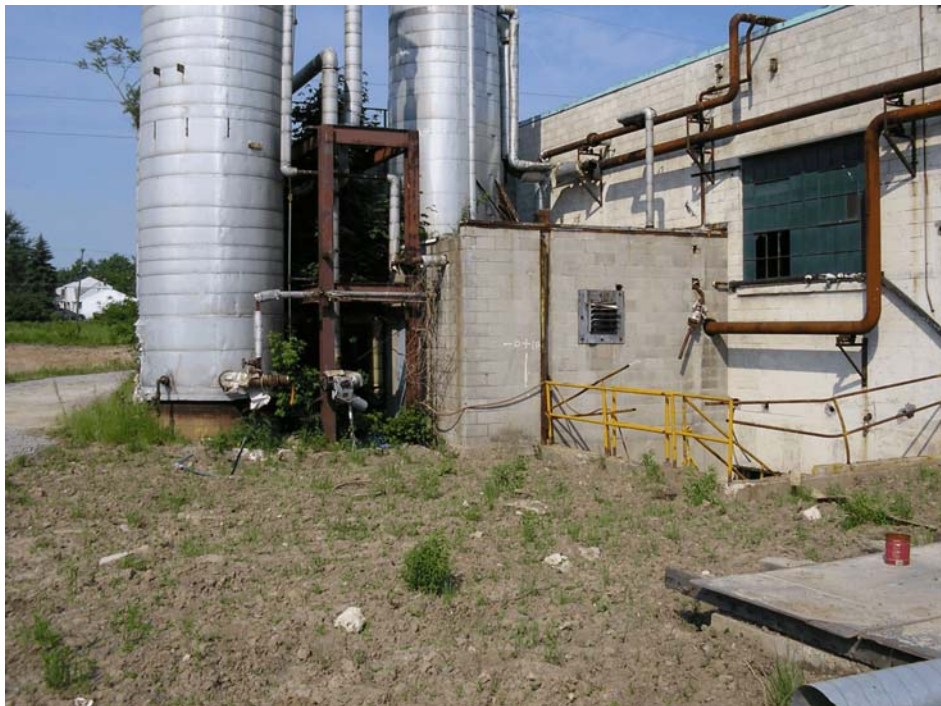
Figure 4-2. Photograph showing the cinder block building and two Supertherm Tanks prior to removal. View looking west. Photograph taken by Ron Huntington on June 8, 2005.

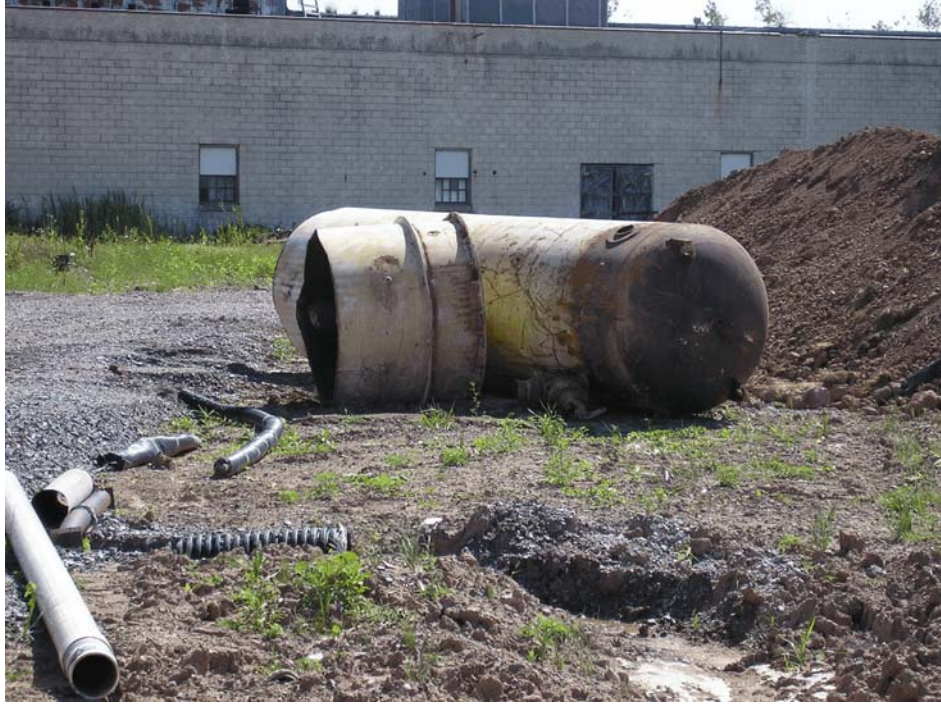
Figure 4-3. Photograph showing the small Supertherm Tank after all piping and insulation was removed. View looking northeast. Photograph taken by Glenn May on July 25, 2005.

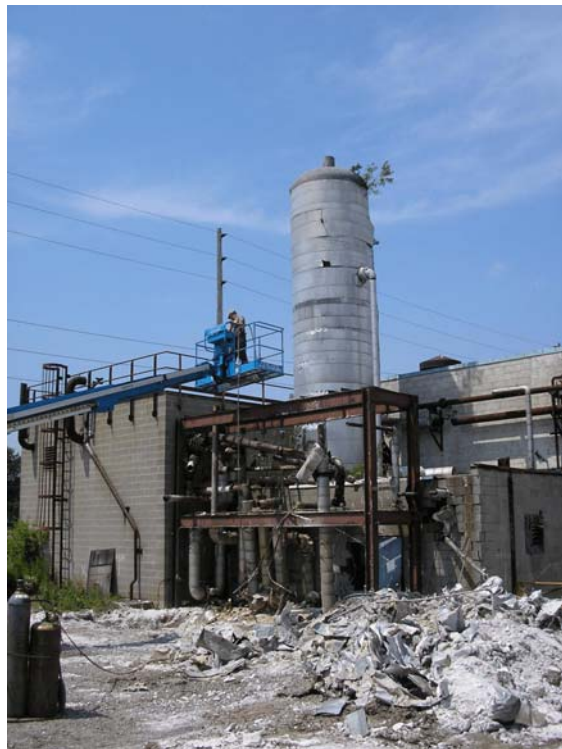
Figure 4-4. Photograph showing the remaining piping, pipe supports and Supertherm Tank. View looking northwest. Photograph taken by Glenn May on August 1, 2005.

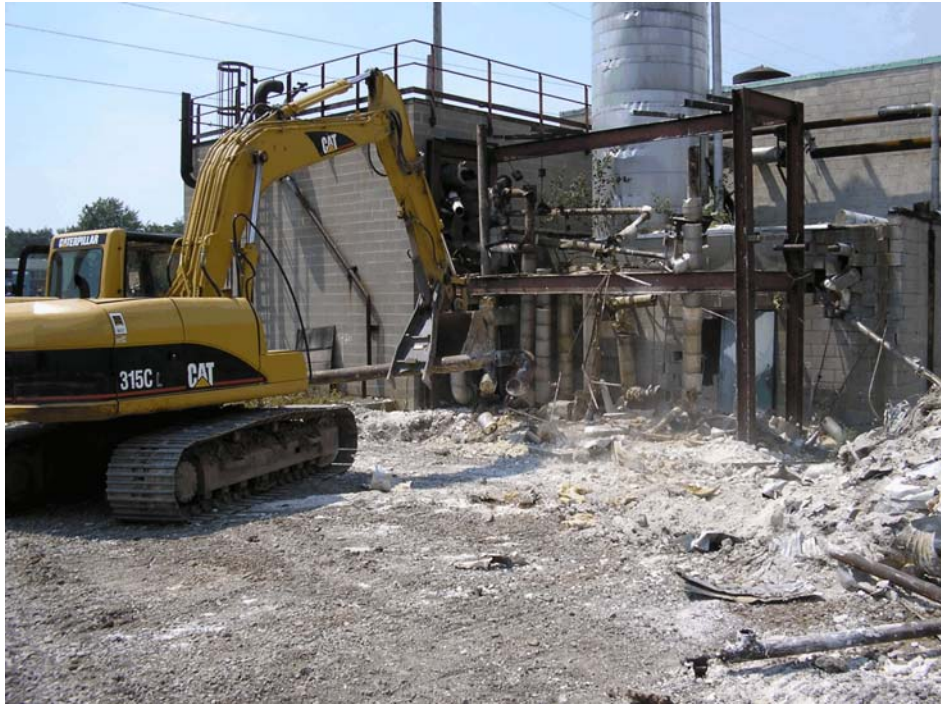
Figure 4-5. Photograph showing the removal of piping during the Supertherm Tank removal. View looking northeast. Photograph taken by Glenn May on August 1, 2005.

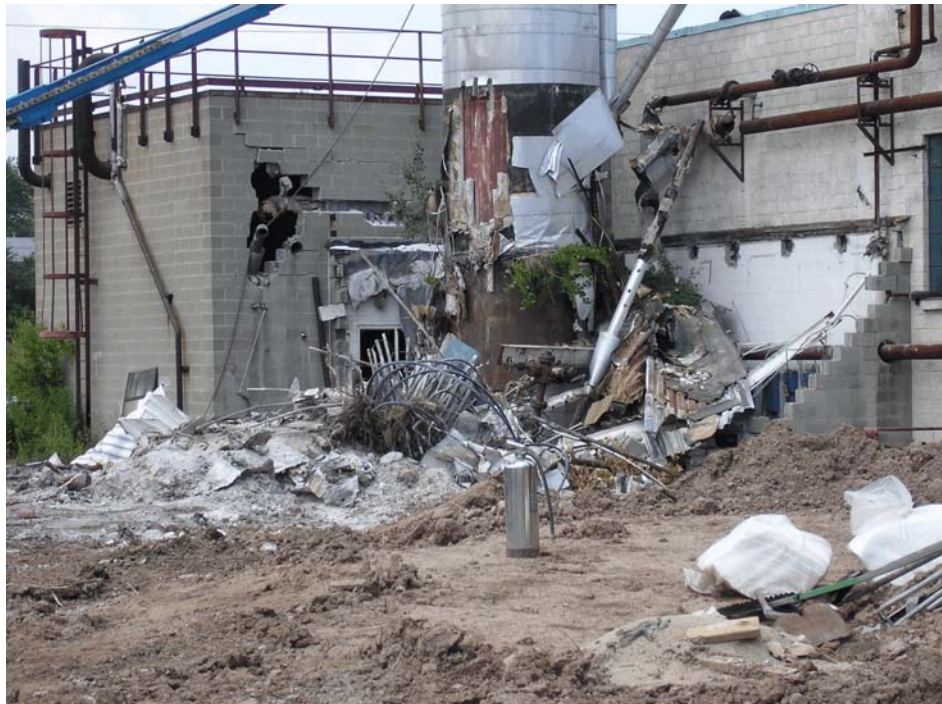
Figure 4-6. Photograph showing the cinder block building following demolition. View looking northeast. Photograph taken by Glenn May on August 2, 2005.

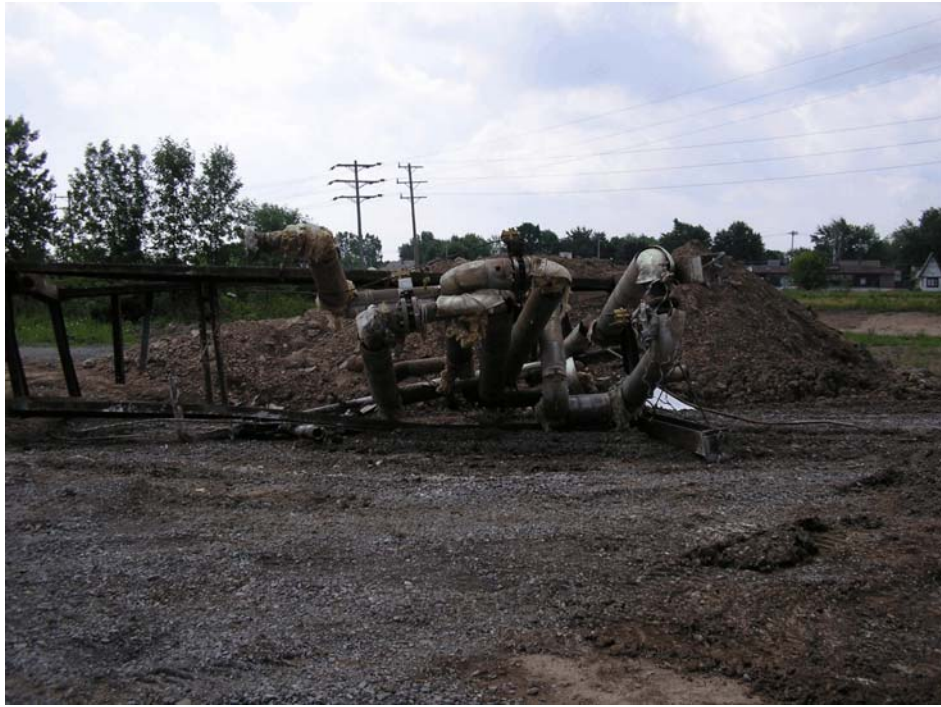
Figure 4-7. Photograph showing piping and pipe supports from the Supertherm Tank removal. View looking south. Photograph taken by Glenn May on August 2, 2005.
