Final IRM Report for Operable Unit 2

**Spaulding Composites Site
Tonawanda, Erie County, New York
Site Number 9-15-050**

**March 2007
Revised July 2008**

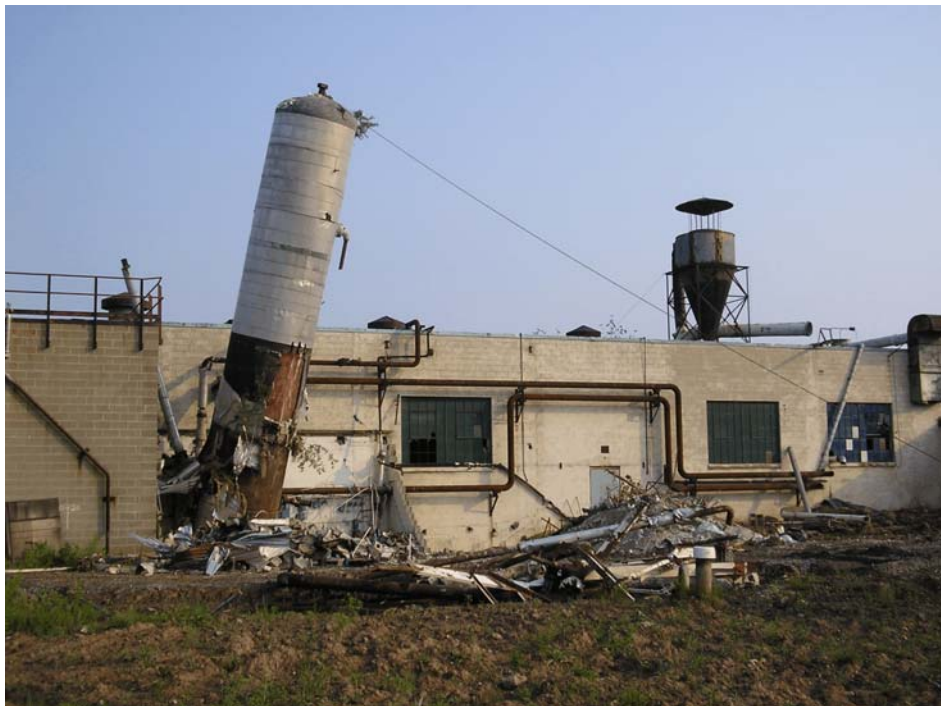
Figure 4-8. Photograph showing the last Supertherm Tank being pulled to the ground. View looking north. Photograph taken by Glenn May on August 3, 2005.

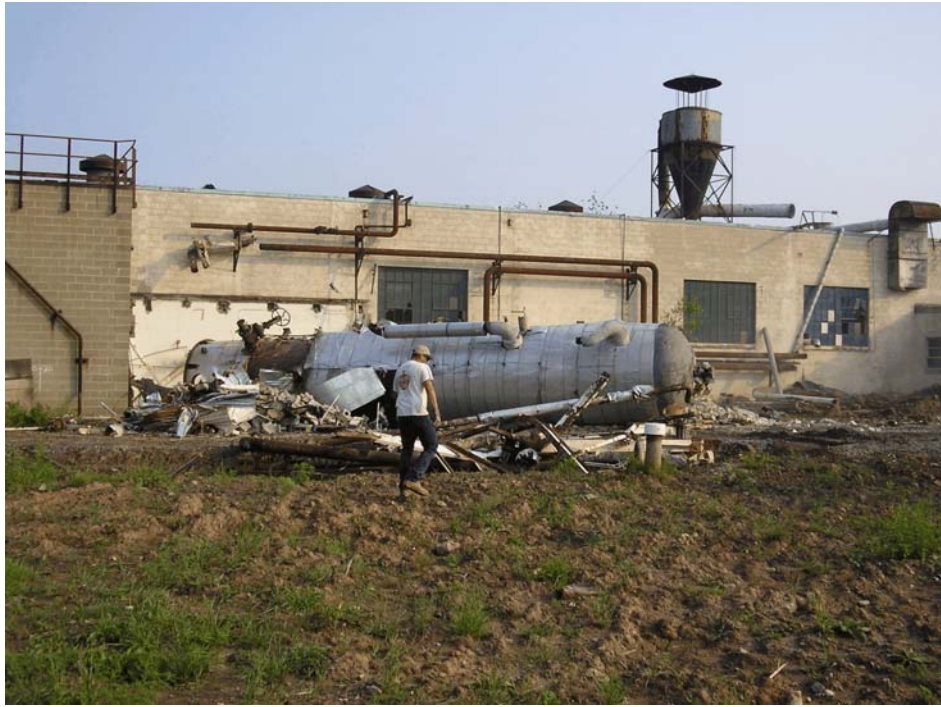
Figure 4-9. Photograph showing the last Supertherm Tank after being pulled to the ground. View looking north. Photograph taken by Glenn May on August 3, 2005.

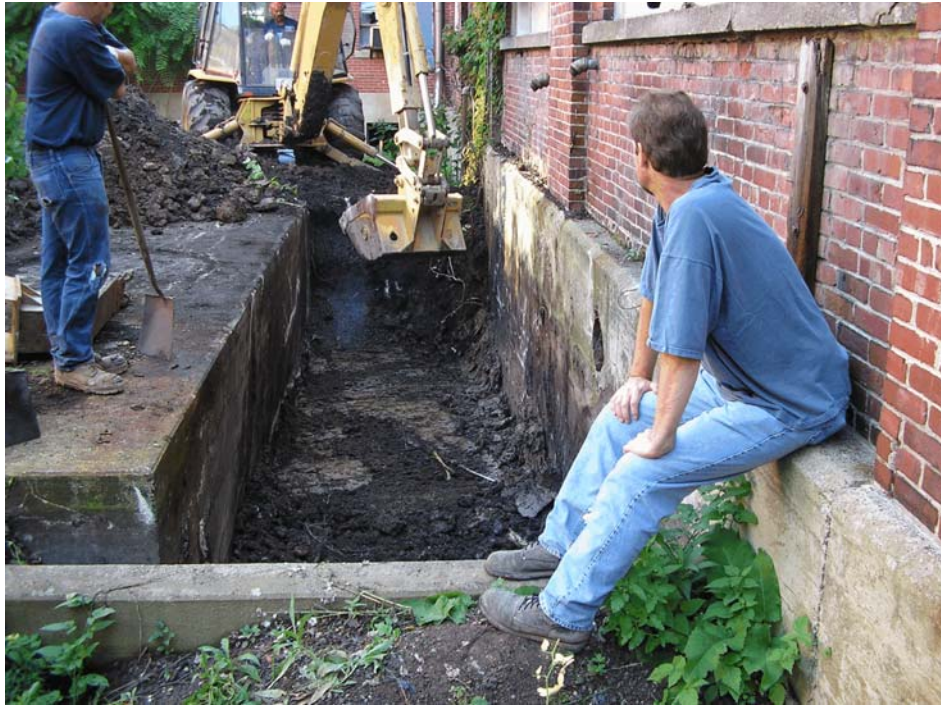
Figure 4-11. Photograph showing the excavation around the concrete pad at AOC 48 nearing completion. View looking northeast. Photograph taken by Jim Tuk on October 5, 2005.

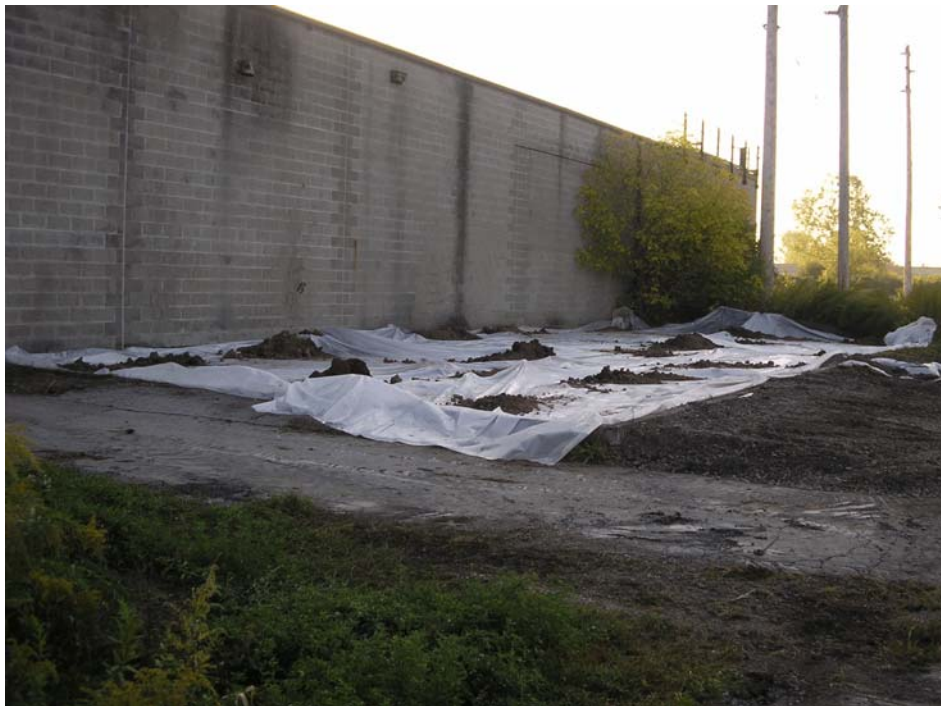
Figure 4-12. Photograph showing the soil staging pad constructed at the west end of the Spauldite Sheet Building. View looking southeast. Photograph taken by Jim Tuk on October 5, 2005.

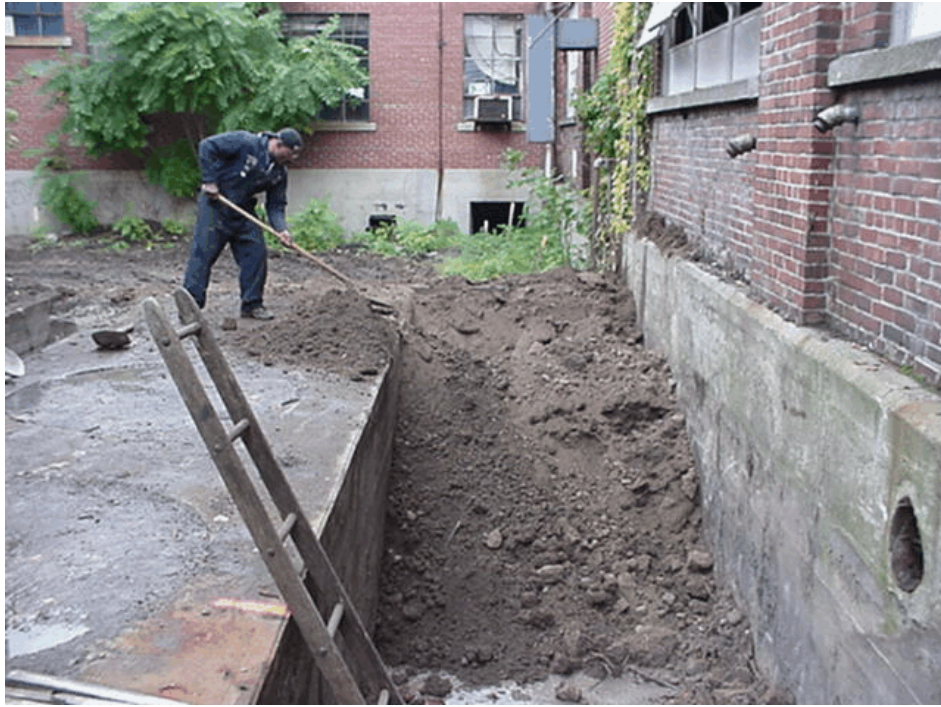
Figure 4-13. Photograph showing the initial backfilling around the concrete pad. View looking northeast. Photograph taken by Glenn May on October 12, 2005.

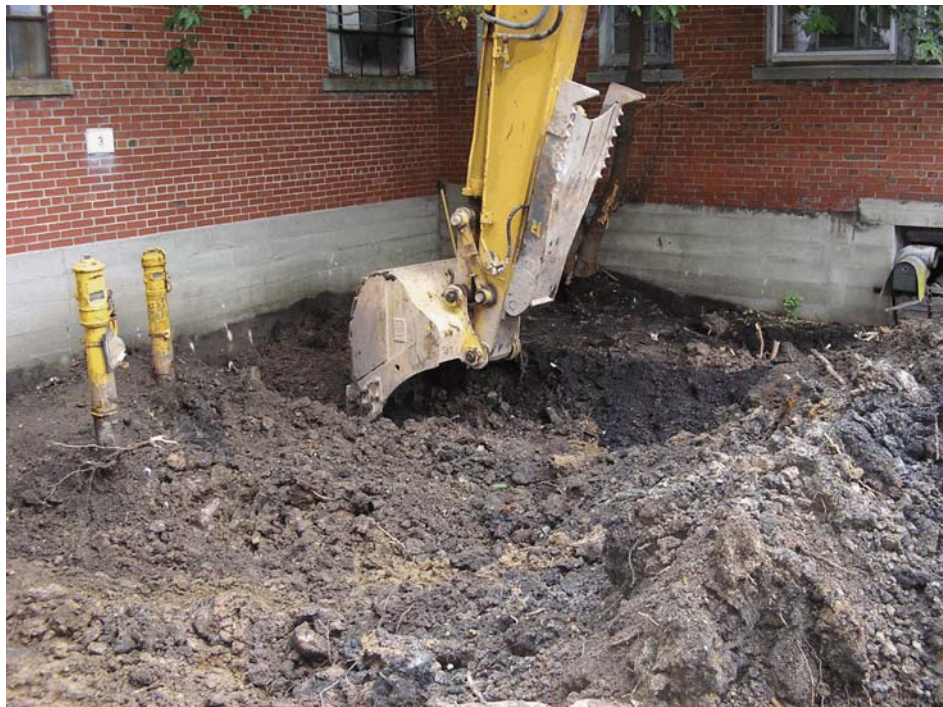
Figure 4-14. Photograph showing the initial excavation of the west end of the courtyard. View looking northwest. Photograph taken by Jim Tuk on October 13, 2005.

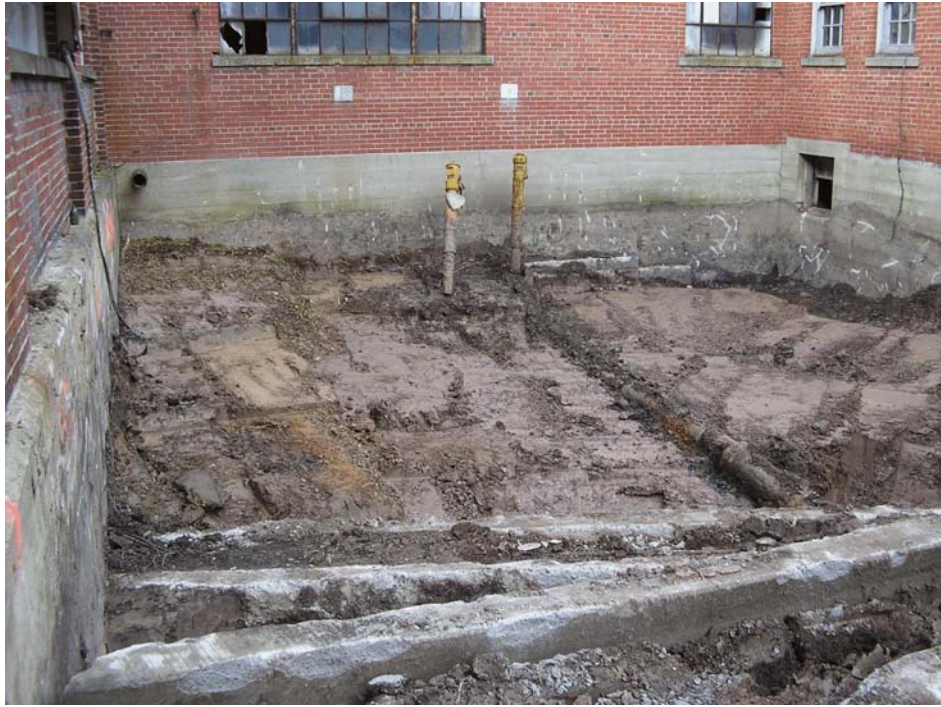
Figure 4-15. Photograph showing the final excavation of the west end of the courtyard. View looking west. Photograph taken by Jim Tuk on October 19, 2005.

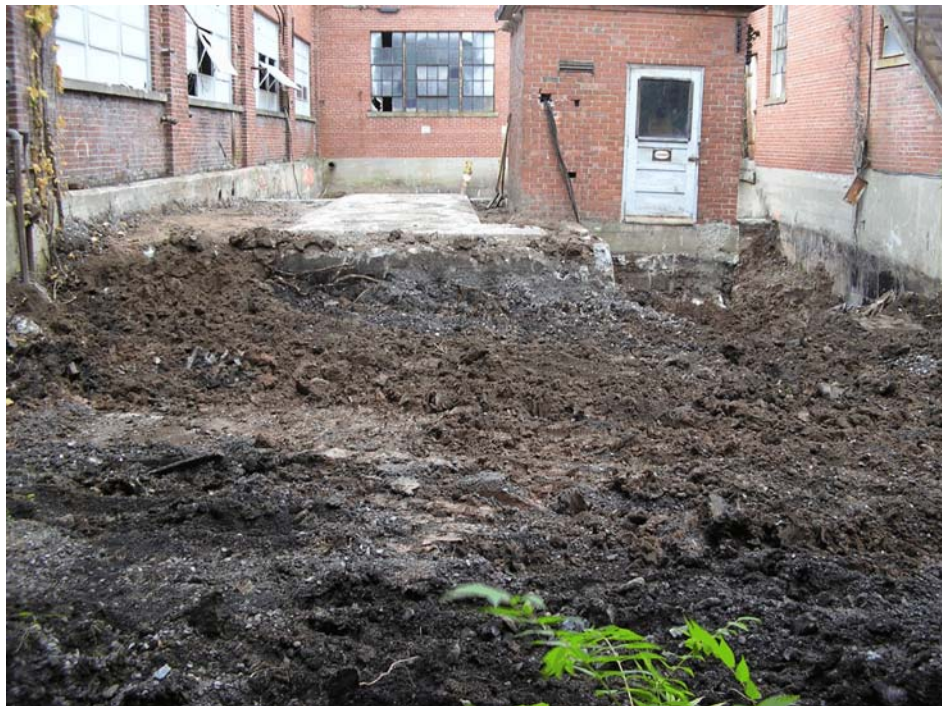
Figure 4-16. Photograph showing the east end of the courtyard following the removal of 1 foot of hazardous soils. View looking southwest. Photograph taken by Jim Tuk on October 19, 2005.

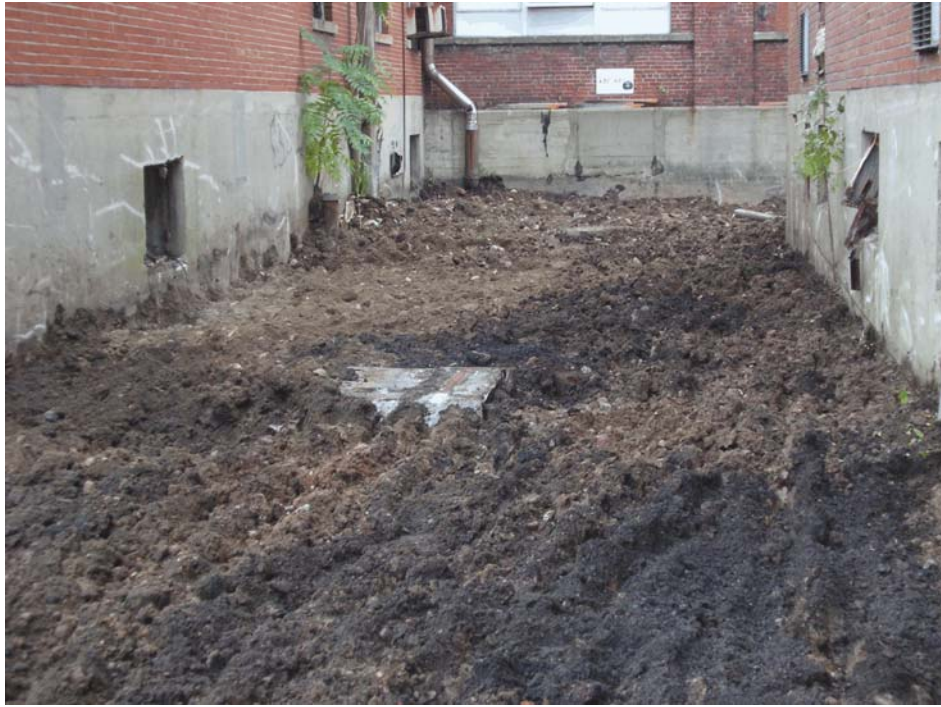
Figure 4-17. Photograph showing the alleyway following the removal of 1 foot of hazardous soils. View looking southeast. Photograph taken by Jim Tuk on October 20, 2005.

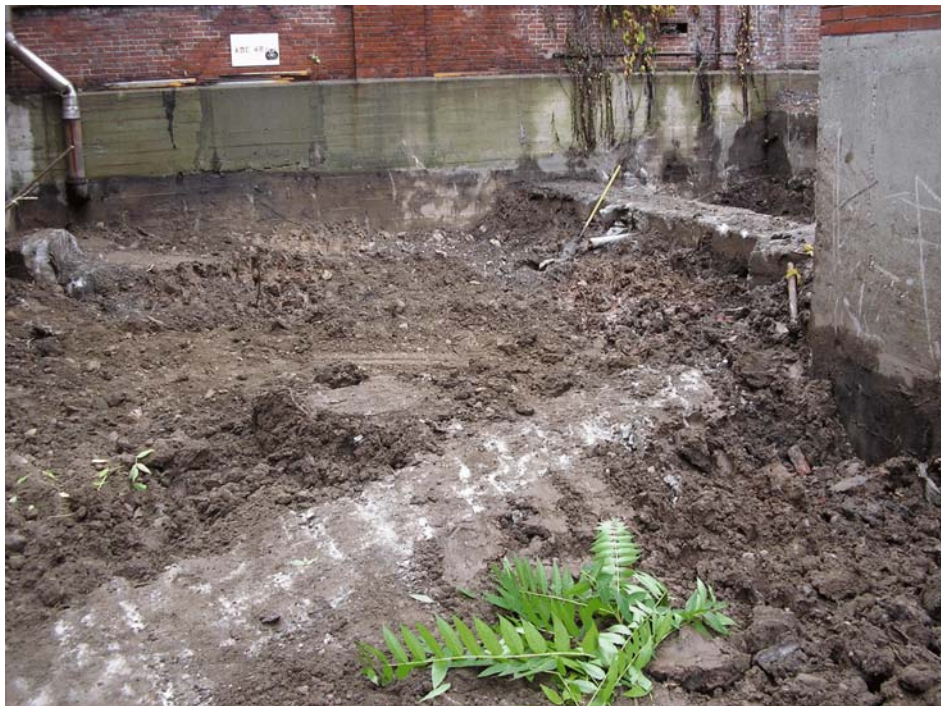
Figure 4-18. Photograph showing the east end of the courtyard following the removal of non-hazardous soils. View looking south. Photograph taken by Jim Tuk on October 24, 2005.

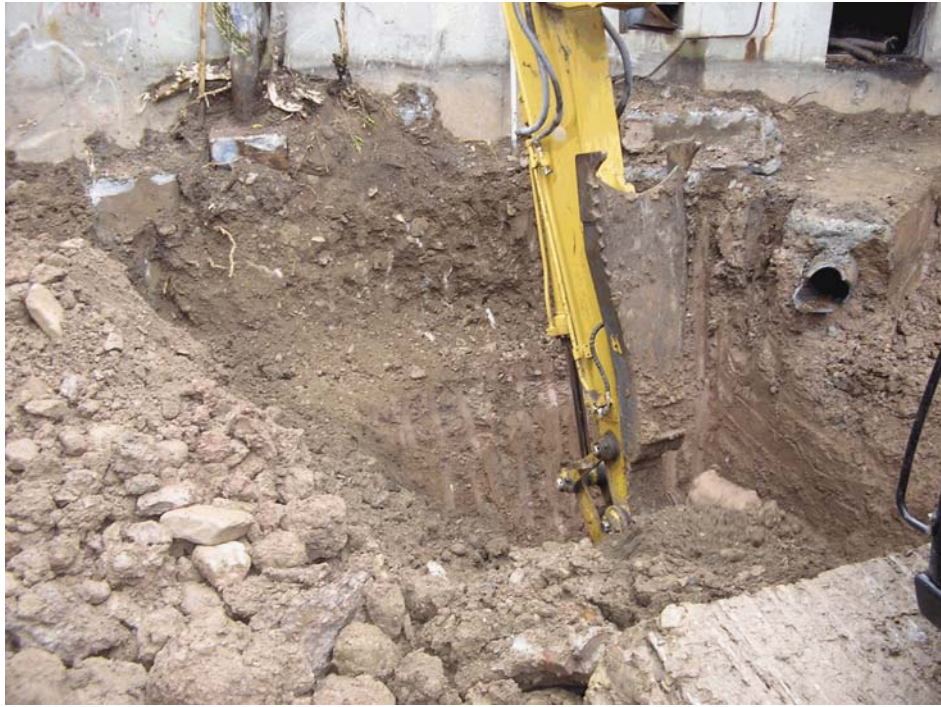
Figure 4-19. Photograph showing the deep excavation at the east end of the courtyard. View looking east. Photograph taken by Jim Tuk on October 25, 2005.

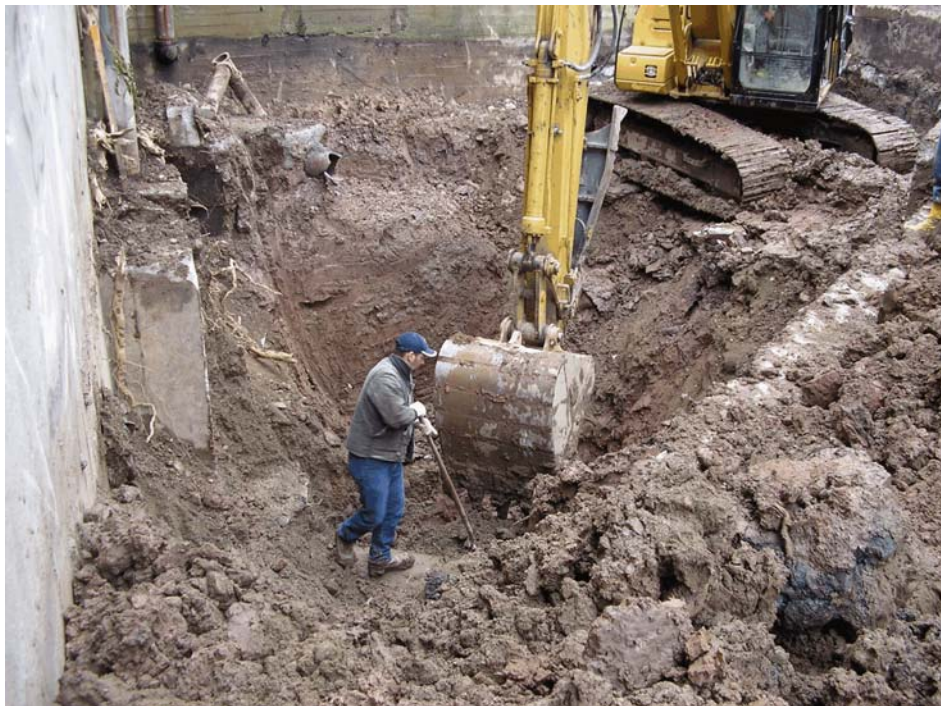
Figure 4-20. Photograph showing the deep excavation nearing completion. View looking south. Photograph taken by Jim Tuk on October 26, 2005.

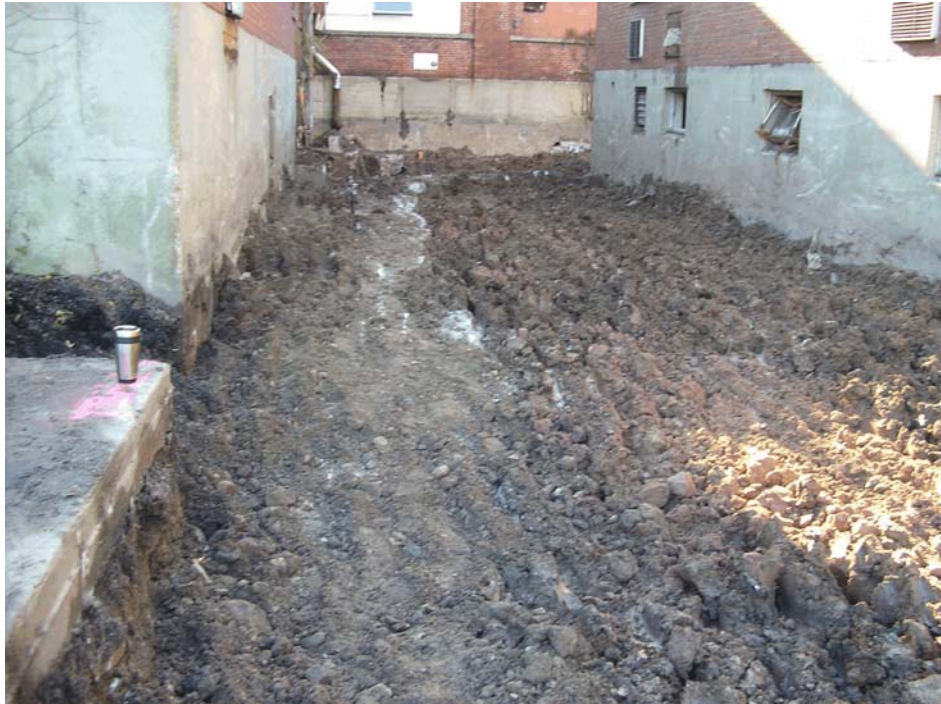
Figure 4-21. Photograph showing the final excavation of the alleyway. View looking south. Photograph taken by Jim Tuk on November 2, 2005.

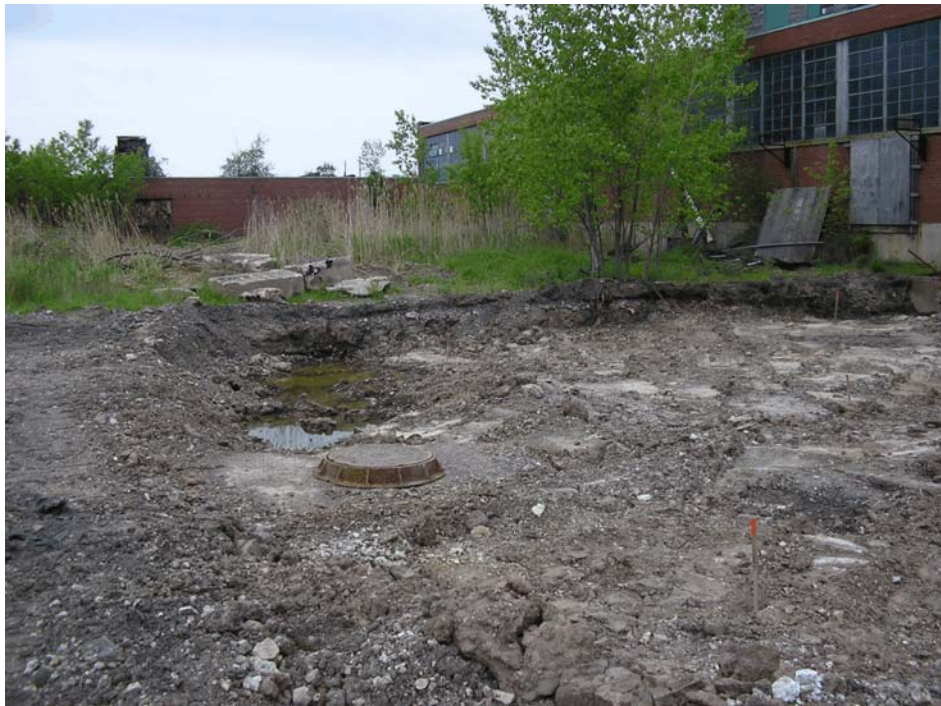
Figure 4-22. Photograph showing the final excavation of AOC 48 outside the alleyway. View looking east. Photograph taken by Glenn May on May 25, 2006.

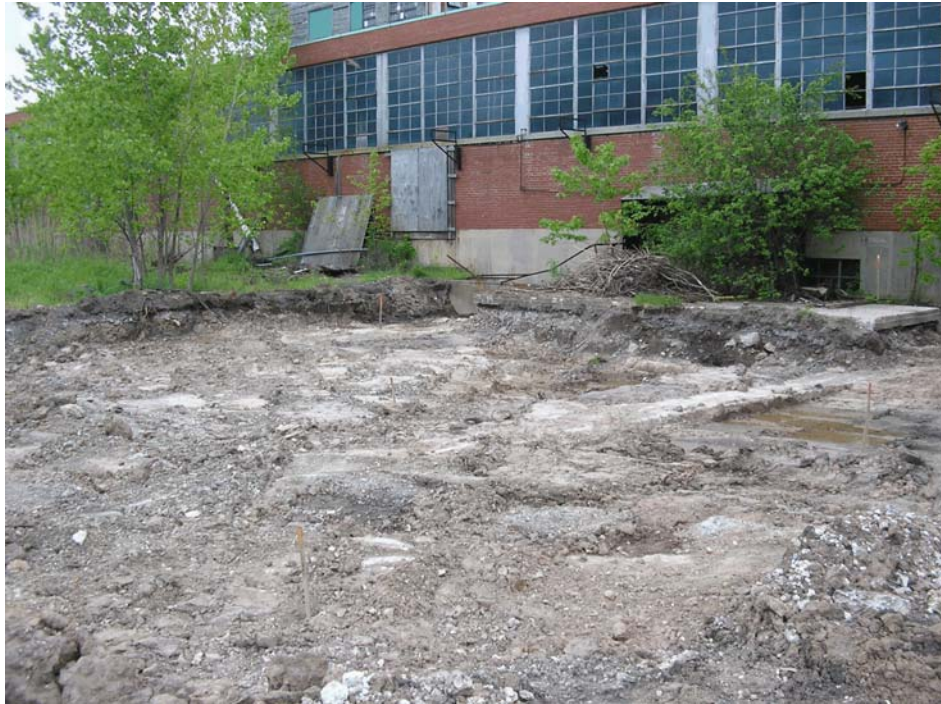
Figure 4-23. Photograph showing the final excavation of AOC 48 outside the alleyway. View looking southeast. Photograph taken by Glenn May on May 25, 2006.

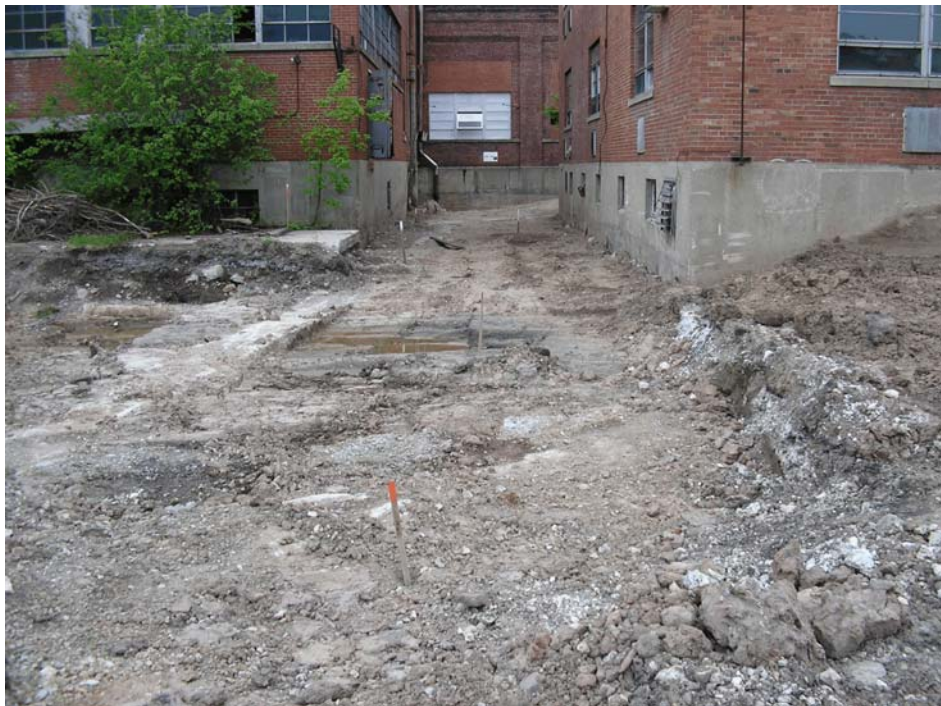
Figure 4-24. Photograph showing the final excavation of AOC 48 outside the alleyway. View looking slightly southeast. Photograph taken by Glenn May on May 25, 2006.

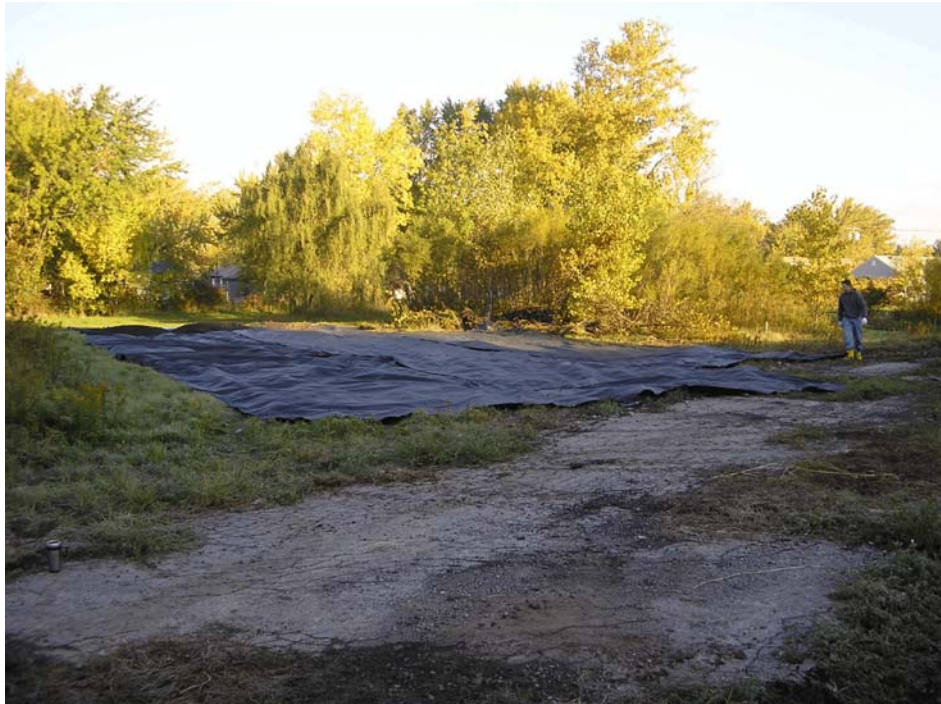
Figure 4-25. Photograph showing the placement of geofabric on the ground surface during construction of the truck turnaround. View looking north. Photograph taken by Jim Tuk on October 28, 2005.

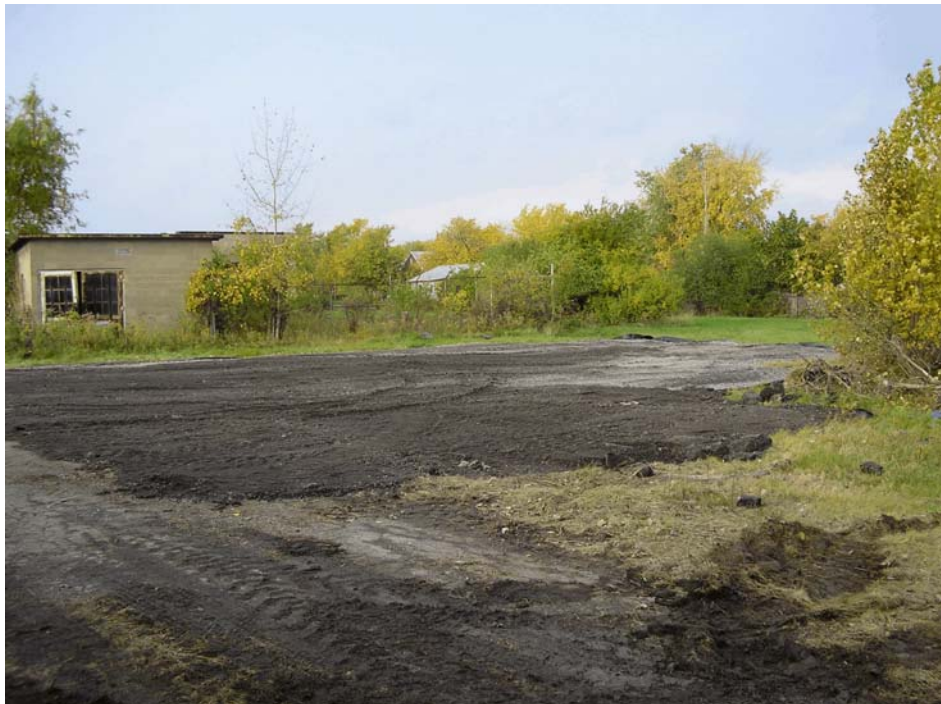
Figure 4-26. Photograph showing the completed truck turnaround. View looking west. Photograph taken by Jim Tuk on November 1, 2005.

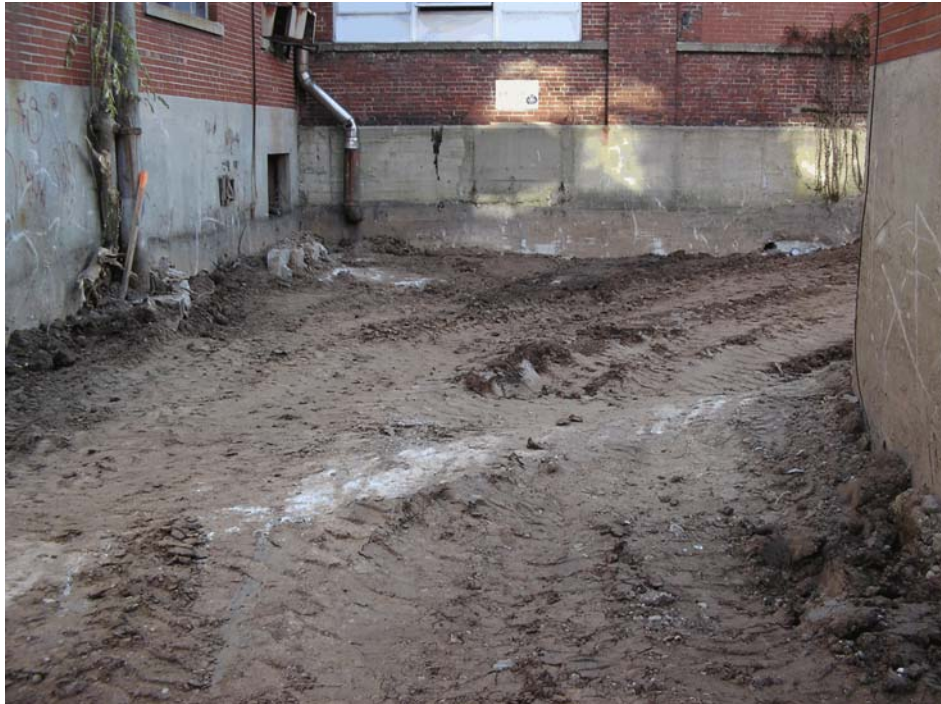
Figure 4-27. Photograph showing the completed backfilling of the deep excavation at the east end of the courtyard. View looking southeast. Photograph taken by Jim Tuk on November 3, 2005.

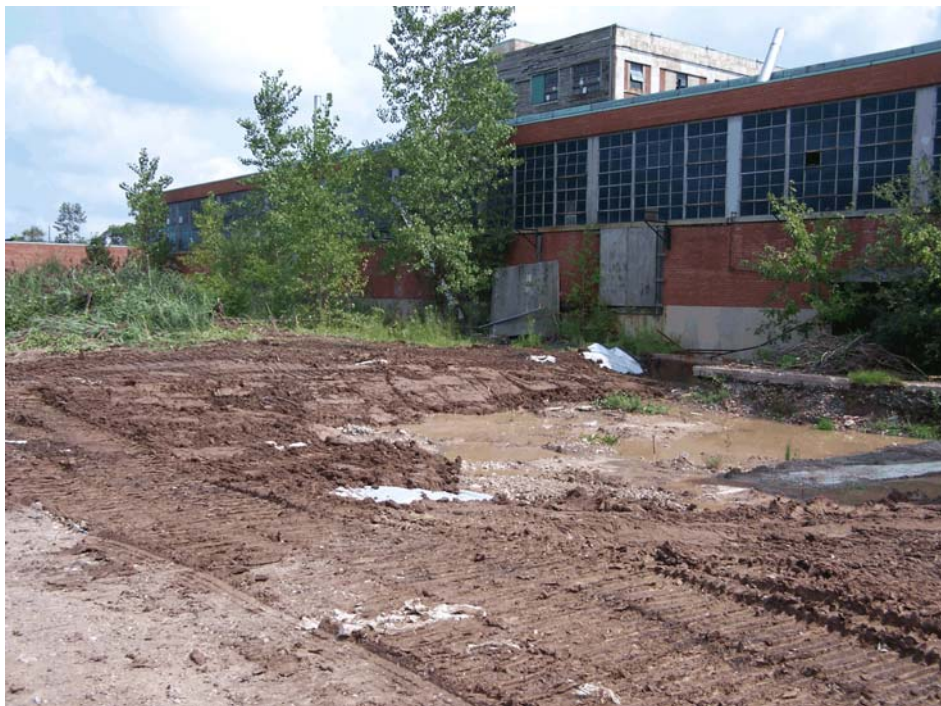
Figure 4-28. Photograph showing the completed backfilling of AOC 48 outside the alleyway. View looking east. Photograph taken by Glenn May on September 6, 2006.

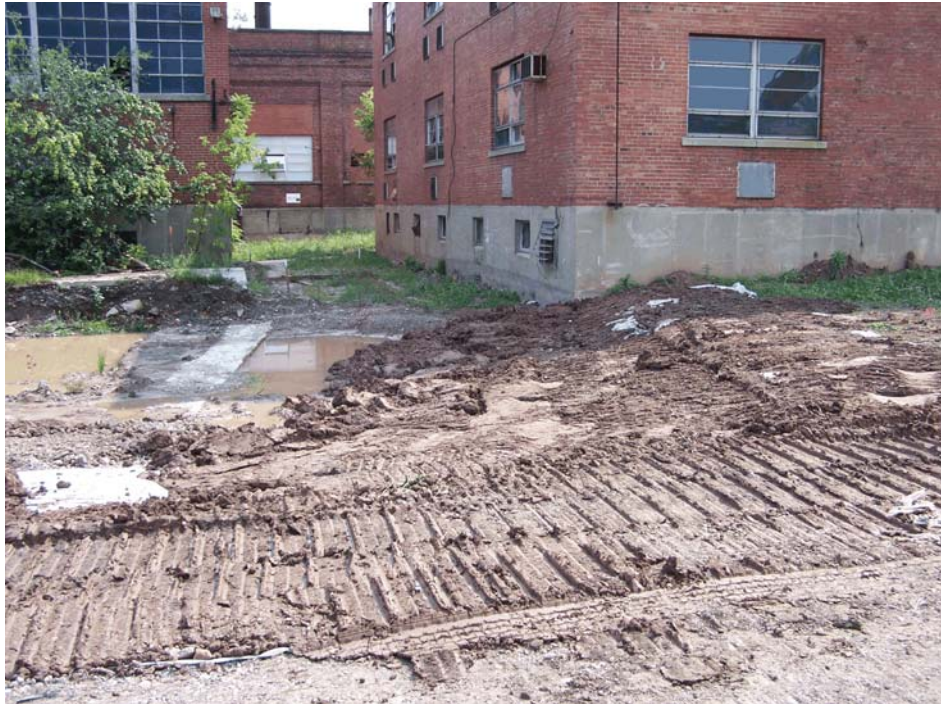
Figure 4-29. Photograph showing the completed backfilling of AOC 48 outside the alleyway. View looking south. Photograph taken by Glenn May on September 6, 2006.

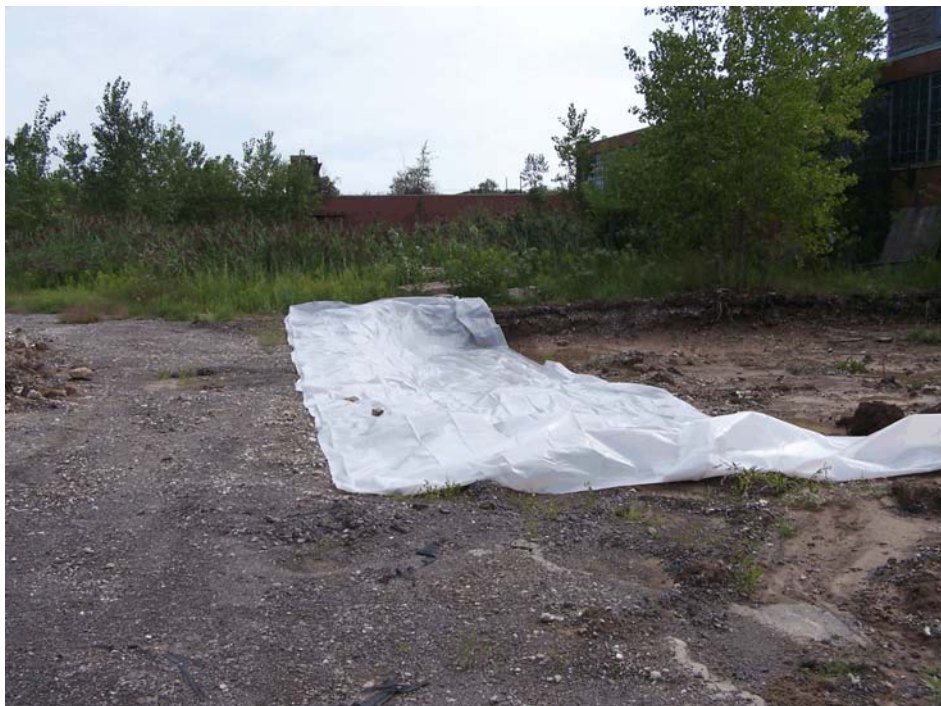
Figure 4-30. Photograph showing the placement of poly over the sidewalls of the excavation to form a demarcation layer. View looking northeast. Photograph taken by Glenn May on September 6, 2006.

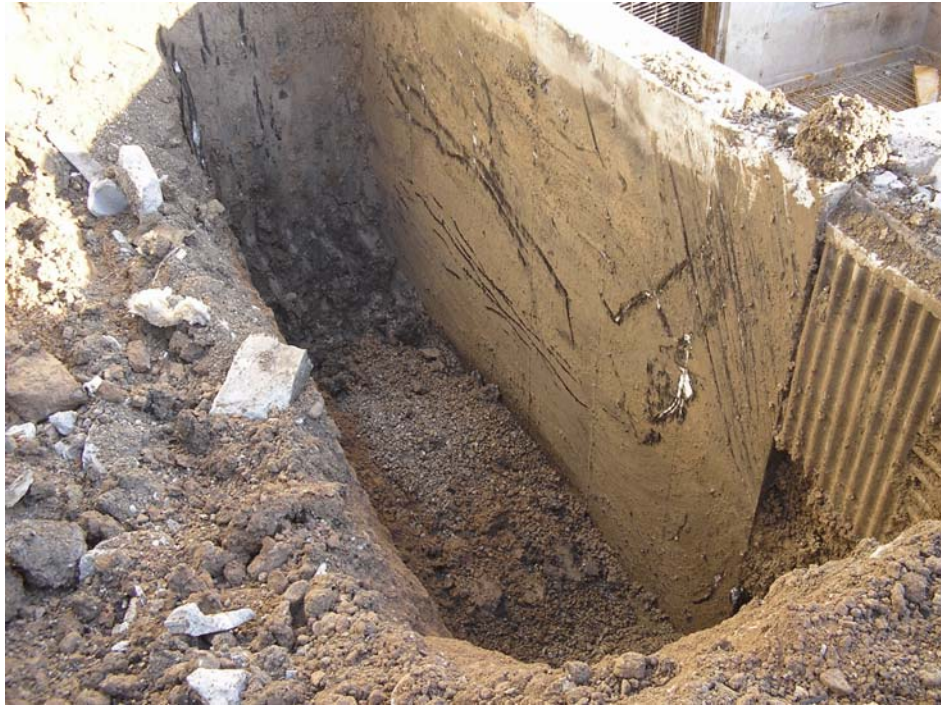
Figure 4-32. Photograph showing the start of excavation along the Spauldite Sheet basement stairwell. View looking north. Photograph taken by Glenn May on October 5, 2006.

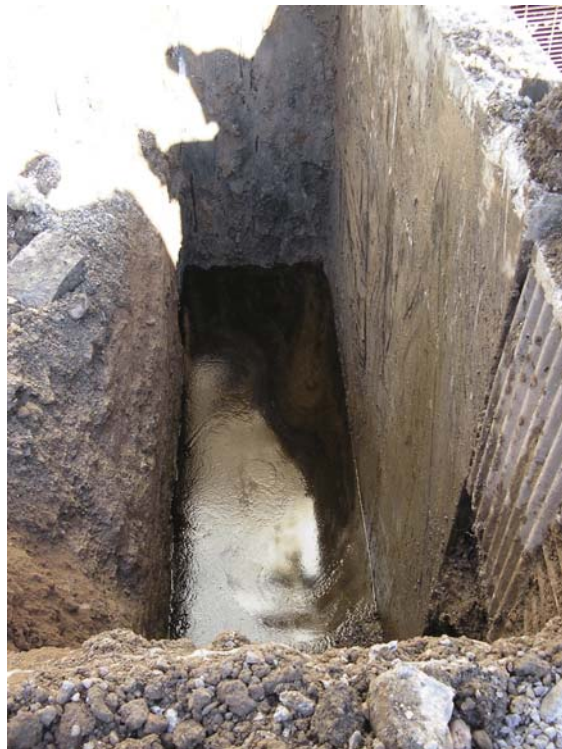
Figure 4-33. Photograph showing NAPL in the excavation along the Spauldite Sheet basement stairwell. View looking slightly northwest. Photograph taken by Glenn May on October 5, 2006.

Excavation of the remaining portion of the Therminol Building Area (SWMU 38) began on Wednesday, October 5, 2005 with the excavation of contaminated soils along the Spauldite Sheet basement stairwell (Figures 4-31 and 4-32). Near the base of this excavation a large quantity of NAPL was encountered (Figures 4-33 and 4-34). Excavation ceased at this point and absorbant pads were placed in the excavation to absorb as much NAPL as possible.

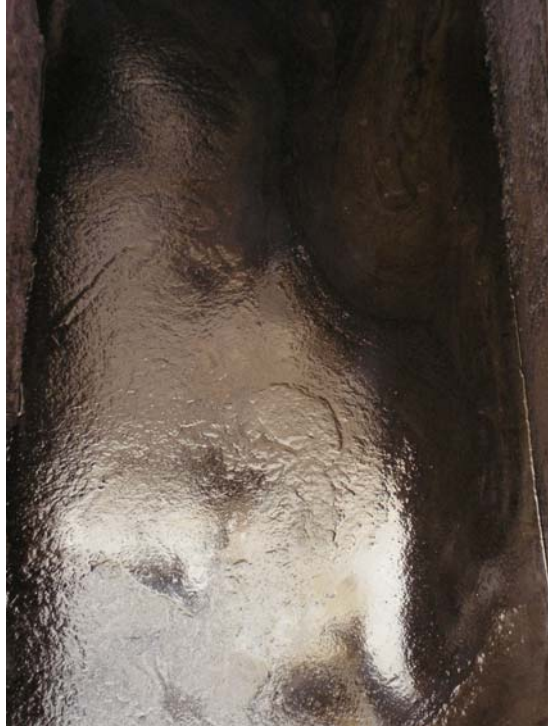
Figure 4-34. Photograph showing a closeup view of the NAPL in the excavation along the Spauldite Sheet basement stairwell. View looking slightly northwest. Photograph taken by Glenn May on October 5, 2006.

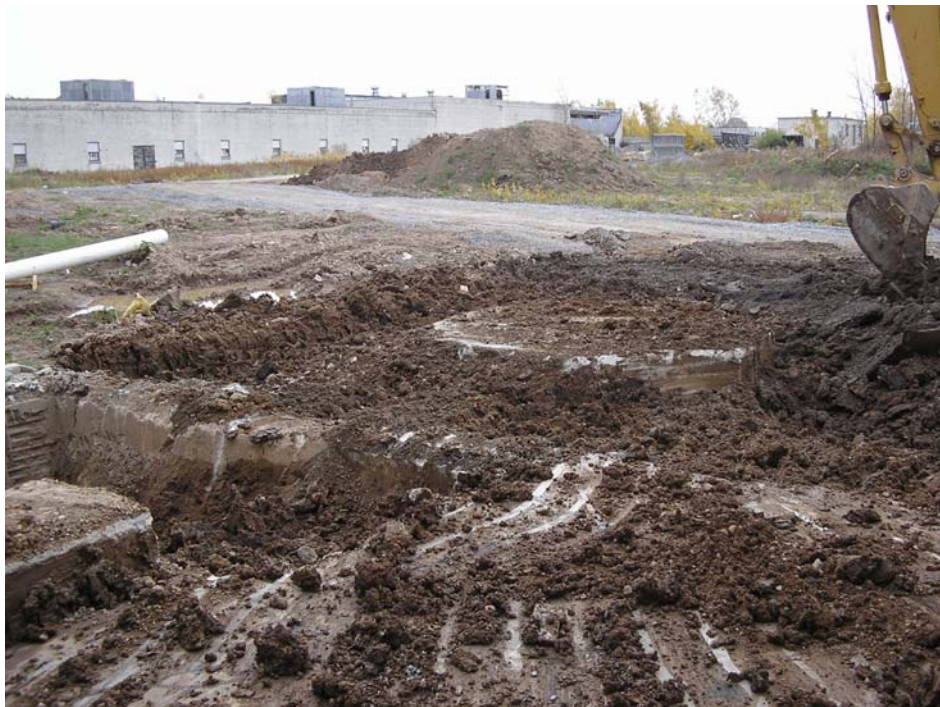
Figure 4-35. Photograph showing the excavation around a former Supertherm Tank pad. View looking southeast. Photograph taken by Jim Tuk on November 4, 2005.

Excavation of the Therminol Building Area resumed on Friday, November 4, 2005 when approximately 1 foot of non-hazardous soil was removed from around the remaining Supertherm Tank pad (Figure 4-31) and from under the roadway south of the Spauldite Sheet Building (Figures 4-35 thru 4-37). The depth of excavation reached approximately 7.5 feet where the westernmost Supertherm Tank pad had been located (Figure 4-31). Excavation near the basement stairwell was not completed at this time due to excessive water in the excavation and basement (the pump for the temporary water treatment system had stopped working). Schutt & Associates were on site between Monday, November 7, 2005 and Thursday, November 11, 2005 to set up control points, and to survey the outer limit of the excavation, the adjacent buildings, concrete pads and the floor of the excavation.

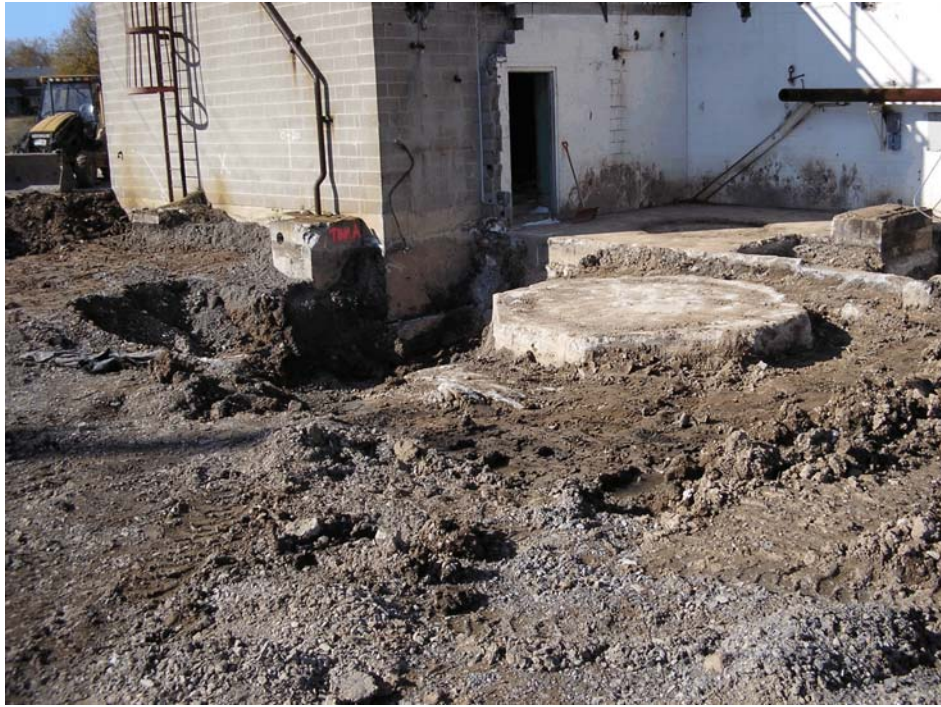
Figure 4-36. Photograph showing the final excavation of the western portion of the Therminol Building area. View looking northwest. Photograph taken by Jim Tuk on November 7, 2005.

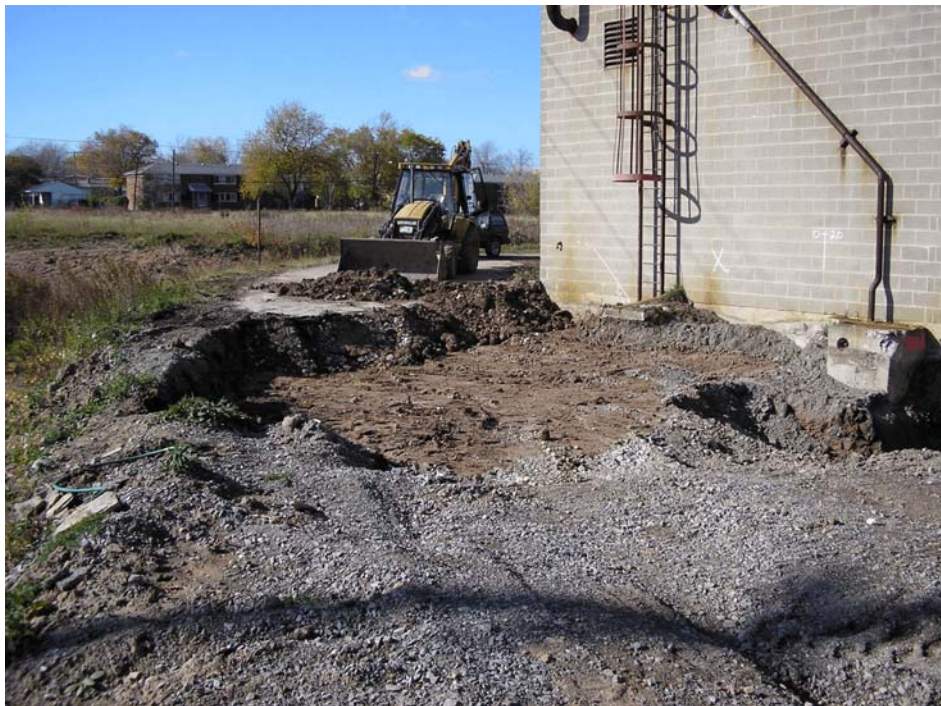
Figure 4-37. Photograph showing the final excavation of the western portion of the Therminol Building area. View looking west. Photograph taken by Jim Tuk on November 7, 2005.

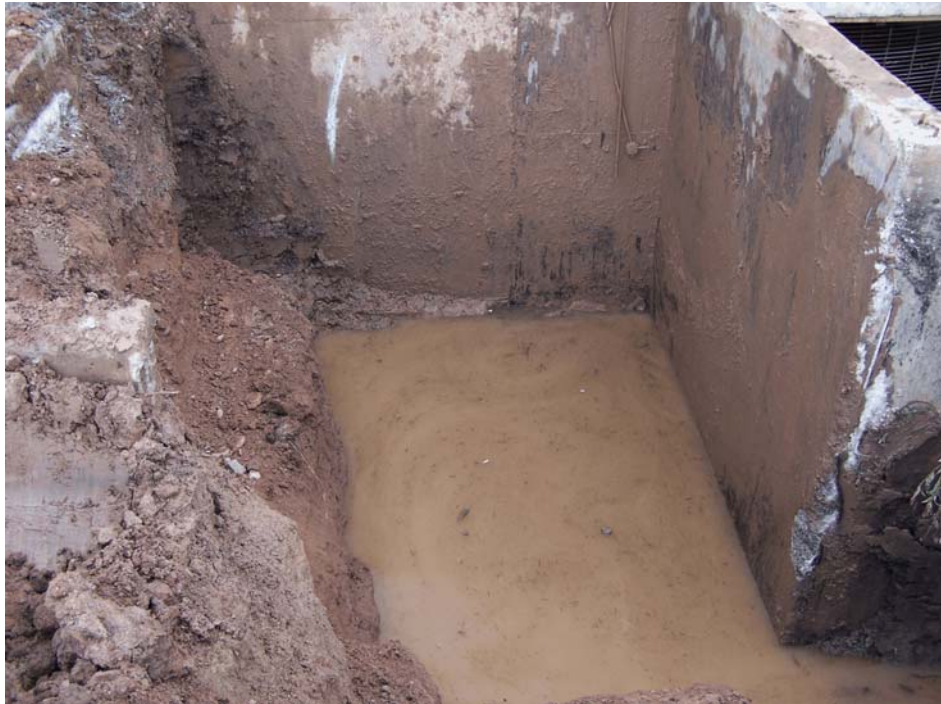
Figure 4-38. Photograph showing the final excavation along the Spauldite Sheet basement stairwell. View looking slightly northwest. Photograph taken by Glenn May on September 7, 2006.

completed the following day (Figures 4-38 and 4-39). Three confirmatory samples of the sidewalls (TS-37 thru TS-39; Figure 4-31) were collected the same day and submitted to STL for analysis. The analytical results from these samples are discussed in Section 5.3. A confirmatory sample of the floor was not collected due to the inflow of water (Figure 4-38) from a severed foundation drain line. The outer limit and floor of the excavation, and the locations of the confirmatory samples were surveyed by Schutt & Associates on Tuesday, September 12, 2006.

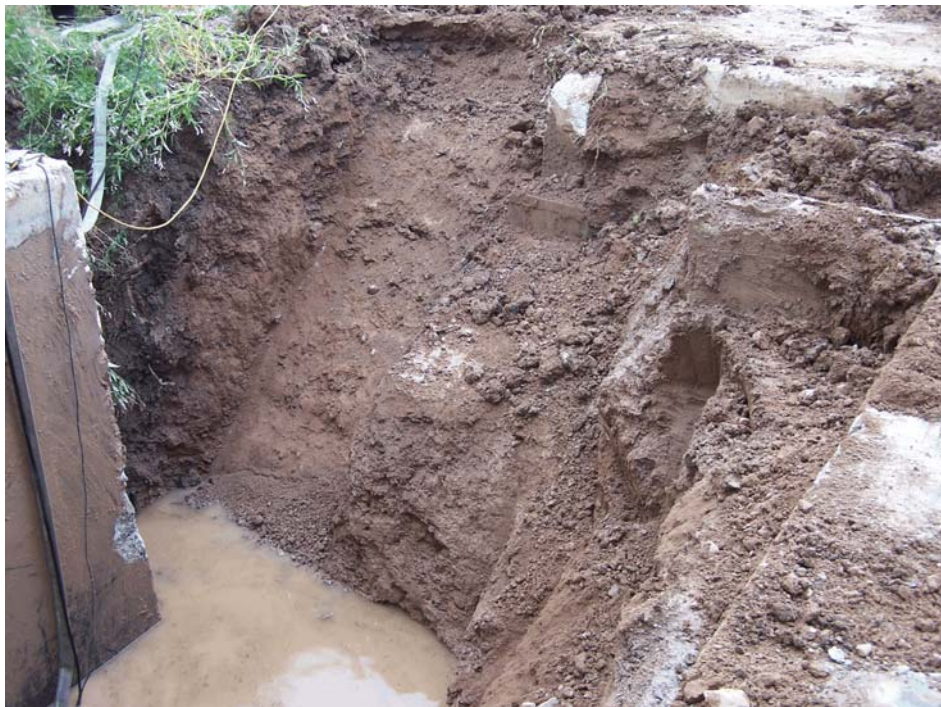
Figure 4-39. Photograph showing the final excavation along the Spauldite Sheet basement stairwell. View looking southeast. Photograph taken by Glenn May on September 7, 2006.

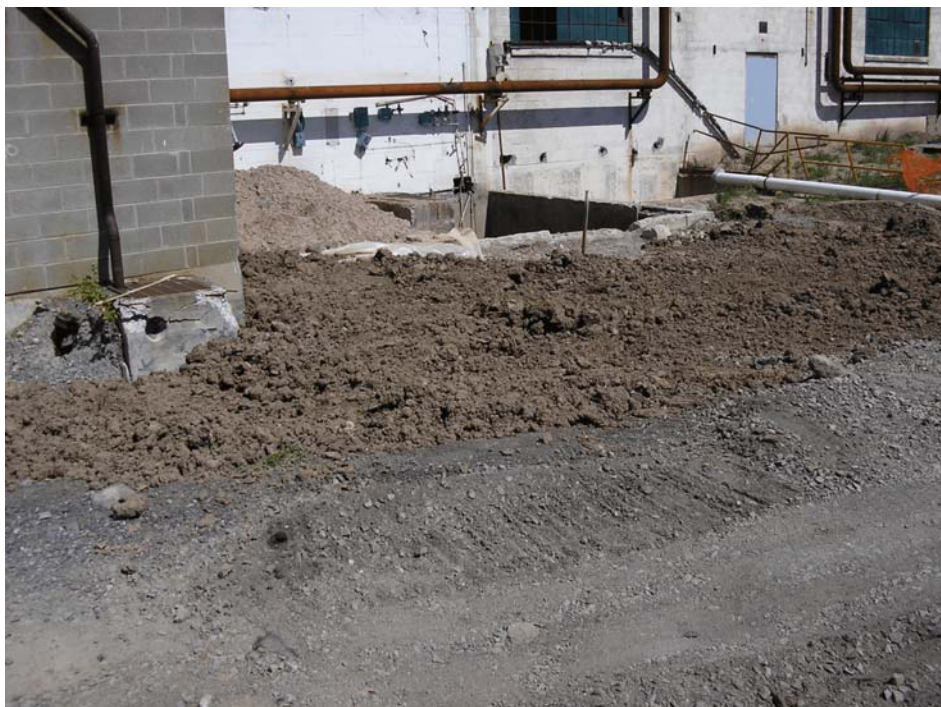
Figure 4-42. Photograph showing the completed backfilling of the western portion of the Therminol Building area. View looking north. Photograph taken by Glenn May on May 2, 2006.

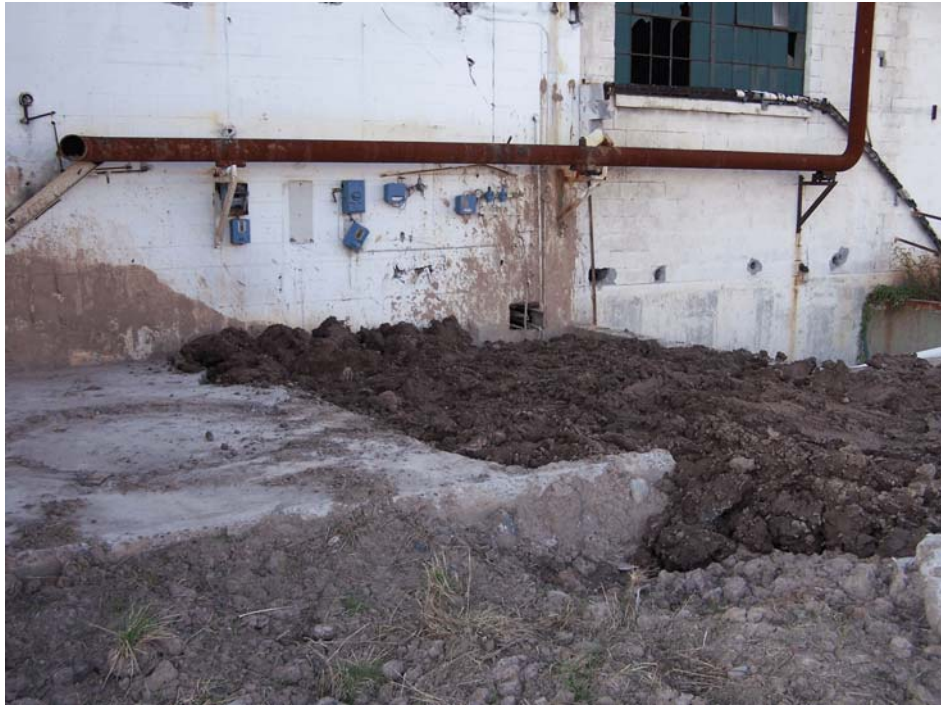
Figure 4-43. Photograph showing the completed backfilling of the western portion of the Therminol Building area. View looking north. Photograph taken by Glenn May on September 27, 2006.
