Final IRM Report for Operable Unit 2

**Spaulding Composites Site
Tonawanda, Erie County, New York
Site Number 9-15-050**

**March 2007
Revised July 2008**

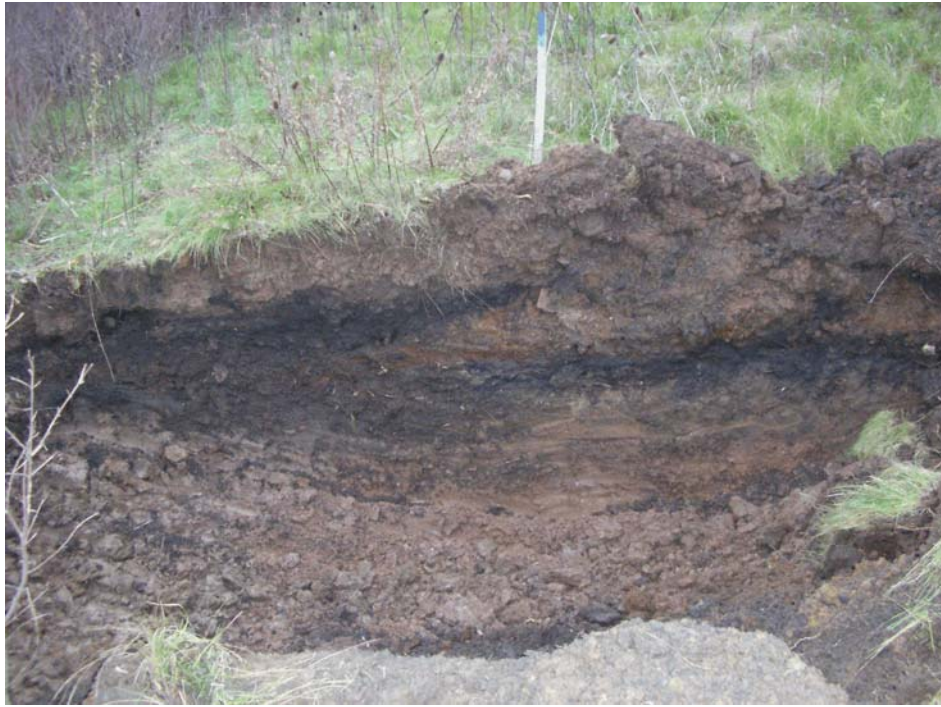
Figure 4-45. Photograph showing the fill material encountered in the SWMU 13 excavation. The mounded area in the background is the Resin Drum Landfill (SWMU 7). View looking southwest. Photograph taken by Jim Tuk on November 21, 2005.

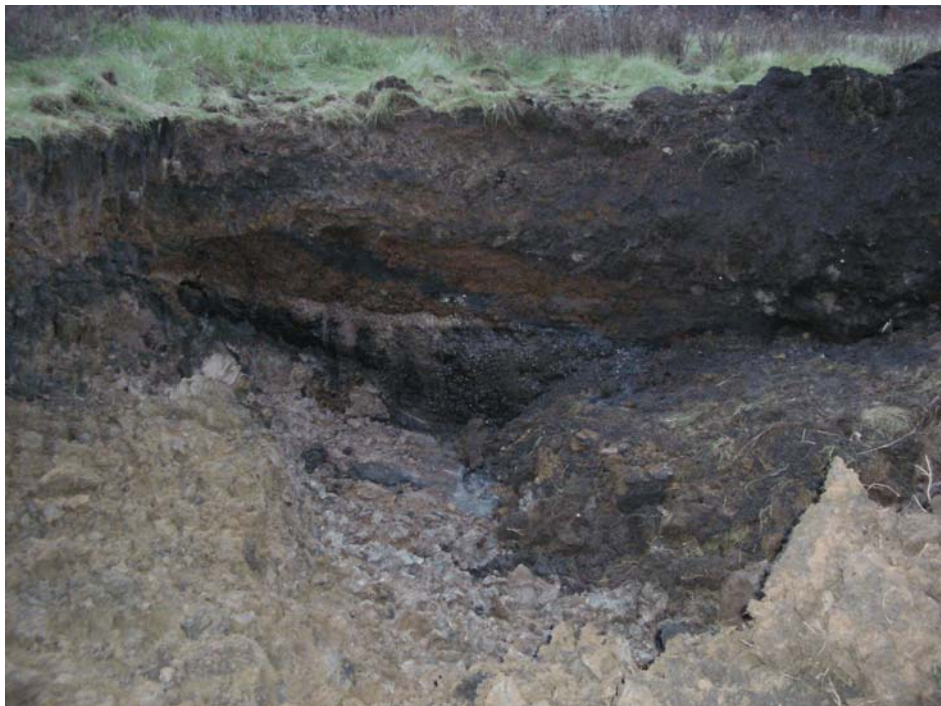
Figure 4-46. Photograph showing the fill material encountered in the SWMU 13 excavation. View looking southwest. Photograph taken by Jim Tuk on November 21, 2005.

(SWMU 7) and adjacent ditch (Figure 4-44). All excavated soils were staged near the cinder block building. Later that day, cinders, ash and grinding waste were encountered in the excavation at depths ranging to 4 feet below ground surface (Figures 4-45 thru 4-47). Remediation activities at SWMU 13 were halted the following day and subsequently incorporated into the State Superfund remedial program due to its close proximity to SWMU 7 (Figure 4-44) and the non-PCB remediation required for the remainder of SWMU 13. The stockpiled soils were subsequently tested, found to be non-hazardous, and transported to BFI in Niagara Falls, New York for disposal with the non-hazardous soils from SWMU 23.

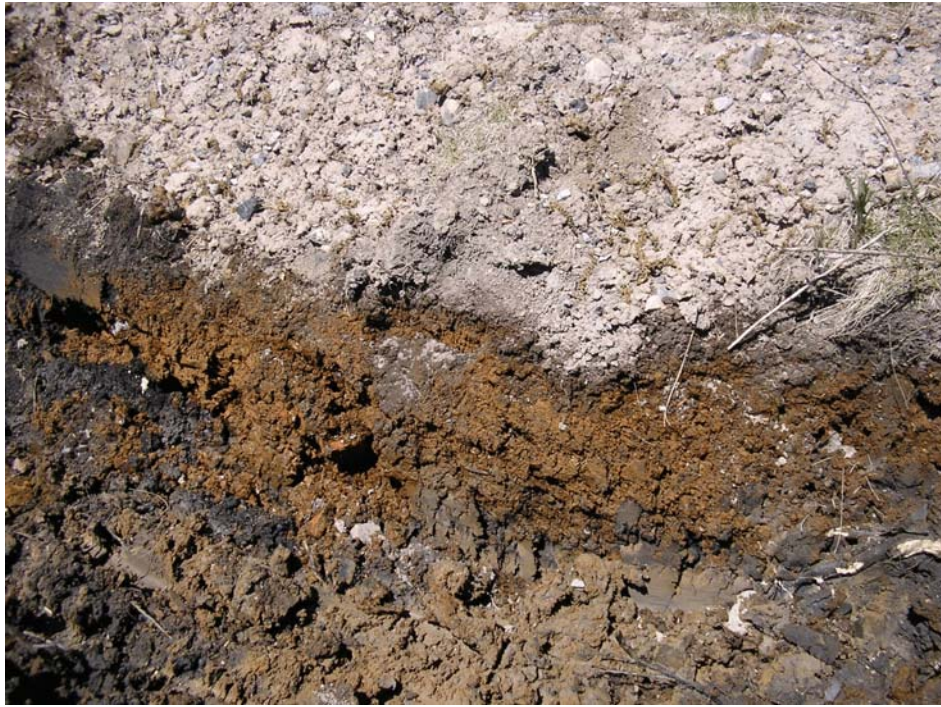
Figure 4-47. Photograph showing a closeup of the grinding waste encountered in the SWMU 13 excavation. View looking southwest. Photograph taken by Glenn May on May 2, 2006.

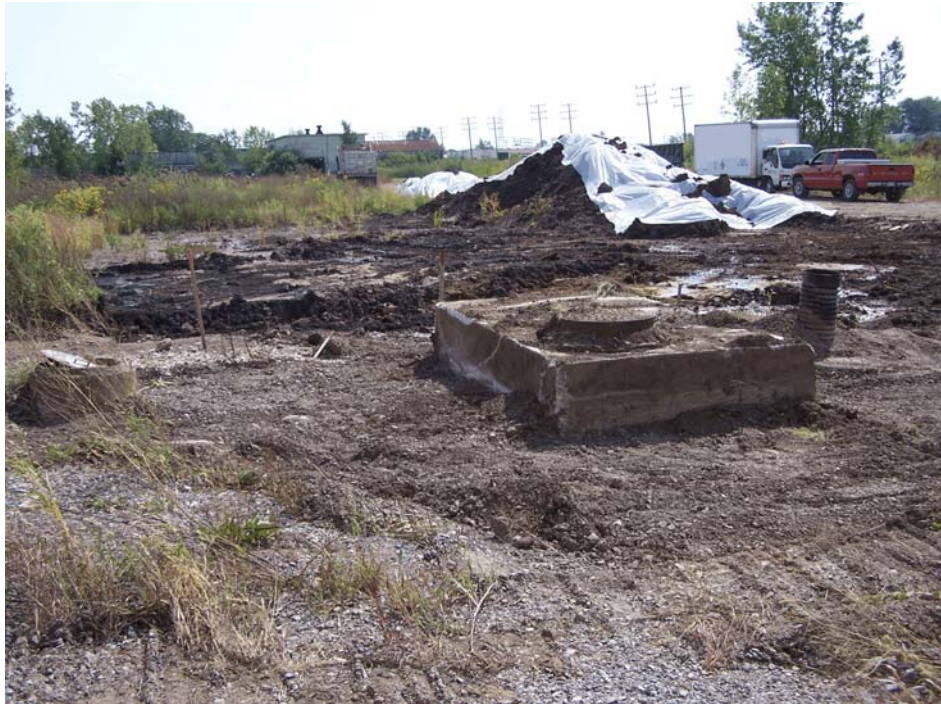
Figure 4-51. Photograph showing SWMU 23 following the excavation of RCRA hazardous soils. View looking southeast. The area beyond the concrete vault is shown in Figure 4-52. Photograph taken by Glenn May on September 8, 2006.

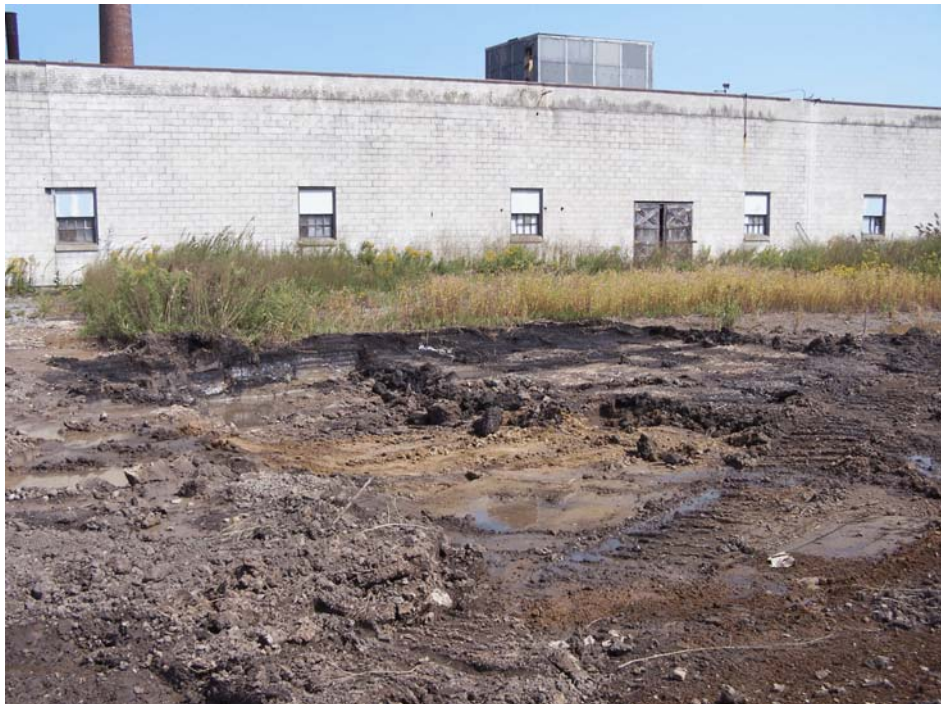
Figure 4-52. Photograph showing SWMU 23 following the excavation of RCRA hazardous soils. View looking east. Photograph taken by Glenn May on September 8, 2006.

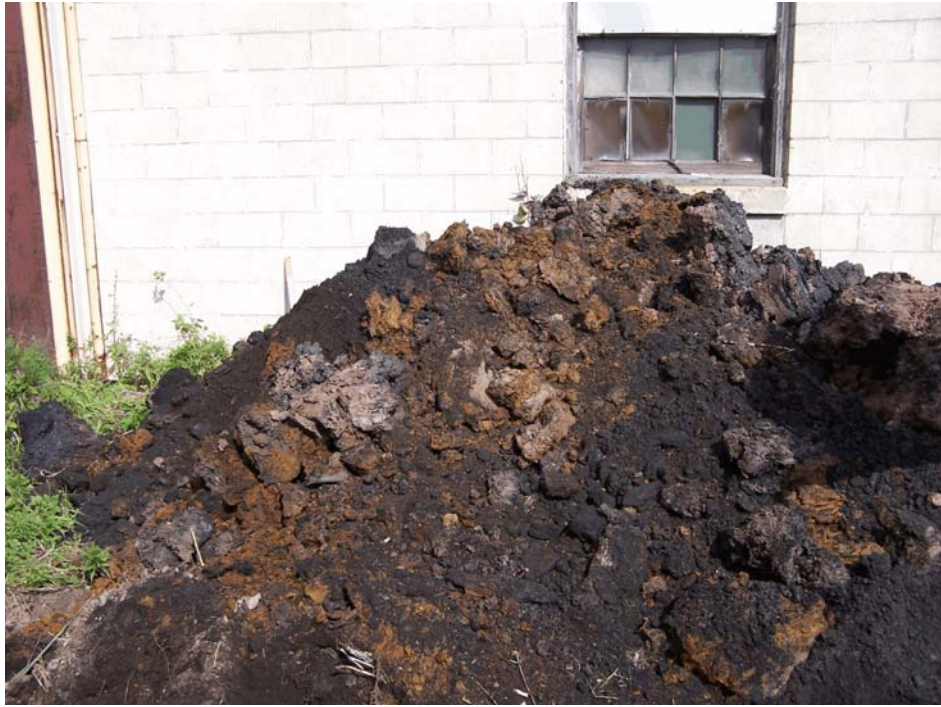
Figure 4-53. Photograph showing the grinding waste, ash and slag fill from the former ditch near the Boiler House. View looking northeast. Photograph taken by Glenn May on September 27, 2006.

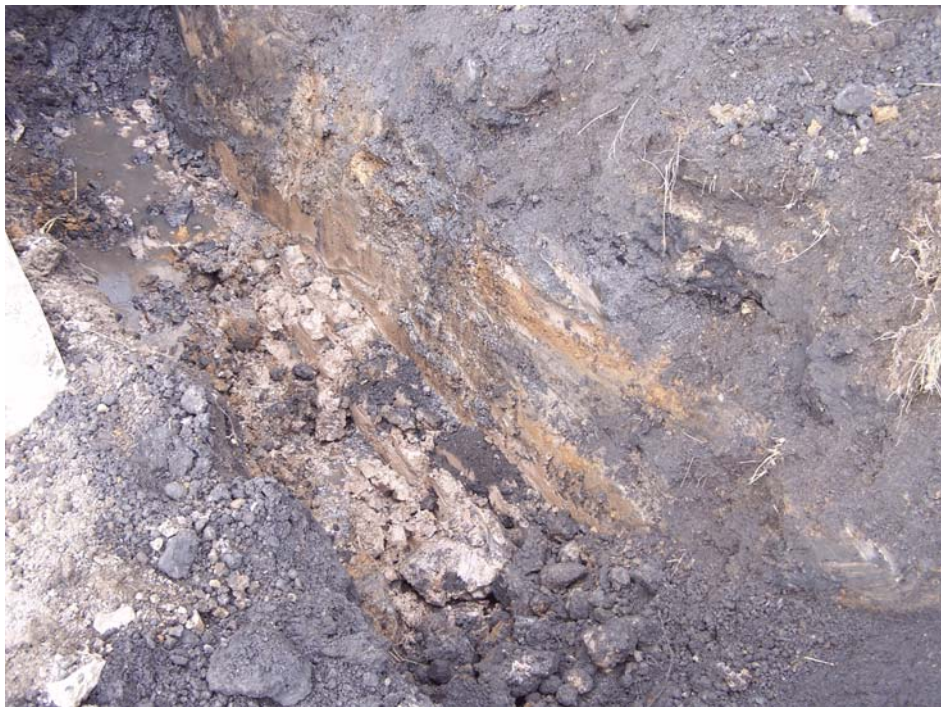
Figure 4-54. Photograph showing a test trench excavated across the former ditch near the Boiler House. View looking north. Photograph taken by Glenn May on September 27, 2006.

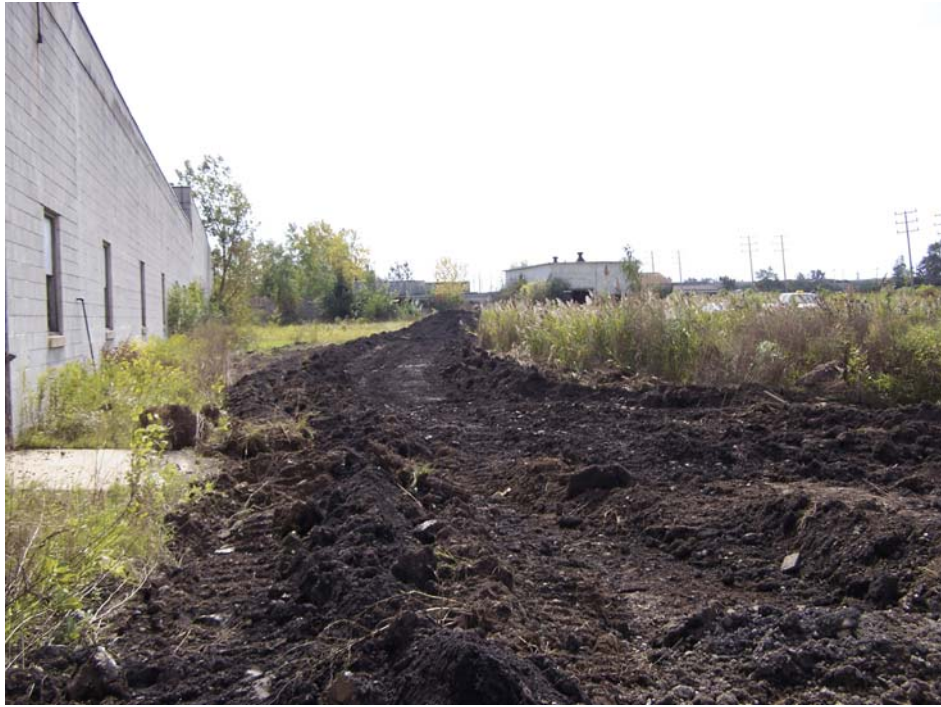
Figure 4-55. Photograph showing the start of non-hazardous soil removal at SWMU 23. View looking southeast. Photograph taken by Glenn May on September 27, 2006.

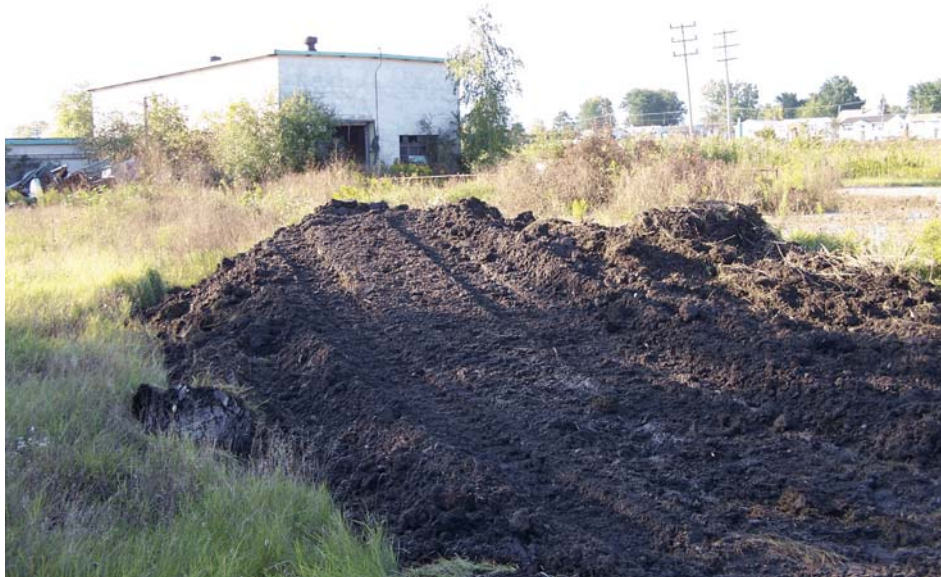
Figure 4-56. Photograph showing the non-hazardous soil stockpile south of SWMU 23. View looking south. Photograph taken by Glenn May on September 27, 2006.

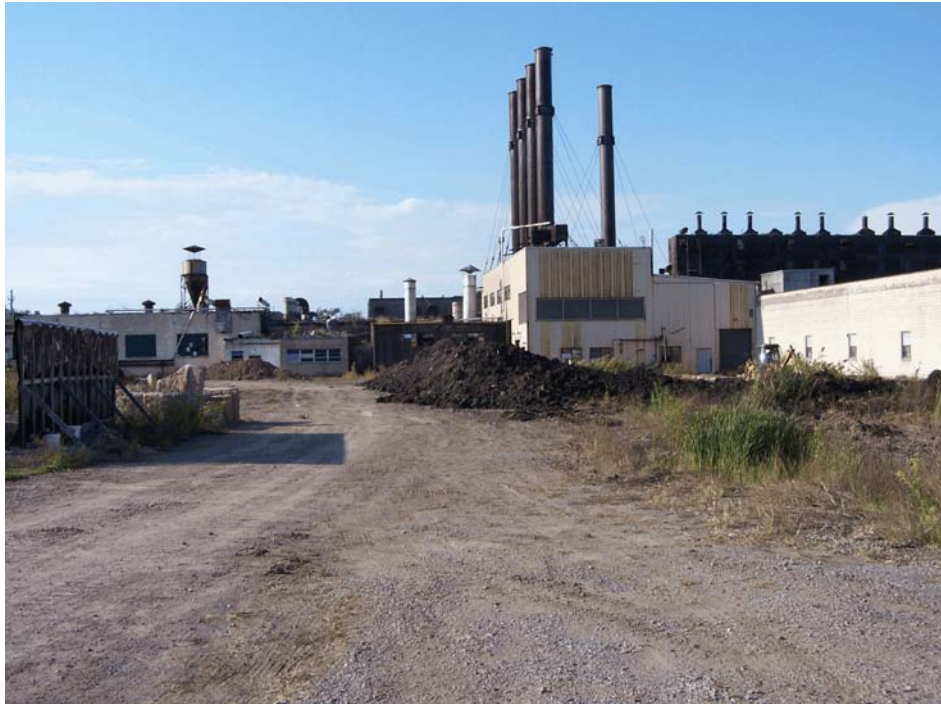
Figure 4-57. Photograph showing the non-hazardous soil stockpile along the roadway west of SWMU 23. View looking north. Photograph taken by Glenn May on September 27, 2006.

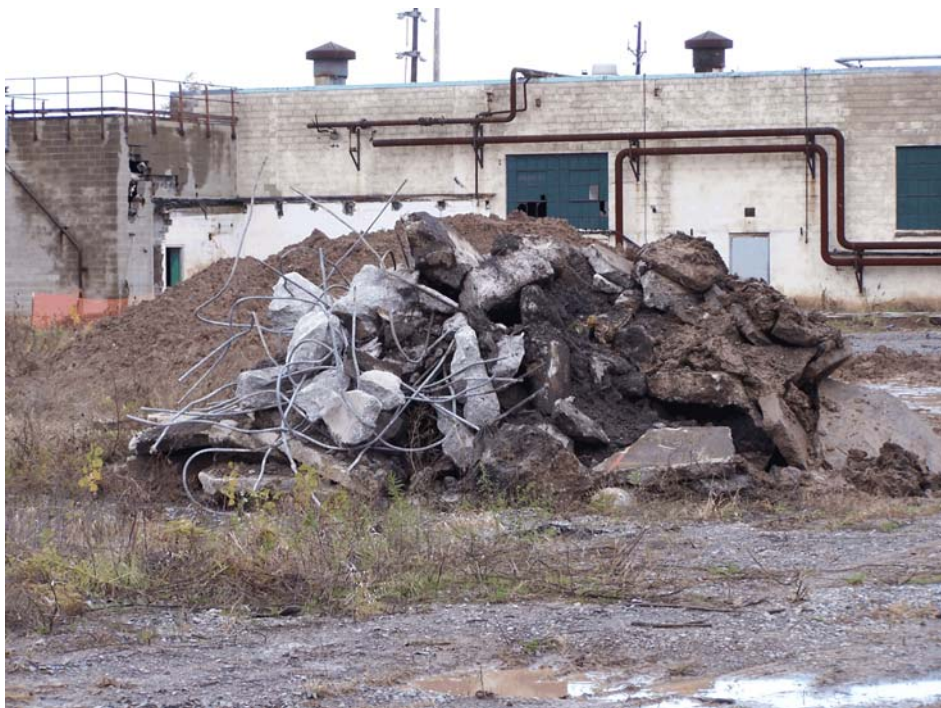
Figure 4-58. Photograph showing the concrete debris that was stockpiled near the decontamination pad. View looking northwest. Photograph taken by Glenn May on October 23, 2006.

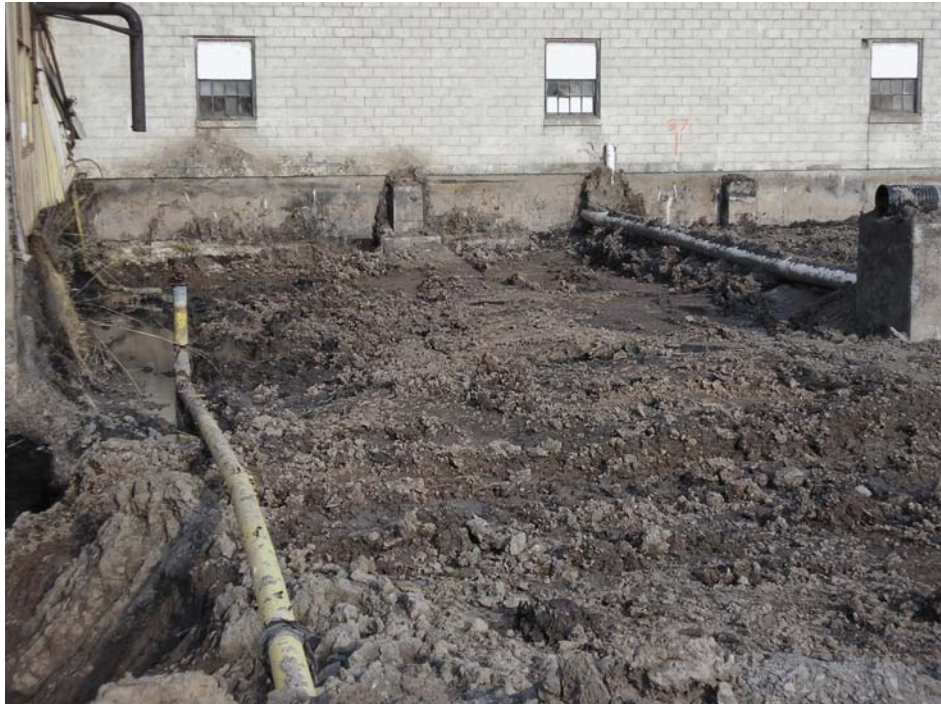
Figure 4-59. Photograph showing the final excavation of SWMU 23 near the Boiler House. View looking northeast. Photograph taken by Jim Tuk on November 3, 2006.

The removal of the non-hazardous soils from SWMU 23 resumed on Thursday, October 26, 2006 along the south wall of the Boiler House between the Fibre Sheet Building and the roadway (Figure 4-59). Excavation progressed to the south between the Fibre Sheet Building and the roadway. The soil stockpiles along the roadway were loaded into trucks for transport to BFI in Niagara Falls, New York for disposal as the excavation proceeded (Figure 4-60). Remediation of SWMU 23 was completed on Thursday, November 9, 2006 (Figures 4-61 and 4-62).

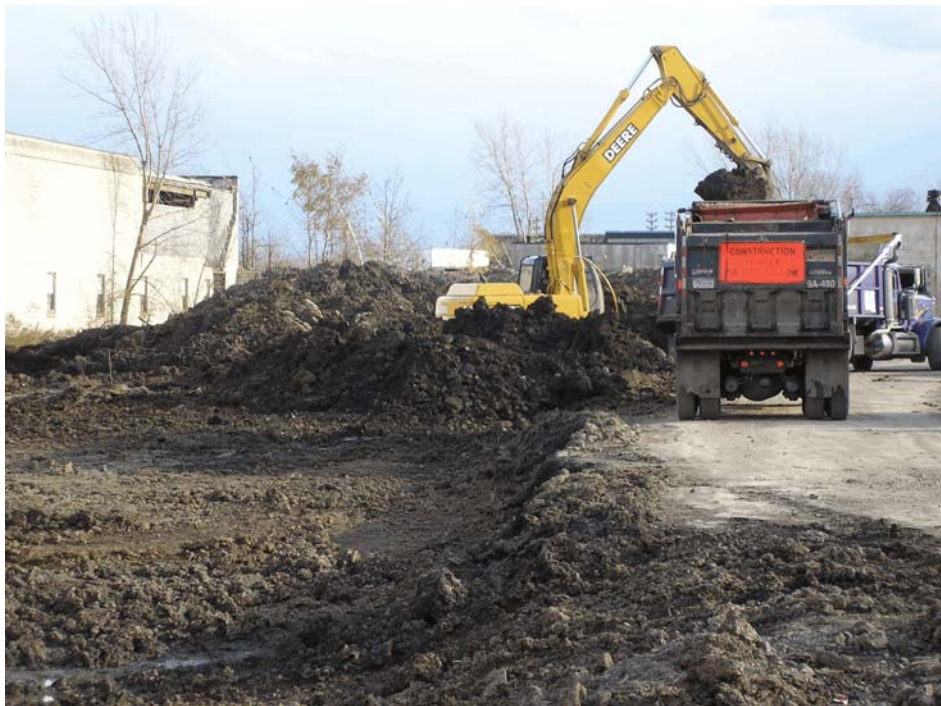
Figure 4-60. Photograph showing the loading of trucks during the excavation of SWMU 23. View looking southeast. Photograph taken by Jim Tuk on November 3, 2006.

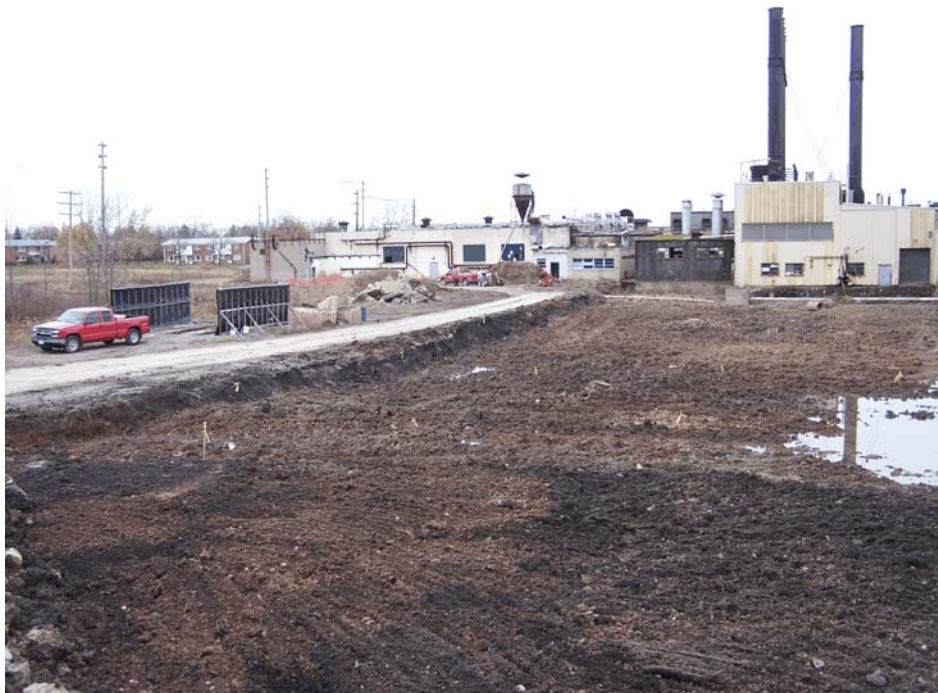
Figure 4-61. Photograph showing the final excavation of SWMU 23. View looking northwest. Photograph taken by Glenn May on November 10, 2006.

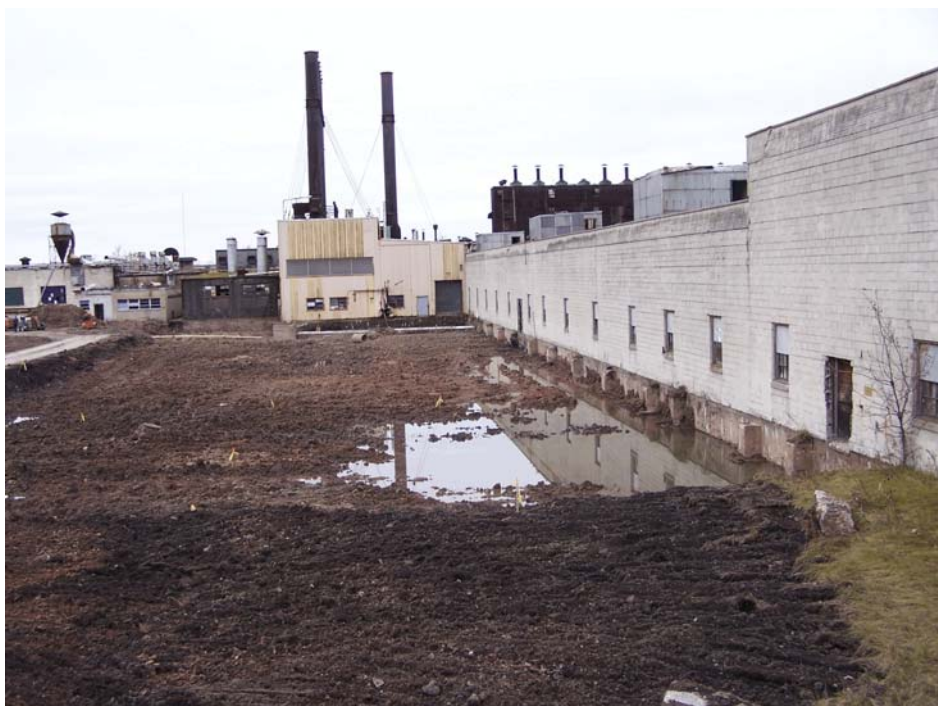
Figure 4-62. Photograph showing the final excavation of SWMU 23. View looking north. Photograph taken by Glenn May on November 10, 2006.

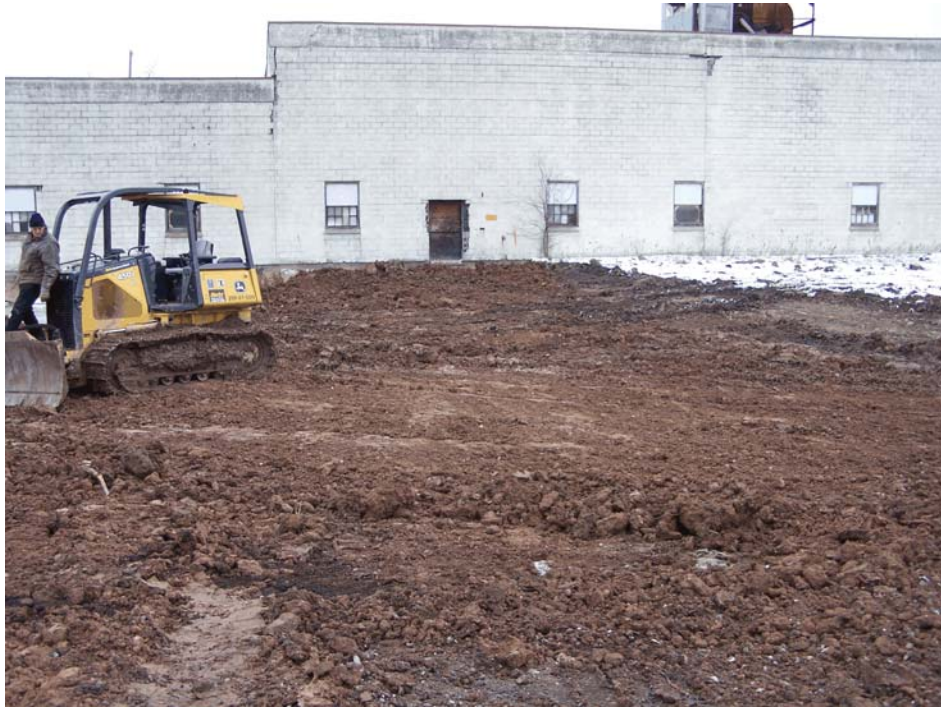
Figure 4-64. Photograph showing the start of backfilling activities at the south end of SWMU 23. View looking east. Photograph taken by Glenn May on December 6, 2006.

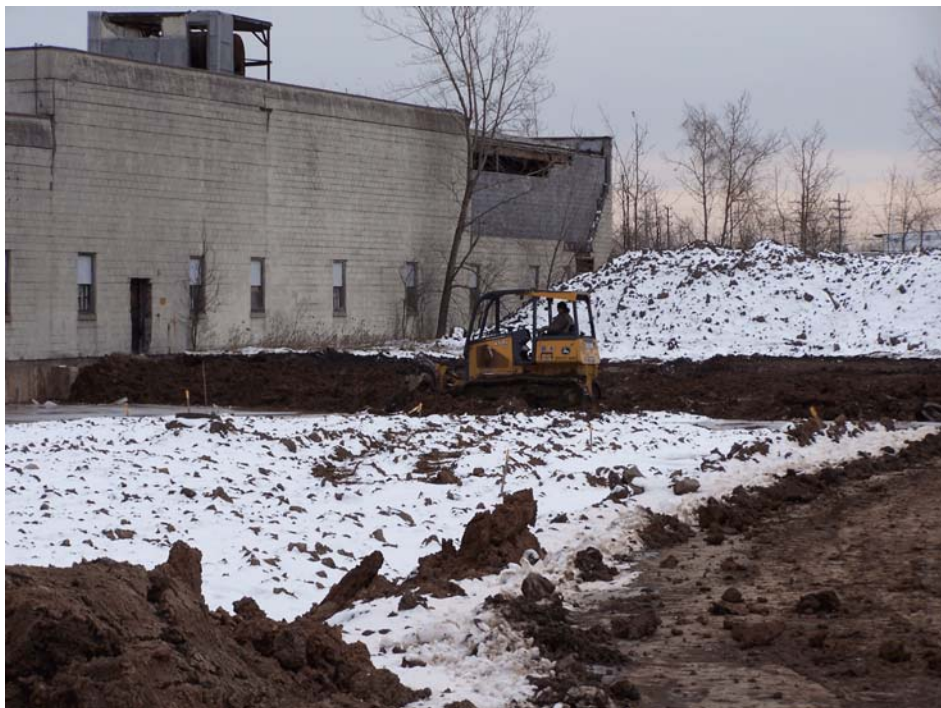
Figure 4-65. Photograph showing the start of backfilling activities at the south end of SWMU 23. View looking southeast. Photograph taken by Glenn May on December 6, 2006.

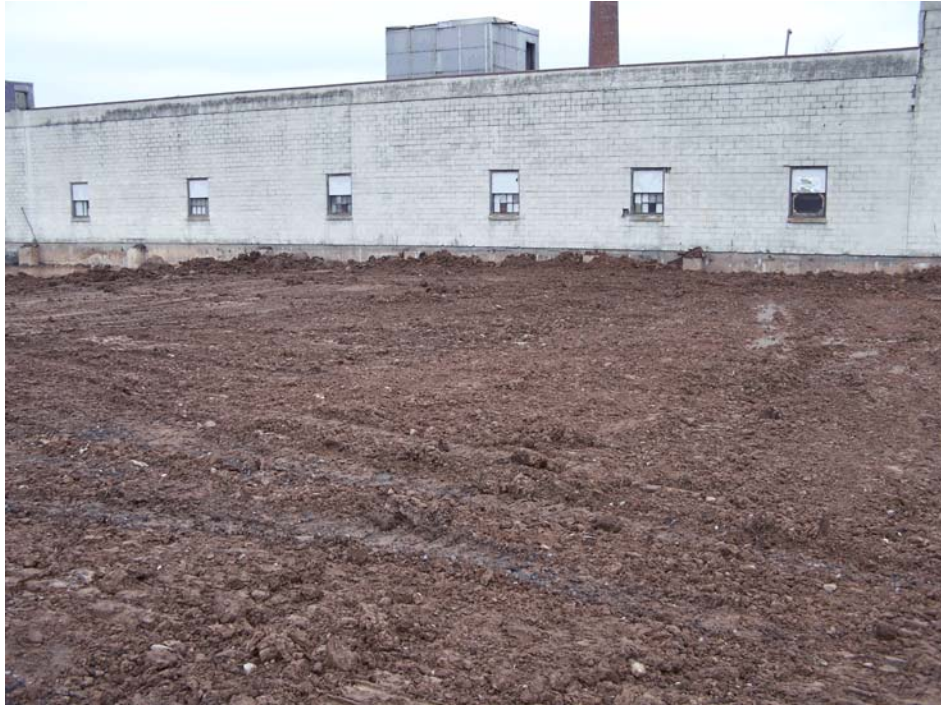
Figure 4-66. Photograph showing the continued backfilling of SWMU 23. View looking northeast. Photograph taken by Glenn May on December 13, 2006.

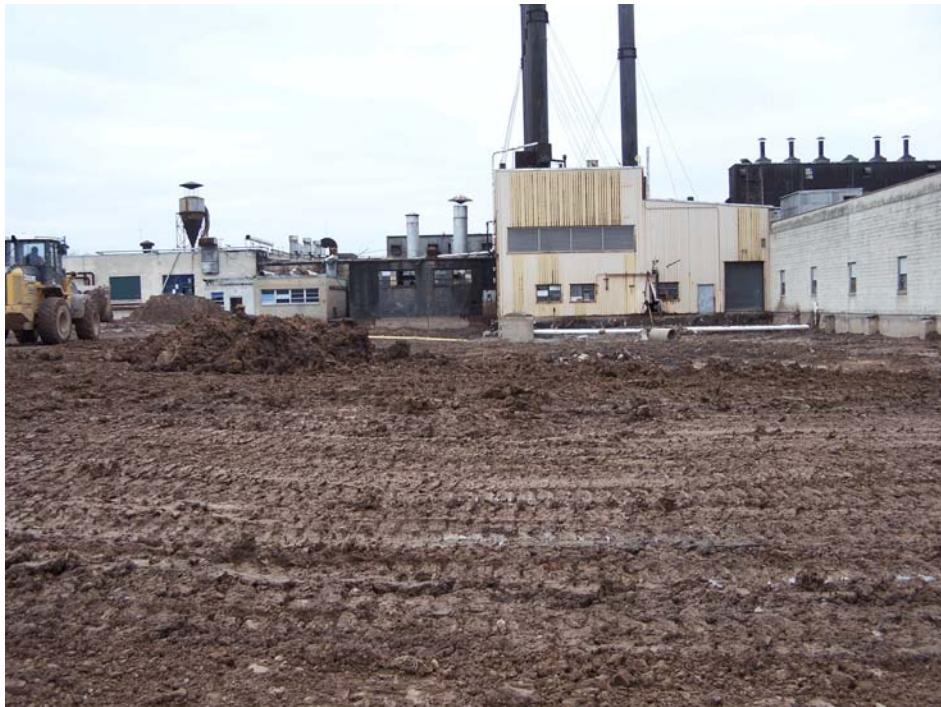
Figure 4-67. Photograph showing the continued backfilling of SWMU 23. View looking north. Photograph taken by Glenn May on December 13, 2006.

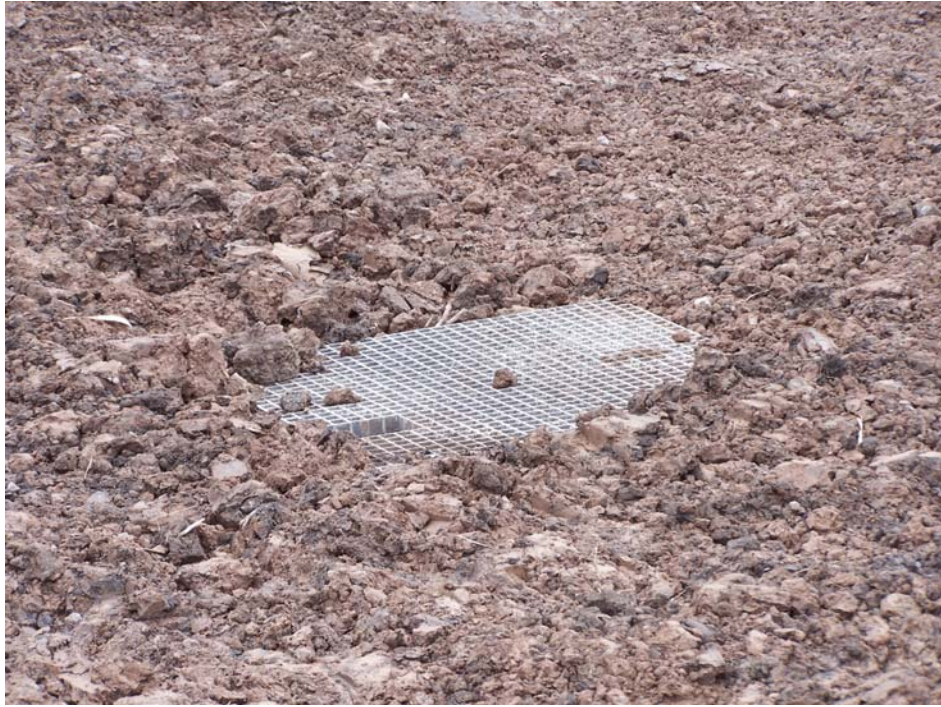
Figure 4-68. Photograph showing the grating placed over the southern manhole in the SWMU 23 remediation area. View looking east. Photograph taken by Glenn May on December 13, 2006.

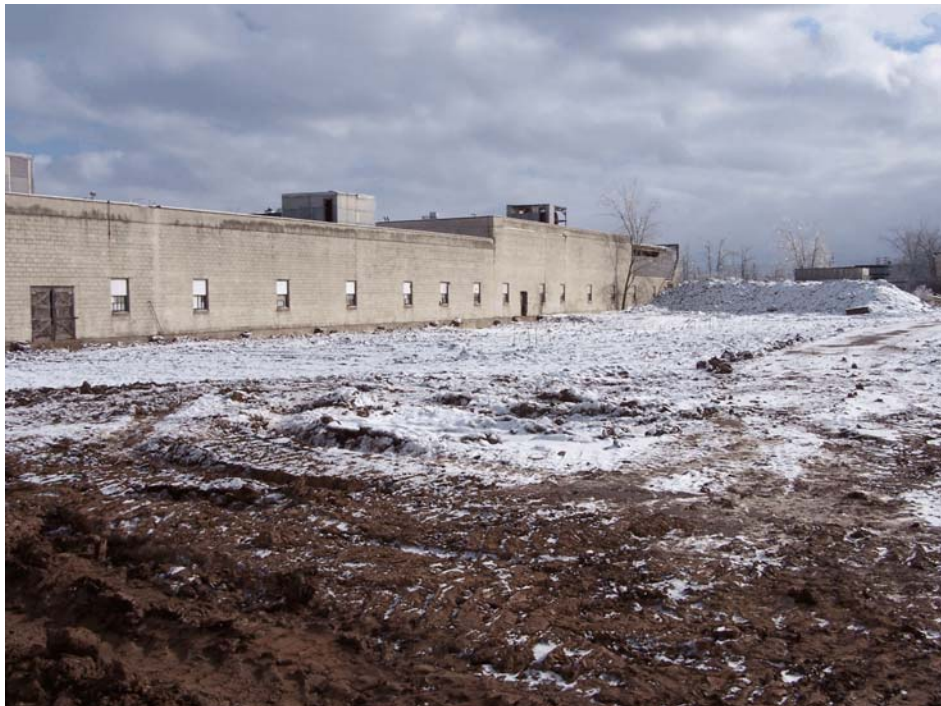
Figure 4-69. Photograph showing the completed backfilling of SWMU 23. View looking southeast. Photograph taken by Glenn May on January 18, 2007.

Backfilling of the SWMU 23 excavation began on Monday, December 4, 2006 after the confirmatory sample results indicated that the Part 375 restricted residential soil cleanup objective for PCBs had been achieved. Backfilling began at the southern end of the excavation (Figures 4-64 and 4-65) and progressed to the north (Figures 4-66 and 4-67). The backfill soils were sloped toward the center of the excavation to promote drainage into the existing manholes (Figures 4-63 and 4-68). Backfilling of the Former Tank Farm excavation was completed on Monday, January 22, 2007 (Figures 4-69 and 4-70). The clean soils utilized for backfill came from the Hinds Street area.

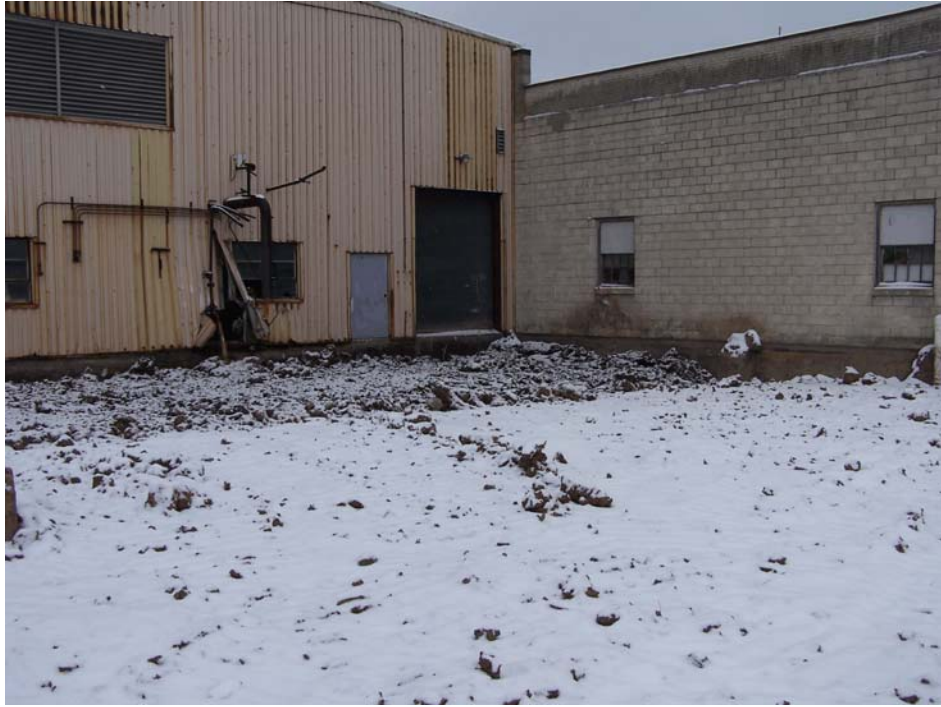
Figure 4-70. Photograph showing the completed backfilling of SWMU 23. View looking north. Photograph taken by Glenn May on January 23, 2007.

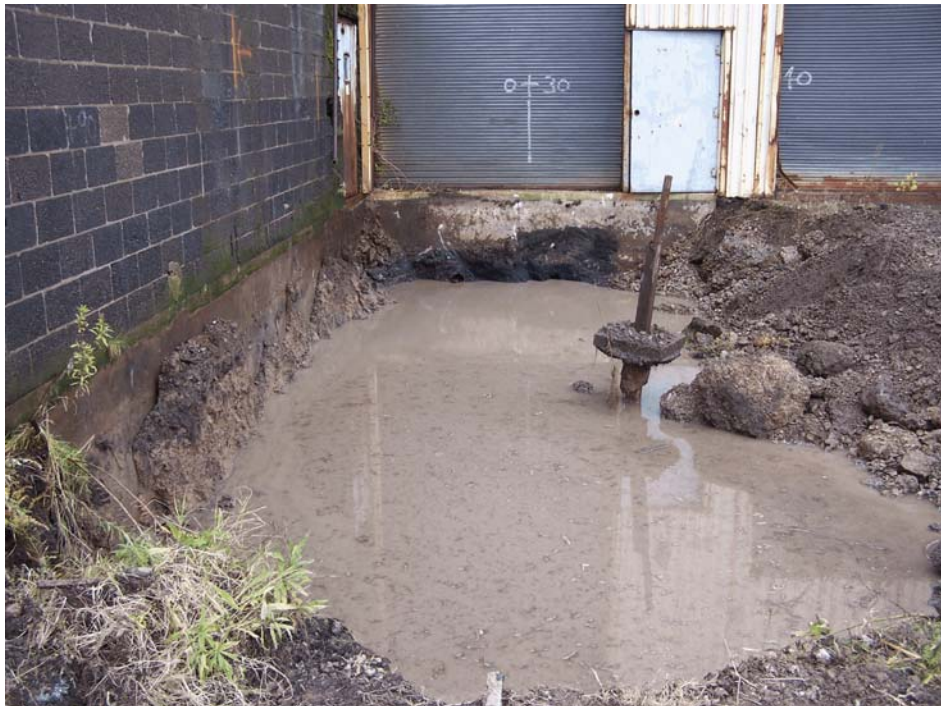
Figure 4-71. Photograph showing the start of excavation of SWMU 11 along the Cinder Block Building. View looking northeast. Photograph taken by Glenn May on October 23, 2006.

Excavation of the Small Settling Lagoon began on Monday, October 23, 2006. The removal of non-hazardous soils began along the south wall of the Cinder Block Building adjacent to the Boiler House (Figure 4-71). Water initially flowed into the excavation (Figure 4-71) from a 24-inch concrete pipe that formerly discharged into the Small Settling Lagoon (Figure 4-72). This flow of water ceased by the end of the day. Excavation progressed to the south (Figures 4-73 and 4-74) until the natural gas pipeline was encountered (Figure 4-75). Remediation of the Small Settling Lagoon was completed on Friday, October 27, 2006 (Figure 4-76).

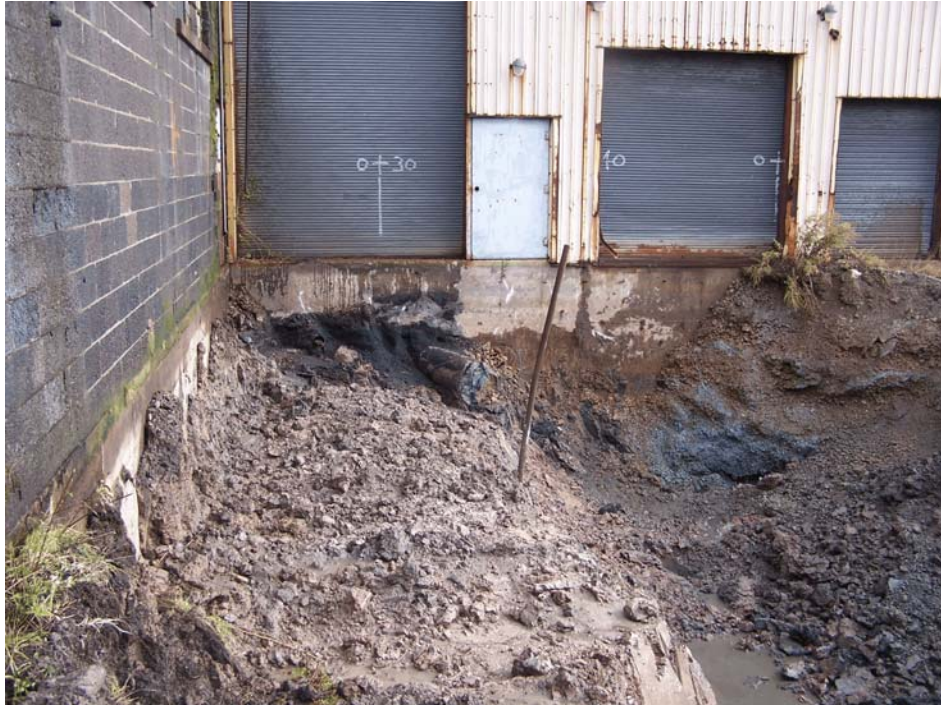
Figure 4-72. Photograph showing the SWMU 11 excavation. Note the inflow pipe to the Small Settling Lagoon and the fill material under the Boiler House. View looking northeast. Photograph taken by Glenn May on October 24, 2006.

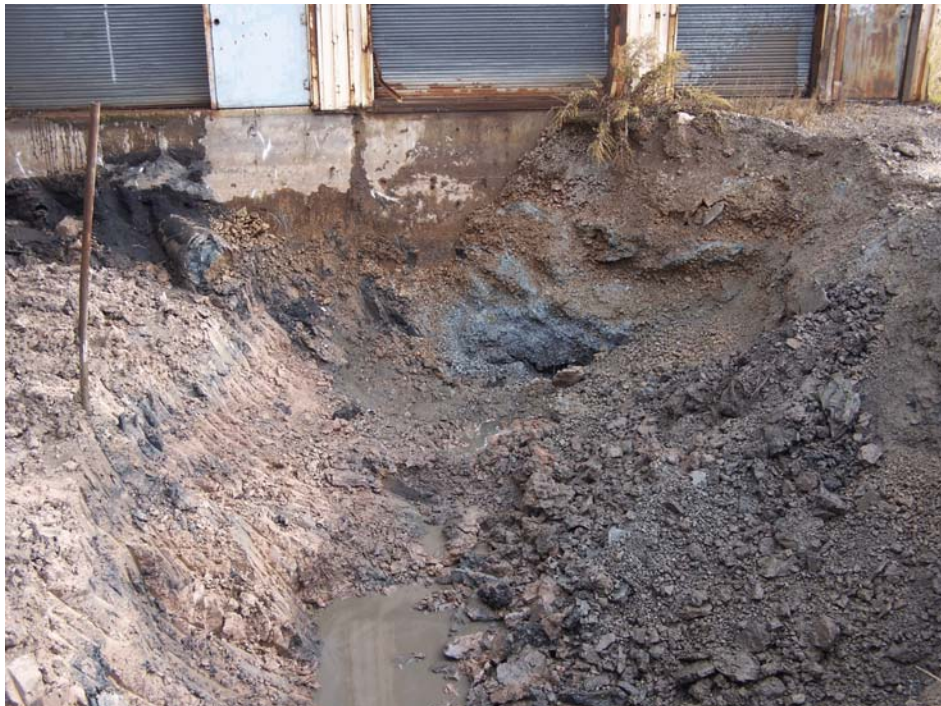
Figure 4-73. Photograph showing the SWMU 11 excavation. Note the inflow pipe to the lagoon and the fill material under the Boiler House. View looking northeast. Photograph taken by Glenn May on October 24, 2006.

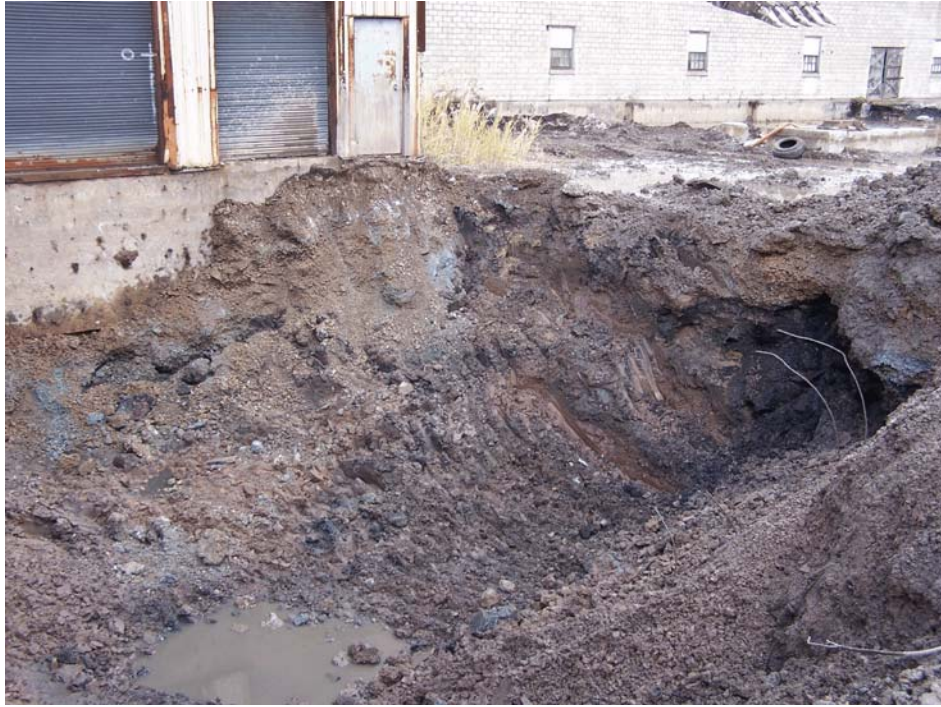
Figure 4-74. Photograph showing the SWMU 11 excavation. Note the fill material in the south sidewall, which was the location of a former ditch. View looking east. Photograph taken by Glenn May on October 24, 2006.

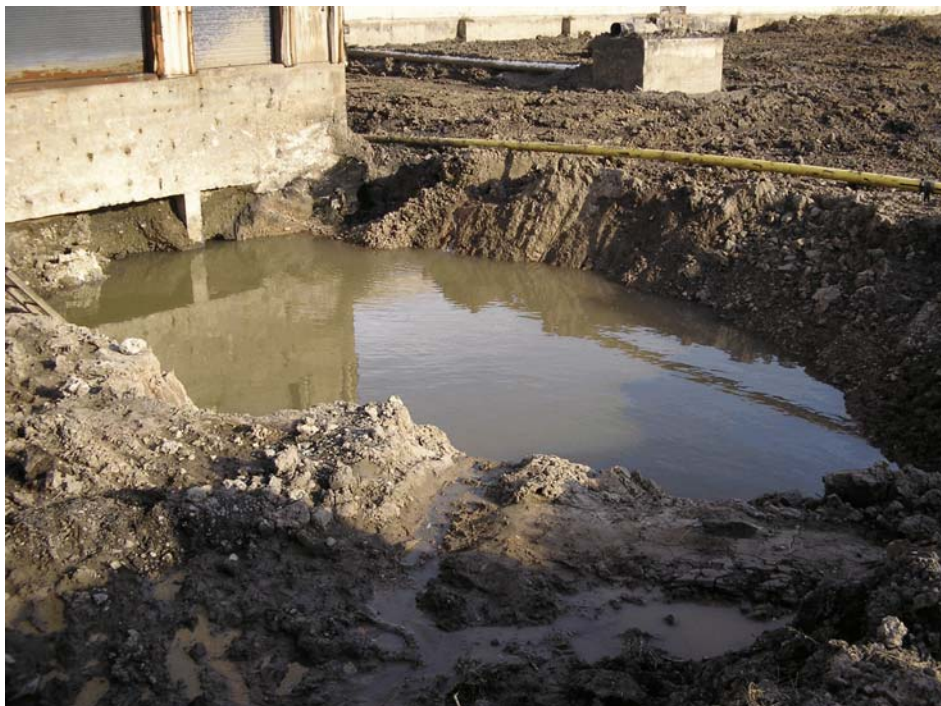
Figure 4-75. Photograph showing the completed SWMU 11 excavation. Note the natural gas pipeline in the background. View looking east. Photograph taken by Glenn May on November 3, 2006.

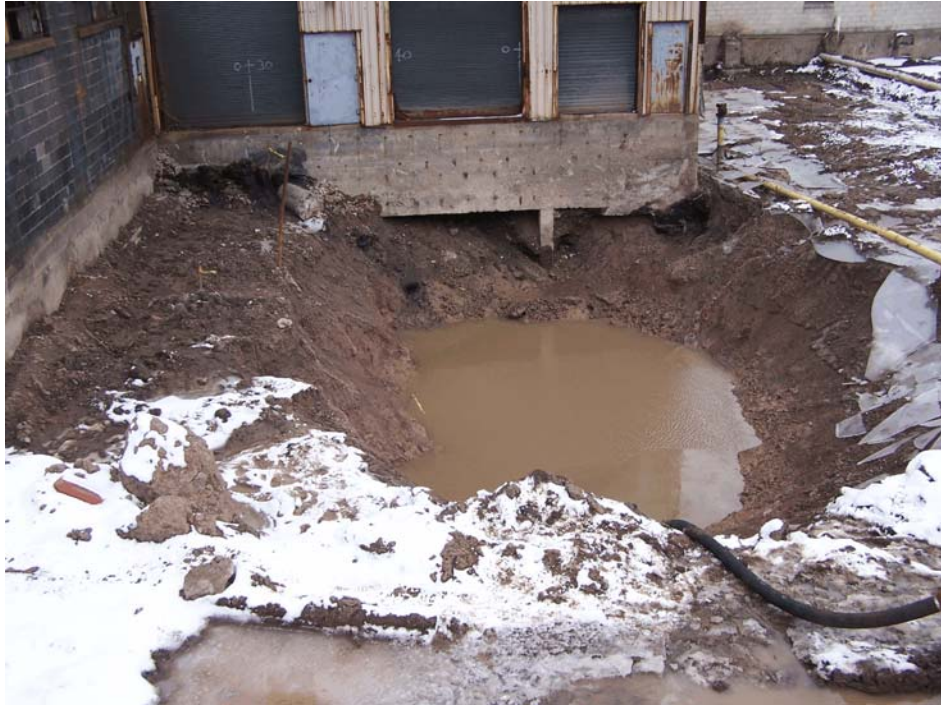
Figure 4-76. Photograph showing the completed SWMU 11 excavation. View looking northeast. Photograph taken by Glenn May on December 6, 2006.
