Division of Environmental Remediation

Final Remediation Report for Operable Unit 2 - Spauldite Sheet Basement and K-Line Storm Sewer

**Spaulding Composites Site
Tonawanda, Erie County, New York
Site Number 9-15-050**

June 2010

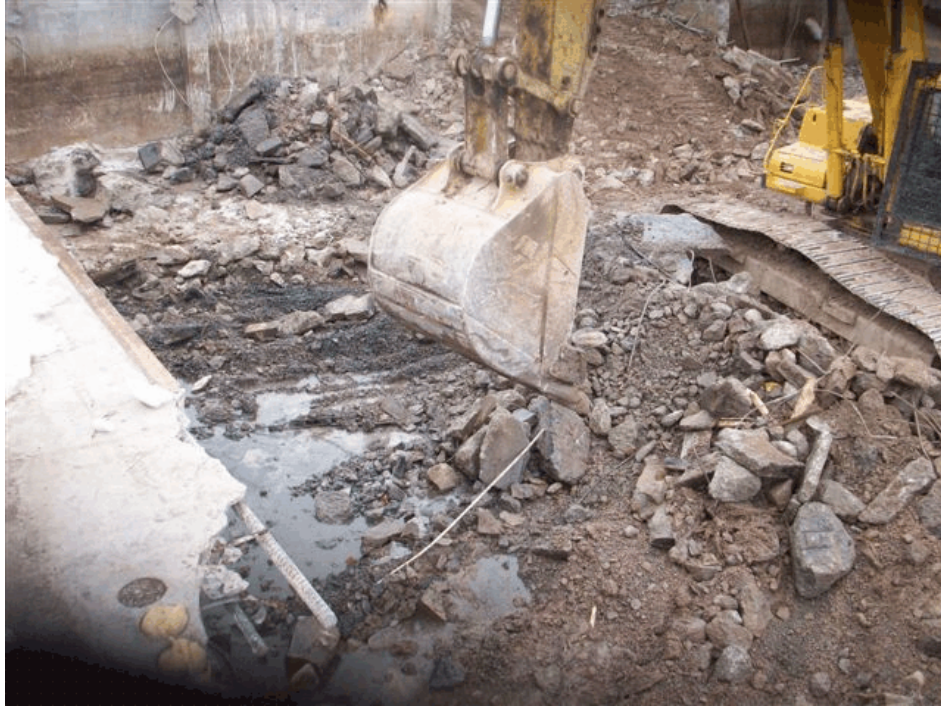
Figure 2-1. Photograph showing the removal of the concrete floor of the Spauldite Sheet Basement. View looking south. Photograph taken by Brian Hutzler on February 9, 2010.

Following the completion of the asbestos abatement activities, the concrete slab over the Spauldite Sheet Basement and K-Line Storm Sewer, the entire concrete basement slab (Figures 2-1 and 2-2), and a portion of the east basement wall (Figures 2-3 and 2-4) were removed to provide access to underlying contaminated soils. Column supports were stained with oil suspected of containing PCBs. As a result, this concrete was staged in a separate stockpile from concrete that visually looked clean. The stained concrete was sampled on Thursday, February 18, 2010 and submitted to TestAmerica for limited analysis. Based upon these results, a second sample was collected on Thursday, February 25, 2010 and submitted to TestAmerica for analysis of disposal

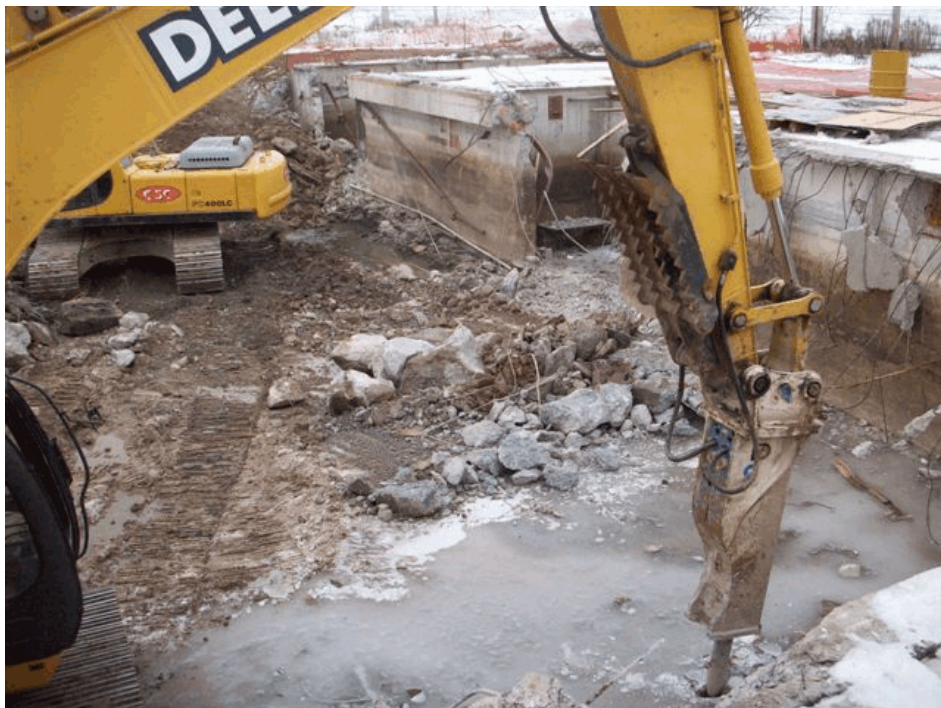
Figure 2-2. Photograph showing the removal of the concrete floor of the Spauldite Sheet Basement. View looking south. Photograph taken by Brian Hutzler on February 9, 2010.

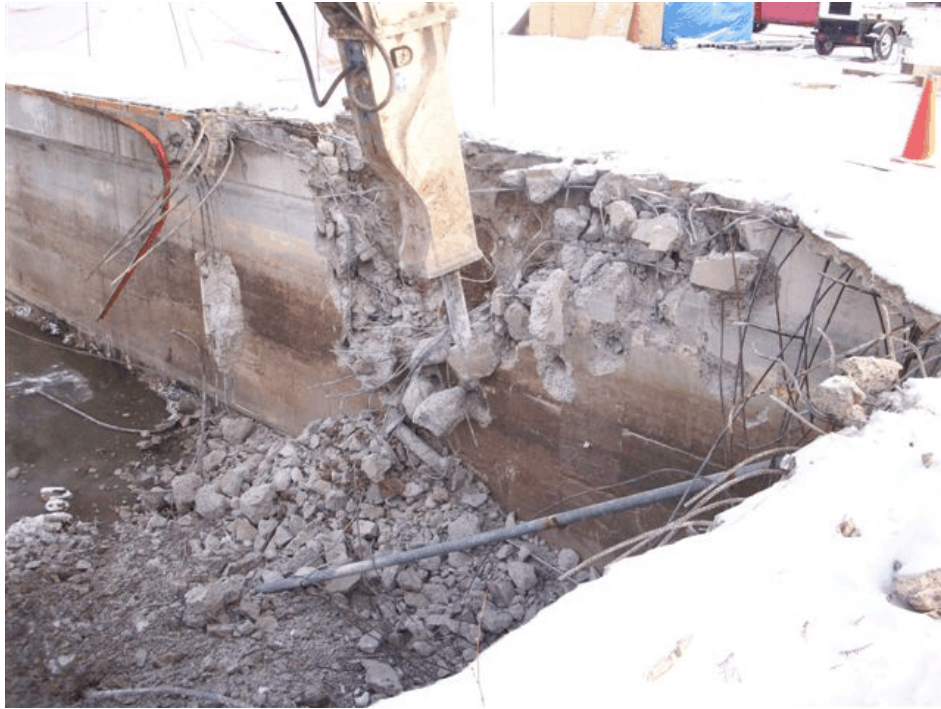
Figure 2-3. Photograph showing the removal of the east foundation wall of the Spauldite Sheet Basement. View looking northeast. Photograph taken by Brian Hutzler on February 11, 2010.

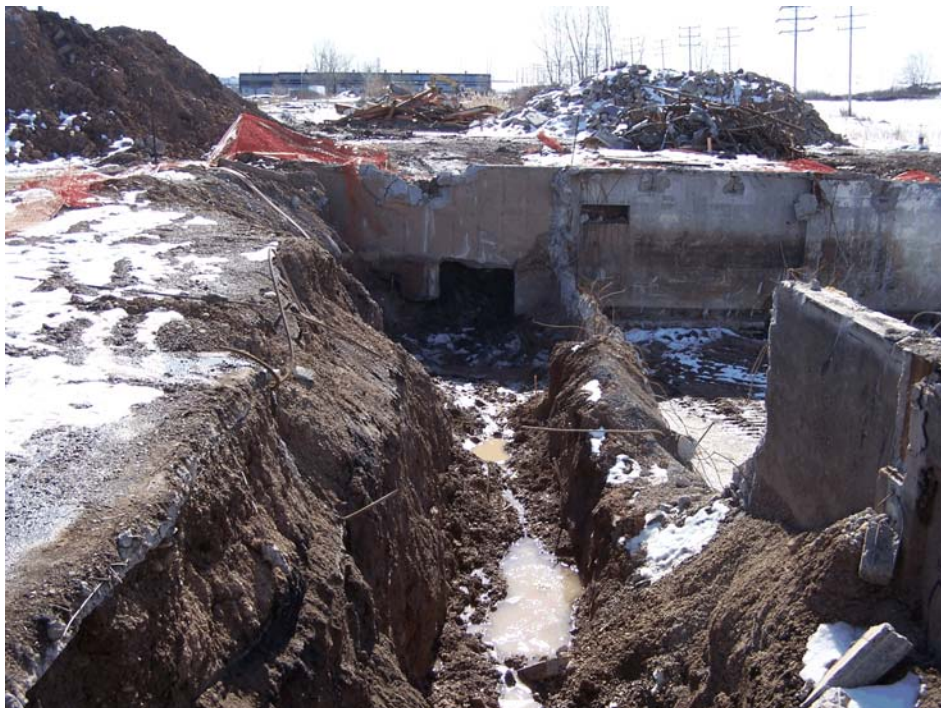
Figure 2-4. Photograph showing the portion of the east foundation wall that was removed during the Spauldite Sheet Basement and K-Line Storm Sewer remediation. View looking southwest. Photograph taken by Glenn May on March 4, 2010.

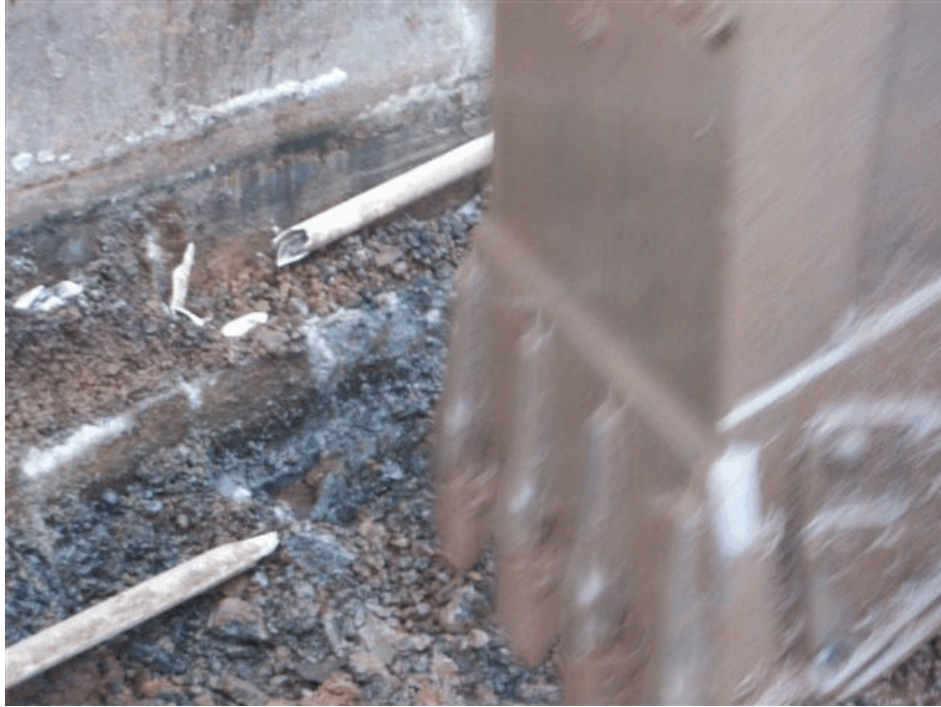
Figure 2-5. Photograph showing NAPL contaminated fill along the west foundation wall of the Spauldite Sheet Basement. Photograph taken by Brian Hutzler on February 12, 2010.

Excavation of contaminated soil underlying the Spauldite Sheet Basement began on Friday, February 12, 2010 along the southern portion of the west basement wall. Soil removal activities began in this area to determine if the basement foundation wall prevented the migration of NAPL under the east-west trending side basement; this basement was not part of the original Spauldite Sheet Basement and was added on during subsequent building construction. Excavation proceeded northward along the west foundation wall until the northern limit of the PCB remediation area (Figure 1-5) was reached. Excavation then proceeded eastward across the basement. NAPL was observed in the backfill along the west foundation wall (Figure 2-5), in the bedding of the floor drains (Figures 2-6 and 2-7), and beneath areas where the basement floor had seams in the concrete (e.g., around support footers).

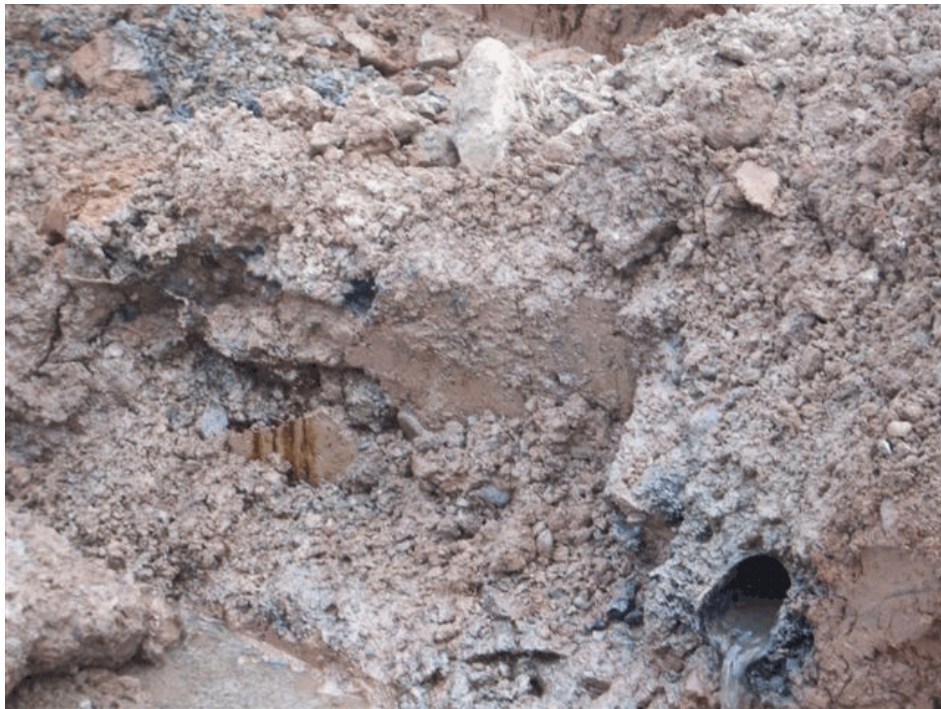
Figure 2-6. Photograph showing NAPL in the bedding along a floor drain under the Spauldite Sheet Basement. Photograph taken by Brian Hutzler on February 12, 2010.

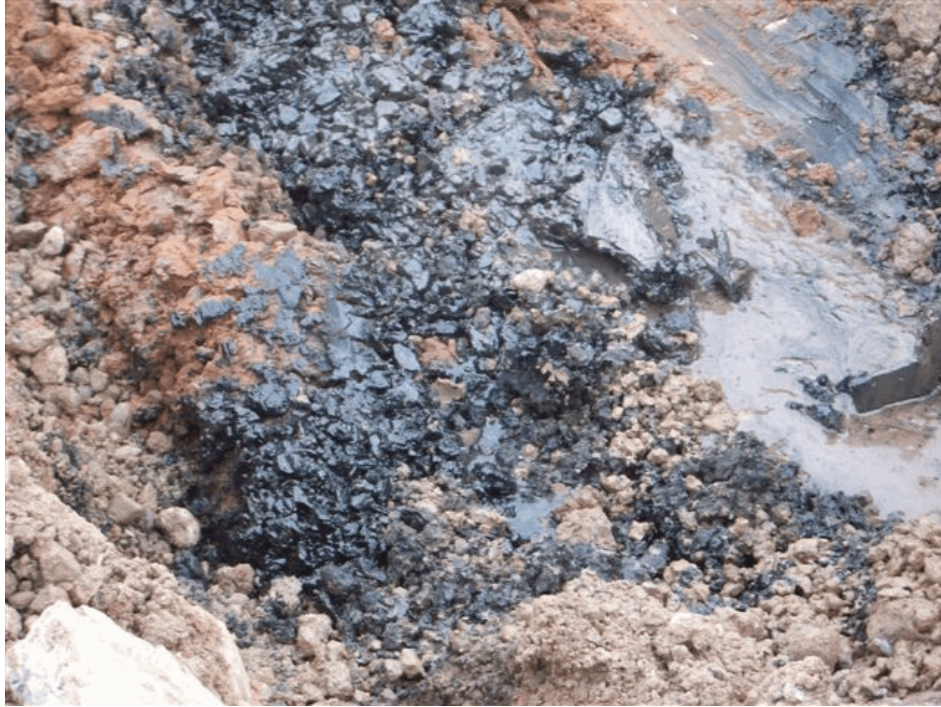
Figure 2-7. Photograph showing NAPL contaminated bedding along a floor drain under the Spauldite Sheet Basement. Photograph taken by Brian Hutzler on February 12, 2010.

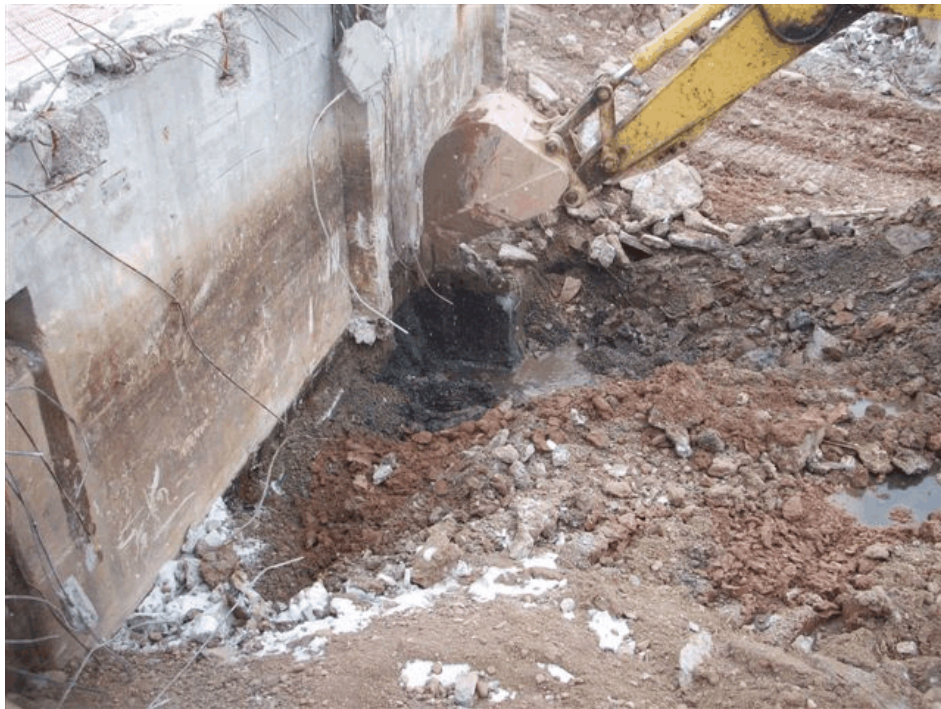
Figure 2-8. Photograph showing the excavation of the basement sump along the south foundation wall of the Spauldite Sheet Basement. View looking southwest. Photograph taken by Brian Hutzler on February 16, 2010.

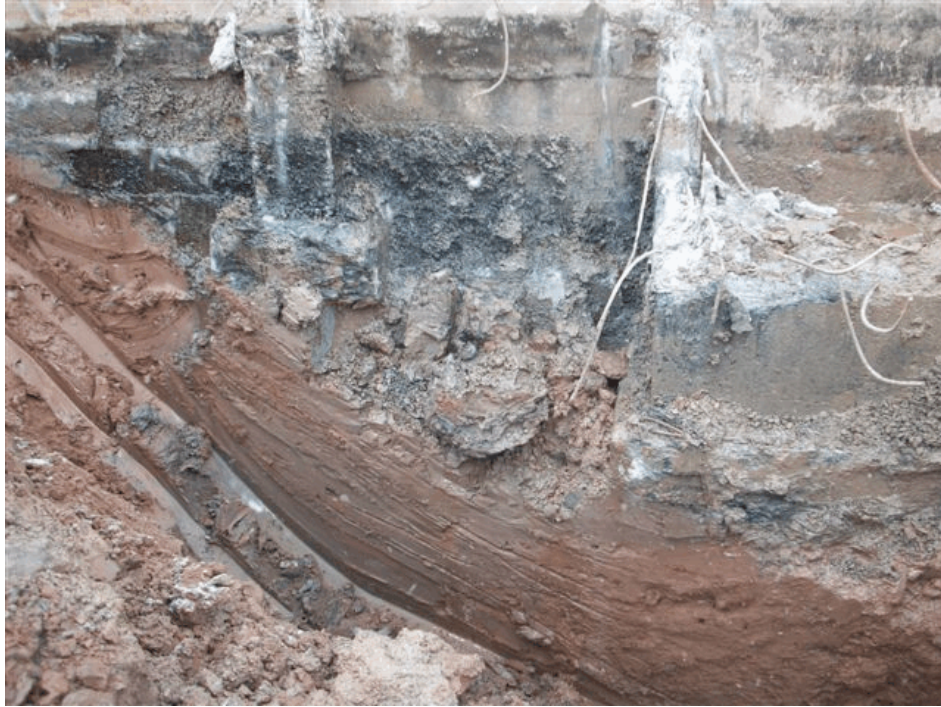
Figure 2-9. Photograph showing the native silty clay underlying the former basement sump along the south foundation wall of the Spauldite Sheet Basement. View looking southeast. Photograph taken by Brian Hutzler on February 16, 2010.

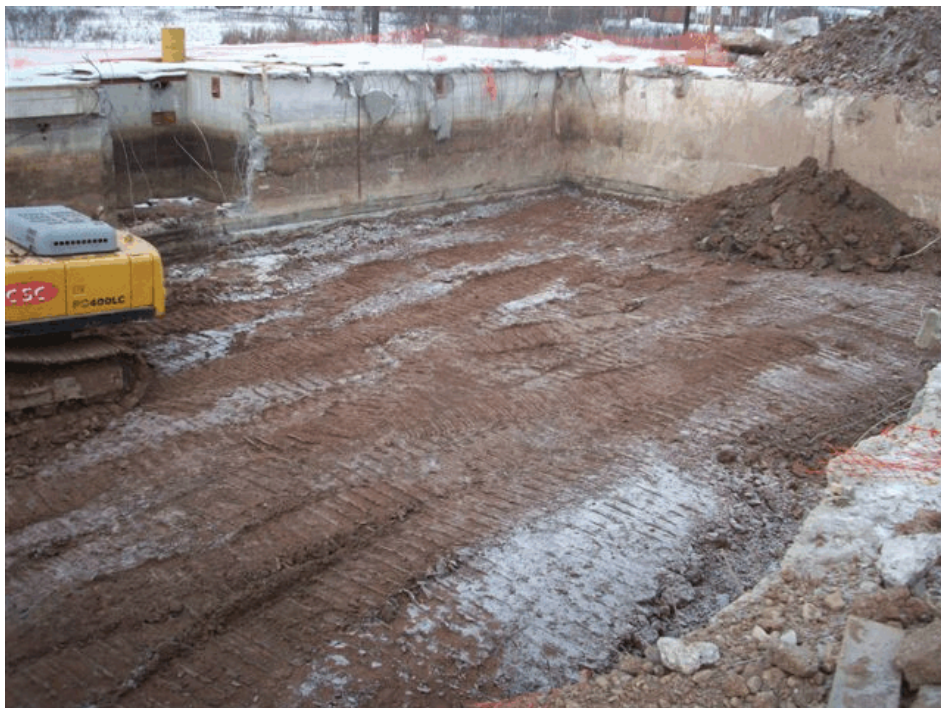
Figure 2-10. Photograph showing the completion of initial excavation activities of the Spauldite Sheet Basement. View looking northwest. Photograph taken by Brian Hutzler on February 17, 2010.

Excavation in the Spauldite Sheet Basement continued on Monday, February 15, 2010 and progressed in a northward direction. NAPL was found to follow the drain lines and foundation walls to the north wall of basement. Removal of NAPL contaminated backfill along the north and south basement foundation walls (Figures 2-8 and 2-9) continued on Tuesday and Wednesday of that week. Once this excavation work was complete, contaminated soil and fill from beneath the southern stairwell was removed. These initial excavation activities were completed on Wednesday, February 17, 2010 (Figures 2-10 and 2-11).

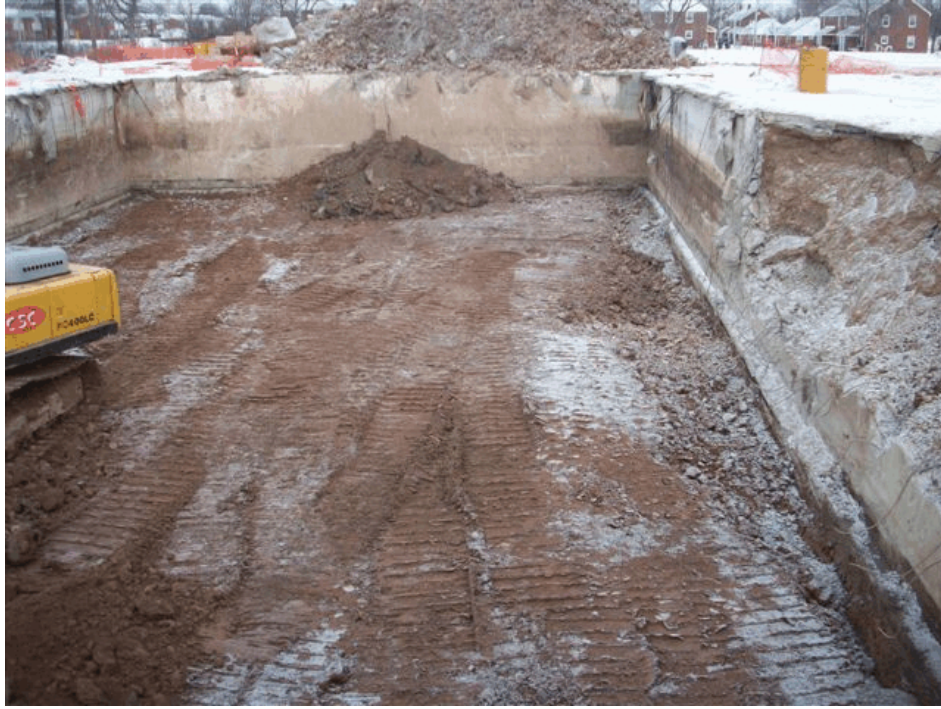
Figure 2-11. Photograph showing the completion of initial excavation activities of the Spauldite Sheet Basement. View looking slightly northwest. Photograph taken by Brian Hutzler on February 17, 2010.

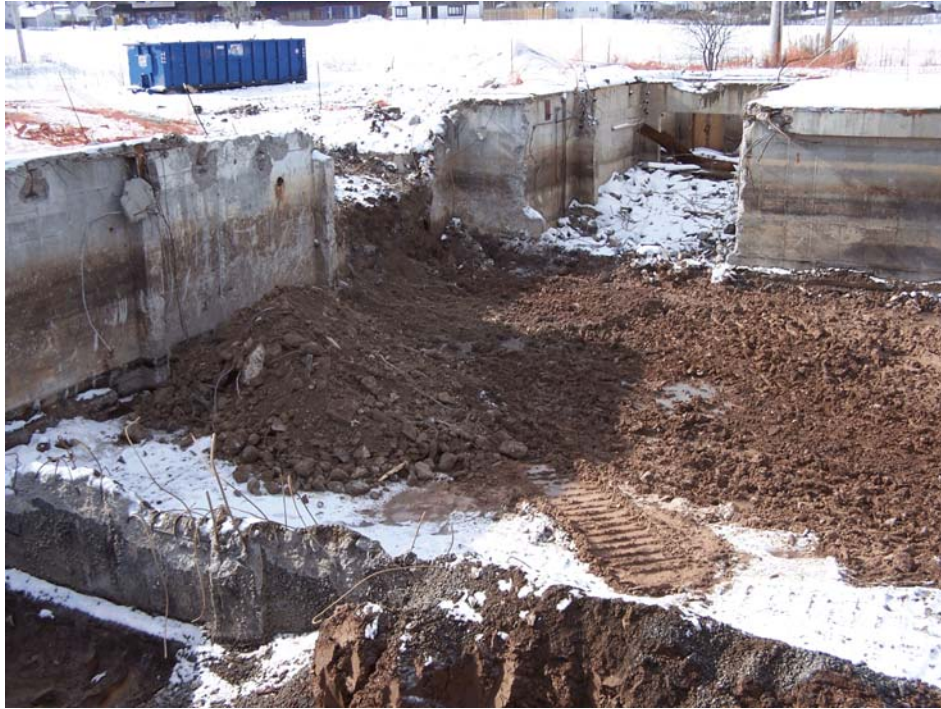
Figure 2-13. Photograph showing the Spauldite Sheet Basement following additional excavation. View looking southwest. Photograph taken by Glenn May on February 24, 2010.

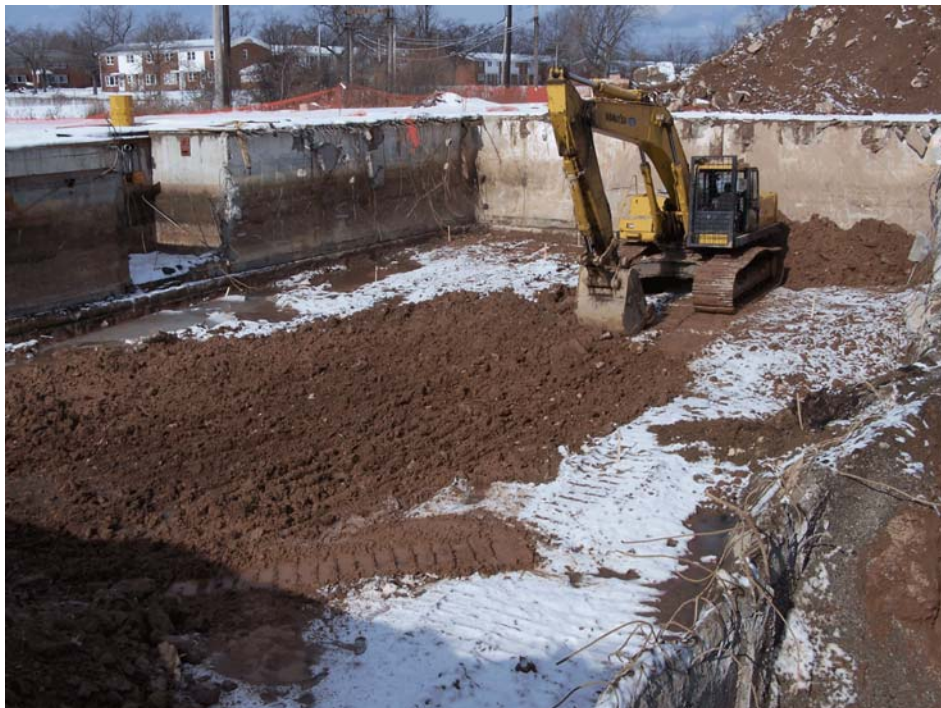
Figure 2-14. Photograph showing the Spauldite Sheet Basement following additional excavation. View looking northwest. Photograph taken by Glenn May on February 24, 2010.

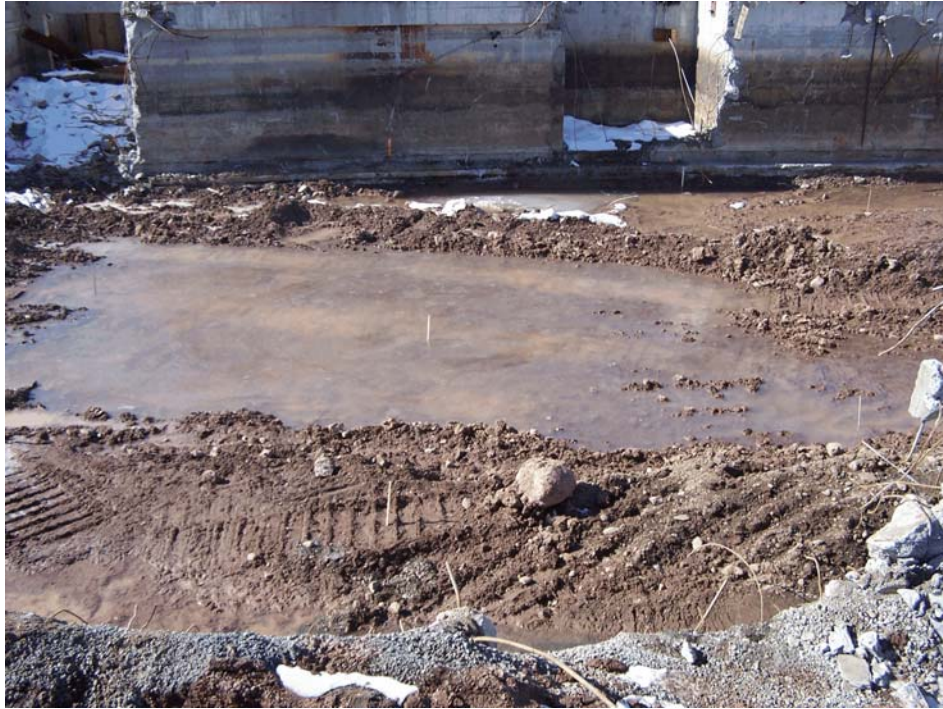
Figure 2-15. Photograph showing the completed excavation of the Spauldite Sheet Basement. View looking northwest. Photograph taken by Glenn May on March 4, 2010.

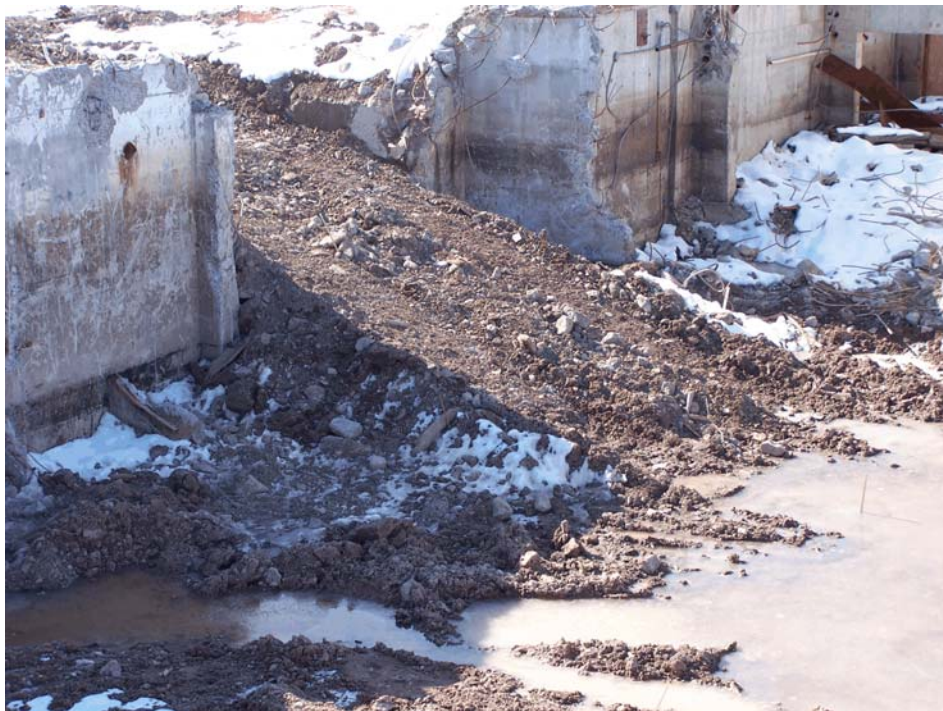
Figure 2-16. Photograph showing the ramp into the Spauldite Sheet Basement for excavator access. This ramp was left in place following remedial activities. View looking southwest. Photograph taken by Glenn May on March 4, 2010.

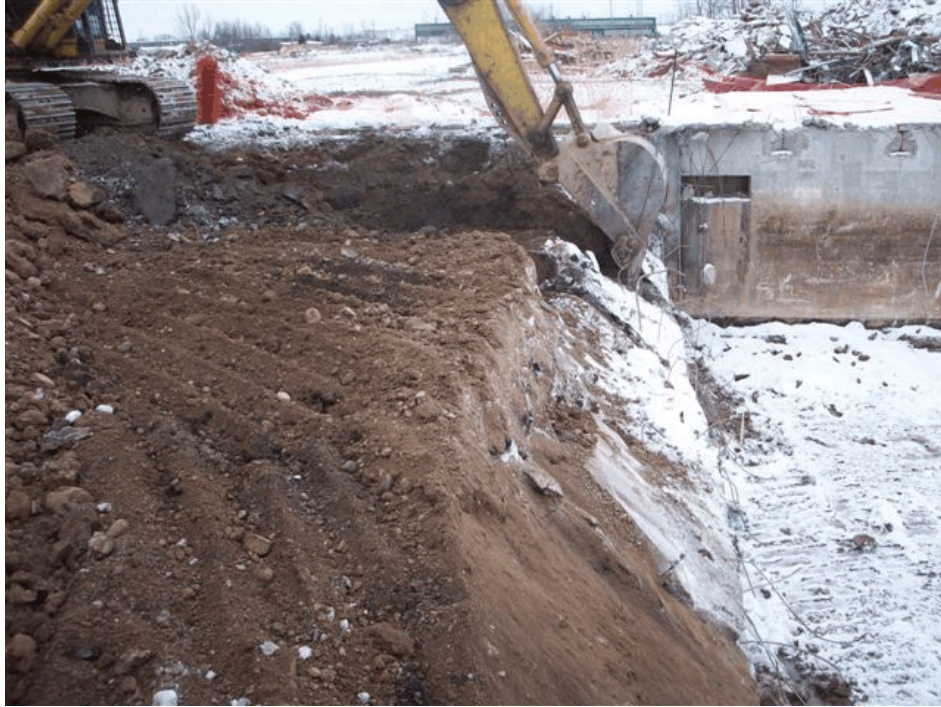
Figure 2-17. Photograph showing the start of excavation along the K-Line Storm Sewer. View looking slightly southeast. Photograph taken by Brian Hutzler on February 19, 2010.

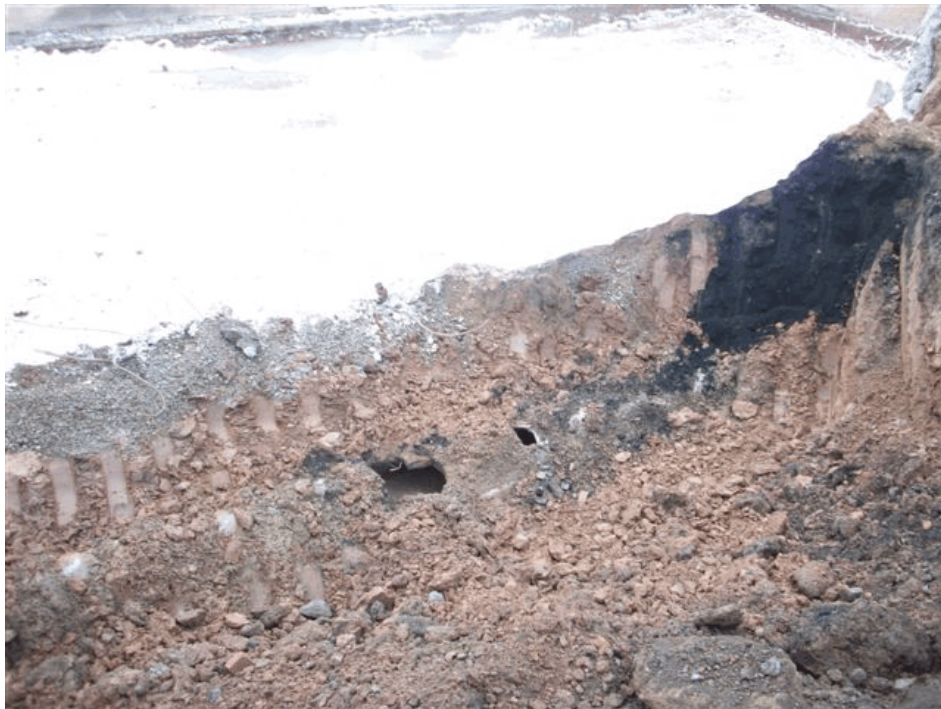
Figure 2-18. Photograph showing the K-Line Storm Sewer and the black fill material overlying the sewer. View looking west. Photograph taken by Brian Hutzler on February 19, 2010.

The analytical results from the confirmatory samples also indicated that the black, foundry sand overlying the K-Line Storm Sewer (38-024) contained concentrations of arsenic and barium that exceeded the 6 NYCRR Part 375 restricted residential soil cleanup objectives (Table 3-3). Because PCBs were not detected in this sample, additional excavation along the K-Line Storm Sewer was not completed as the arsenic and barium contamination is not related to SWMU 38.

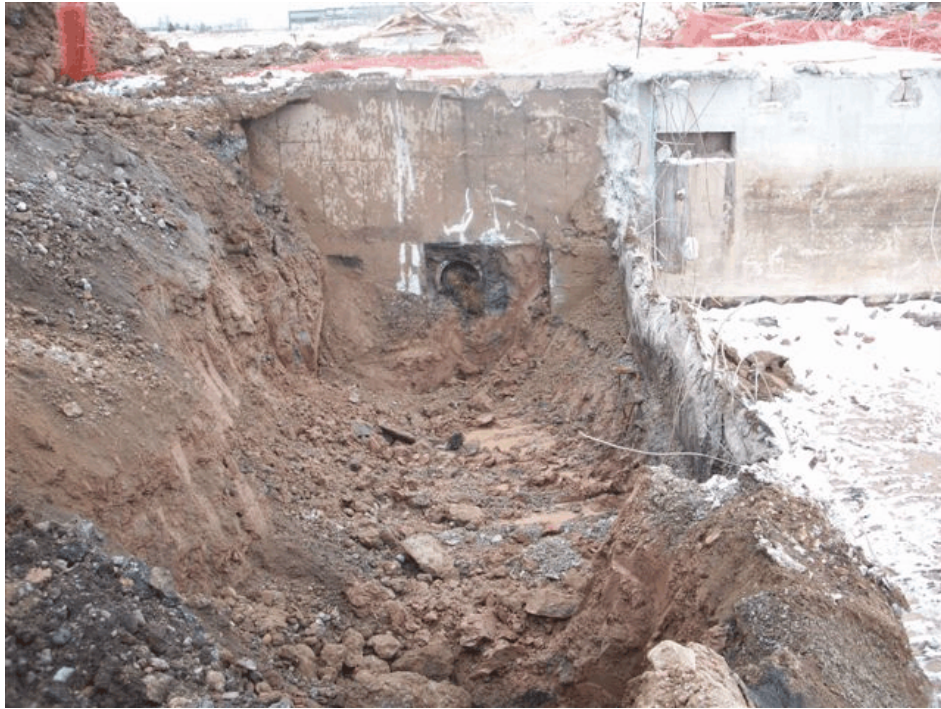
Figure 2-19. Photograph showing the excavation of the southern portion of the K-Line Storm Sewer. View looking slightly southeast. Photograph taken by Brian Hutzler on February 19, 2010.

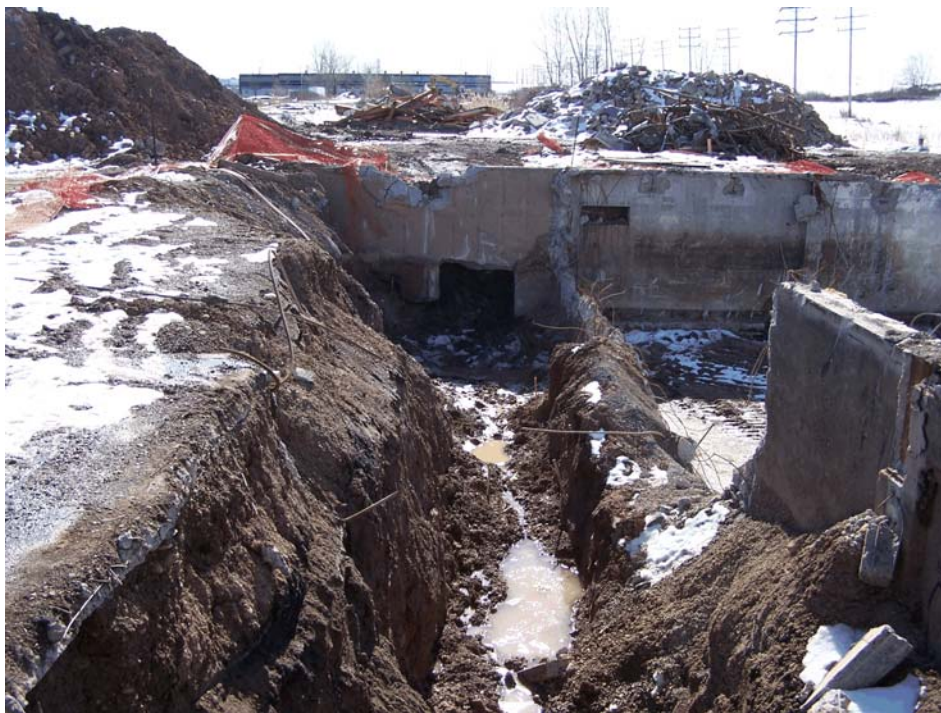
Figure 2-20. Photograph showing the completed excavation along the K-Line Storm Sewer. View looking slightly southeast. Photograph taken by Glenn May on March 4, 2010.

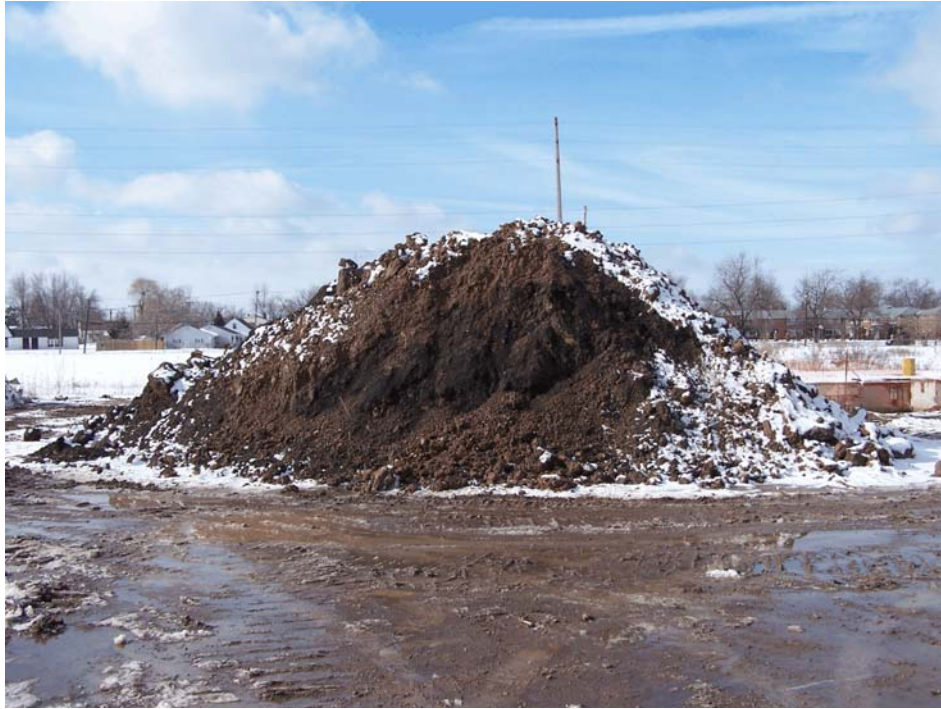
Figure 2-21. Photograph showing one of two soil and fill stockpiles from the K-Line Storm Sewer excavation. View looking southwest. Photograph taken by Glenn May on February 24, 2010.

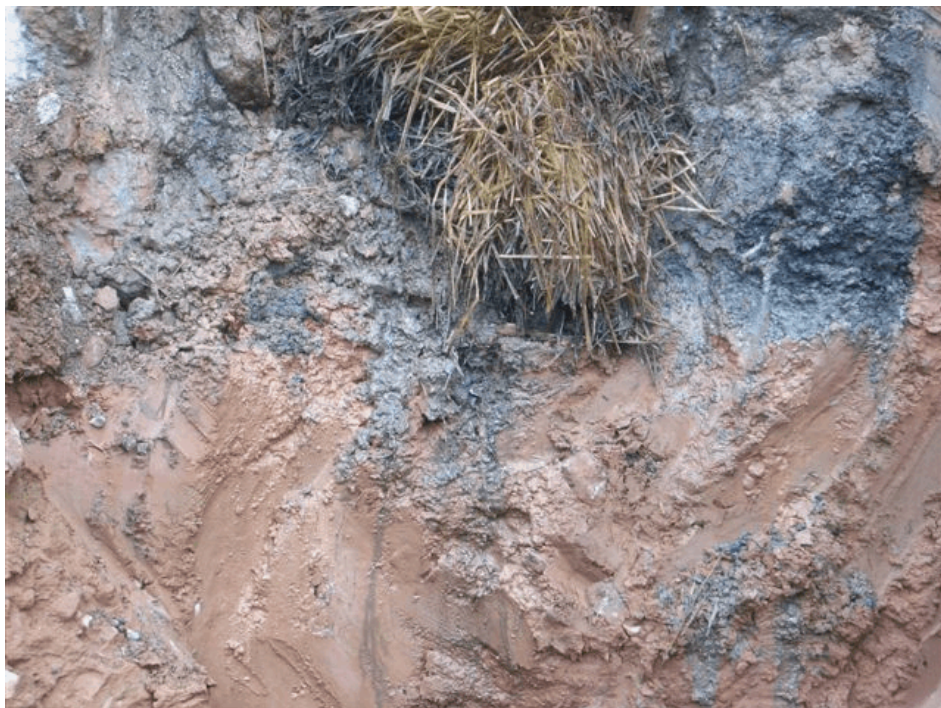
A small quantity of NAPL was observed when excavating along the south foundation wall of the Saw Room (Figures 2-22 and 2-23). In addition, a clay tile pipe with some NAPL surrounding it was encountered along this wall. As a result, the excavation in this area extended to the east wall of the Spauldite Sheet Basement (Figure 2-19). The K-Line Storm Sewer was also removed from beneath the south wall of the Saw Room (Figure 2-24), as was the concrete plug poured around the end of the sewer during the initial IRM in 2003.

Figure 2-22. Photograph showing NAPL contaminated soil under the K-Line Storm Sewer where it exits the south foundation wall of the Saw Room. Photograph taken by Brian Hutzler on February 19, 2010.

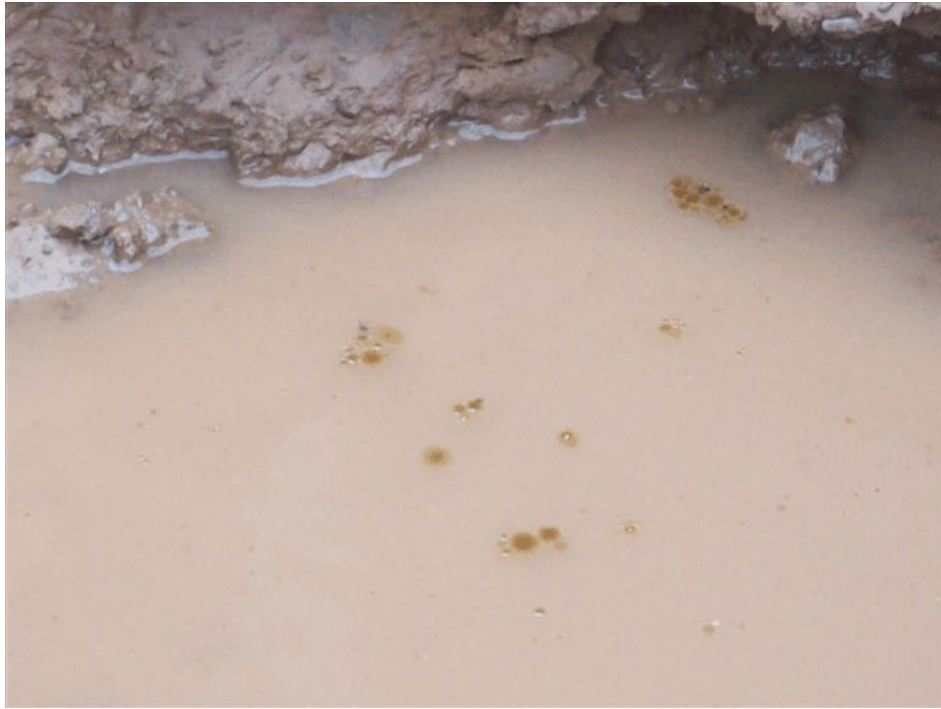
Figure 2-23. Photograph showing NAPL droplets on water in the K-Line Storm Sewer excavation. Photograph taken by Brian Hutzler on February 19, 2010.

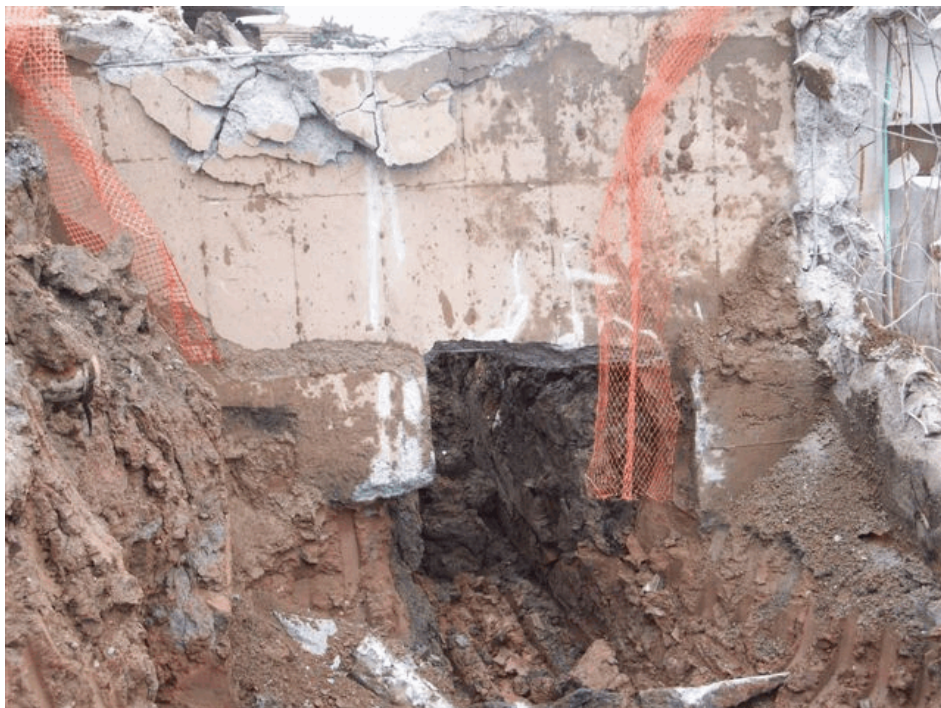
Figure 2-24. Photograph showing the south foundation wall of the Saw Room following removal of the K-Line Storm Sewer. View looking south. Photograph taken by Brian Hutzler on February 19, 2010.
