Re: Long Term Monitoring
Strippit, Inc.
Akron, New York
NYSDEC Site ID: 9-15-053

DRAWING TITLE
Groundwater Potentiometric Contour Map For
March 14, 2005

**LONG-TERM QUARTERLY MONITORING REPORT
INTERIM REMEDIAL MEASURE
STRIPPIT, INC.
AKRON, NEW YORK**

Date of Inspection: March 14, 2005

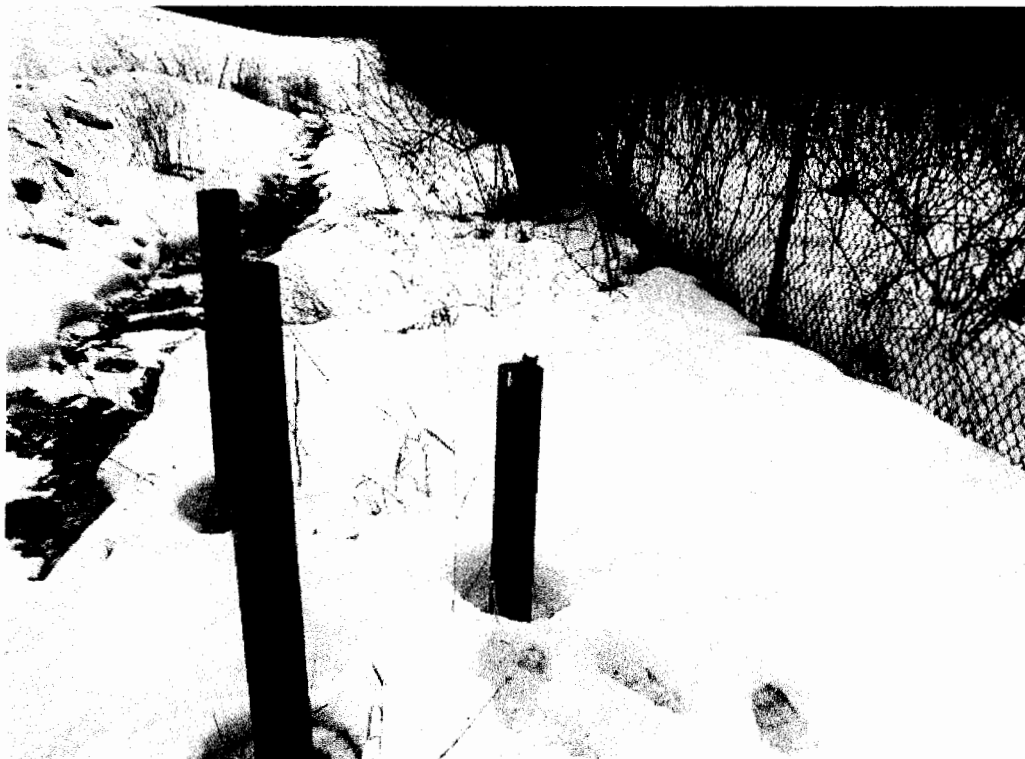
Condition of monitoring wells and gas wells: Gas wells are in good
condition, monitoring wells are in good condition, outer
casing rusting, dedicated rope is starting to unravel and fray.

Monitoring Well GW-3.

Action Item(s) Required: Possible replacement of dedicated rope
for each monitoring well.

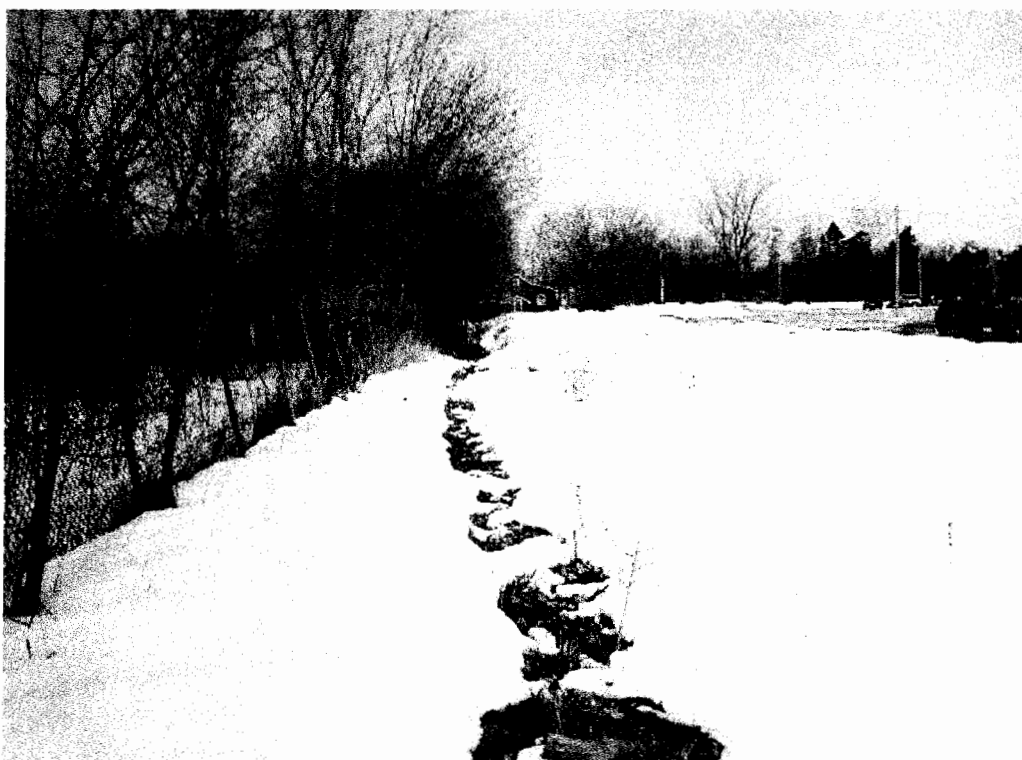
Condition of drainage ways (discuss amount of water/sediments present, vegetative growth unusual staining, blockage, etc.). Drainage ways in good
condition, small amounts of frozen water noted,
no unusual vegetative growth noted.

View of drainage swale on western side of parking lot, looking north.

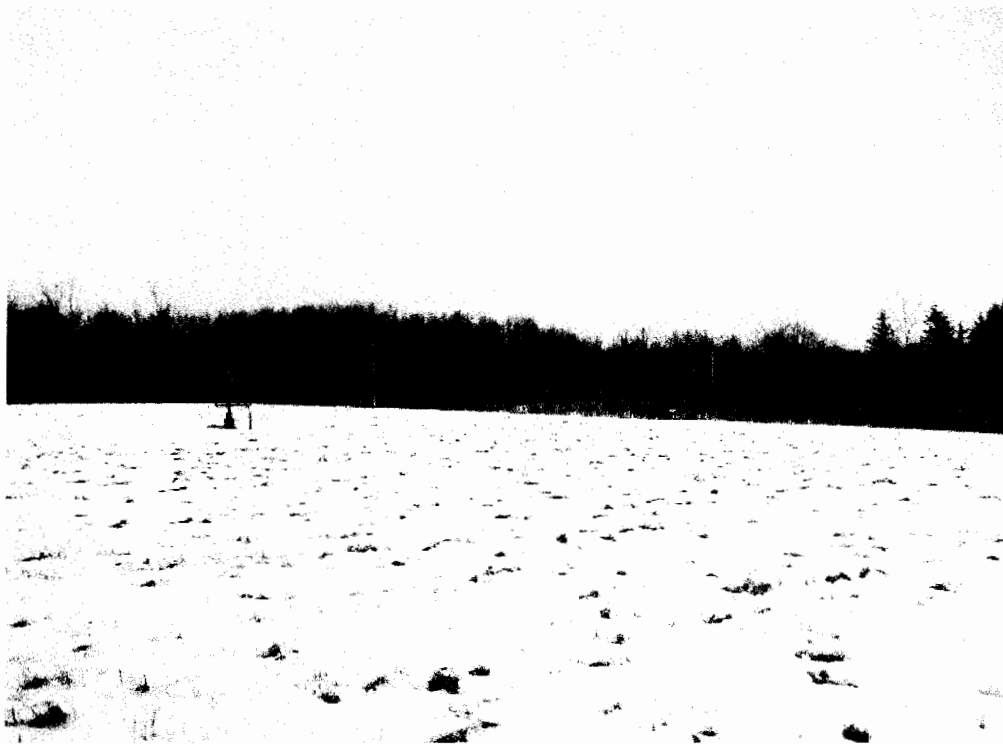
View of closure cover gas well (on left side of picture), looking west.
