Re: Long Term Monitoring  
Strippit, Inc.  
Akron, New York  
NYSDEC Site ID: 9-15-053

DRAWING TITLE  
Groundwater Potentiometric Contour Map For  
December 28, 2007

LONG-TERM QUARTERLY MONITORING REPORT  
INTERIM REMEDIAL MEASURE  
STRIPPIT, INC.  
AKRON, NEW YORK

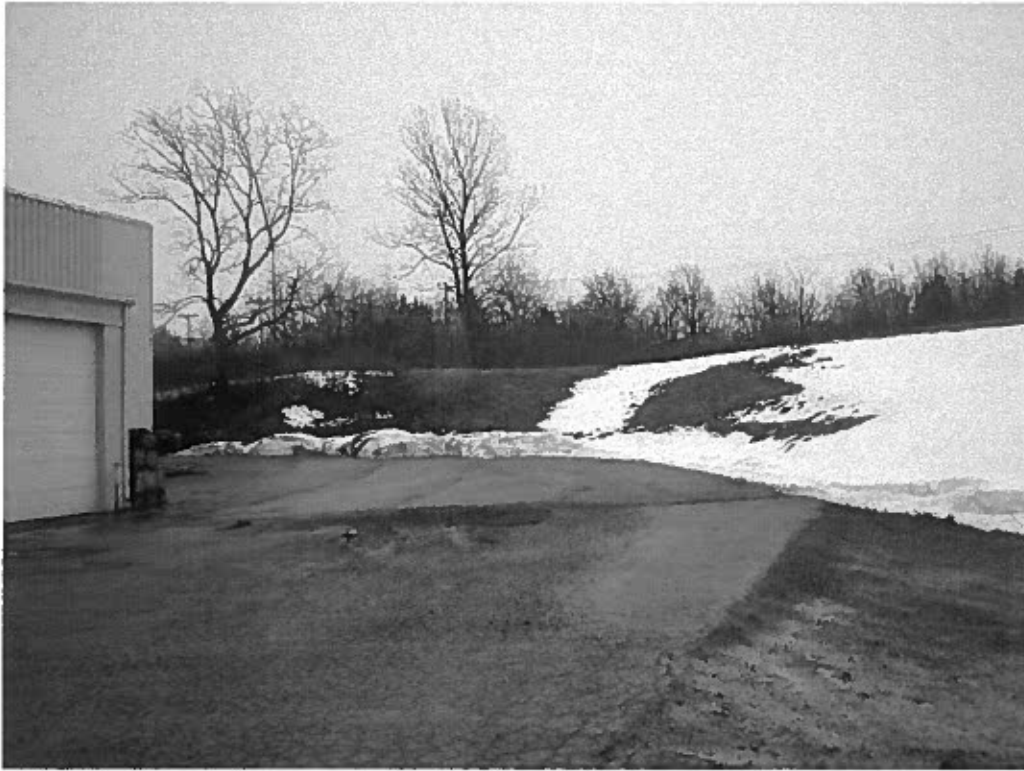
Summary of Observation:  
General Condition of Cover: Covers looks in OK condition, about 3" snow cover.

View of the Site looking east.

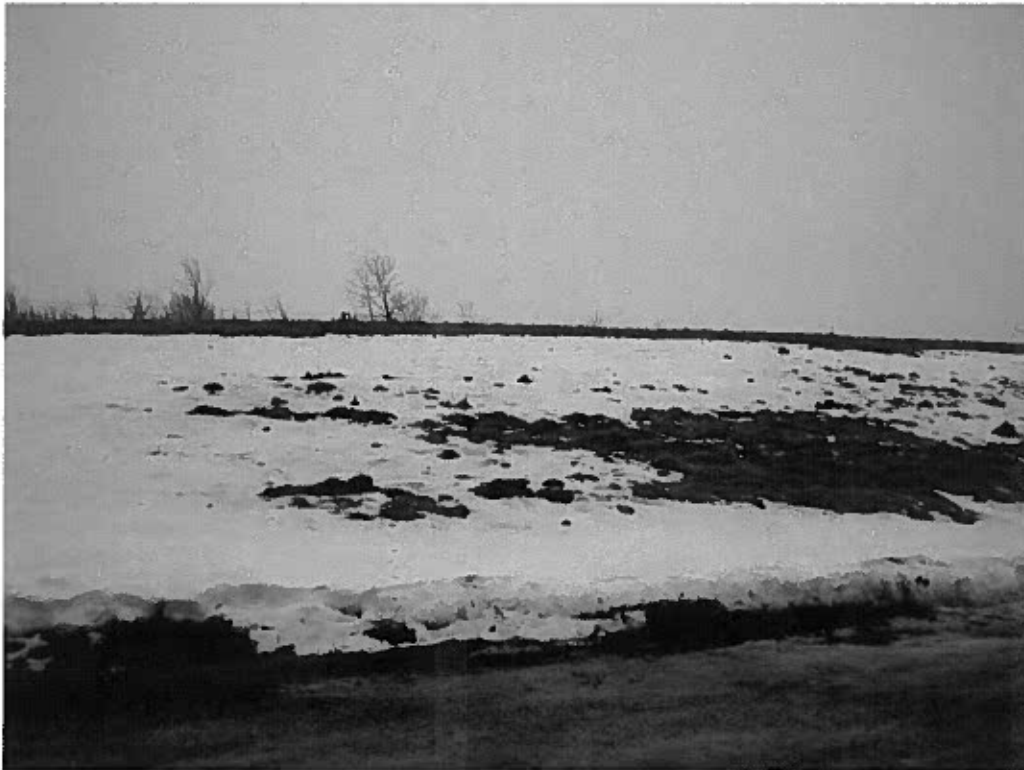
View of the Site looking north.

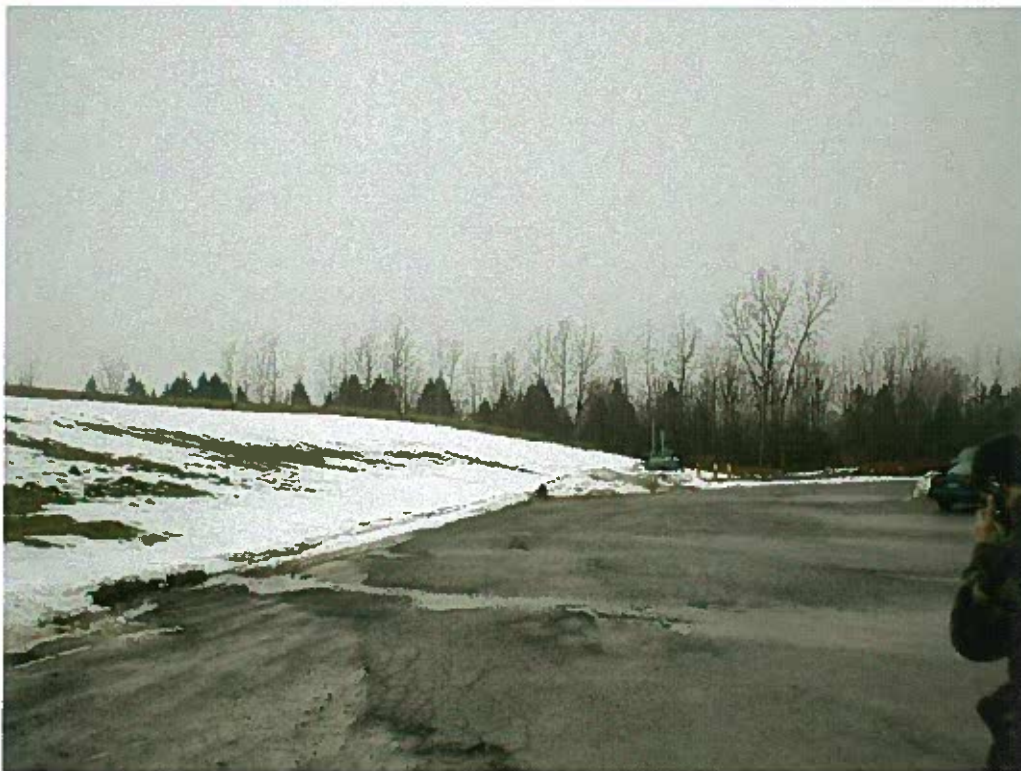
View of the Site looking west.

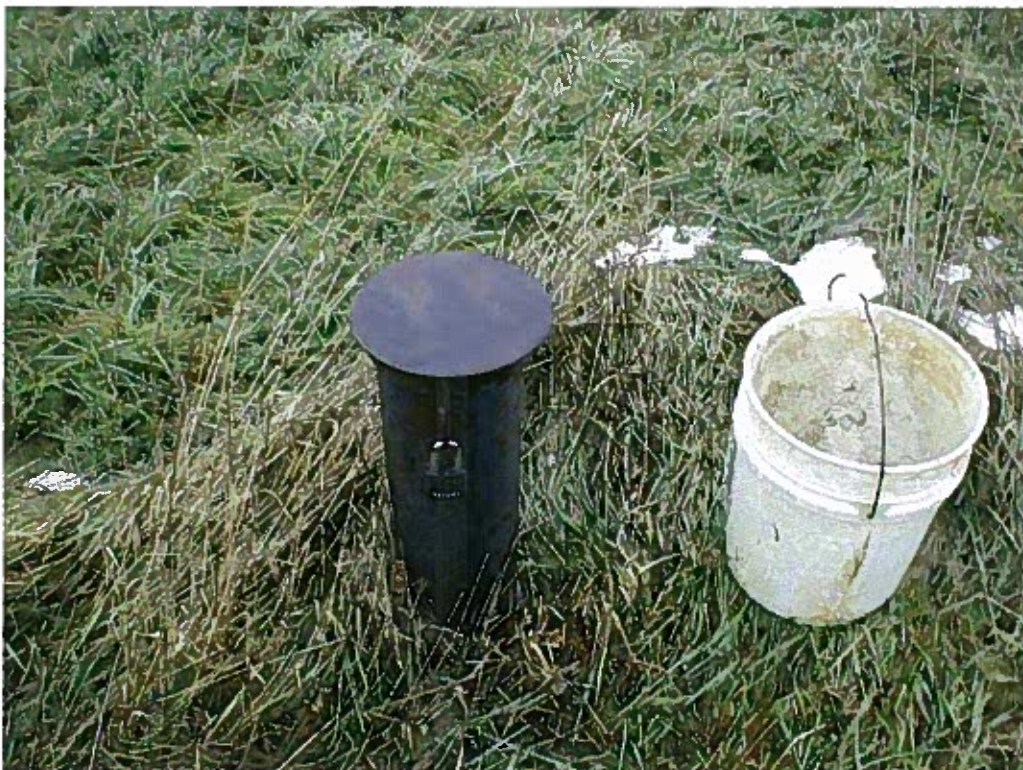
Condition of monitoring wells and gas wells: Monitoring wells & gas wells in OK condition.

View of a typical monitoring well on the Site.
