March 30, 2012

Subject: **2011 Periodic Review Report**
 Alltift Landfill Site /Ramco Steel Site
 Site Nos. 9-15-054 /9-15-046B

Submitted To:
The New York State Department of Environmental Conservation
Division of Hazardous Waste Remediation

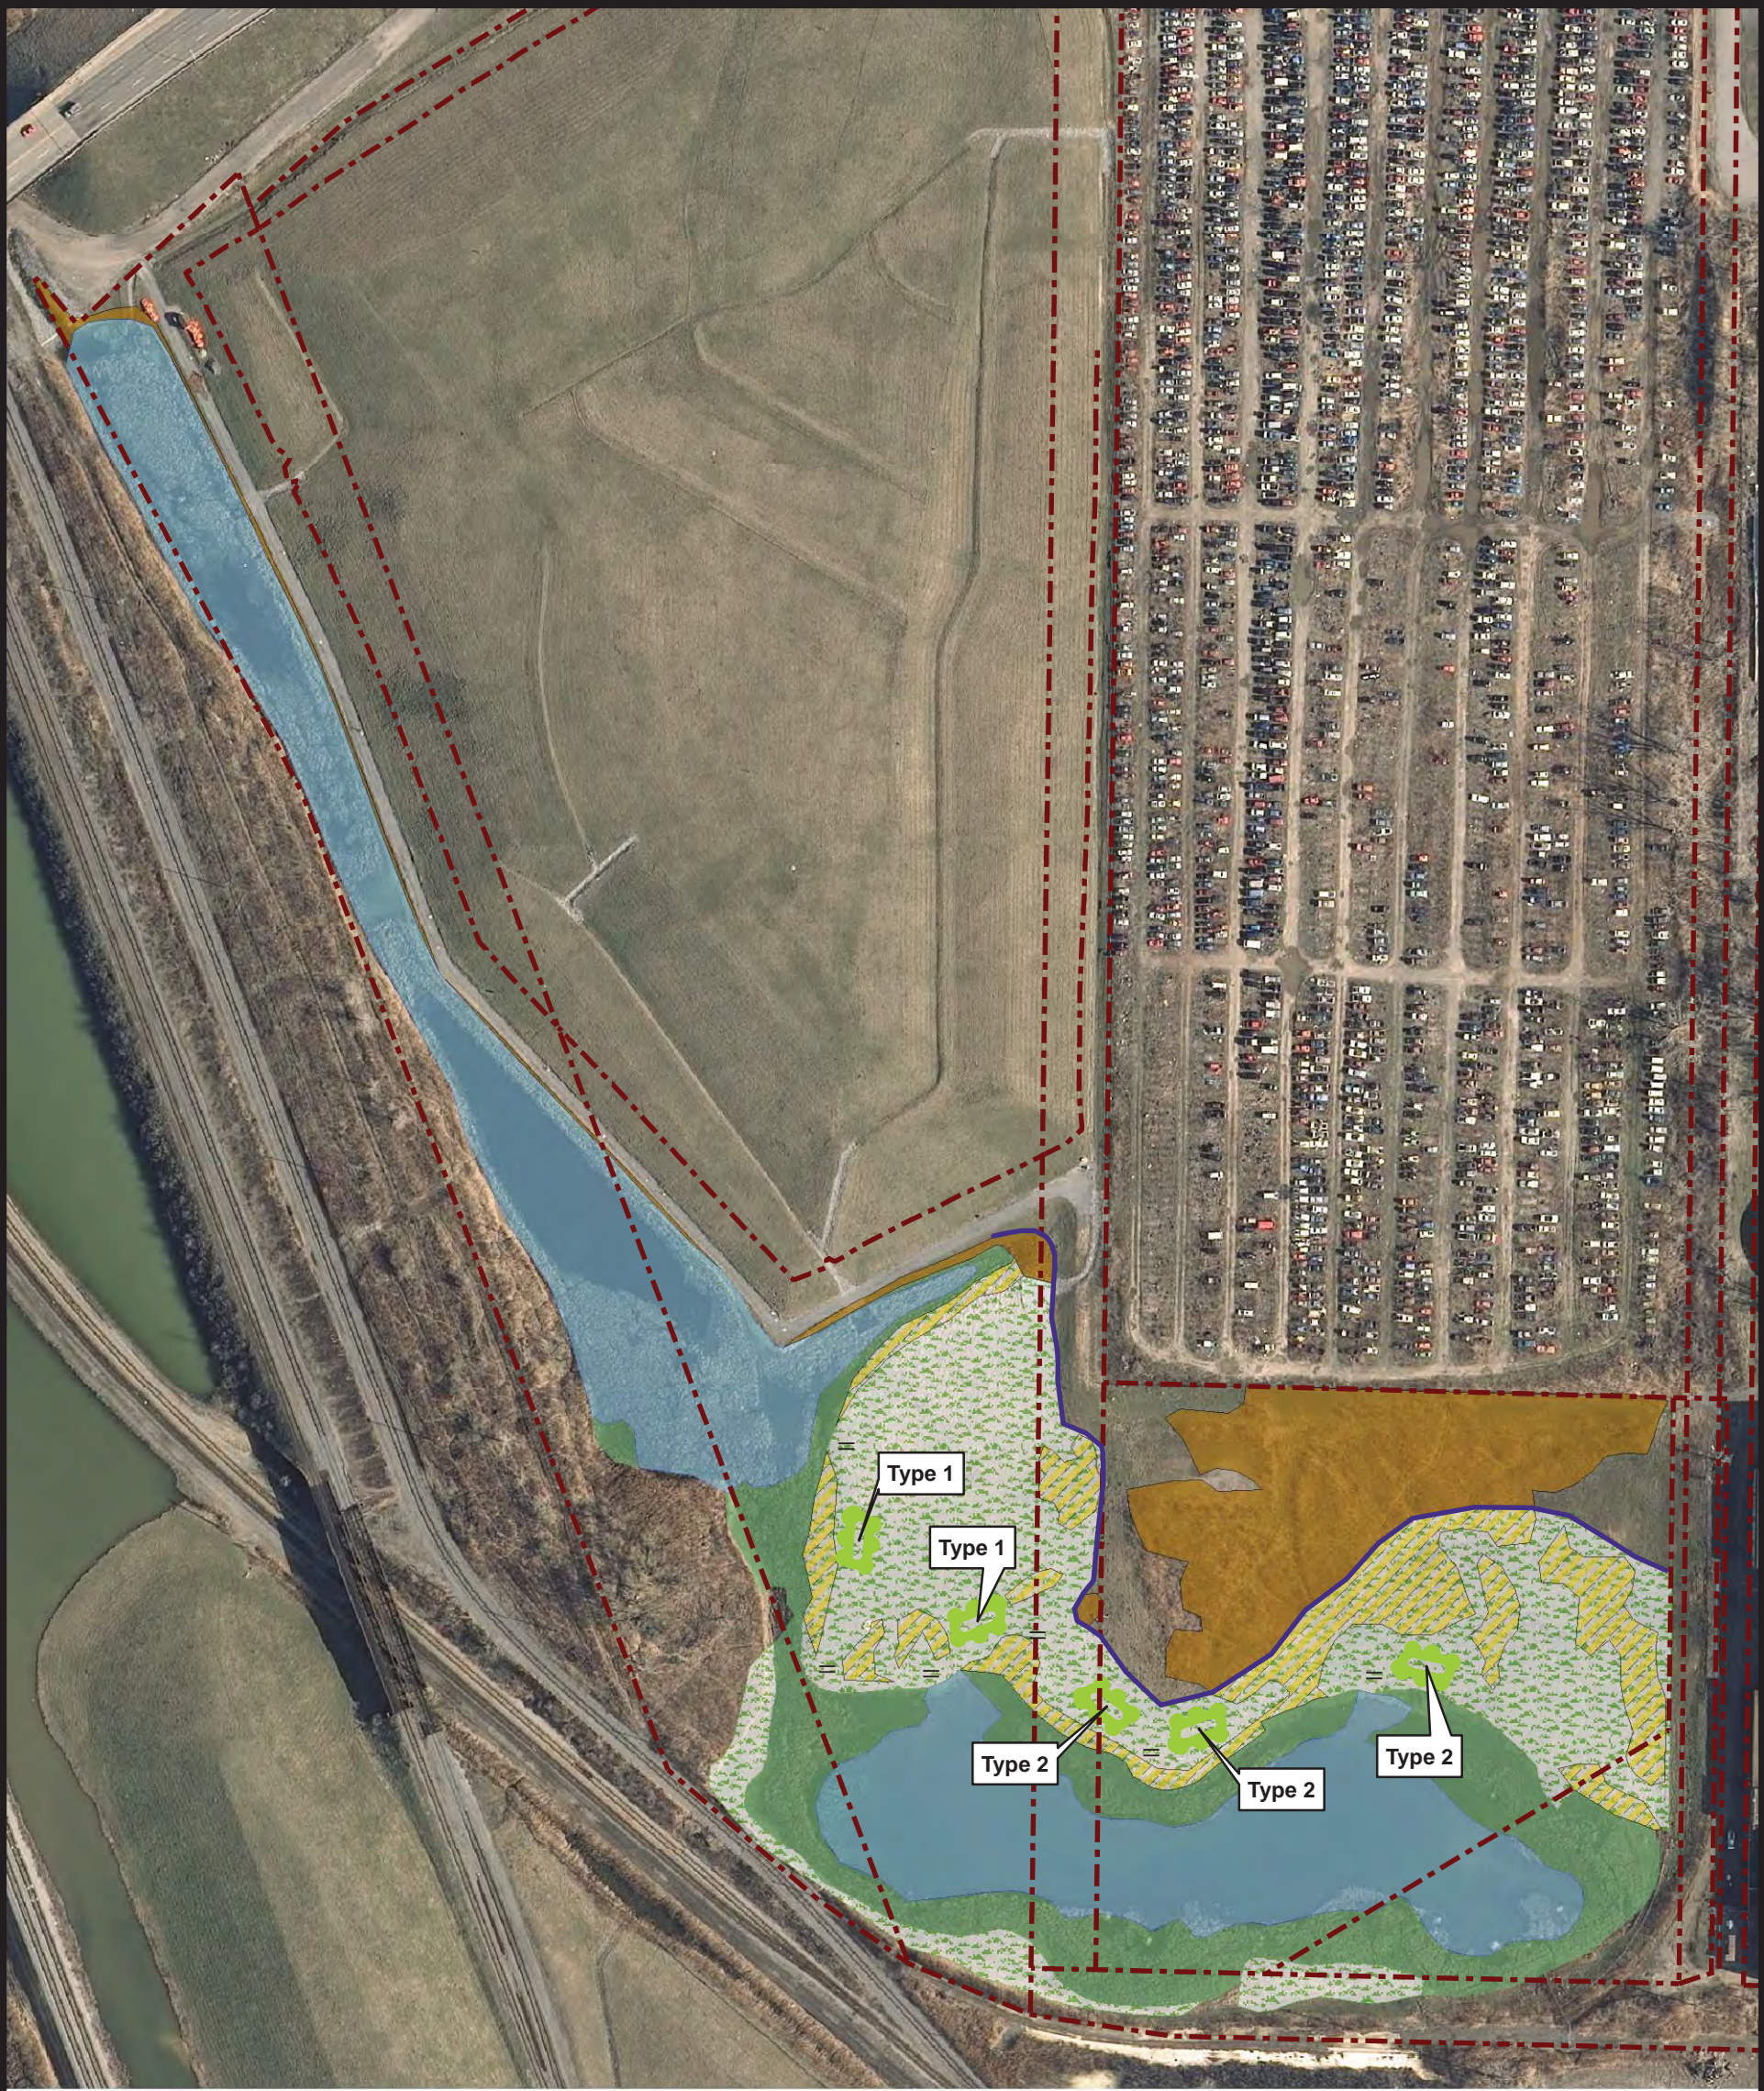
Current Conditions

- Legend**
- = Coarse Woody Debris
 - Proposed Tree/Shrub Planting Area
 - upland, mechanical treatment
 - wetland, herbicide treatment
 - Open Water
 - Deep Water Emergent
 - Wet Meadow Emergent

Note:
Mowing to occur in upland areas as shown. Mowing may be expanded into wetland areas based on site conditions at the time mowing occurs.

Honeywell accepted the additional conditions requested by the USACE as indicated in Amec's letter submitted to the USACE on behalf of Honeywell on March 8, 2012. The additional corrective action proposed for the spring of 2012 includes planting trees and shrubs to fulfill the requirement of establishing a woody buffer on the site, a second herbicide application event proposed for the late July or early August of 2012, and a mitigation wetland survey in September 2012. Once these activities have been completed a report will be prepared and submitted to the USACE to document the performance of the corrective actions at the site. Acceptance of the corrective actions by the USACE would result in closure the USACE Permit Application No. 98-976-0162(0).
