ENGINEERING INVESTIGATIONS AT INACTIVE HAZARDOUS WASTE SITES

PHASE I INVESTIGATION

Winsmith Div.-UMC Corp.

Site No. 915058

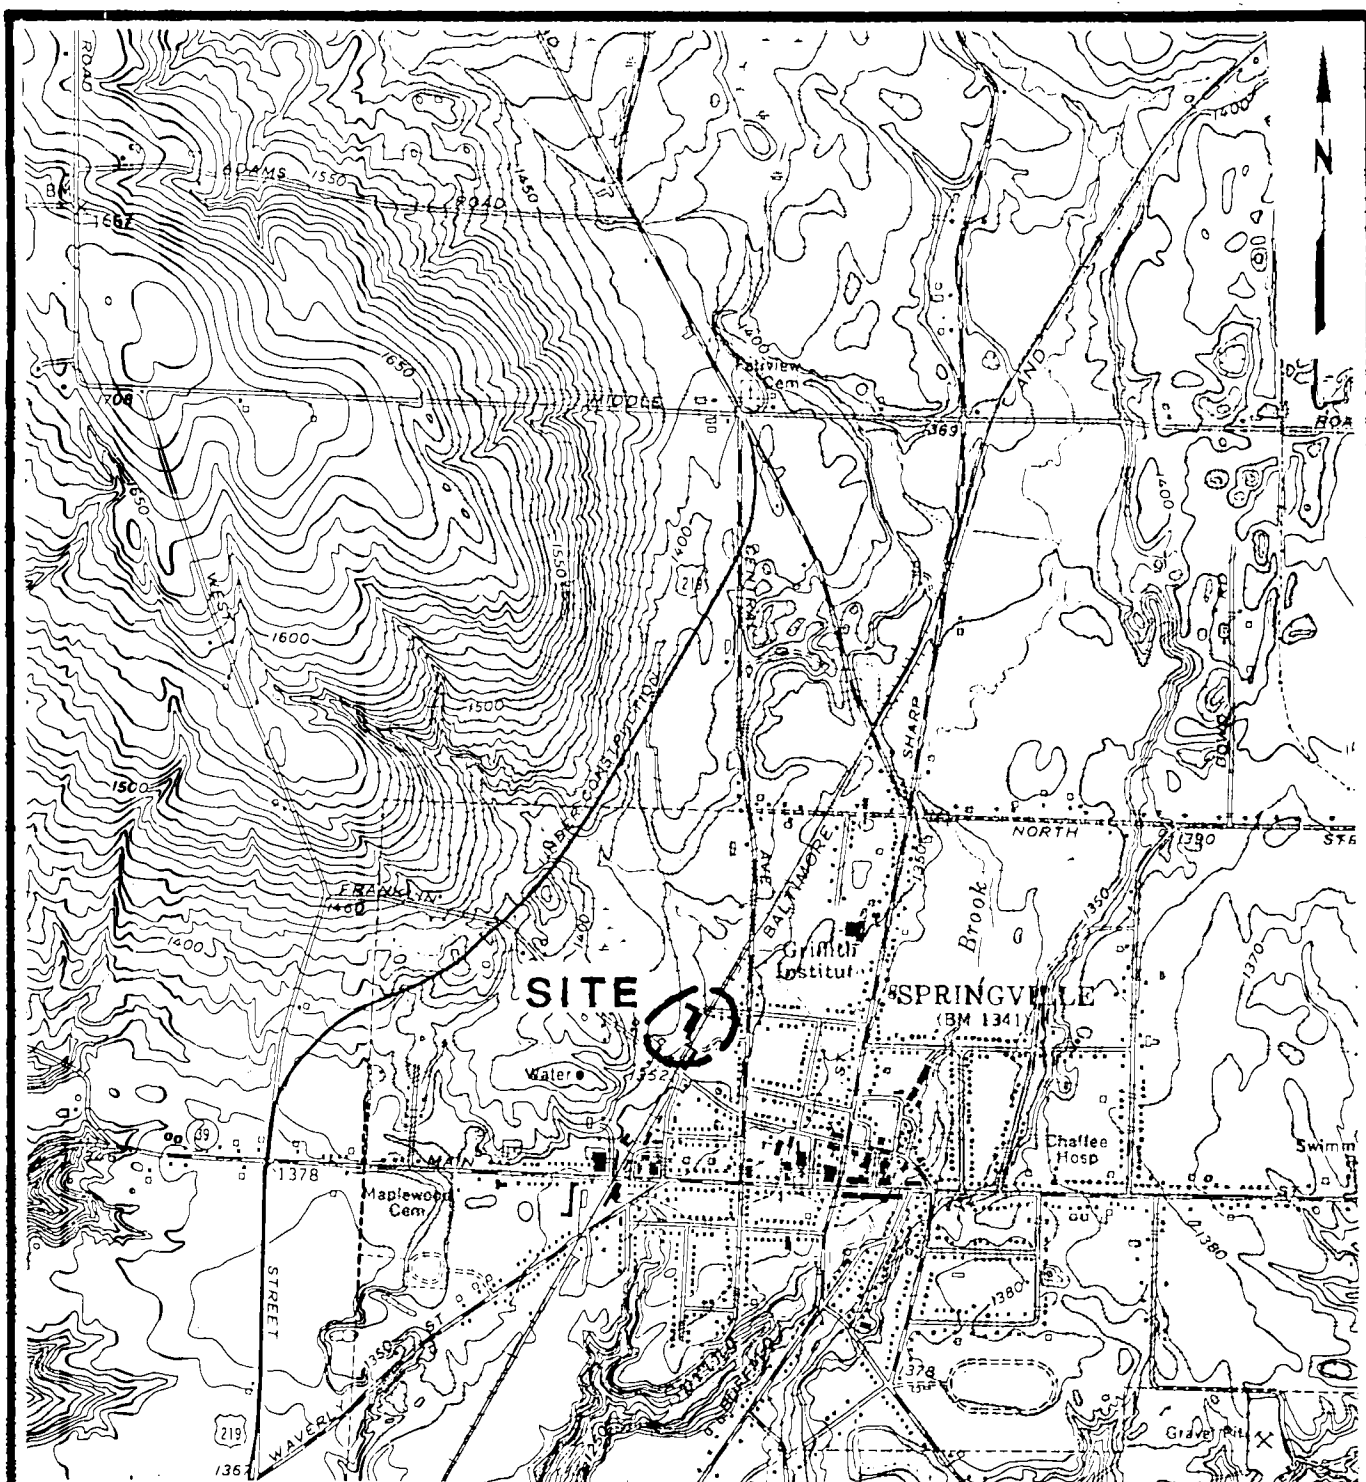
FIGURE I-1

ENGINEERING-SCIENCE, INC.
 IN ASSOCIATION WITH
 DAMES & MOORE
 NEW YORK STATE DEPARTMENT
 OF ENVIRONMENTAL CONSERVATION
 PHASE I REPORT
 SITE LOCATION MAP
 WINSMITH DIV. - UMC CORPORATION

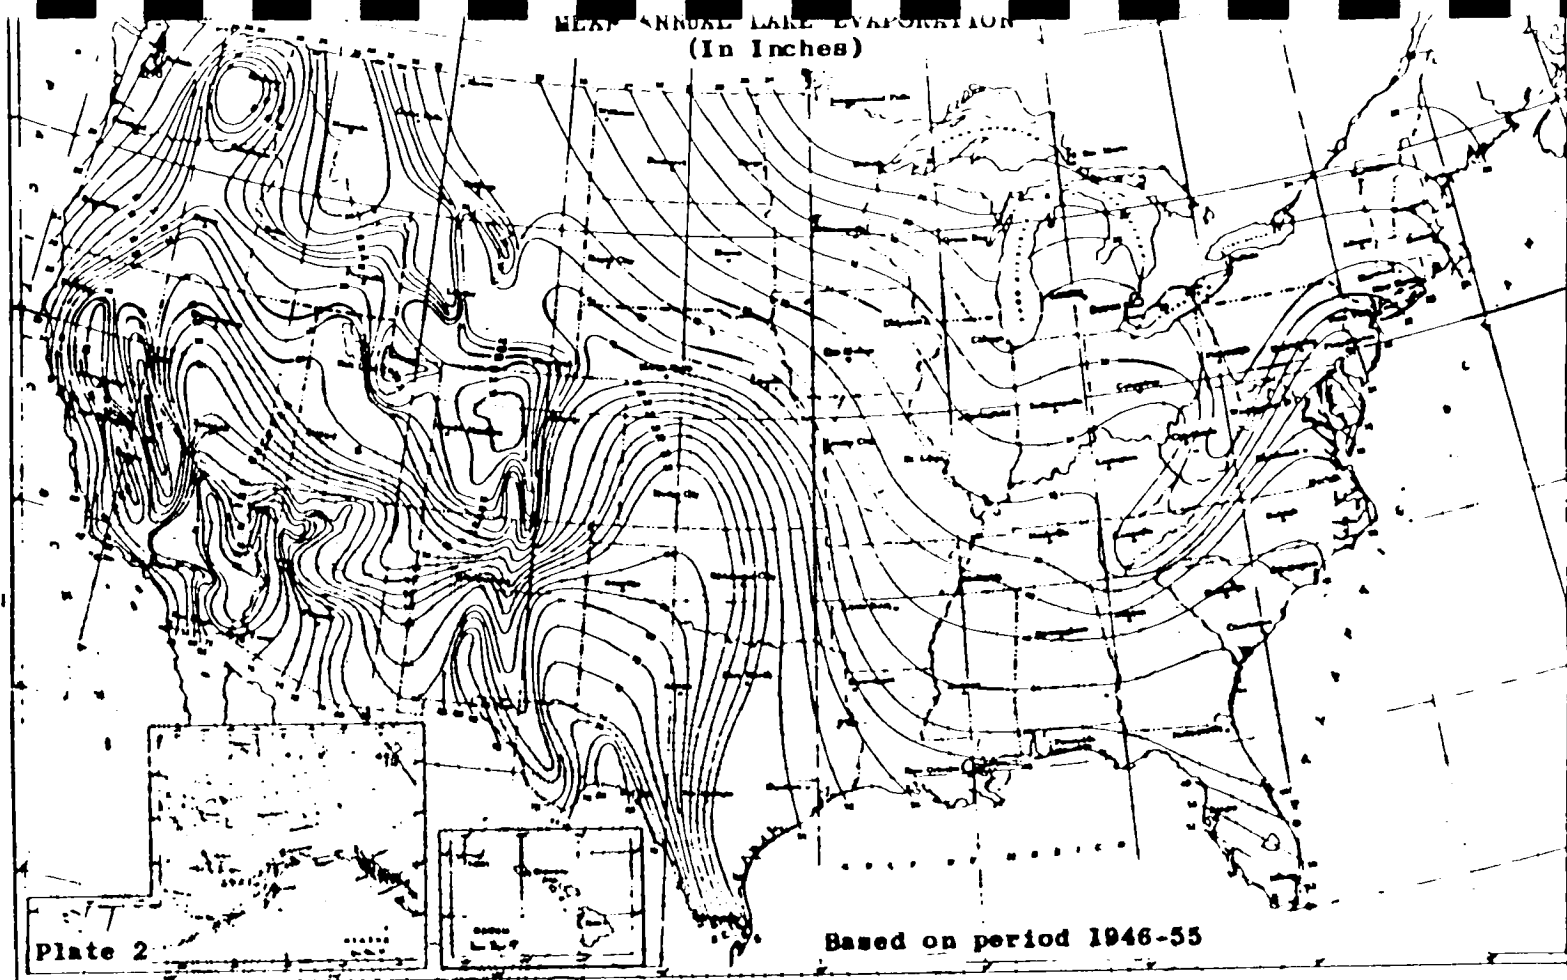
Figure 4

Mean Annual Lake Evaporation (In Inches)
