ENGINEERING INVESTIGATIONS AT INACTIVE HAZARDOUS WASTE SITES

PRELIMINARY SITE ASSESSMENT

Winsmith Division - UMC Corp. Site No. 915058

Village of Springville Erie County

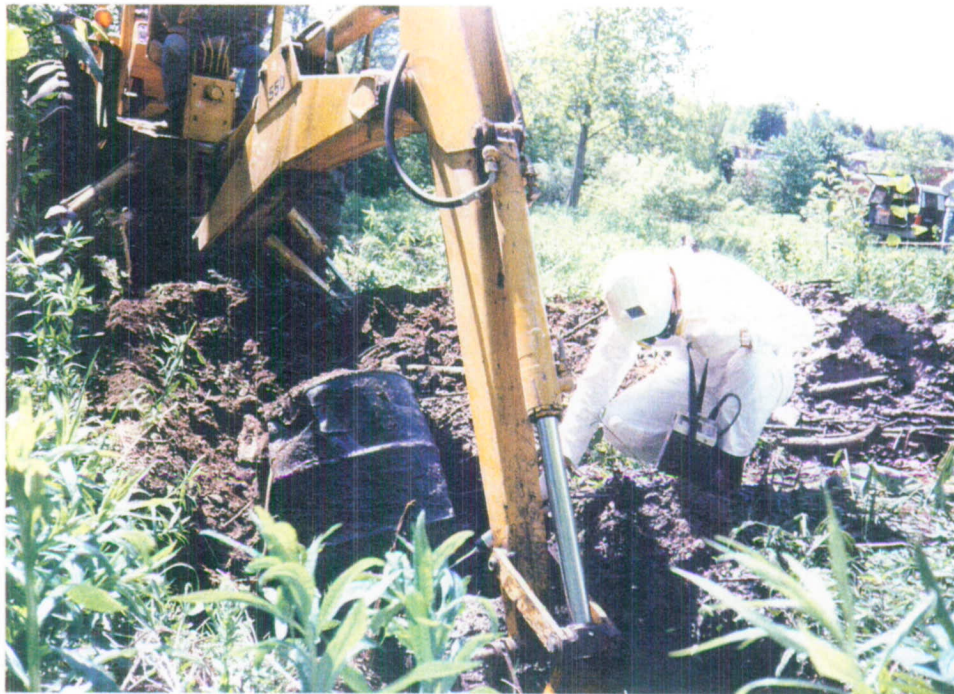
Test Pit excavation in disposal area reveals buried drum. Technician monitors VOC emissions.

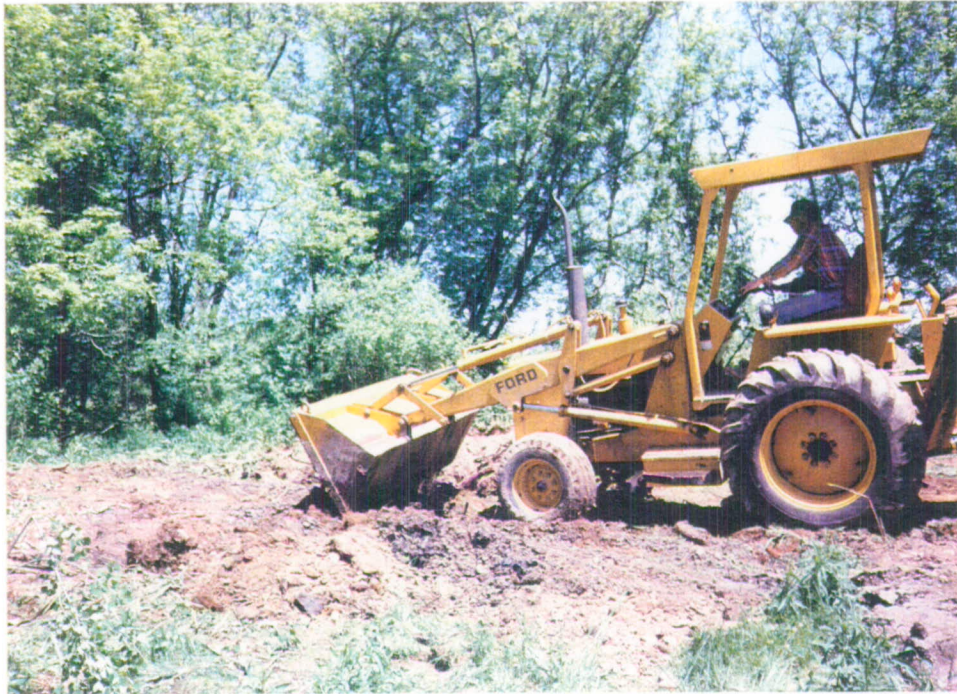
Covering test pit completed at disposal area.
