**POST-CLOSURE MONITORING REPORT**  
**GROUNDWATER COLLECTION AND**  
**TREATMENT SYSTEM**

**NYSDEC SITE NO. 9-15-066, OPERABLE UNIT 2**  
**CHEEKTOWAGA, NEW YORK**

**CBS CORPORATION**  
**PITTSBURGH, PENNSYLVANIA**

**FEBRUARY 14, 2017**

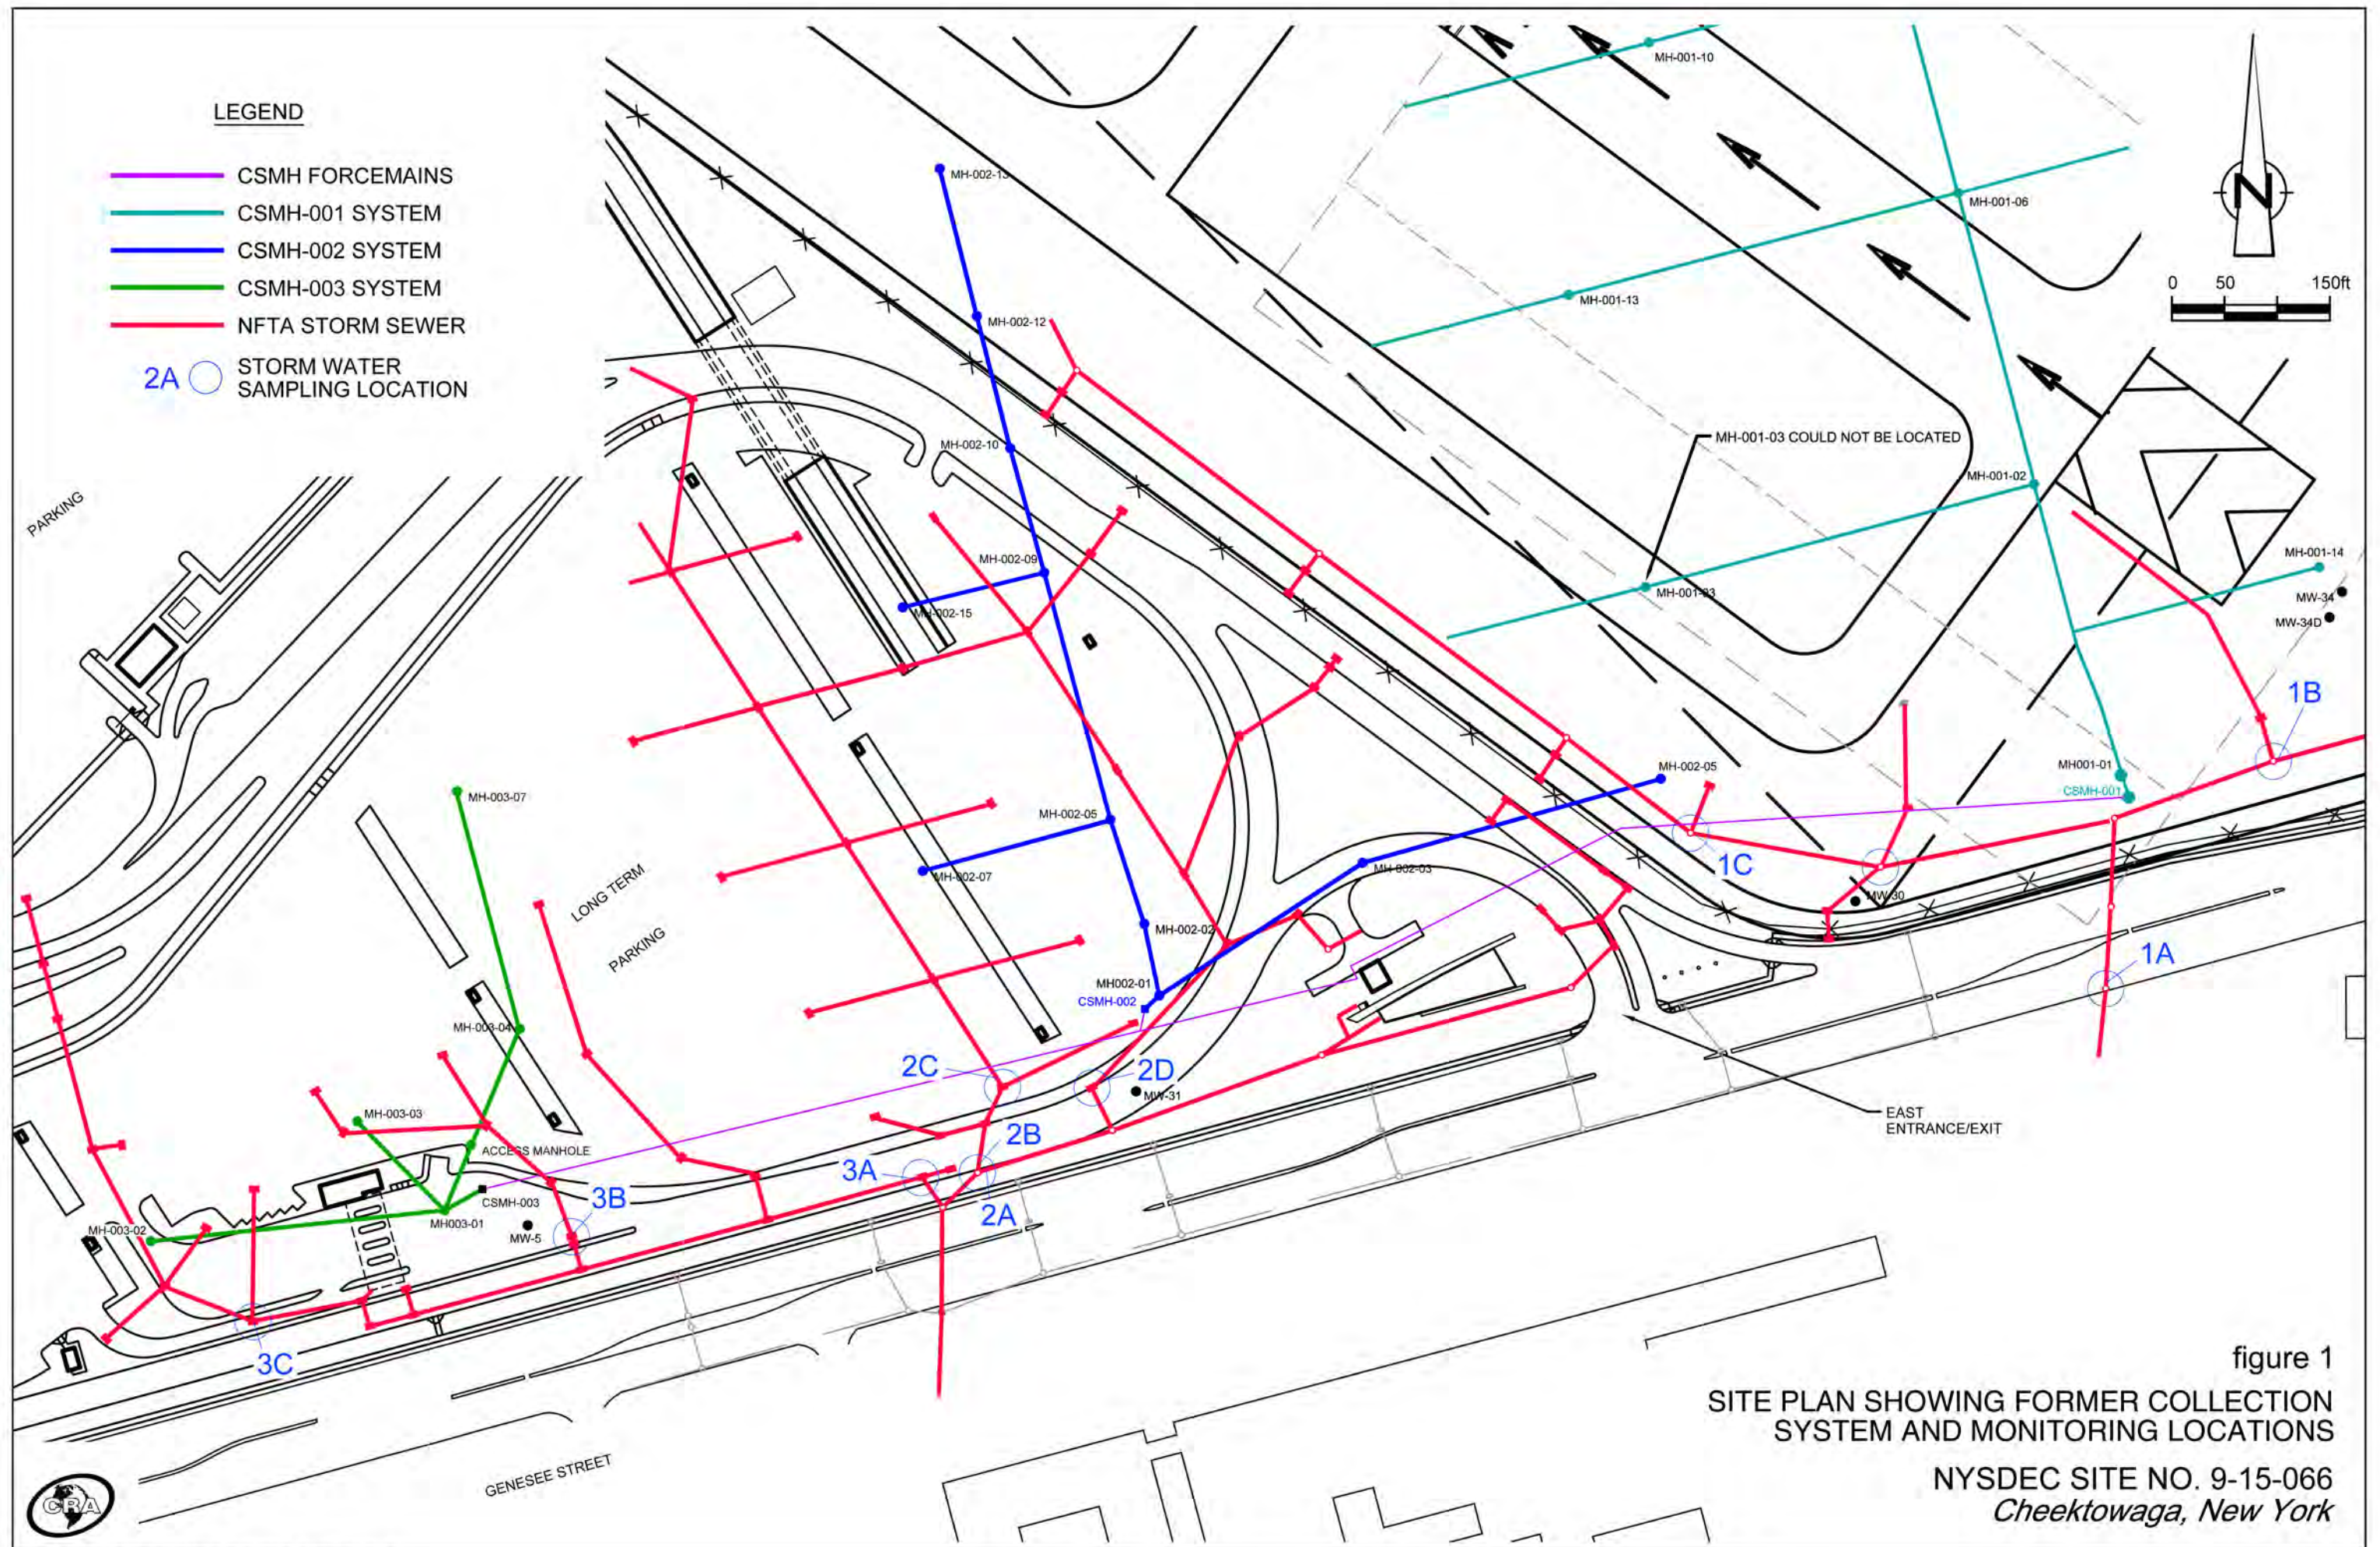
| <b><u>Figure No.</u></b> | <b><u>Title</u></b> |
|---|---|
| 1 | Site Plan Showing Former Collection System and Monitoring Locations |

Groundwater samples were collected on a quarterly basis for two years beginning in November 2014 from monitoring wells MW-2, MW-5, MW-28, MW-30, MW-31, MW-32, MW-33, MW-34, MW-34D, and MW-35. The locations of these wells are shown in Figure 1, and Table 1 presents well construction details.

Table 3 summarizes the results of the groundwater analyses over the course of post-closure monitoring. The analytical data have been routinely uploaded to the NYSDEC EQuIS database, and copies of the laboratory reports, along with an index of laboratory report numbers and sample numbers, are provided in Appendix D. Monitoring well locations are shown in Figure 1.

The analytical data have been routinely uploaded to the NYSDEC EQuIS database, and copies of the laboratory reports, along with an index of laboratory report numbers and sample numbers, are provided in Appendix D. Manhole and catch basin sampling locations are shown in Figure 1.
