ENGINEERING INVESTIGATIONS AT INACTIVE HAZARDOUS WASTE SITES IN THE STATE OF NEW YORK

PHASE II INVESTIGATIONS

**Town of Marilla Landfill
Site No. 915093
Town of Marilla, Erie County**

July 1991

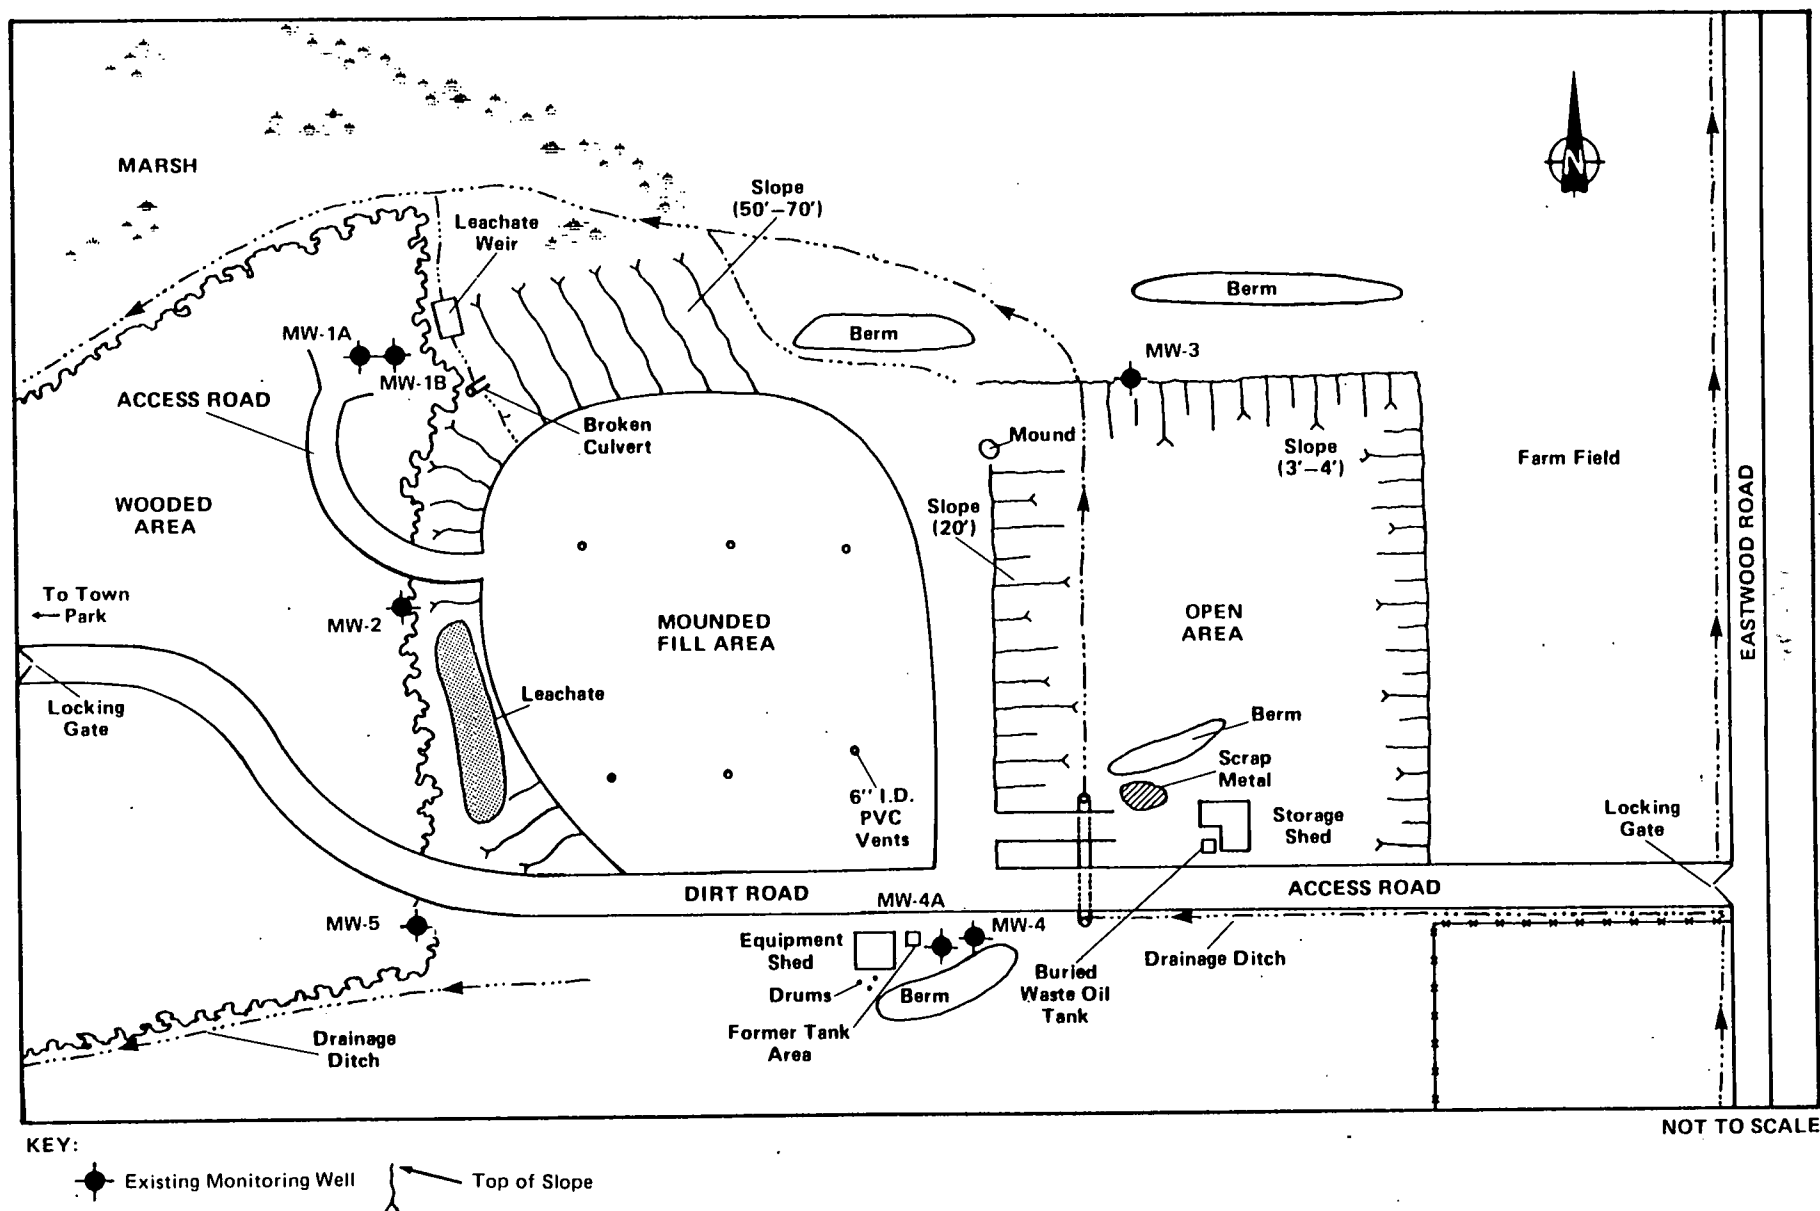
Figure 1-2
SITE SKETCH: TOWN OF MARILLA LANDFILL

Several discrepancies were noted between present site conditions and features indicated on the site map in the Phase II work plan. The following changes have been incorporated into Figure 1-2 from the field logbook:

- o The access road continues westward past the equipment shed, through the wooded area to the west of the landfill, and into the town park to the northwest. The town park contains a small pond;
- o The culvert to the northwest of the landfill appeared to be non-functional. Remains of a broken concrete pipe were noted without any visible signs of where it was previously connected;
- o The leachate weir was actually further west, near the broken culvert at the base of the northwest corner of the landfill;
- o The scrap metal pile near the northeast corner of the landfill was removed; however, a scrap metal pile noted to the west of the new building may have been the same scrap materials relocated;
- o A major leachate seep was noted along the west slope of the landfill; and
- o The inactive area to the east of the landfill extended further east.

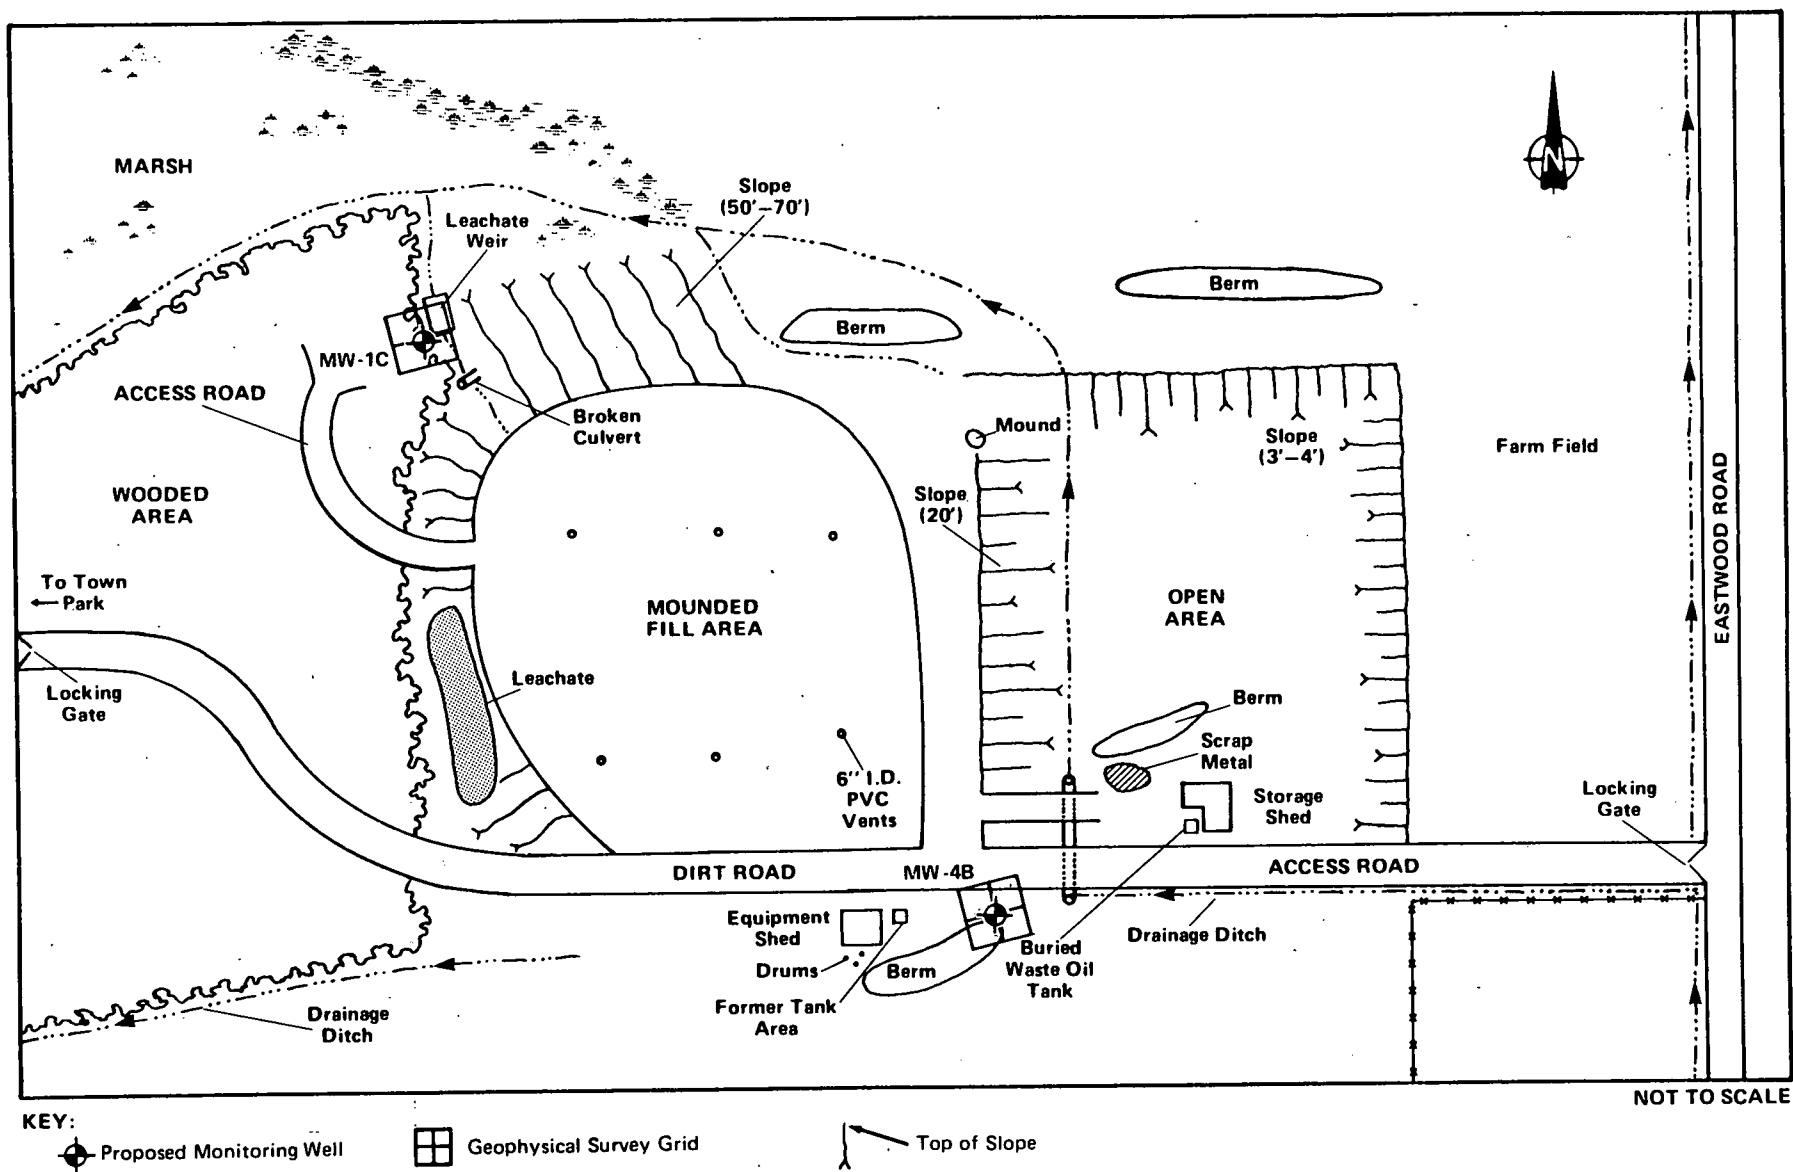
Figure 3-1
GEOPHYSICAL SURVEY AND PROPOSED GROUNDWATER MONITORING WELL LOCATIONS

A geophysical survey utilizing an EM31 ground conductivity meter and proton precession magnetometer was performed at the Marilla site on May 24, 1989. These surveys were conducted at two locations within and around the perimeter of the site (see Figure 3-1). The results were used to determine site geological conditions, locate buried materials, verify proposed monitoring well locations, and identify any conductive subsurface plumes. Analysis of the EM31 and magnetometer data indicated that grids 1 and 2 were free from subsurface metallic debris. The geophysical survey methods and a more detailed discussion of results are presented in Appendix B.

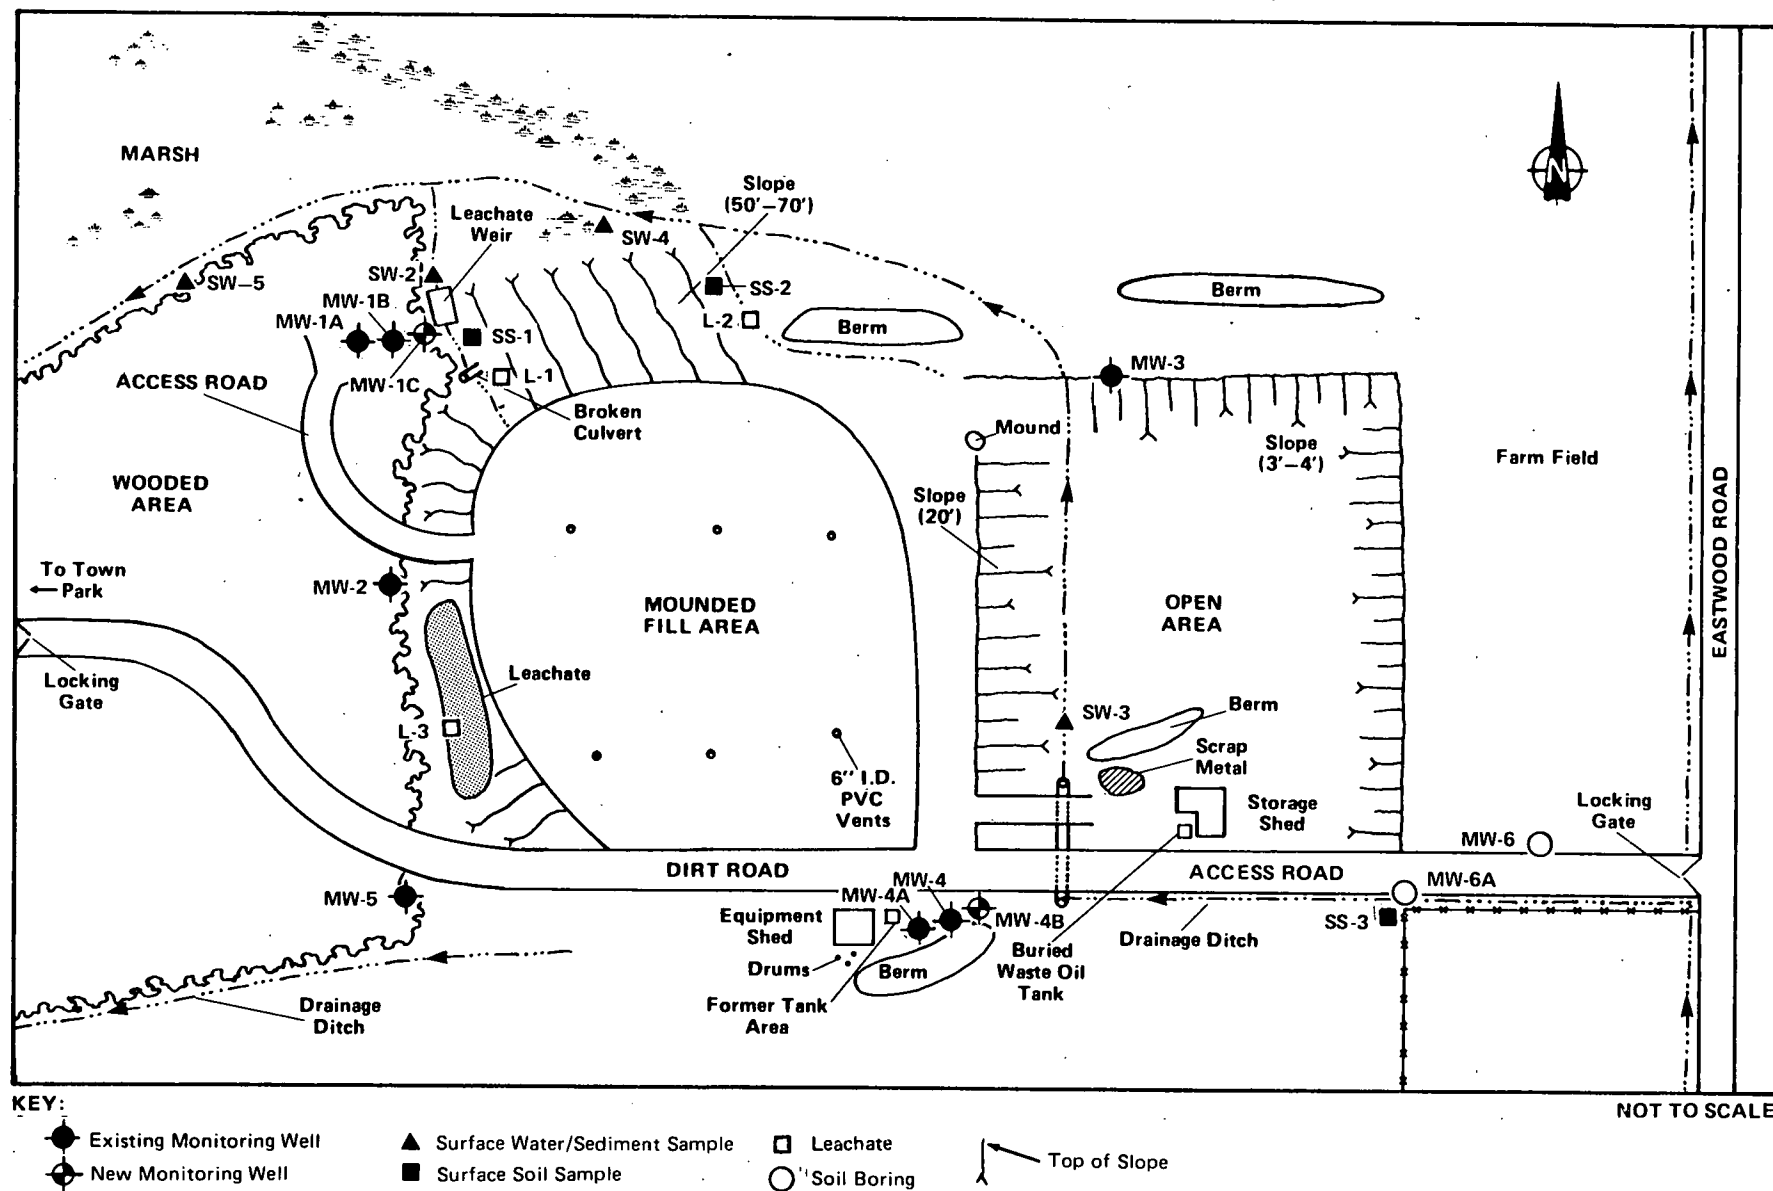
Figure 3-2
MONITORING WELL, SURFACE WATER, SEDIMENT, SURFACE SOIL, AND LEACHATE SAMPLING LOCATIONS

Two leachate samples (L-1 and L-2) were collected on May 9 and one (L-3) on August 16, 1989 from the north, northwest, and west sides of the landfill (see Figure 3-2 and Table 3-3). Two of the samples (L-1 and L-2) were liquid (mostly water) and one (L-3) was leachate-stained soil due to a lack of sufficient liquid volumes to fill the appropriate sample containers. The samples were analyzed for TCL organics and inorganics by E & E's ASC. In addition, a QA/QC sample consisting of one MS/MSD sample (L-3MS/L-3MSD) was analyzed for the above-mentioned compounds. The field procedures are described in Appendix D, results

Sample	Location
SW/SWS-1 (not sampled)	Proposed upgradient in intermittent stream on west side of landfill (not found).
SW/SWS-2	Downgradient in intermittent stream below culvert on west side of landfill.
SW/SWS-3	Upgradient in intermittent stream on east side of landfill.
SW/SWS-4	Downgradient of major leachate seep on north side of landfill in intermittent stream.
SW/SWS-5	Downgradient of landfill drainageways to the northwest; upgradient of the town park.
SS-1	West side of landfill near culvert pipe.
SS-2	North slope of landfill.
SS-3 (background)	Southeast of landfill in field south of access road, adjacent to horse corral fence.
L-1	At base of northwest slope of landfill near culvert pipe and leachate weir arrangement.
L-2	North slope of landfill.
L-3	West slope of landfill; from major leachate seep.

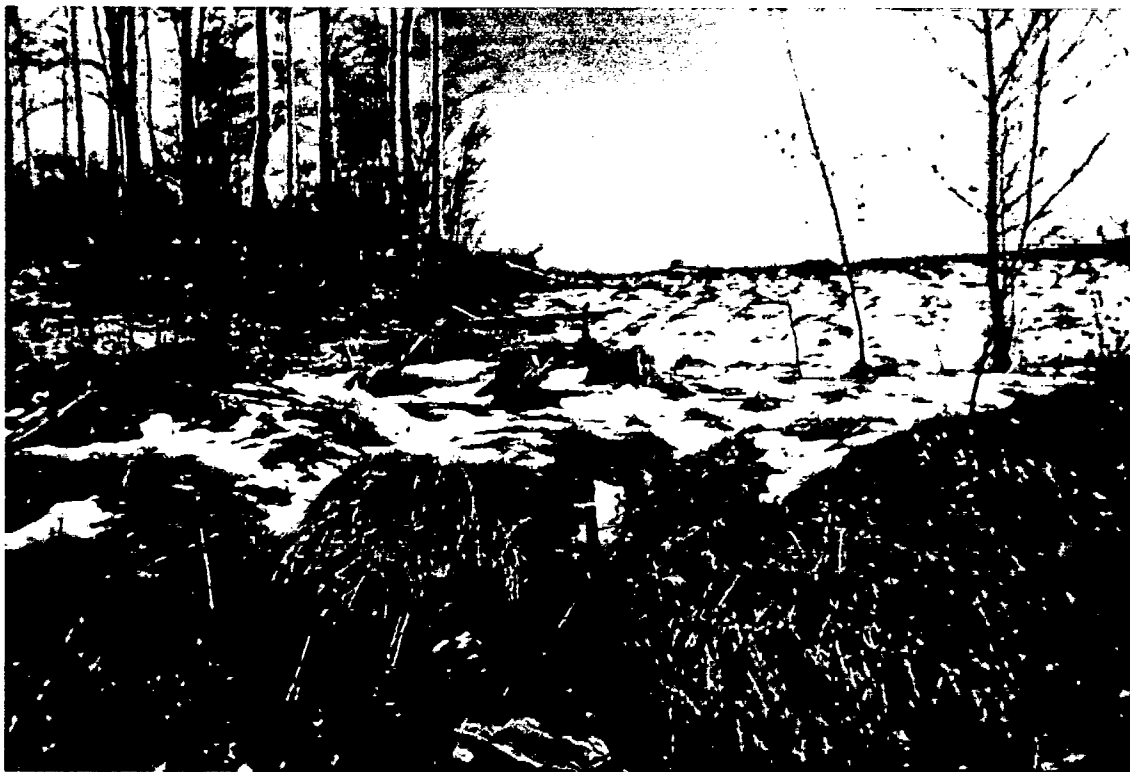
Comments: View to southeast of L-2 sample location (wood stake) located on the north slope of the
landfill in an area of cut trees.

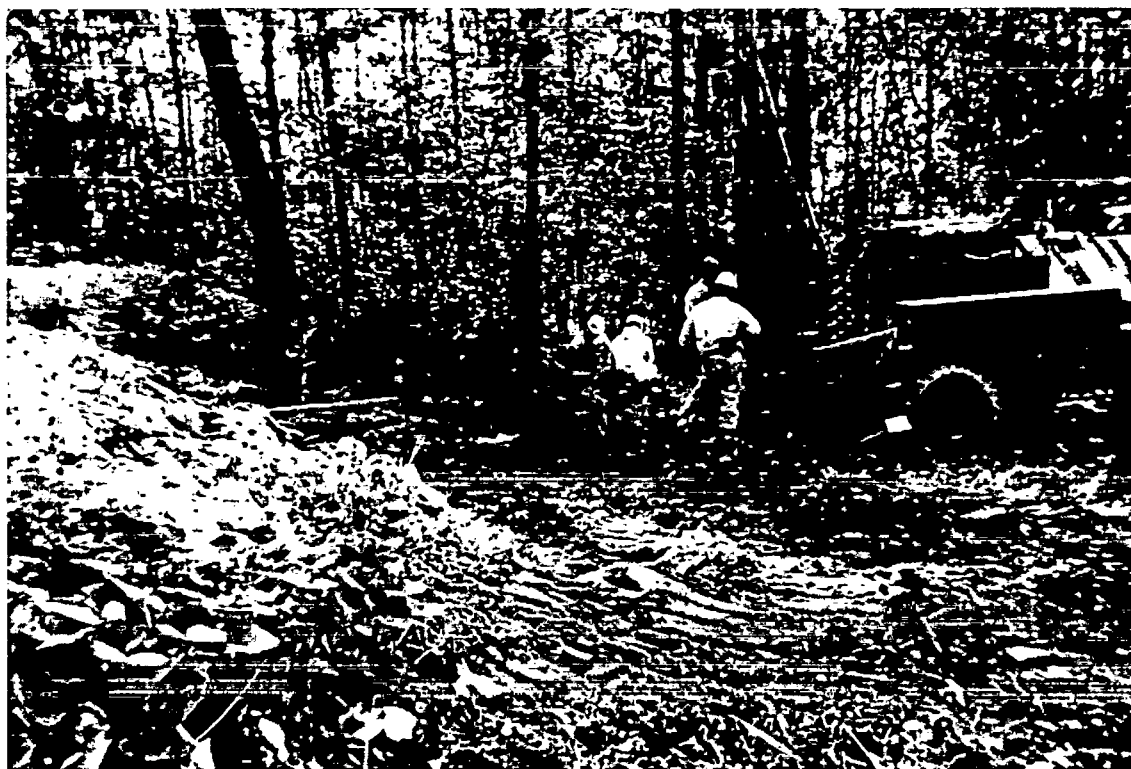
Comments: View to northwest of drilling location of GW-1C.

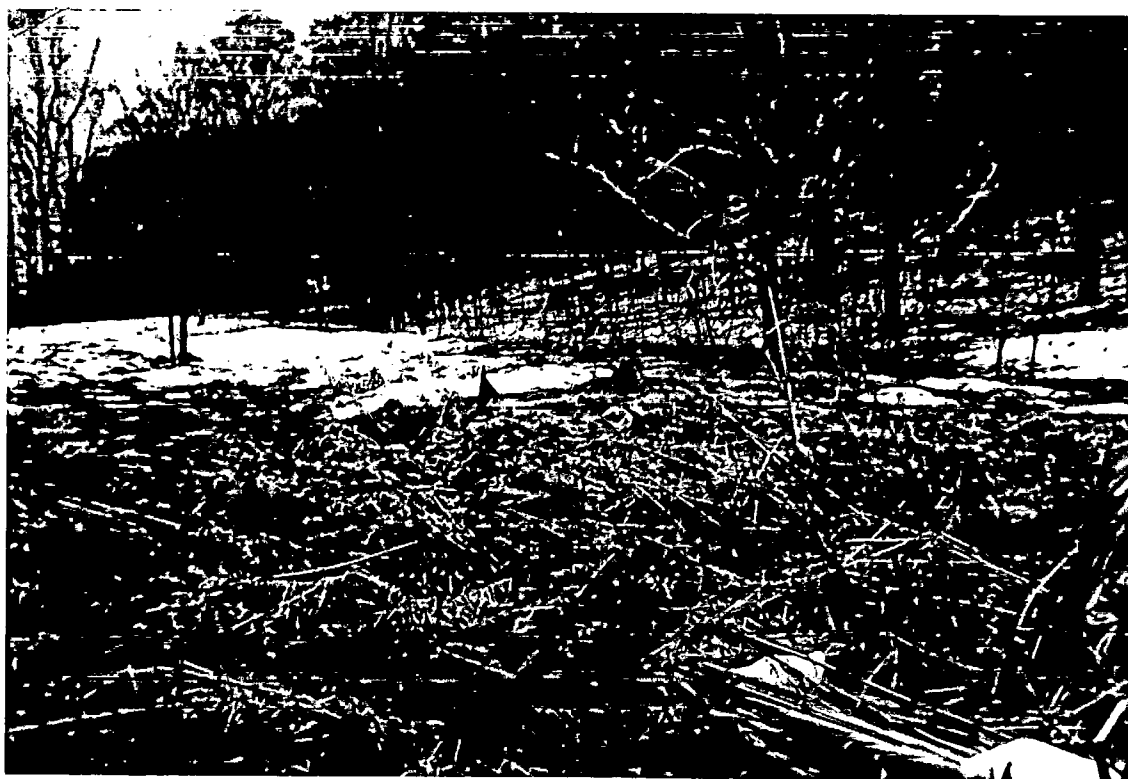
Comments: View to east of SW/SWS-4 sample location (wood stake) located in the marshy area along the
Little Buffalo Creek intermittent tributary. Landfill is located to the right of
photograph.

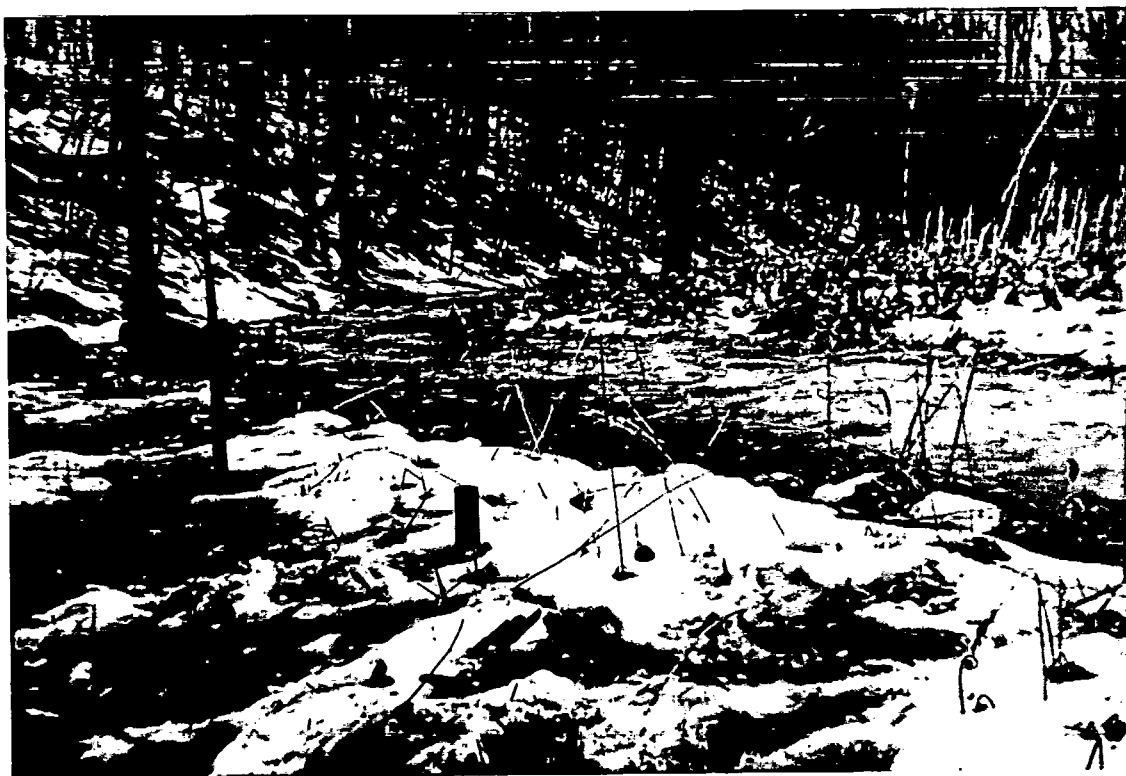
Comments: View to west of SW/SWS-5 sample location (wood stake) from downstream of landfill in the
intermittent tributary to Little Buffalo Creek.

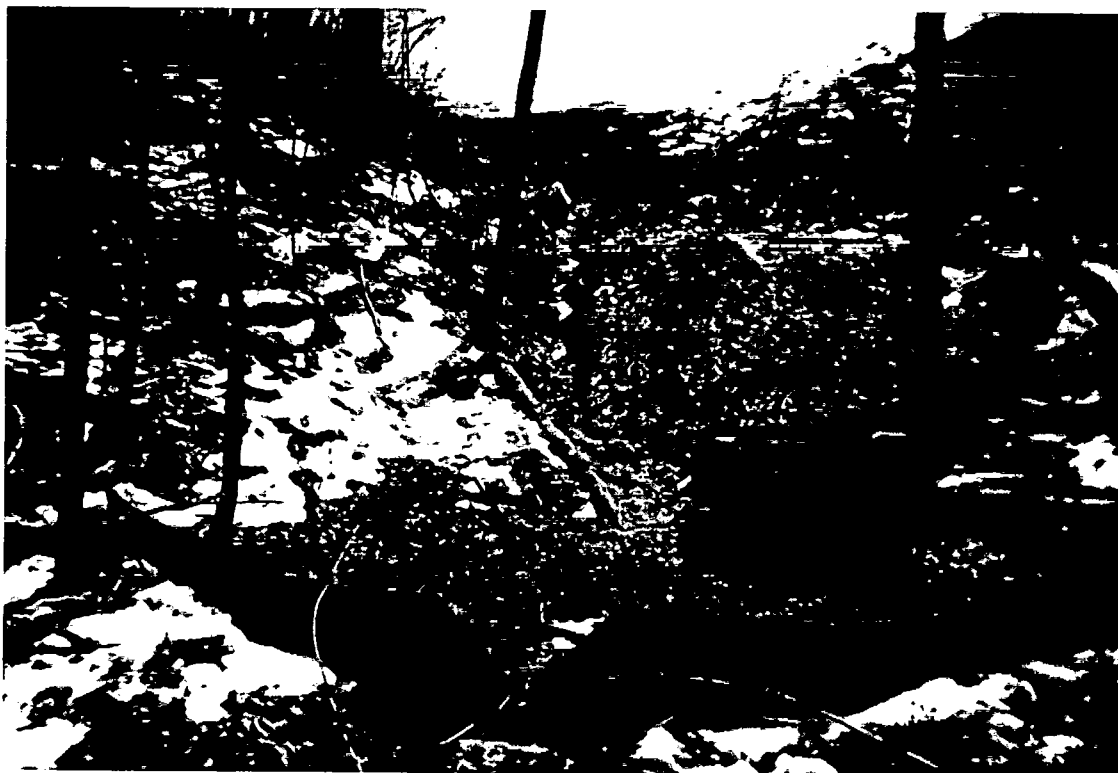
Comments: View to south of L-1 sample location adjacent to tree in center of photograph. Note south
side of leachate weir in foreground, broken concrete culvert pipe, and landfill slope in
background.

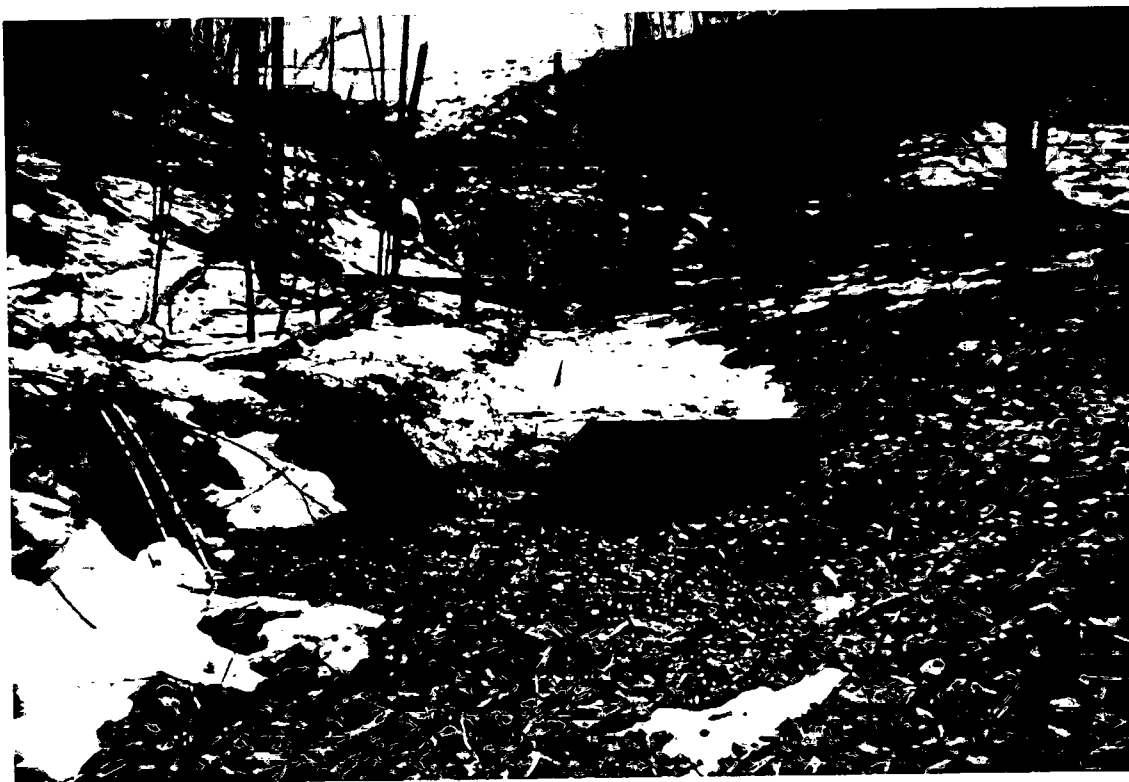
Note the broken culvert and landfill slope in background.

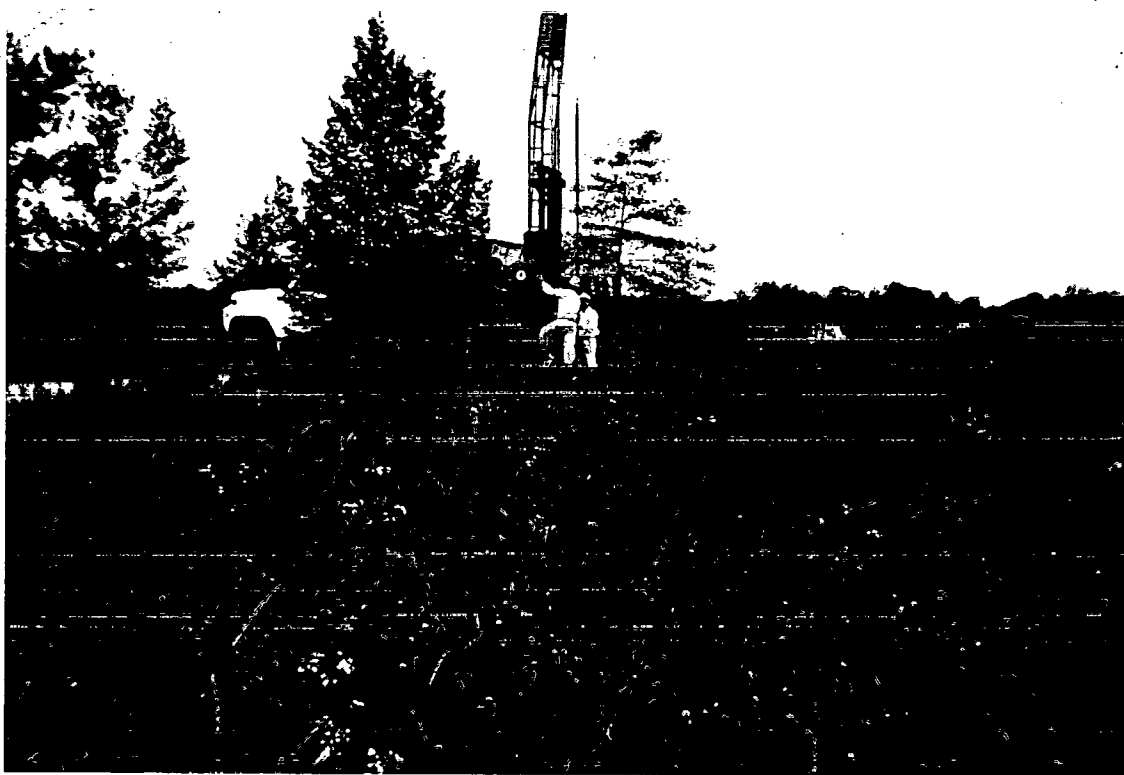
Comments: View to west of new location of the attempted additional upgradient well (GW-6) 30 ft.
north of the access road along the Town of Marilla right-of-way, 100 ft. west of Eastwood Road.

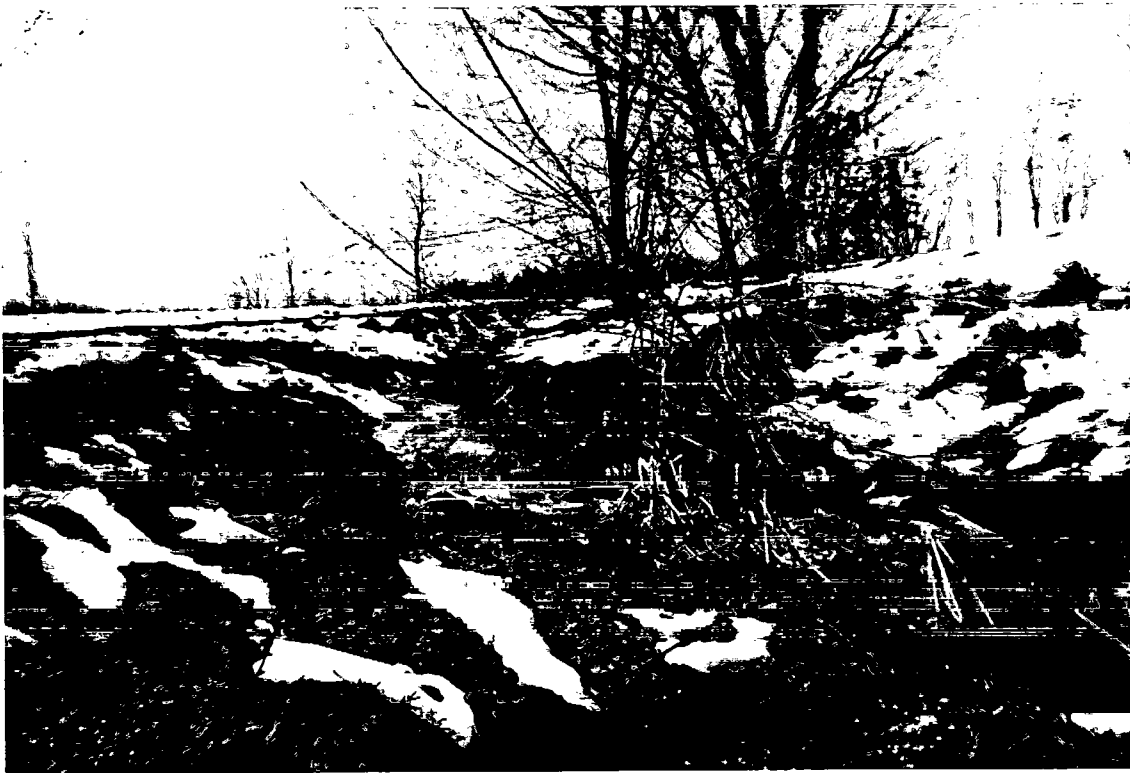
Comments: View to south of SW/SWS-3 sample location (wood stake) from drainage ditch adjacent to the east side of the landfill. Landfill located to the right of the photograph.

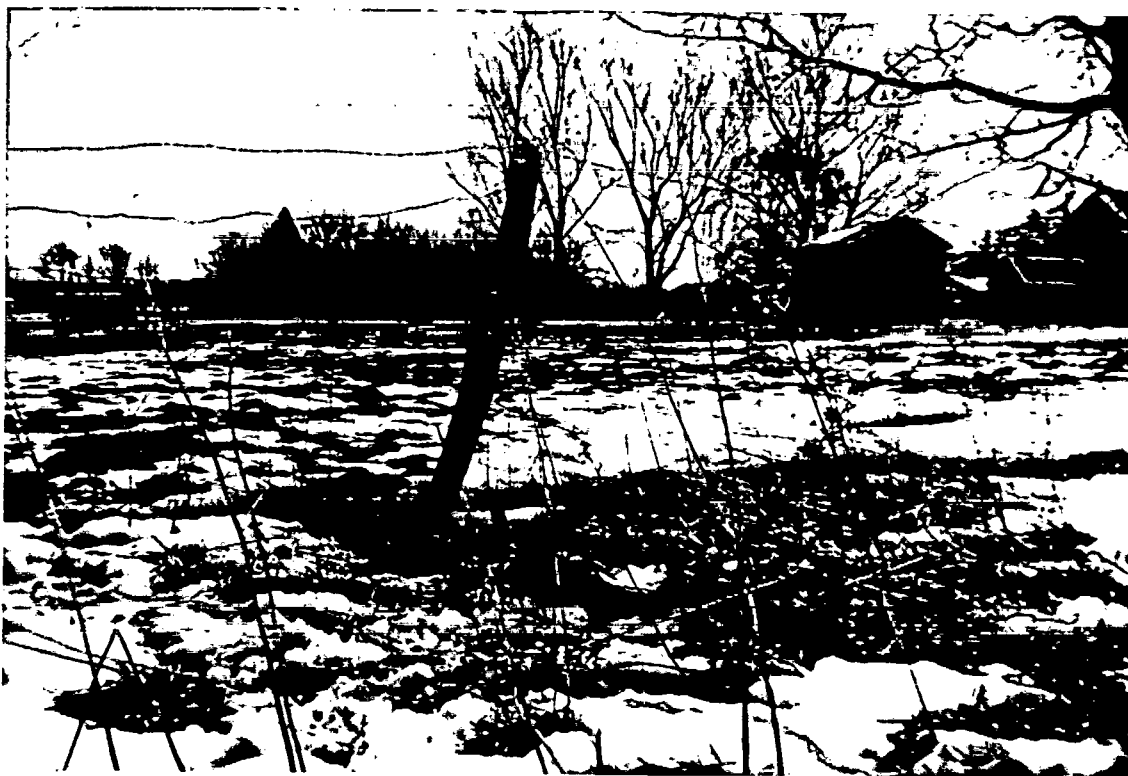
Comments: View to east of SS-3 sample location (wood stake) on south side of access road, along west side of horse corral fence (third post south from corner of fence).

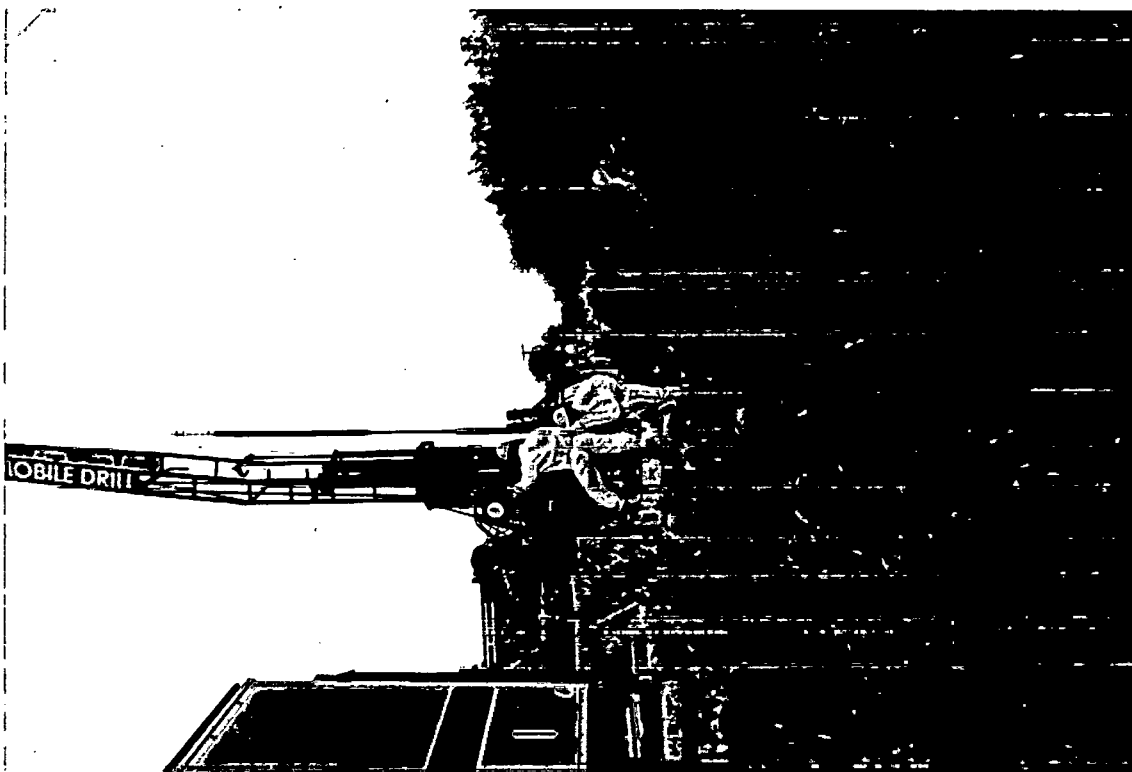
Comments: View to east of additional upgradient well location (GW-6) attempted on south side of
access road near end of horse corral fence.

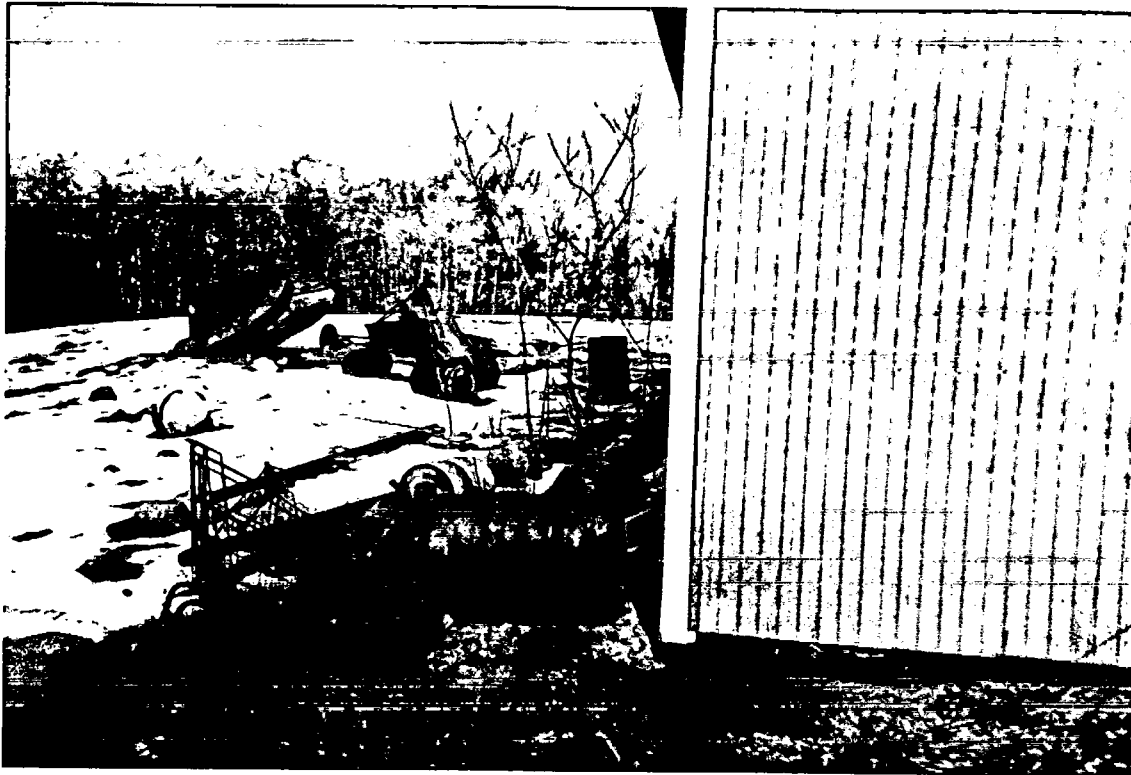
Comments: View to west of empty drums and metal debris behind the equipment shed.

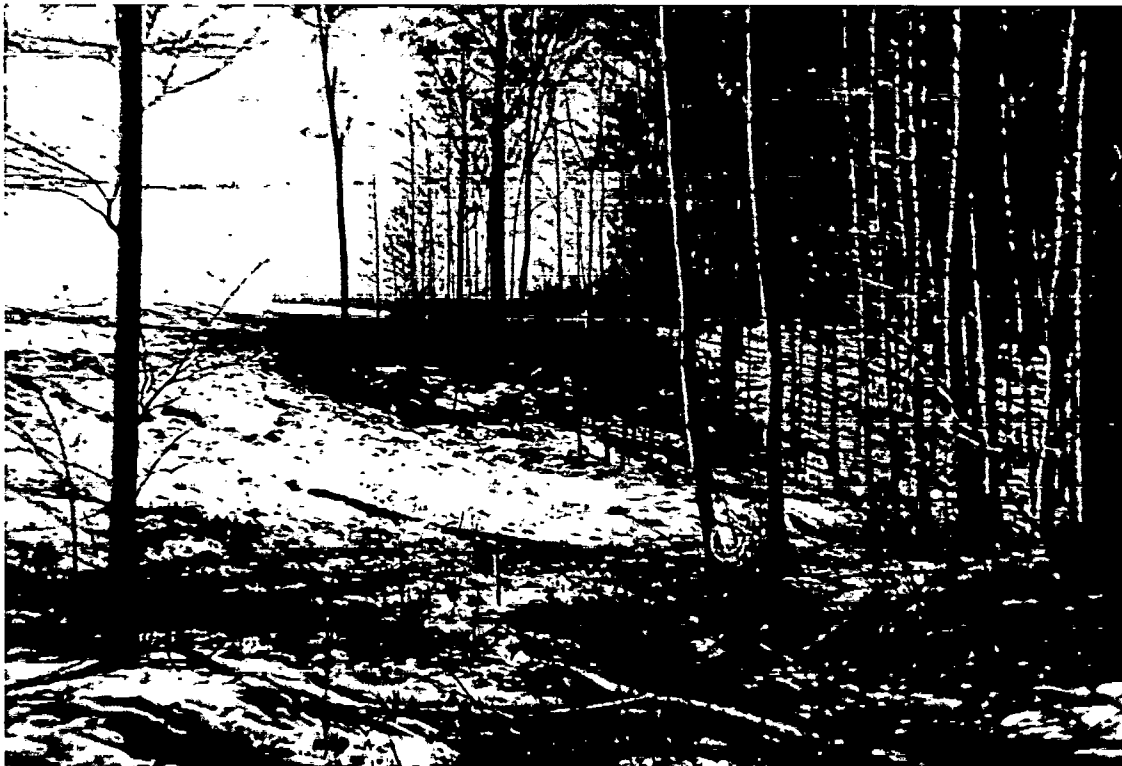
Comments: View to south of GW-2 (2" ID PVC) located in the center of the open space between the
single tree on the left and the two trees to the right of the center of the photograph. The landfill
is located to the left of the photograph.

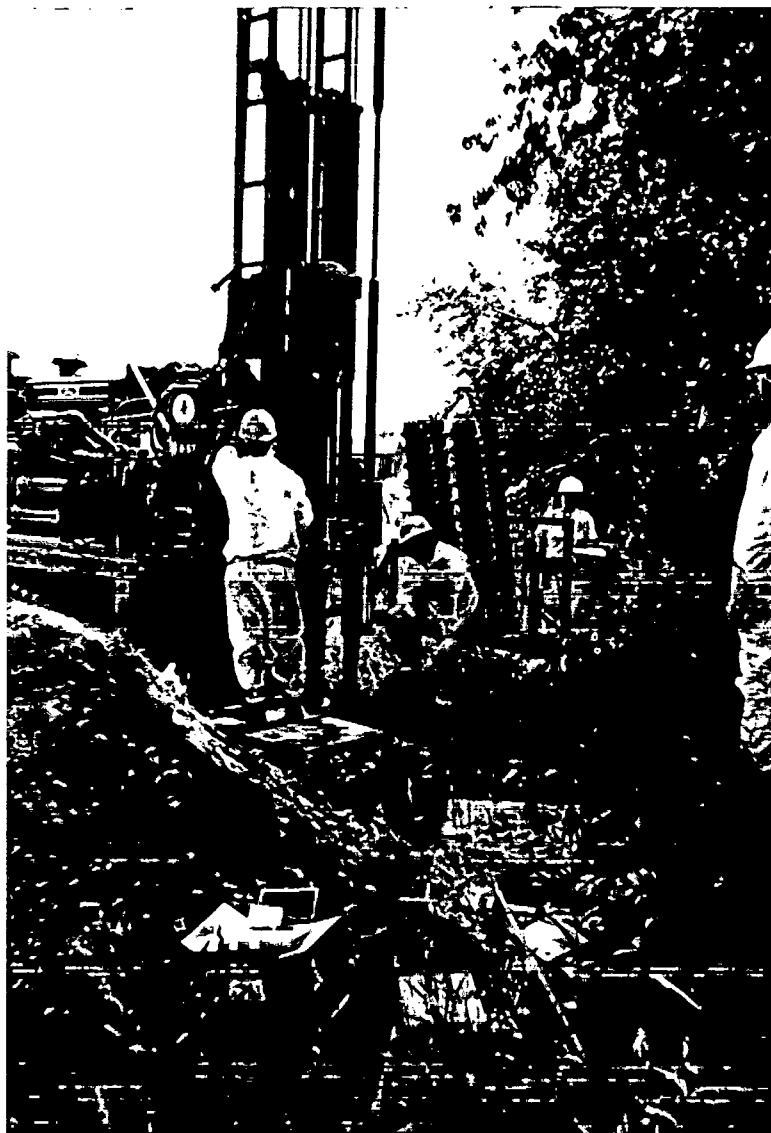
Comments: View to east of drilling of GW-4B.

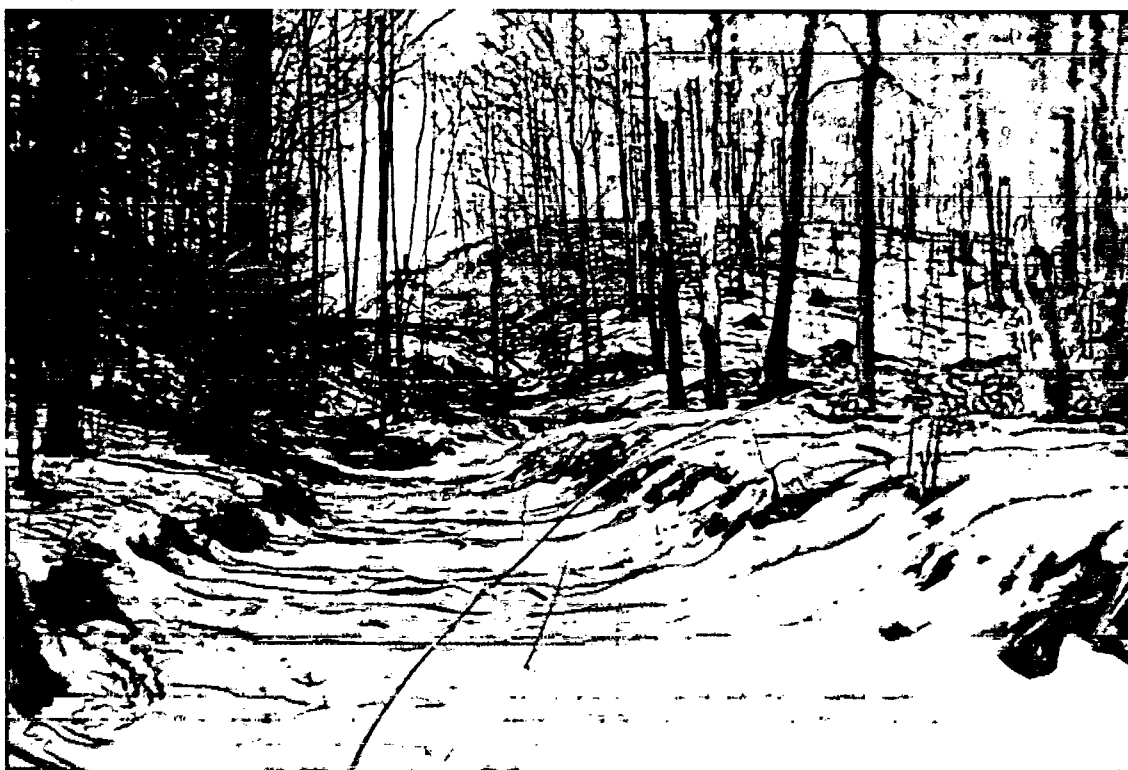
Comments: View to south of west drainage ditch. Landfill is located on top of slope to the left of
the picture. Leachate weir located at base of slope.

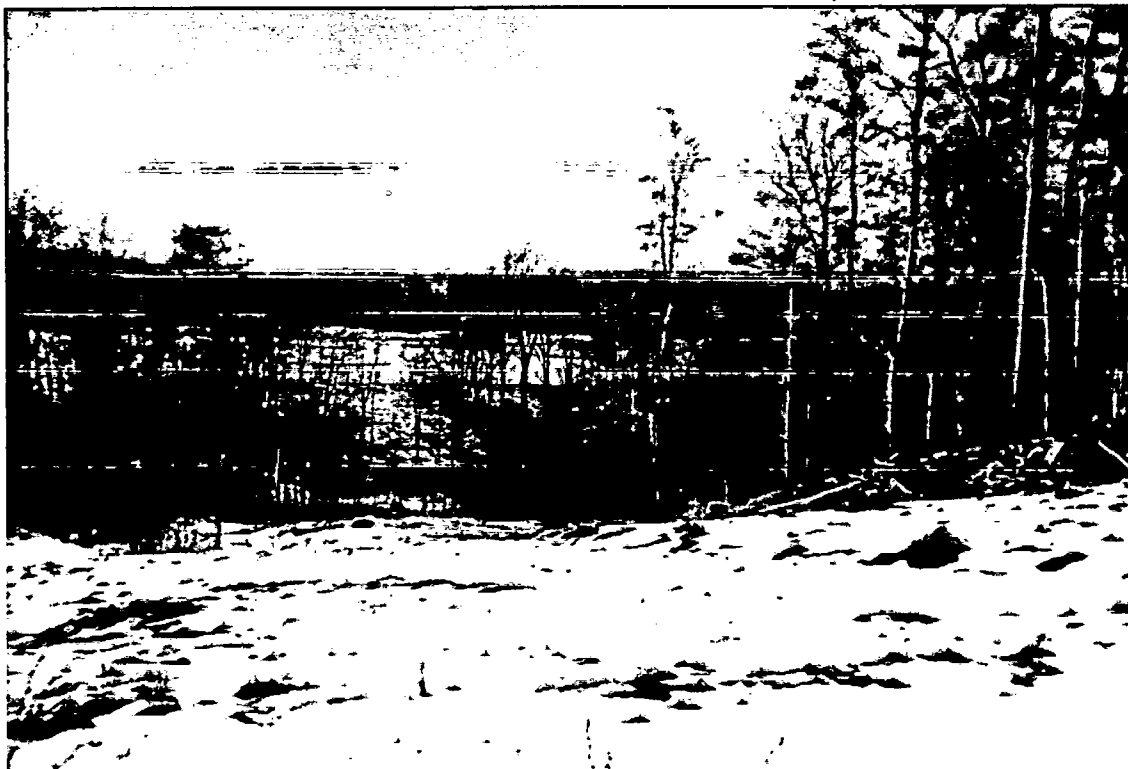
Comments: View to northwest from top of landfill (approx. 50-70 ft. change in elevation).

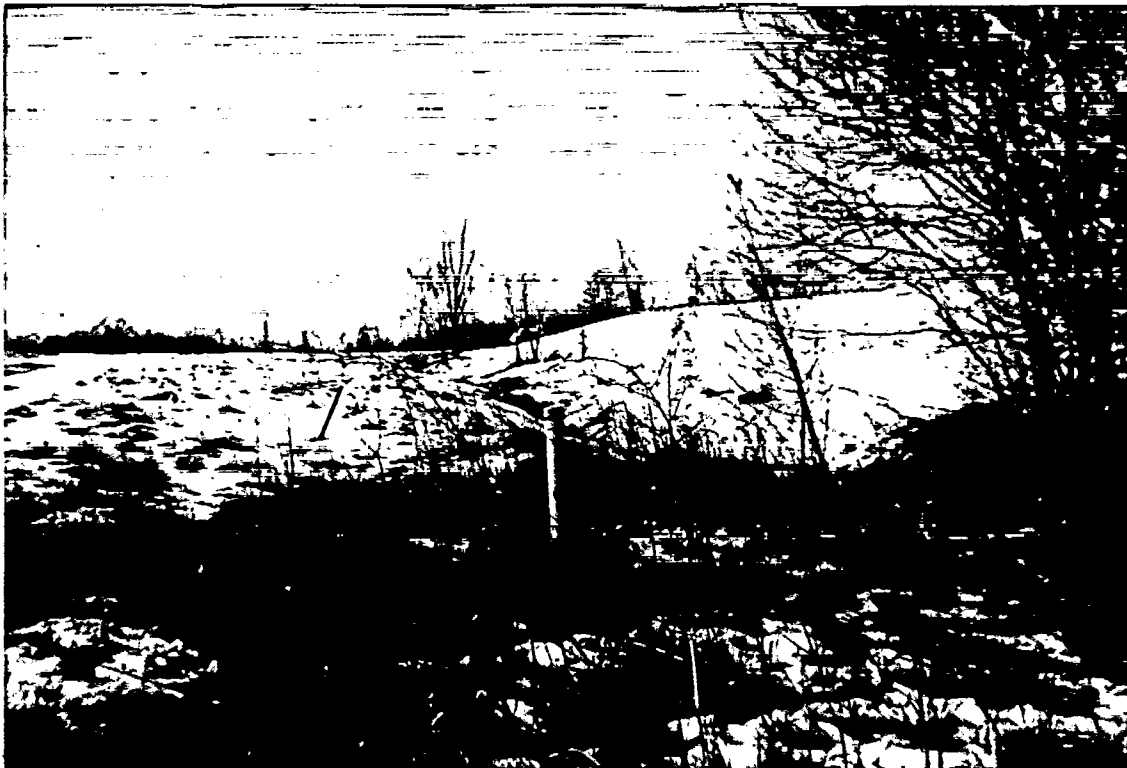
Comments: View to south of GW-3. Landfill slope to the right of the photograph.

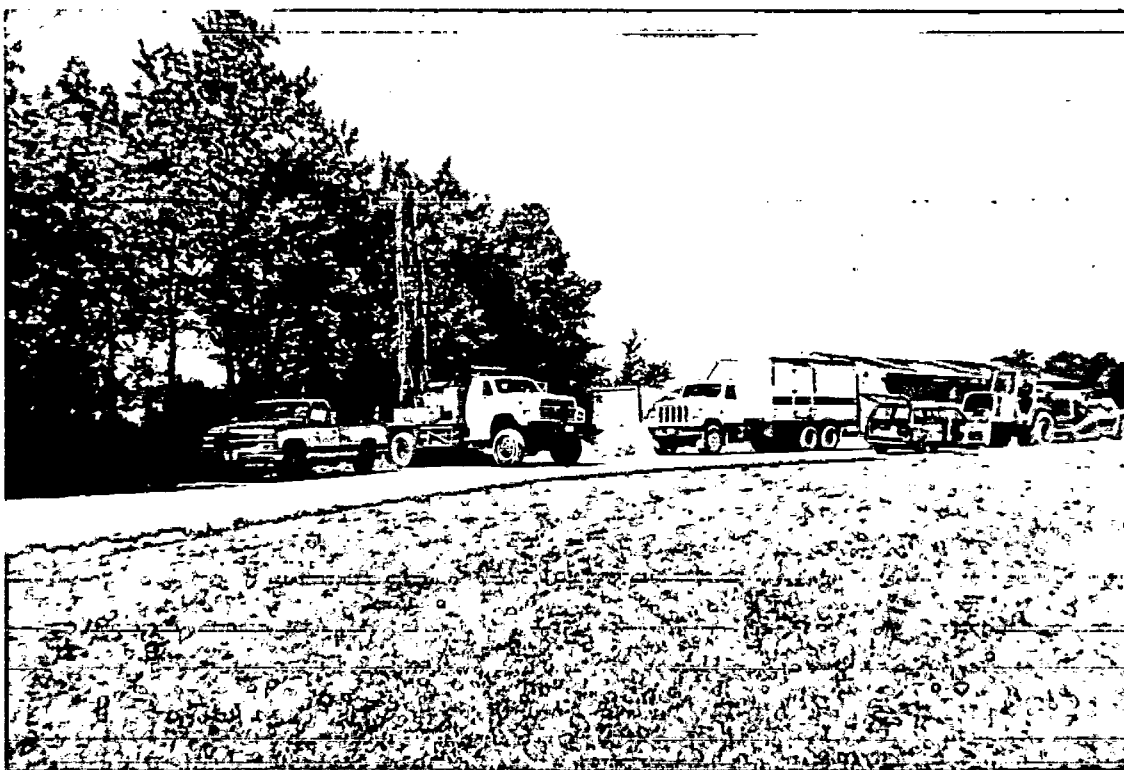
Comments: View to southwest of GW-4B drilling location.
