ENGINEERING INVESTIGATIONS AT INACTIVE HAZARDOUS WASTE SITES IN THE STATE OF NEW YORK

PHASE II INVESTIGATIONS

**Town of Marilla Landfill
Site No. 915093
Town of Marilla, Erie County**

July 1991

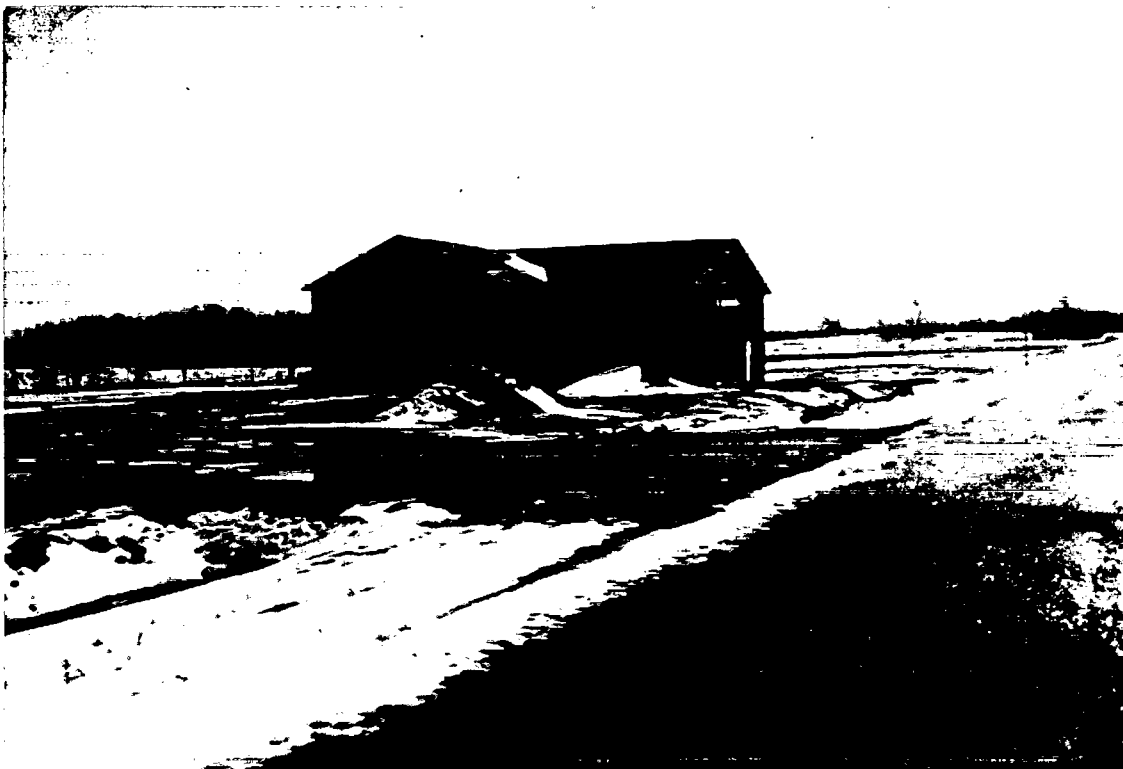
Comments: View to east of new waste recycling building along the north side of the access road.

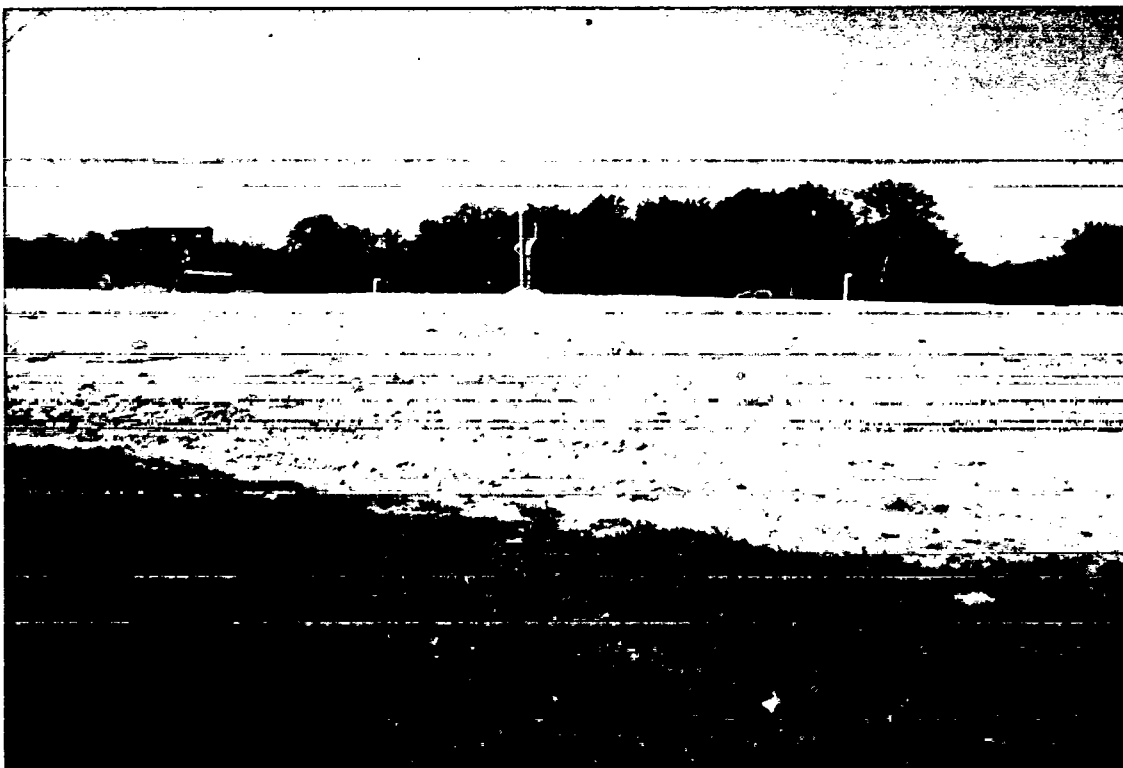
Comments: View to southwest of top of landfill, showing three of six newly-installed landfill
vents (6" ID PVC).

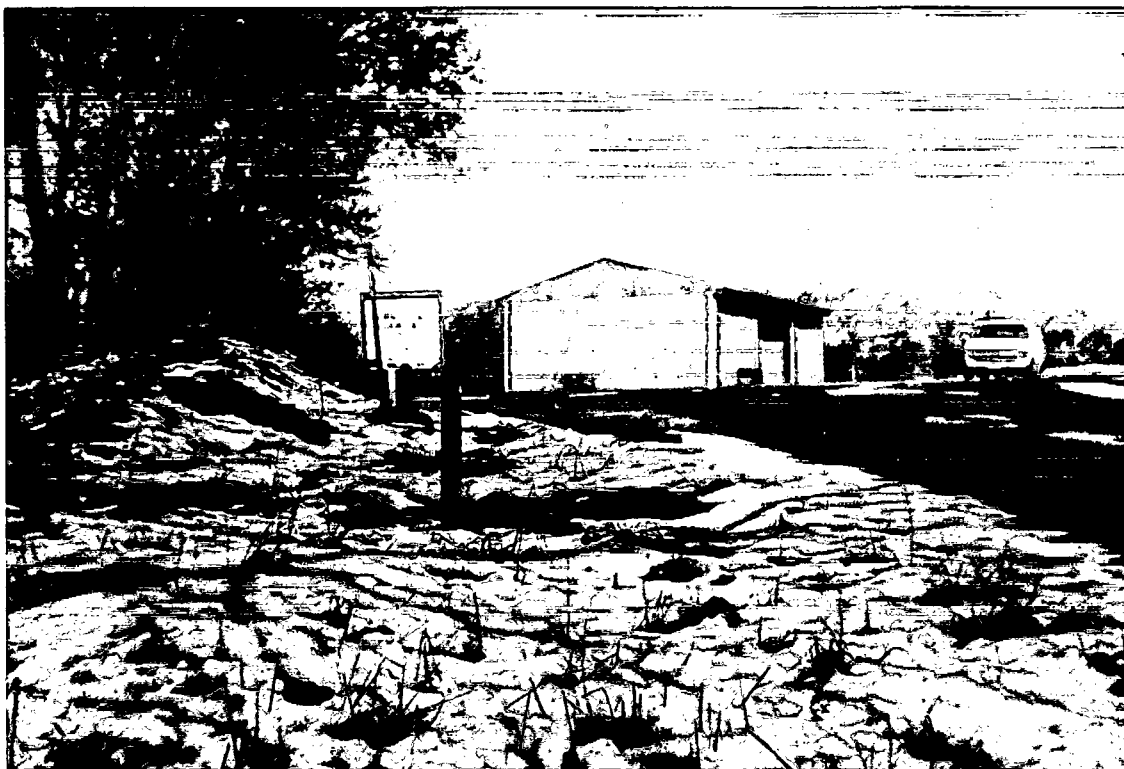
Comments: View to west of GW-4A (with protective casing), GW-4 (2" ID PVC behind GW-4A, adjacent to stake), with truck trailer and equipment shed in background. Proposed site for GW-4B.

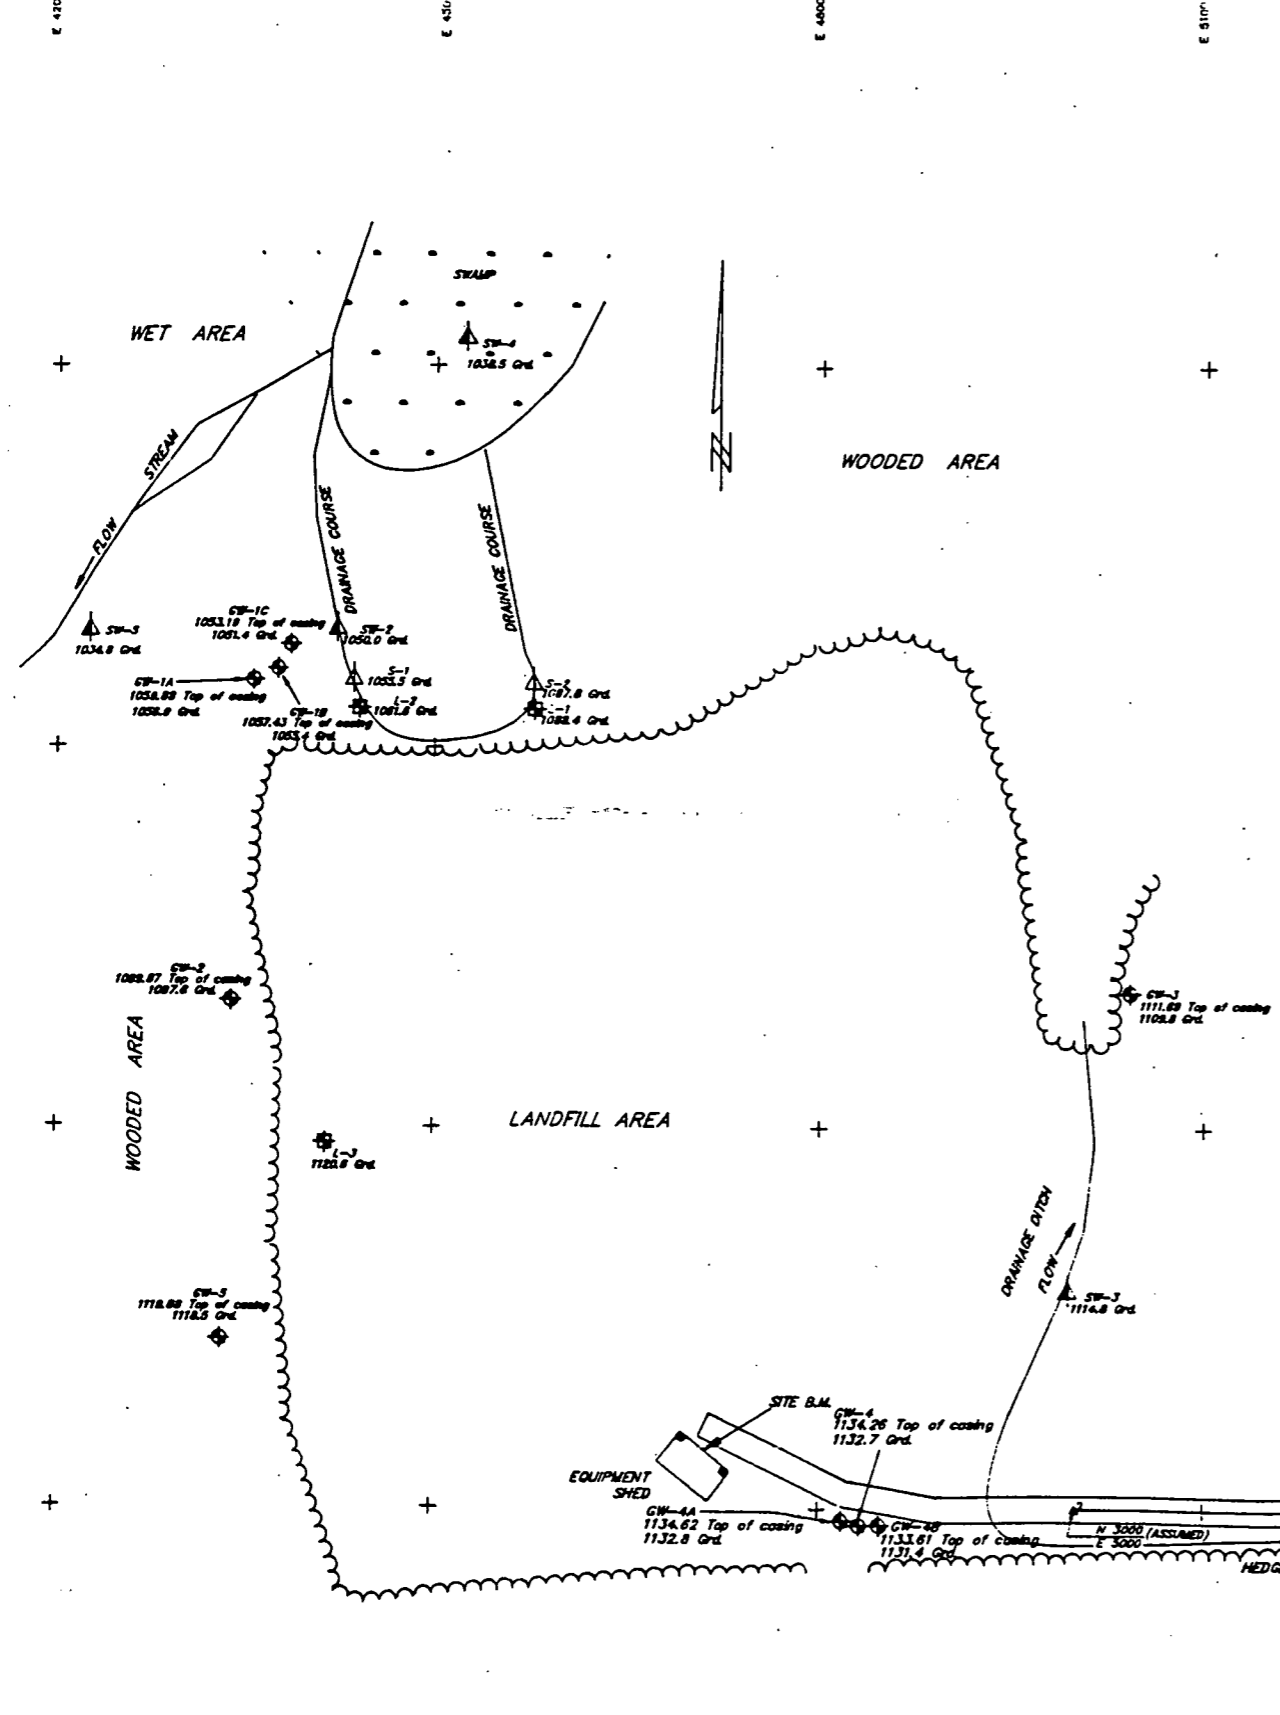
APPENDIX H
SITE SURVEY MAP

COORDINATE LIST		
NAME	NORTH	EAST
GW-1a	3652	4353
GW-1b	3661	4372
GW-1c	3680	4383
GW-2	3399	4336
GW-3	3409	5040
GW-4	2987	4833
GW-4a	2998	4848
GW-5	2991	4819
L-1	3132	4331
L-2	3630	4578
L-3	3631	4440
S-1	3286	4415
S-2	3652	4436
S-3	3650	4578
SW-2	2948	5593
SW-3	3693	4421
SW-4	3173	4994
SW-5	3922	4523
SW-5	3692	4225
NW CORNER EQUIP. SHED	3060.5	4691.5
NE CORNER EQUIP. SHED	3029.7	4730.5
NW CORNER RECYCLE CTR.	3114.7	5291.5
SE CORNER RECYCLE CTR.	3057.0	5342.6

NOTE: Elevations are related to BM established by TVGA of Orchard Park in 1987 at the equipment shed elev. = 1135.95
