ENGINEERING INVESTIGATIONS AT INACTIVE HAZARDOUS WASTE SITES

PHASE I INVESTIGATION

VILLAGE OF DEPEW LANDFILL
NYS SITE NUMBER 915105
VILLAGE OF DEPEW
ERIE COUNTY
NEW YORK STATE

DATE OF SUBMITTAL: JANUARY, 1988

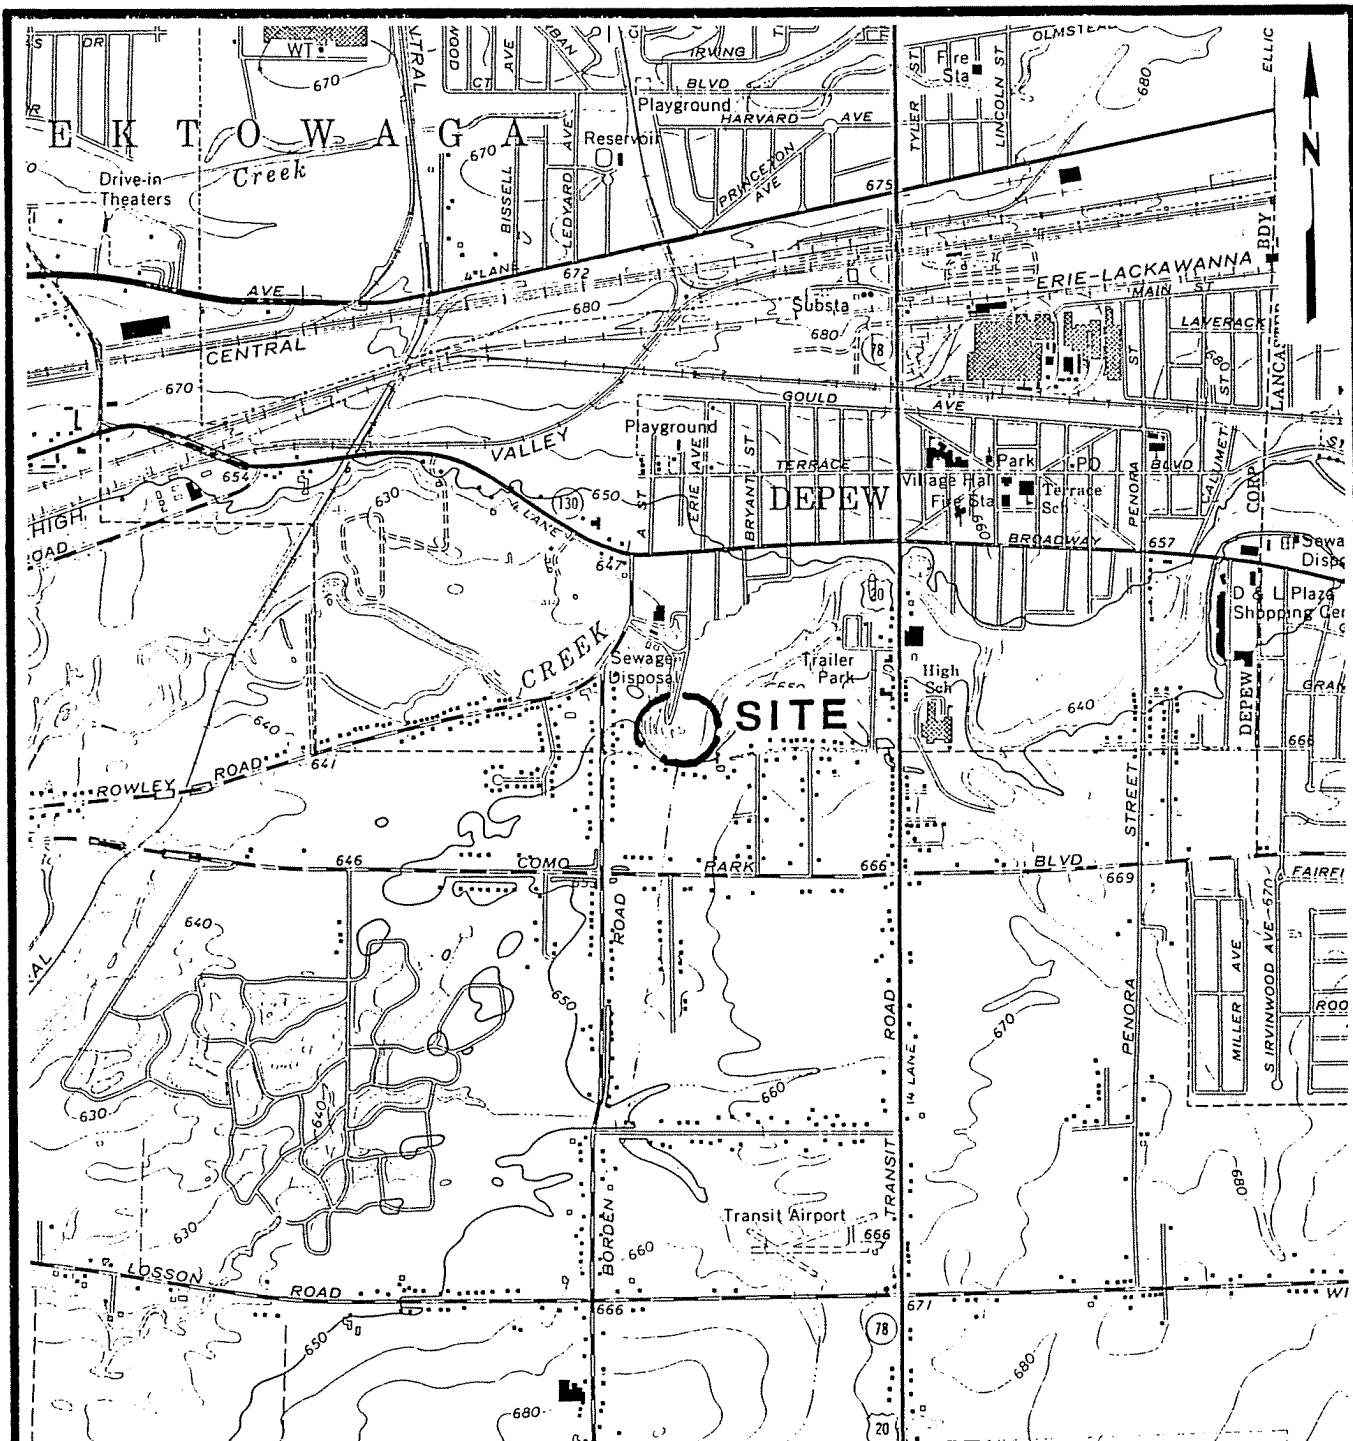
FIGURE I-1

LATITUDE: 42°53'47" N
LONGITUDE: 78°42'28" W

SITE LOCATION MAP
VILLAGE OF DEPEW

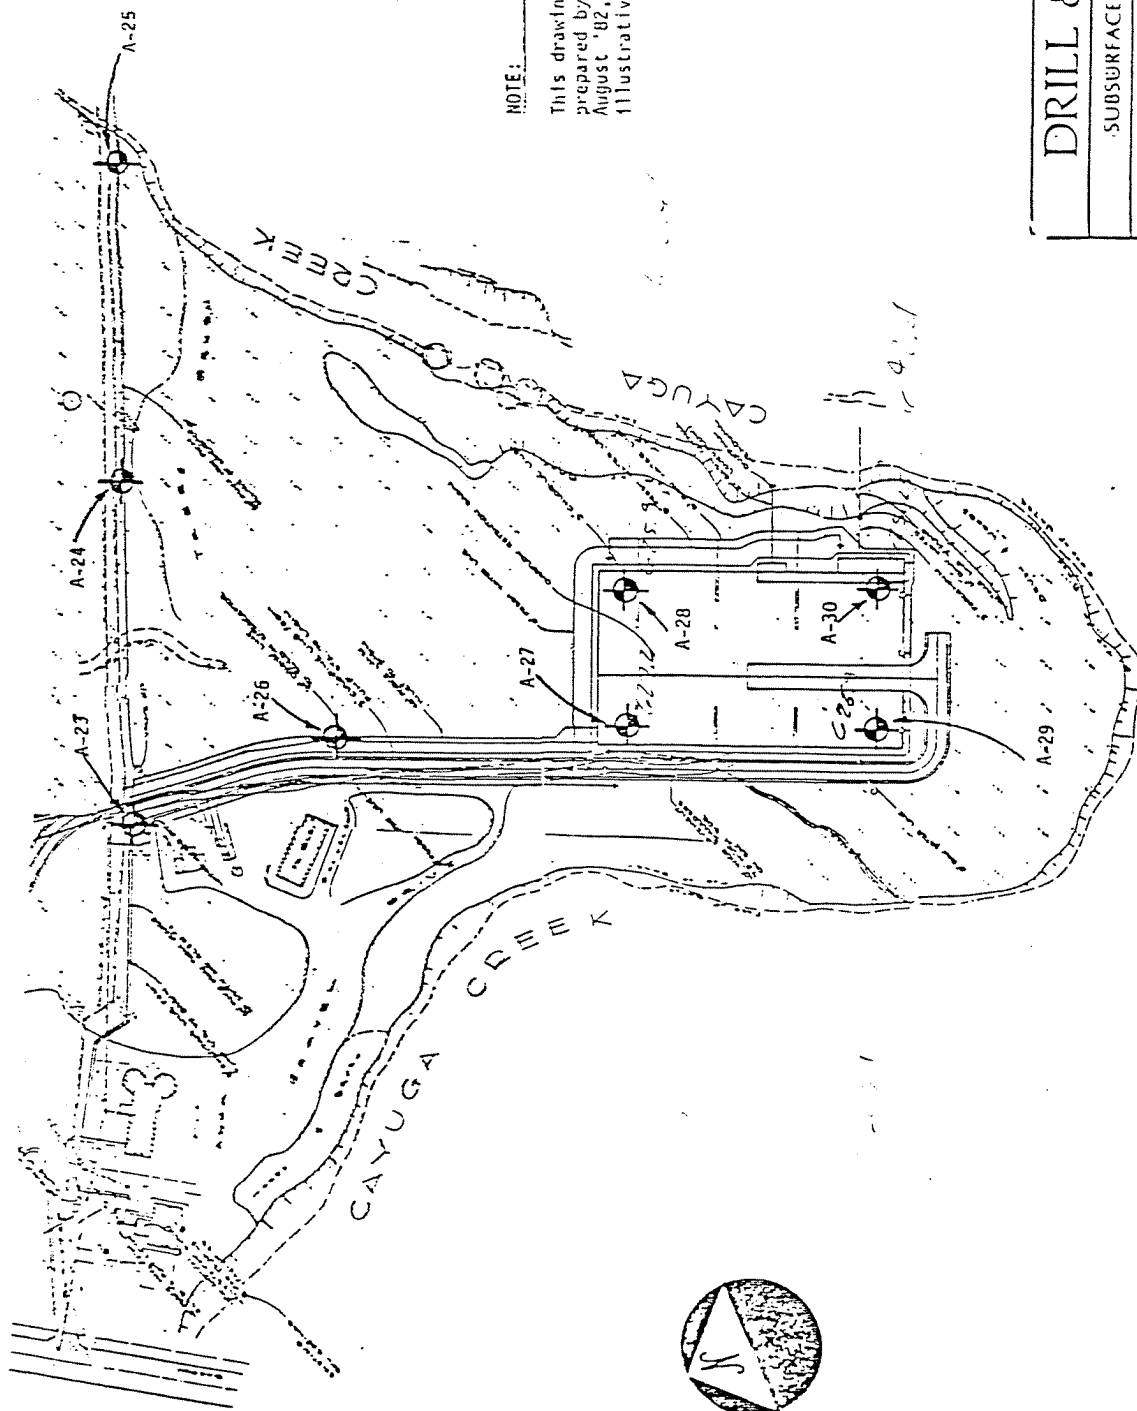
This drawing is a reproduction of a drawing prepared by Krehbiel Associates, Inc. dated August '82, Sheet ECL-2A and is for illustrative purposes only.
