SITE INVESTIGATION REPORT

BENGART AND MEMEL SITE NYSDEC SITE NO. 9-15-115 BUFFALO (C), ERIE COUNTY

March 2007

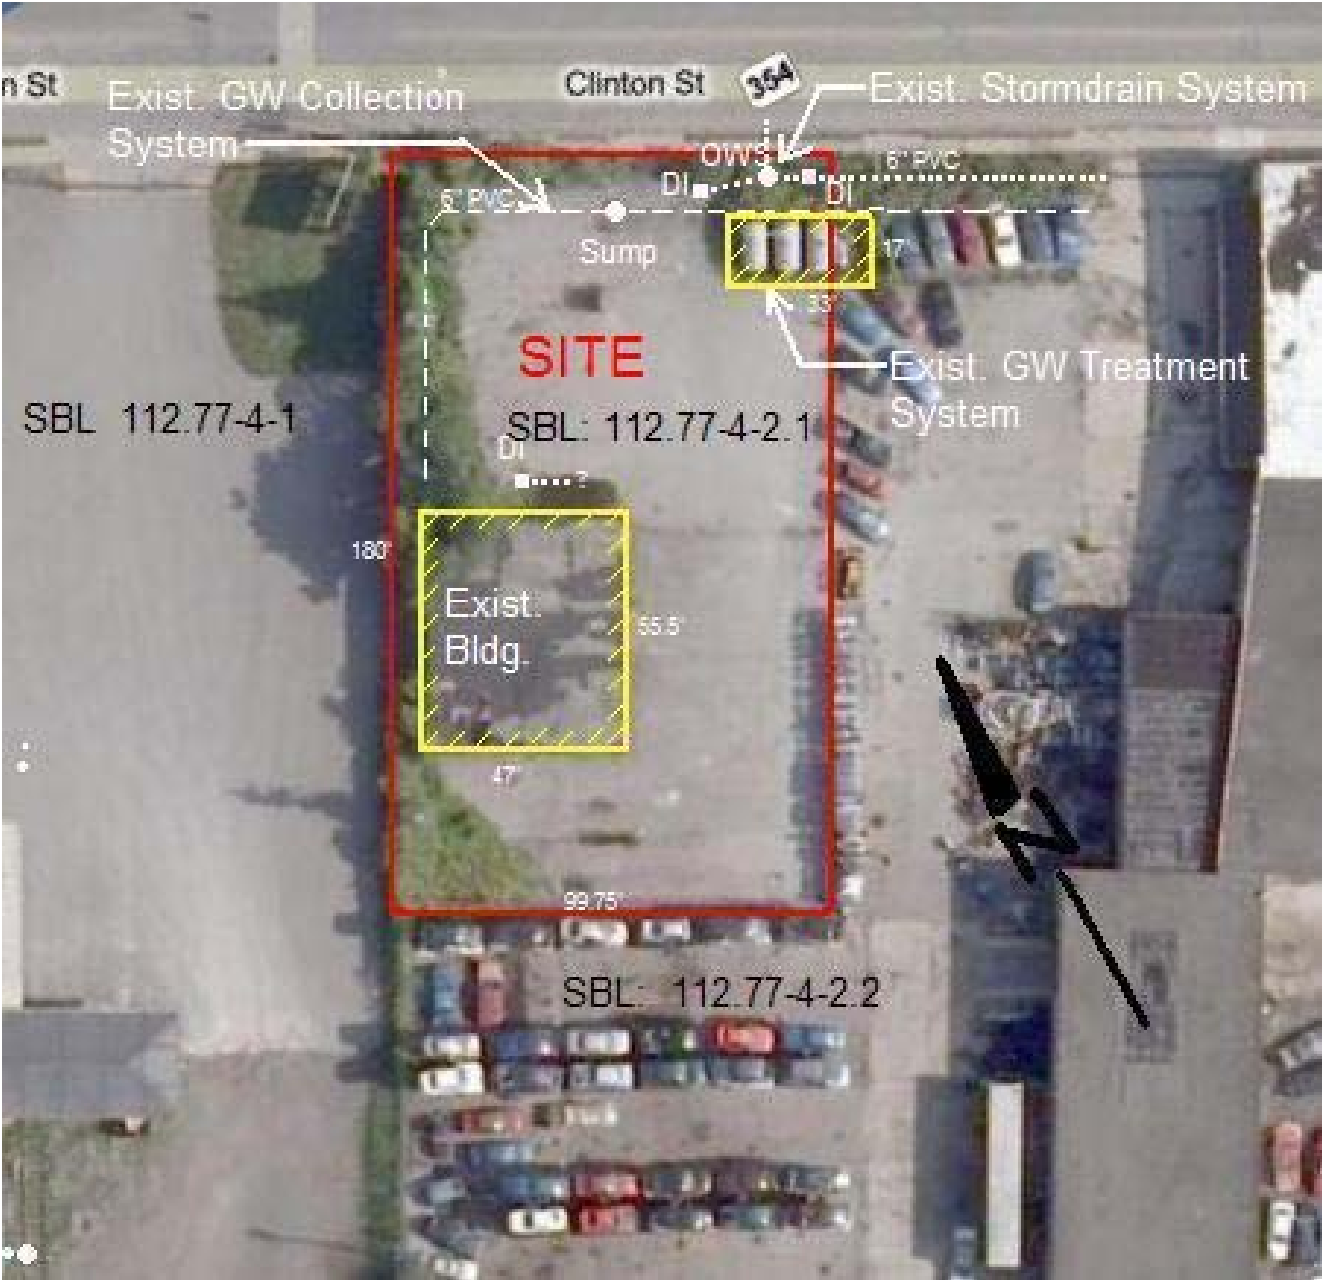
Figure 2

Site Plan
