**Phase II
Environmental Site Assessment**

**100 Tonawanda Road
Amherst, New York 14228
Tax IDs: # 26.00-1-6.1**

Job No.: 11-543A

October, 2011

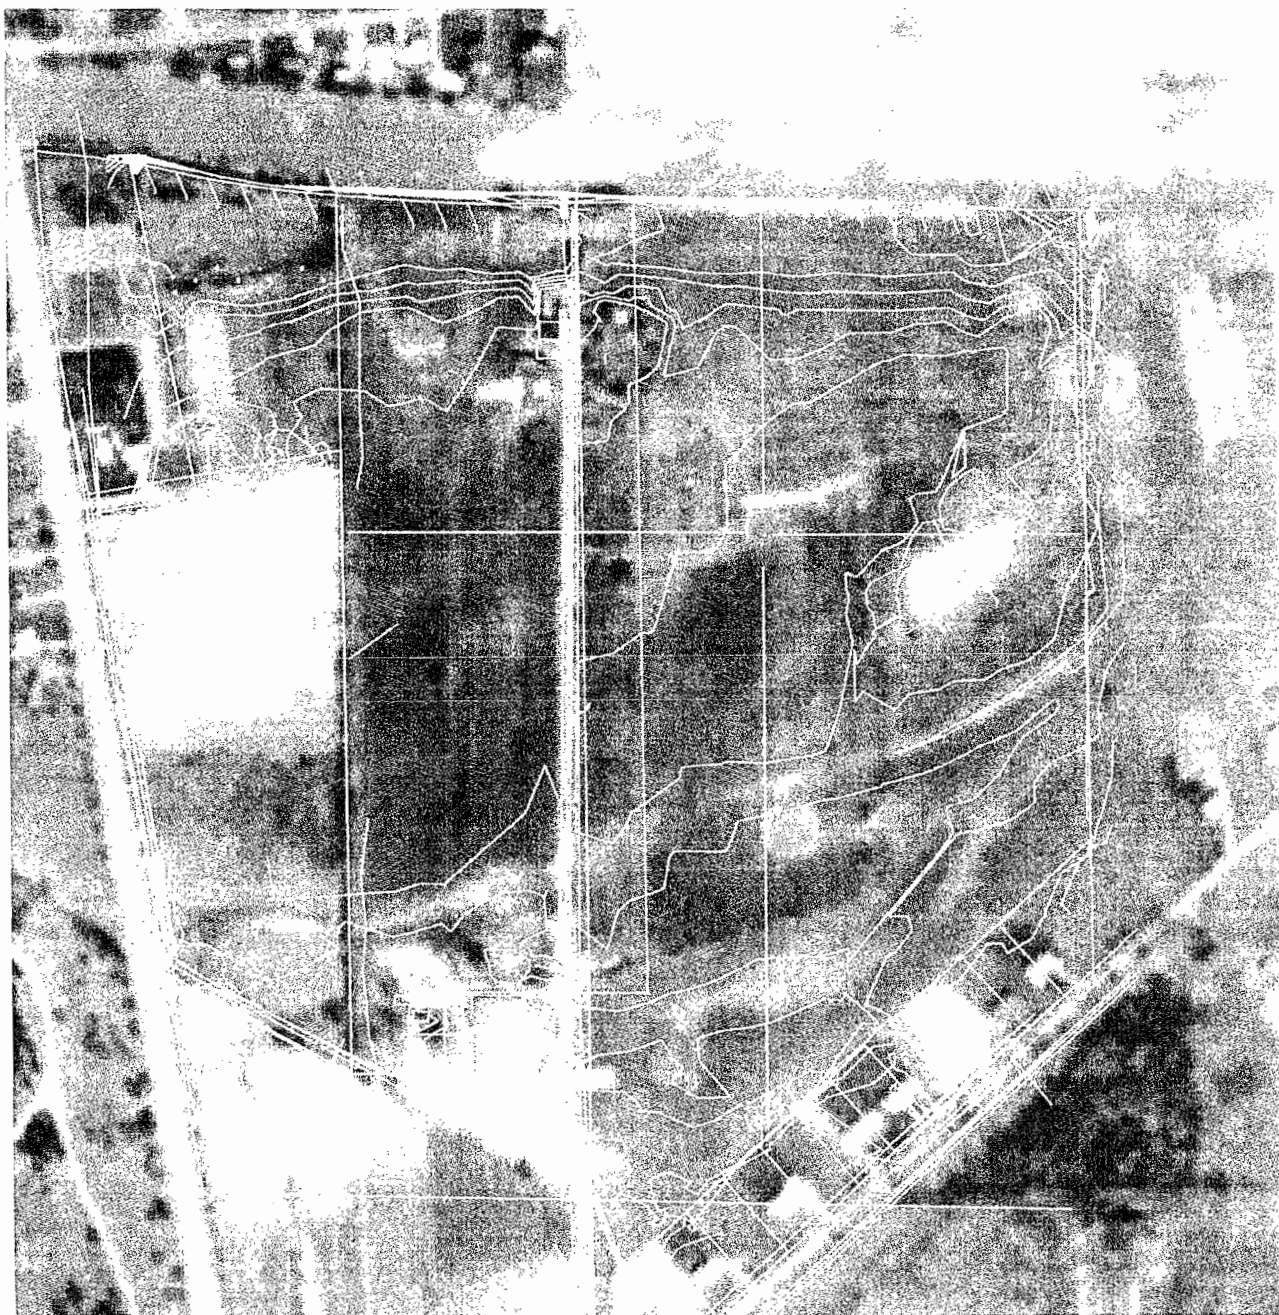
Figure 5 1963 Site Map

USGS Aerial Photograph 05/07/1963

3. Soil probes DP-9 through DP-13 were advanced on a mound in the center of the northern third of the property that a garage and equipment affiliated with the golf course operations is located. The mound was observed during Phase II ESA field activities and is also indicated on Figures 3 through 5. According to Figures 4 and 5 this fill mound is also associated with historic structures on the property including the current garage, former farm house and former outbuildings. According to Town of Amherst records (Section 10.1) the farm house burned in approximately 1982. North of the garage, soil probe DP-13 encountered refusal at 4.5 ftbg. This would generally indicate the potential for an abandoned petroleum underground storage tank (UST), but according to Gulf Course grounds personnel there was a former underground pool that was abandoned in the vicinity. This suggestion is reinforced by Town of Amherst records that report a steel pool formerly on the property associated with the former house and garage. Soil probes DP-9 and DP-13 have between six inches and five feet of brown silt and sand and fine to medium angular gravel fill that is consistent with the topographic mound in the center of the northern third of the property indicated by Figures 3 through 6. This suggests that prior to the construction of the historic buildings indicated by Figure 4, angular gravel with variable quantities of silt and sand was brought onto the property to raise the elevation. No discoloration or odors were observed associated with this fill and it is not considered a REC for the property.

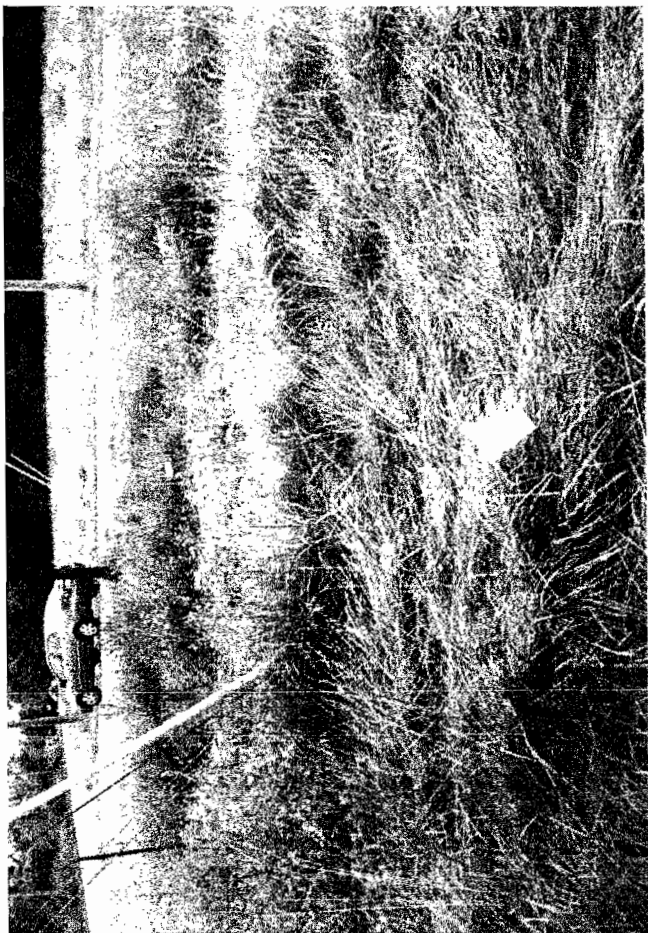
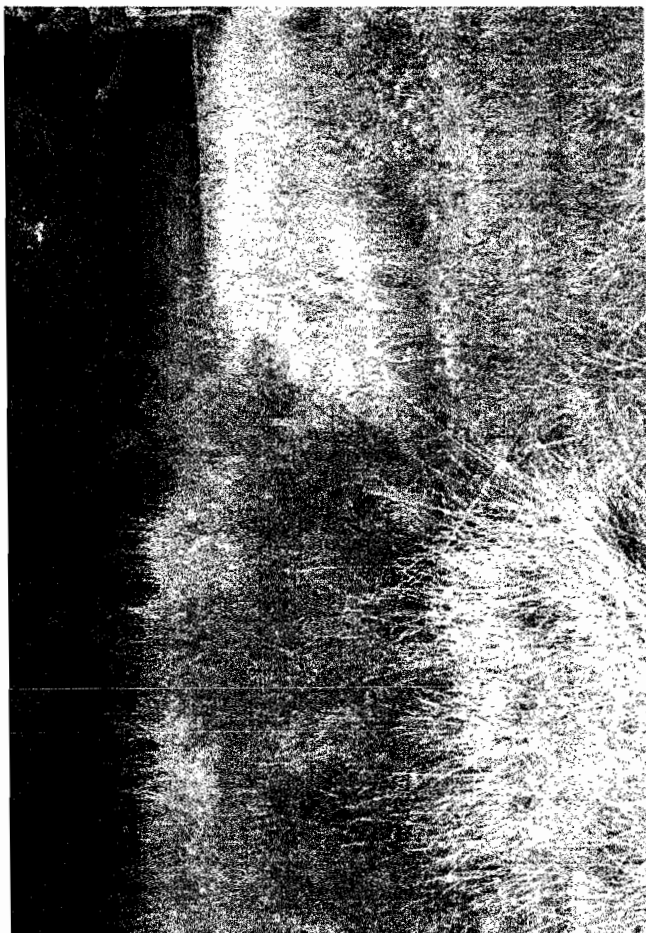
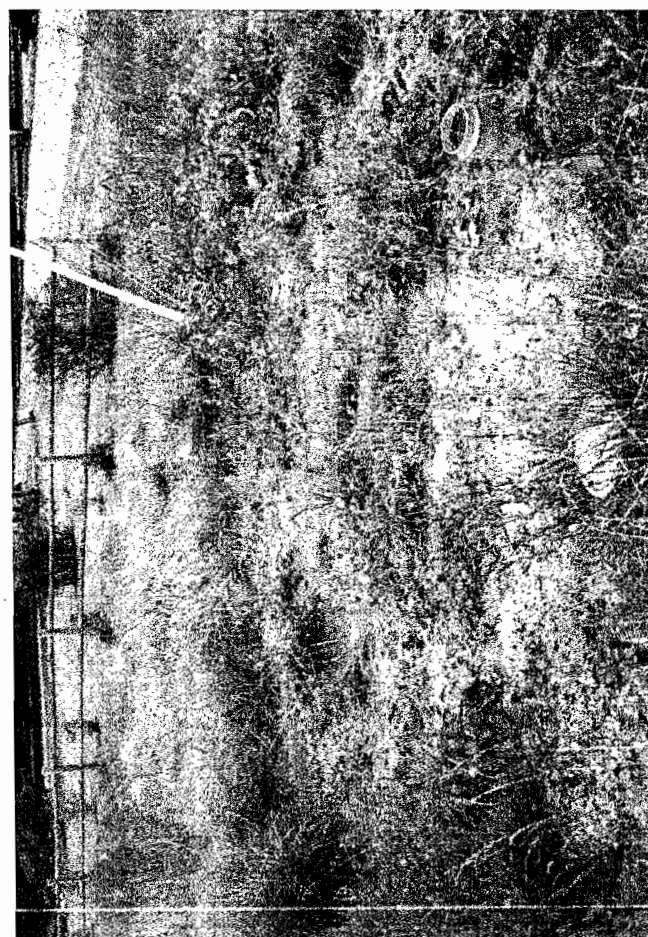
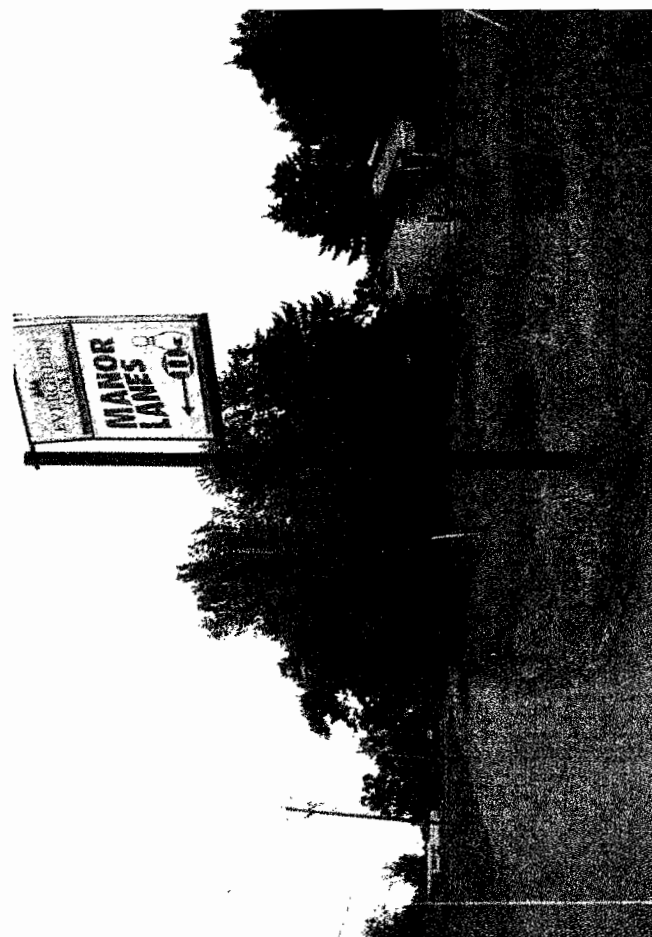
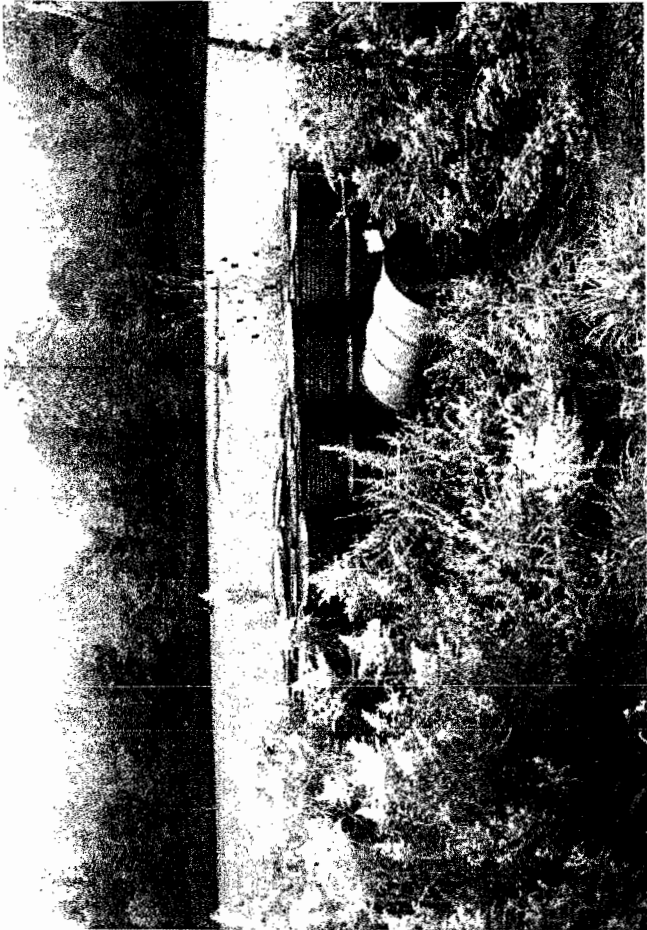
On September 6 and 7, 2011, B&A oversaw Phase II ESA activities on the property (Figures 1 and 2). Twenty-four soil probes were advanced with a direct push soil sampler to depths ranging from four to 30 feet below grade (ftbg). One petroleum above ground storage tank (AST) was observed in the vicinity of the garage. Soil probe locations are shown on Figure 2. This AST was apparently utilized to fuel vehicles associated with golf course operations. Property photographs are included following Figure 6.
