ENGINEERING INVESTIGATIONS AT INACTIVE HAZARDOUS WASTE SITES

PHASE I INVESTIGATIONS

**CENTRAL AUTO WRECKING, SITE NUMBER 915125
CITY OF LACKAWANNA, ERIE COUNTY**

September 1989

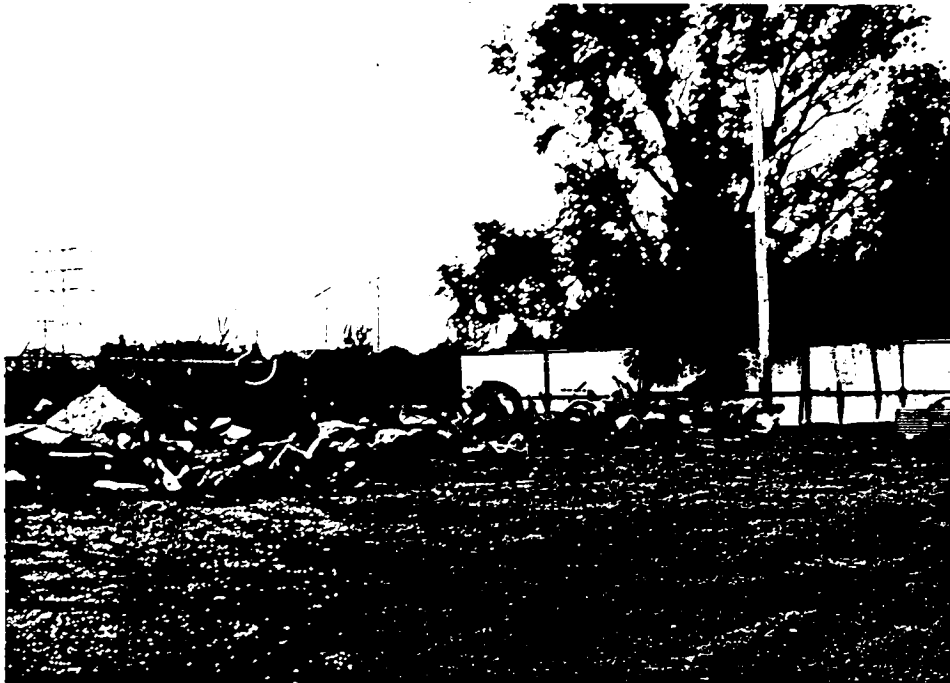
Photographer: P. Gunther
Date/Time: 9/17/87; 10:30
Lens: Type: 50 mm
SN: _____
Frame No.: 1
Comments*: Southeast corner
of property of Central Auto
Wrecking. Debris is of
automobile parts.

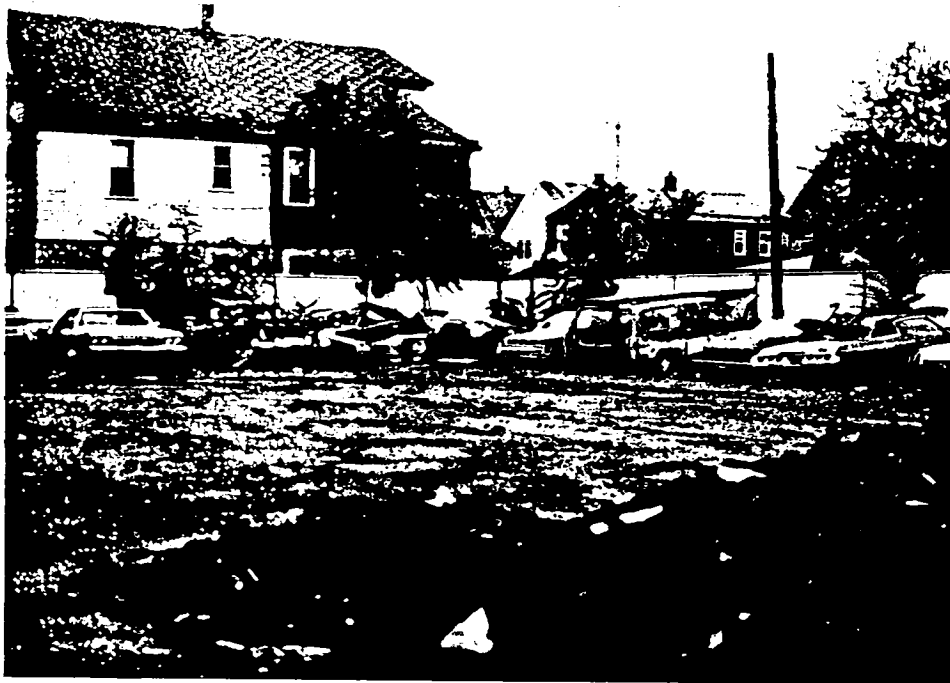
Photographer: P. Gunther
Date/Time: 9/17/87; 10:30
Lens: Type: 50 mm
SN: _____
Frame No.: 2
Comments*: Southwest corner
of Central Auto Wrecking
property. In the foreground
is asphalt for building
foundation.

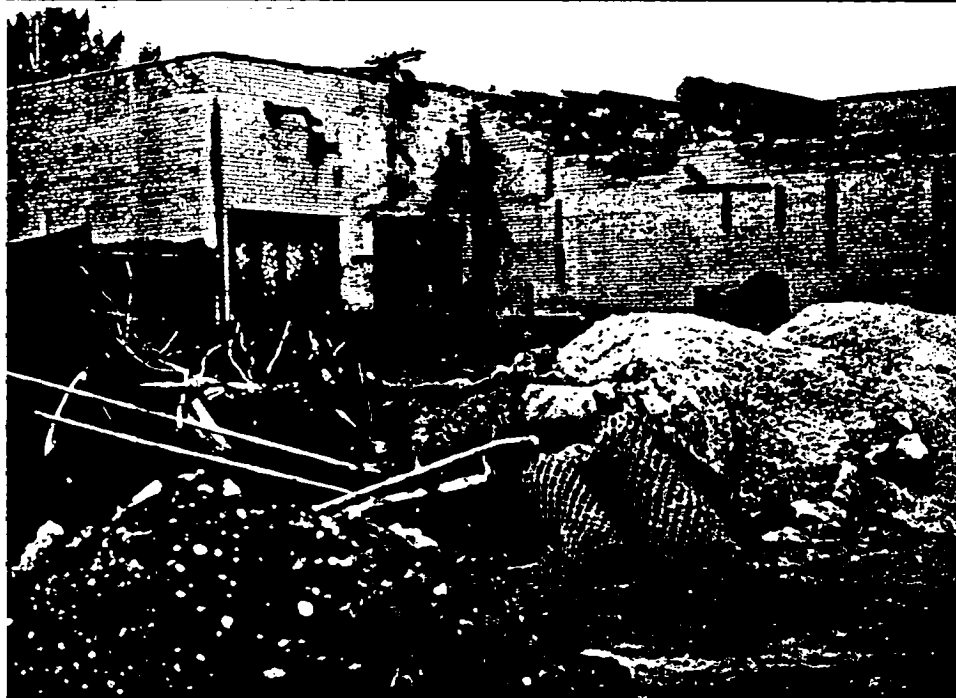
Photographer: P. Gunther
Date/Time: 9/17/87; 10:30
Lens: Type: 50 mm
SN: _____
Frame No.: 3
Comments*: Demolition
debris at the property site
of Central Auto Wrecking
(west side).

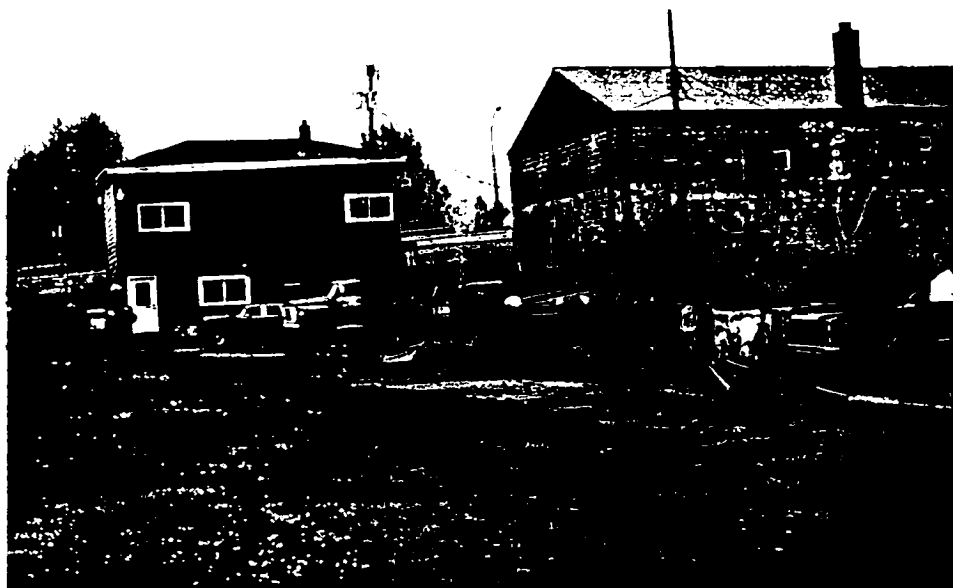
Photographer: P. Gunther
Date/Time: 9/17/87; 10:30
Lens: Type: 50 mm
SN: _____
Frame No.: 4
Comments*: Northeast corner
of Central Auto Wrecking
property. Grey building is
on Stanley G. Tomaka's land.

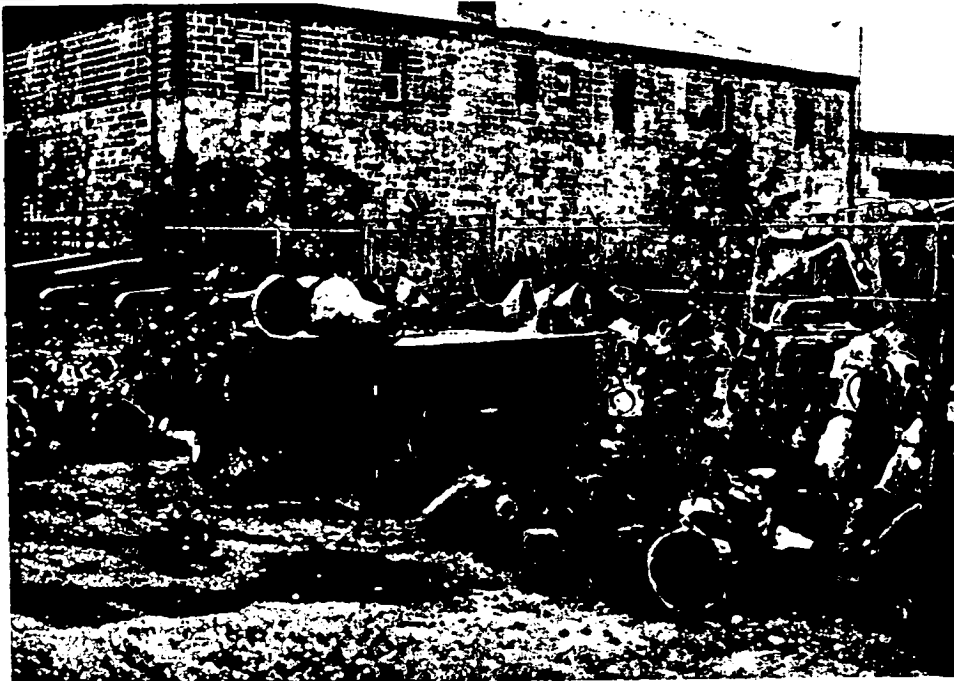
Photographer: P. Gunther
Date/Time: 9/17/87; 10:30
Lens: Type: 50 mm
SN: _____
Frame No.: 5
Comments*: Eastern end of
Central Auto Wrecking yard
where transmissions are
stored.

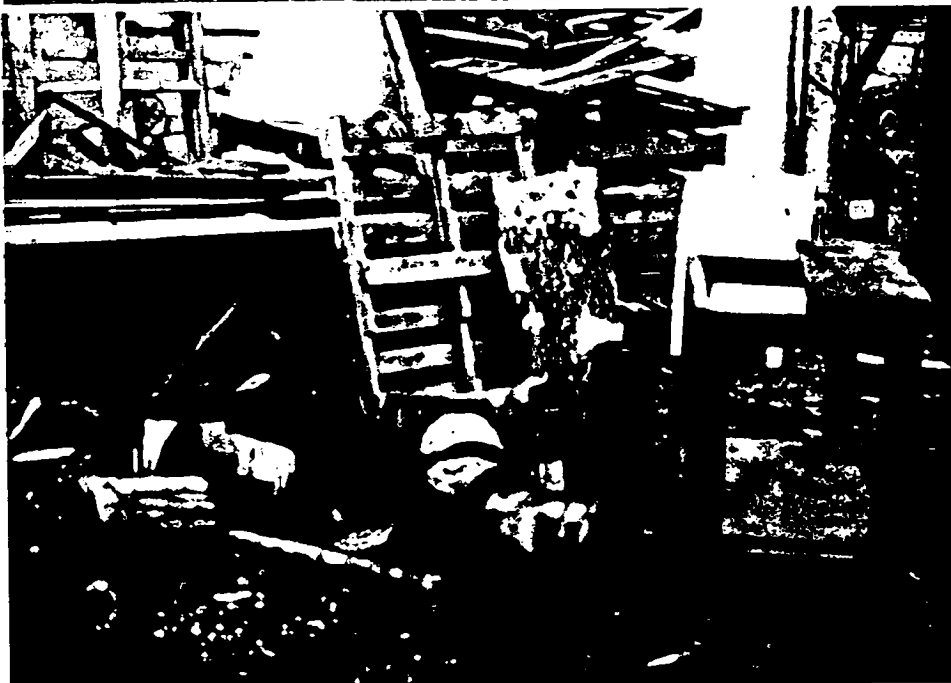
Photographer: P. Gunther
Date/Time: 9/17/87; 10:30
Lens: Type: 50 mm
SN: _____
Frame No.: 6
Comments*: Northwestern end
of Central Auto Wrecking
yard, where roofing material
cans were placed.

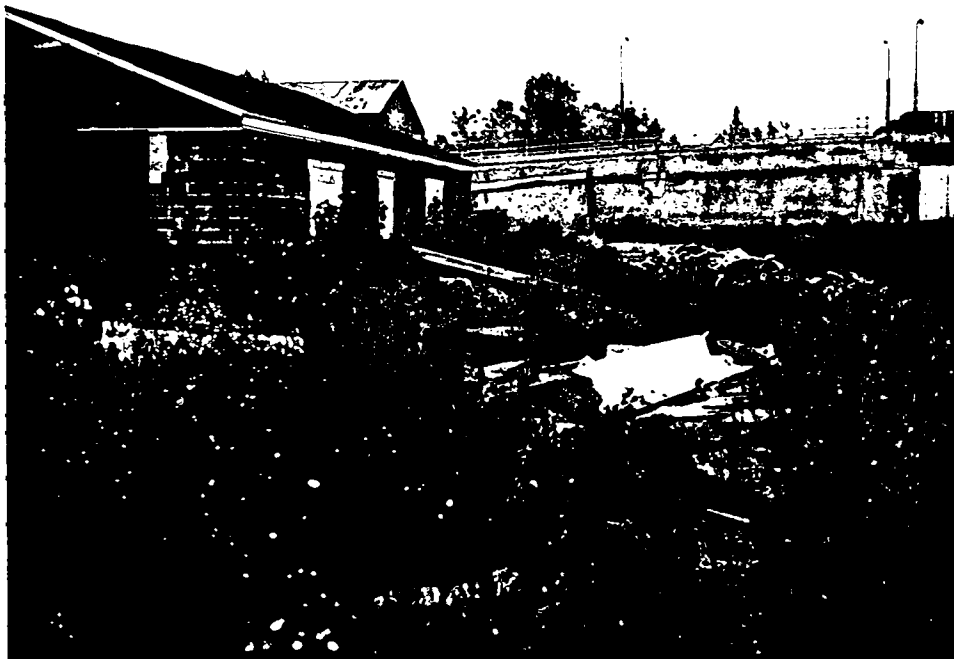
Frame No.: 7

Comments*: North section of
Tomaka property with
scattered demolition debris.

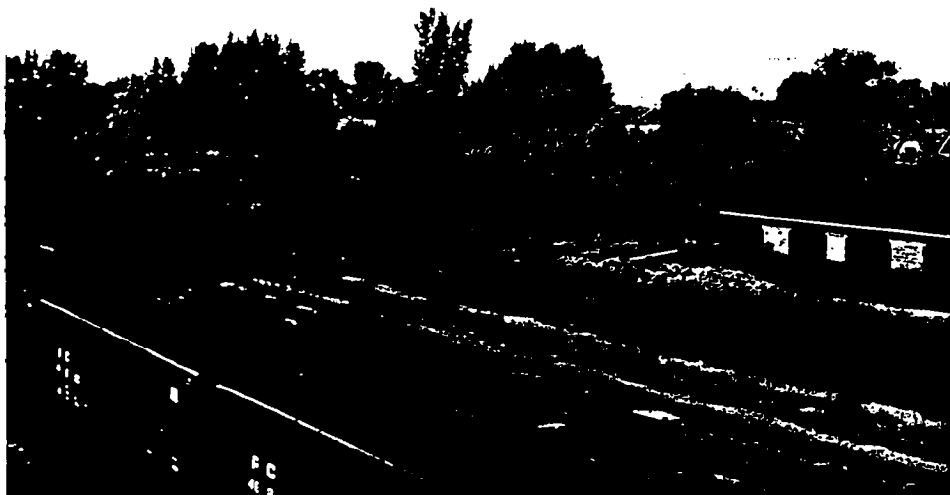
Conrail railroad tracks -

southern end of property.

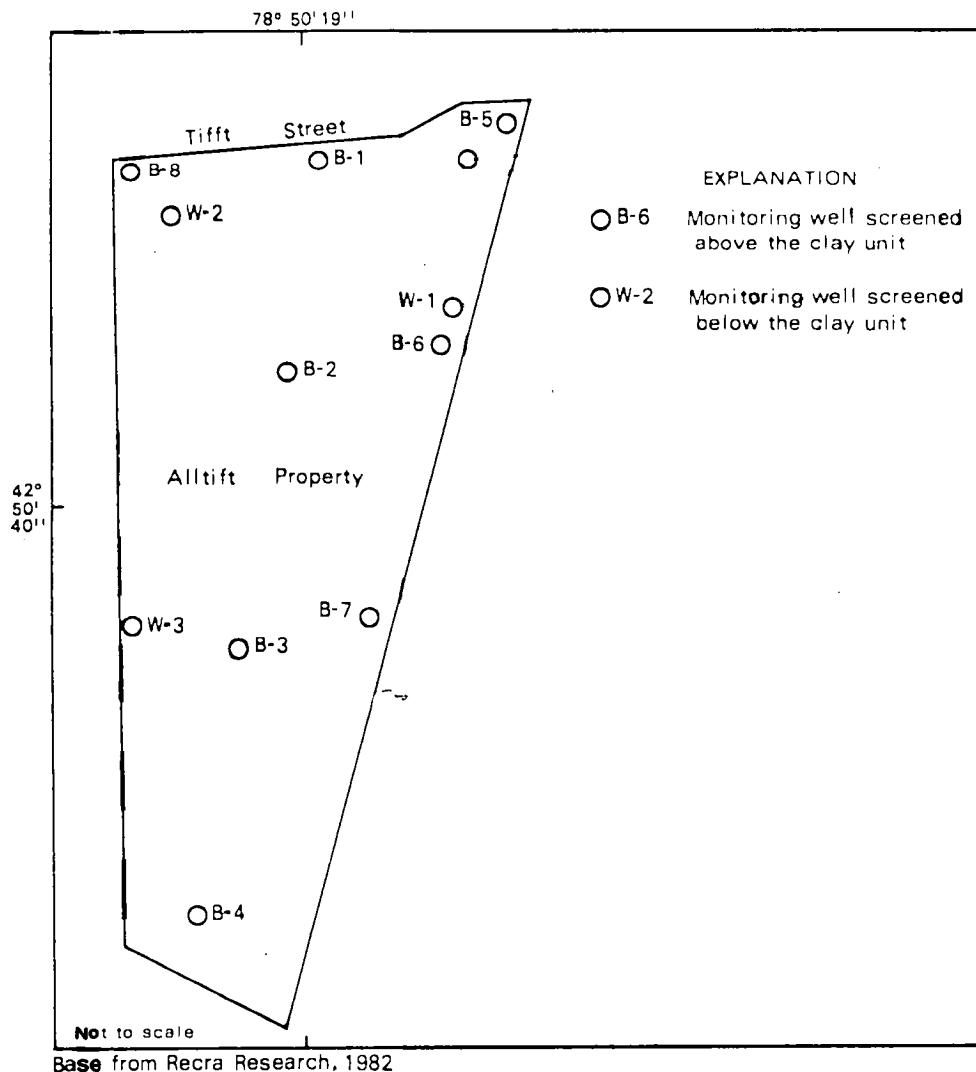
Figure A-12. Location of sampling holes at Alltift Landfill, site 162, Buffalo.

The landfill was inactive from the early 1970's to the late 1970's. Since then it has been used for the disposal of auto-demolition shredder waste, core sands, fly ash, and sand waste at a rate of 40,000 to 60,000 yd³/yr. The disposal area is now in the northern third of the site (fig. A-12).
