ENGINEERING INVESTIGATIONS AT INACTIVE HAZARDOUS WASTE SITES IN THE STATE OF NEW YORK

PHASE II INVESTIGATIONS

**Old Land Reclamation
Site No. 915129
Village of Depew, Erie County**

March 1991

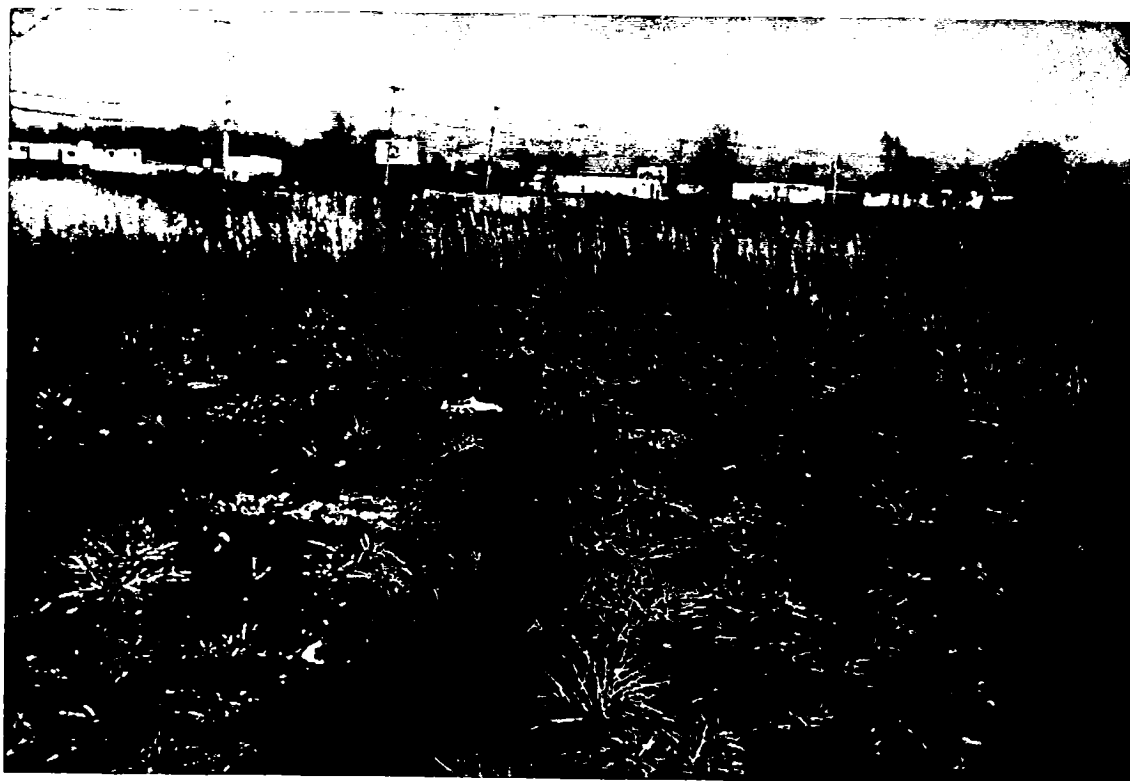
Lens: Type 50mm SN: N/A Frame No.: 2

Comments: Old Land Reclamation landfill. View of groundwater monitoring wells 2A (right) and 2B (left). Monitoring well 2A is an open bedrock completion. Monitoring well 2B is completed in overburden material.

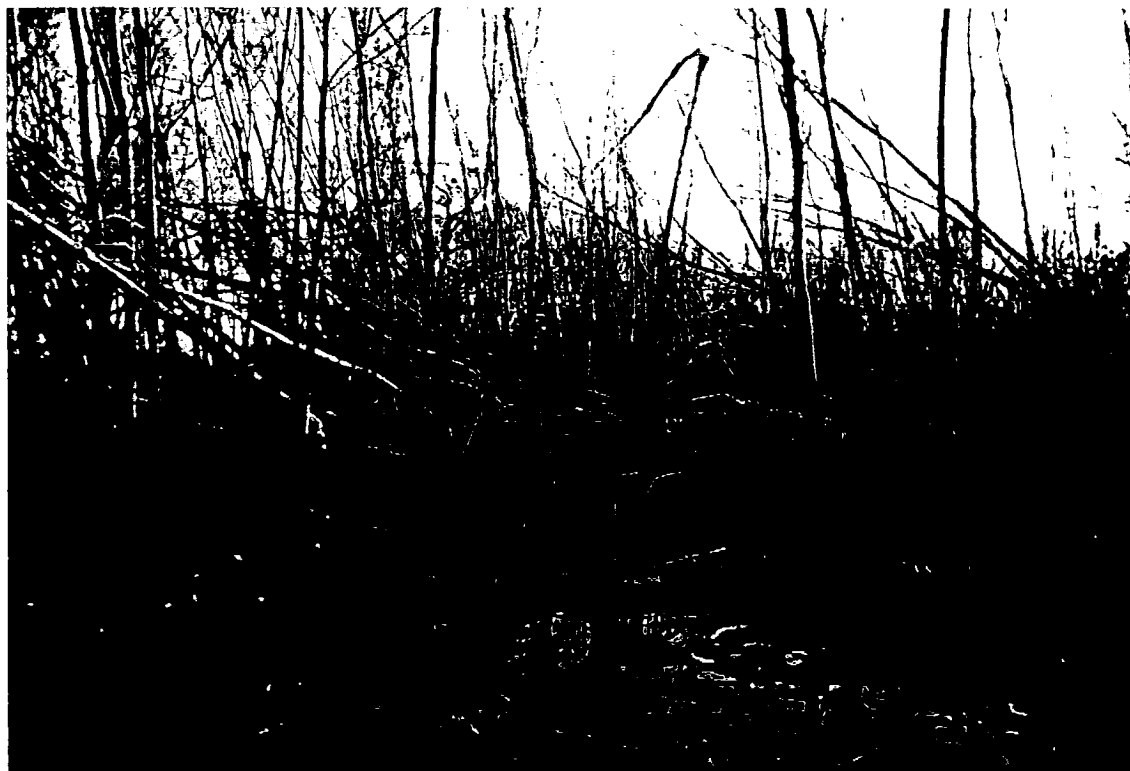
Lens: Type 50mm SN: N/A Frame No.: 4

Comments: Old Land Reclamation landfill. View of groundwater monitoring well 6A on the north bank of the Cayuga Creek floodplain. Monitoring well 6A is an open bedrock completion.
