# ENGINEERING INVESTIGATIONS AT INACTIVE HAZARDOUS WASTE SITES

## PHASE I INVESTIGATION

LSB WAREHOUSING, SITE NUMBER: 915132  
TOWN OF HAMBURG, ERIE COUNTY

September 1989

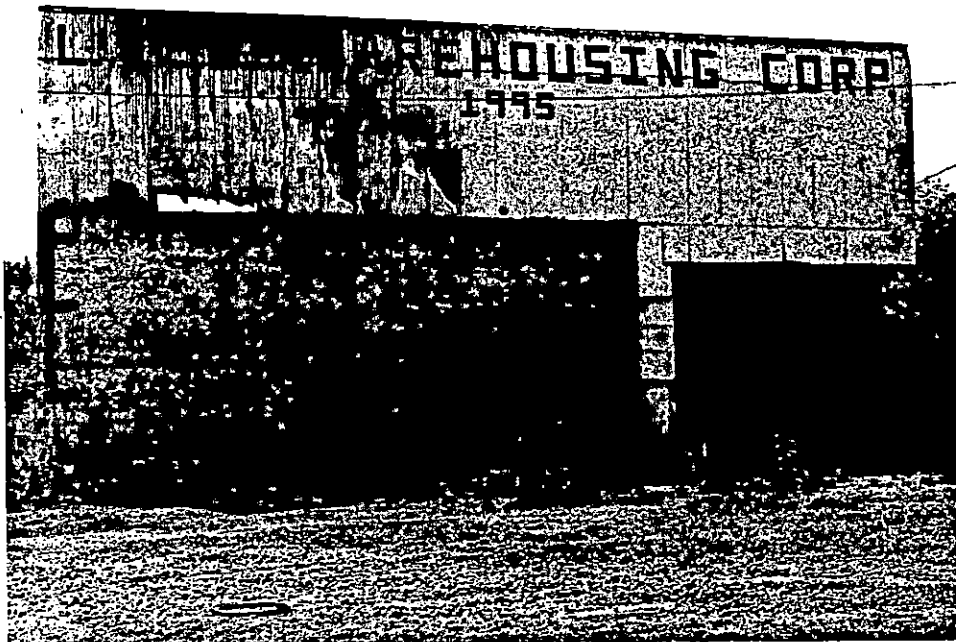
Frame No.: 8

Comments\*: Front of aban-  
doned LSB Warehouse on  
Electric Avenue.

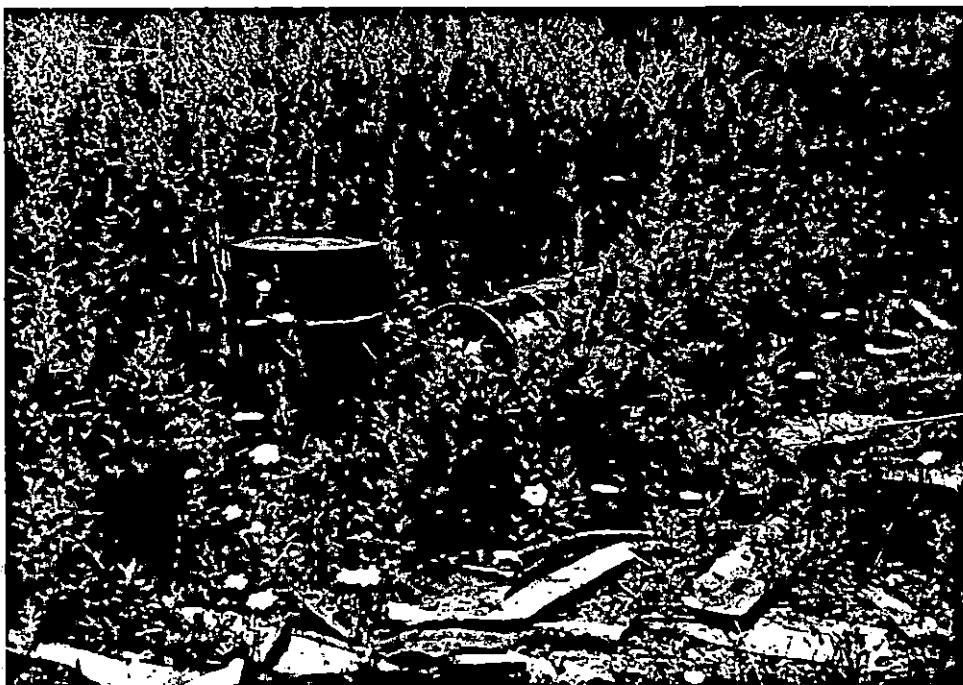
Two drums and household debris were observed by E & E employees during the site inspection of the LSB Warehousing site. The two drums were labeled Elastigun Roof Coating (not considered to be toxic). The warehouse was abandoned and empty except for small scattered debris. Furniture, wood, metal trash, used tires, and abandoned cars were found behind the onsite warehouse. There was a steep embankment at the far eastern end of the property site that was not investigated because of safety reasons. This area was overgrown with weeds and wetland vegetation up to 5 feet in height. The tanker previously seen by ECDEP in 1986 was not observed by E & E, nor was it located by employees of Manufacturers Hanover Trust Company (current owner) who conducted an independent walk-over of the site during summer 1987. There was no visual observation of hazardous materials on site.

Photographer: G. Fiorentino  
Date/Time: 7/29/87/ 15:46  
Lens: Type: 50 mm; 1:1.7  
SN: 2792181  
Frame No.: 13  
Comments\*: Two drums label-  
led "Elastigum Roof Coating  
54 gal," and metal debris.
