**Supplemental Site Investigation and Closure Report for Ameron Site,**

**Site no. 915133- June 2004**

**111 Colgate Avenue, Buffalo, New York**

**AFI Project No. R1015**

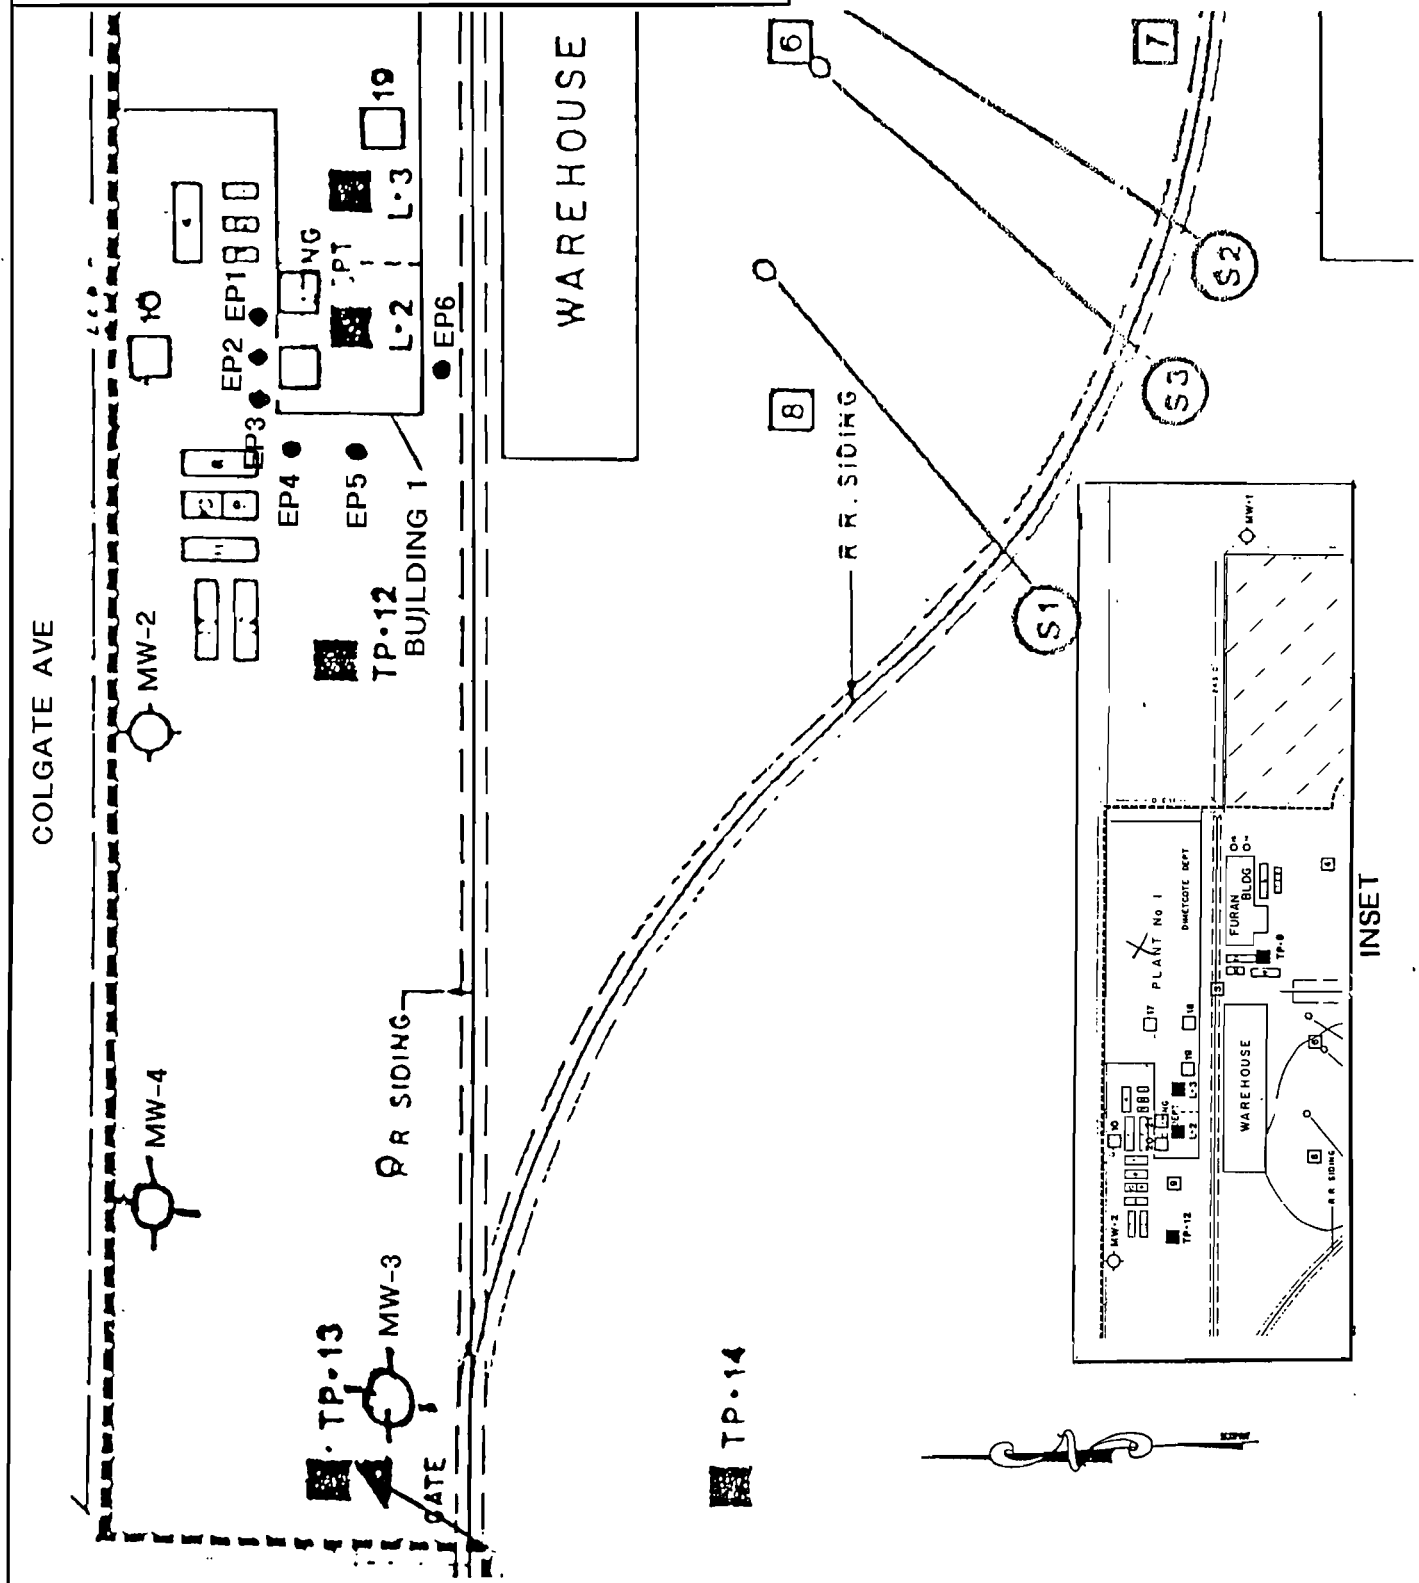
SITE MAP

On June 2, 2004, a total of four (4) soil borings (SB#1-4) were completed by AFI and their subcontractors, C&W Environmental, to a maximum depth of 8.0 feet below ground surface (BGS). Each of these borings were positioned, near the paint tanks, so as to determine soil conditions, beneath the concrete floor, and to identify the possible presence of subsurface contamination inside the treatment building (building #1) at the Ameron Site located at 111 Colgate Avenue, Buffalo, New York. See Figure 1 for boring locations.

SOIL BORING/MONITORING WELL LOCATIONS

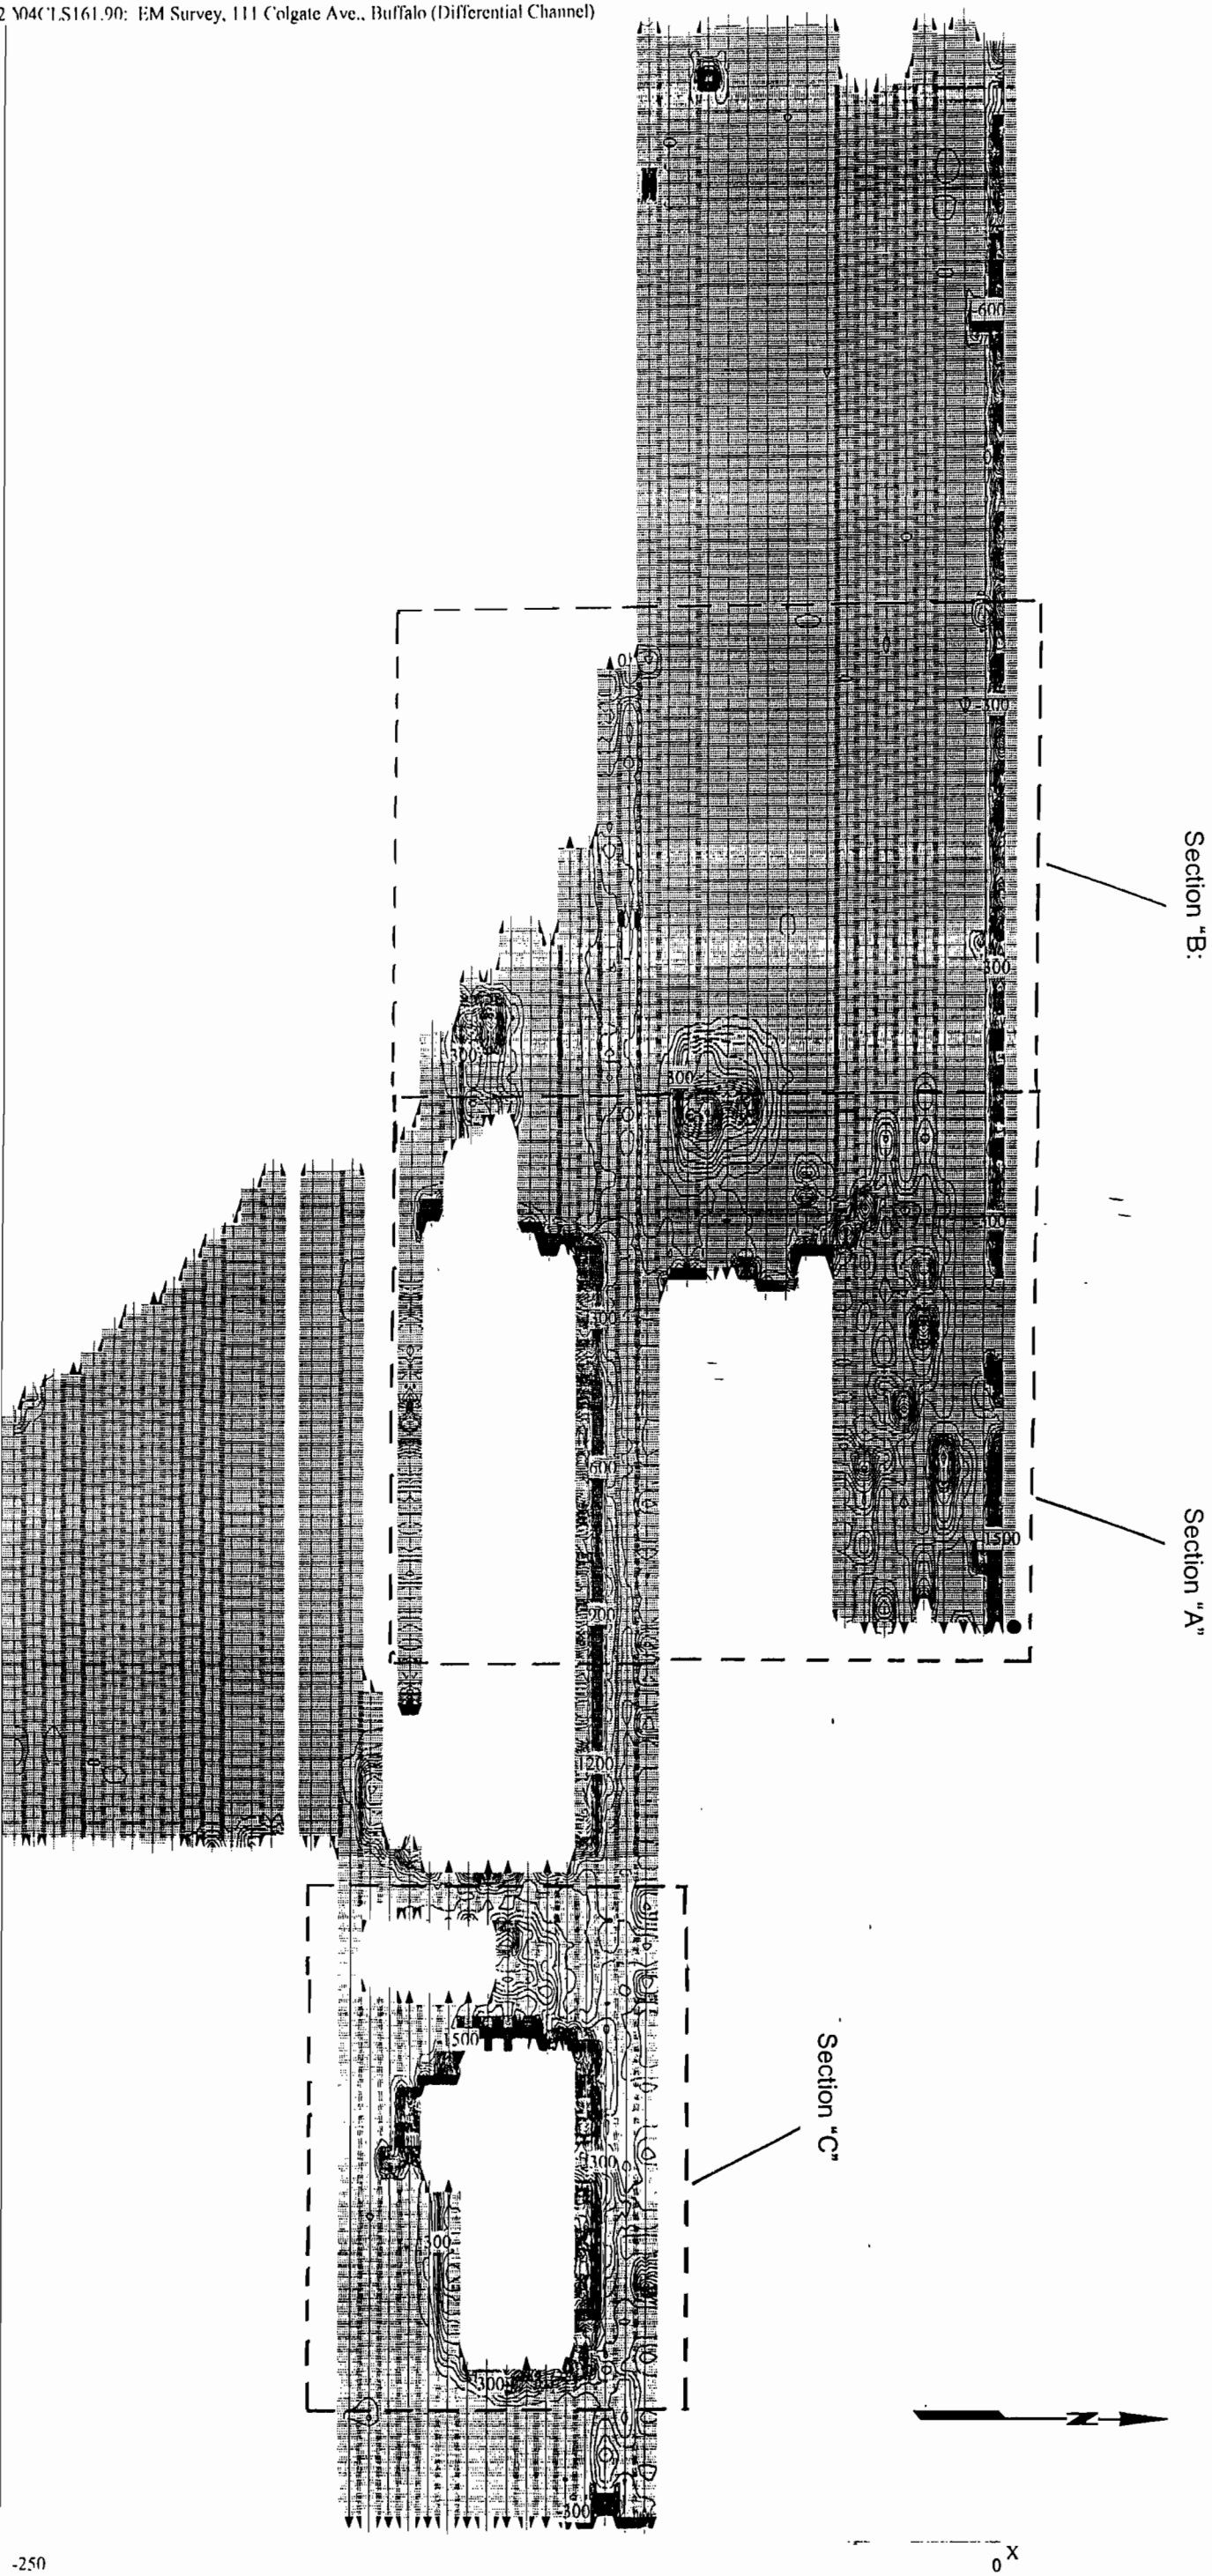
Based on the results of the EM-61 Magnetometer Survey, seventeen (17) anomalies were detected. Twelve (12) are suspected to be UST and the additional five (5) are unknown. See the EM-61 Magnetometer Survey attached as Appendix C.

Construction Lending Services, Inc. P.O. Box 272 Buffalo, New York 14205	EM-61 (Magnetometer) Survey--Section Plan Former Ameron Facility 111 Colgate Avenue, Buffalo, NY
Project No.: 04CLS161.90 Date: 06/07/2004	Differential Channel Data -- Plan View Contour Interval = 300 millivolts

I recommend that the site be removed from the NYSDEC's Registry of Inactive Hazardous Waste Sites site No. 915133 and be closed in respect to the target chemicals of concern; AFI also recommends that a NYSDEC Spill number be issued for the site and that all USTs and potential USTs (identified via magnetometer) be excavated, pumped dry, exhumed and that the tank farm be properly closed under the newly assigned NYSDEC Spill Number. The owner must consider excavation and proper disposal of any petroleum contaminated soils resulting from possible tank leakage. Additional soil sampling will be warranted to document proper UST closure according to NYSDEC Spill Regulations.

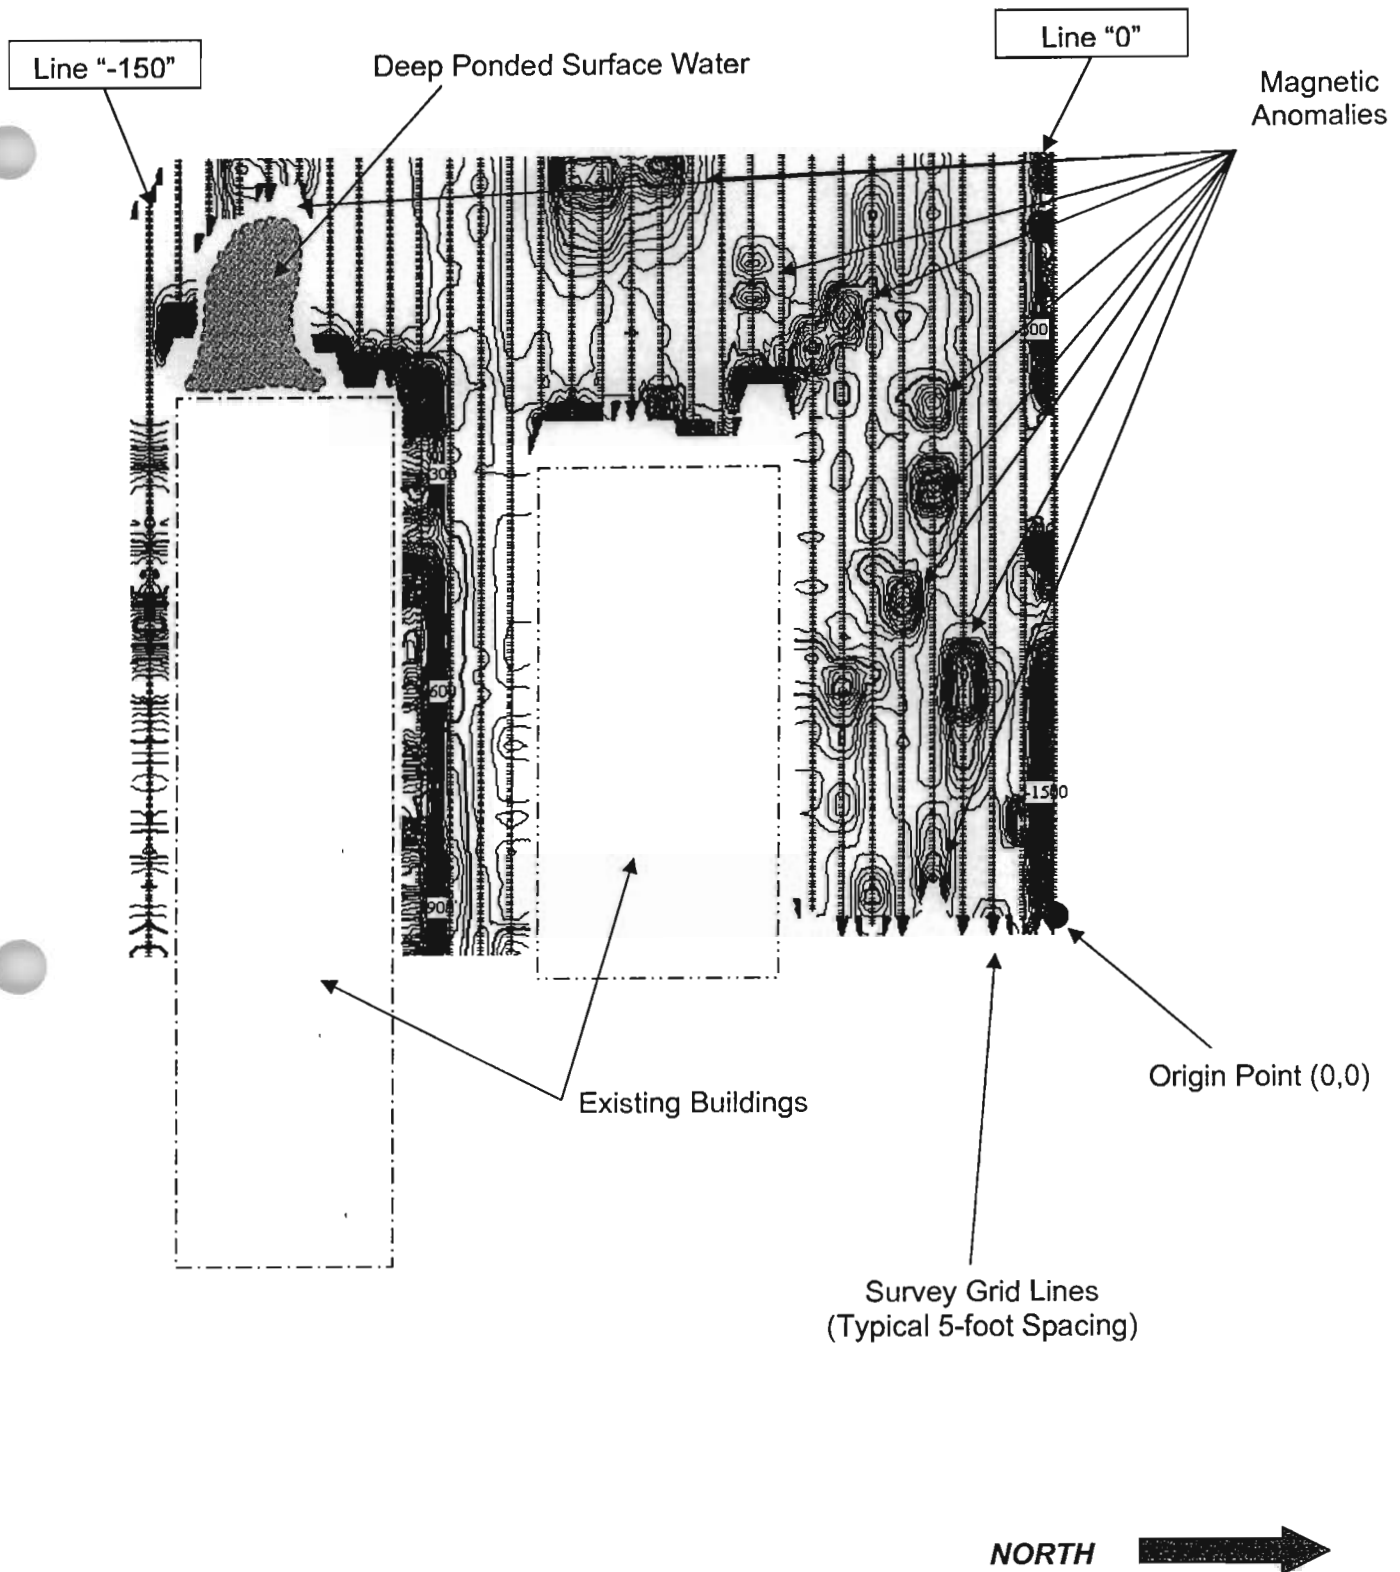
Construction Lending Services, Inc. P.O. Box 272 Buffalo, New York 14205	EM-61 (Magnetometer) Survey – Section "A" Former Ameron Facility 111 Colgate Avenue, Buffalo, NY
Project No.: 04CLS161.90 Date: 06/07/2004	Differential Channel Data – Plan View Contour Interval = 300 millivolts

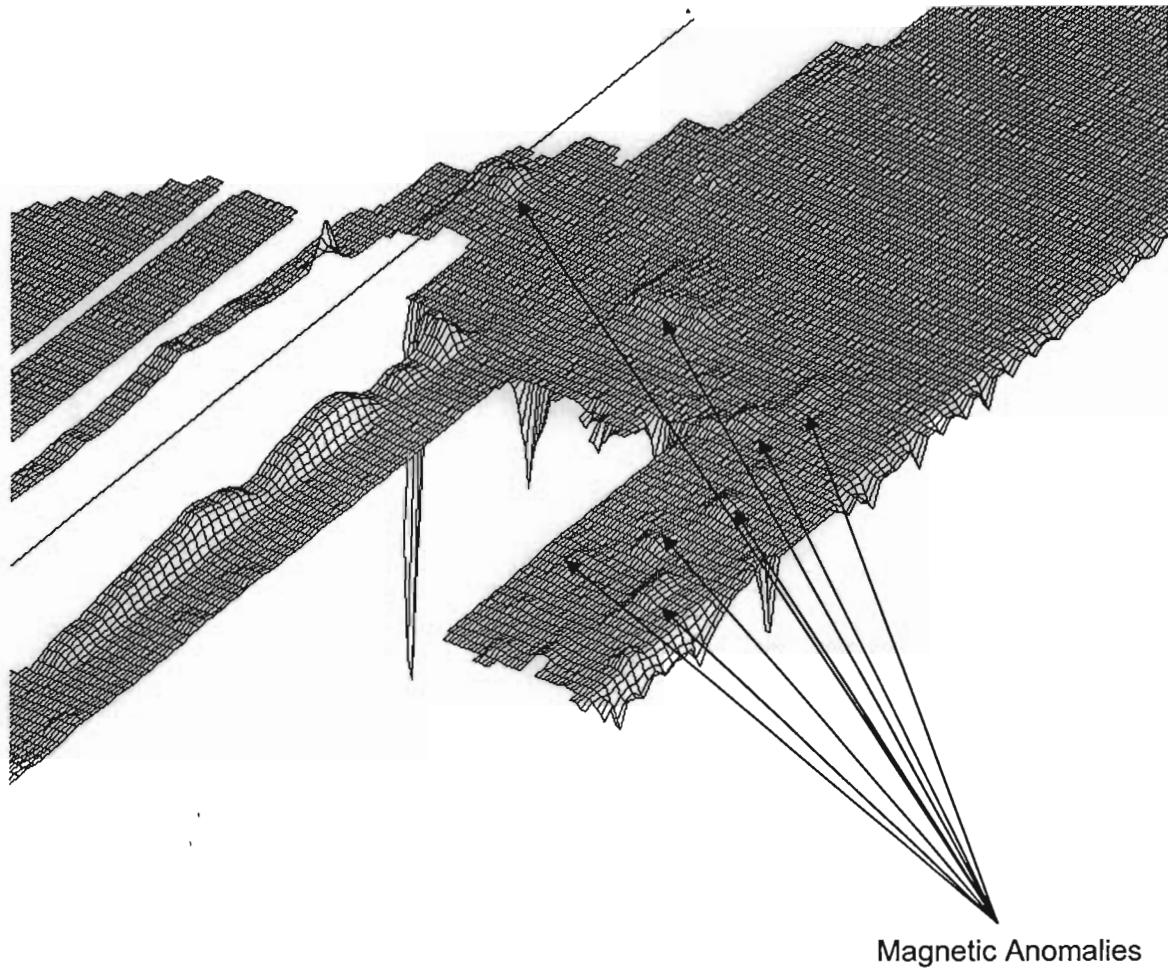
Differential Channel Data – 3D View  
Angle of Viewing: a=35, e=35

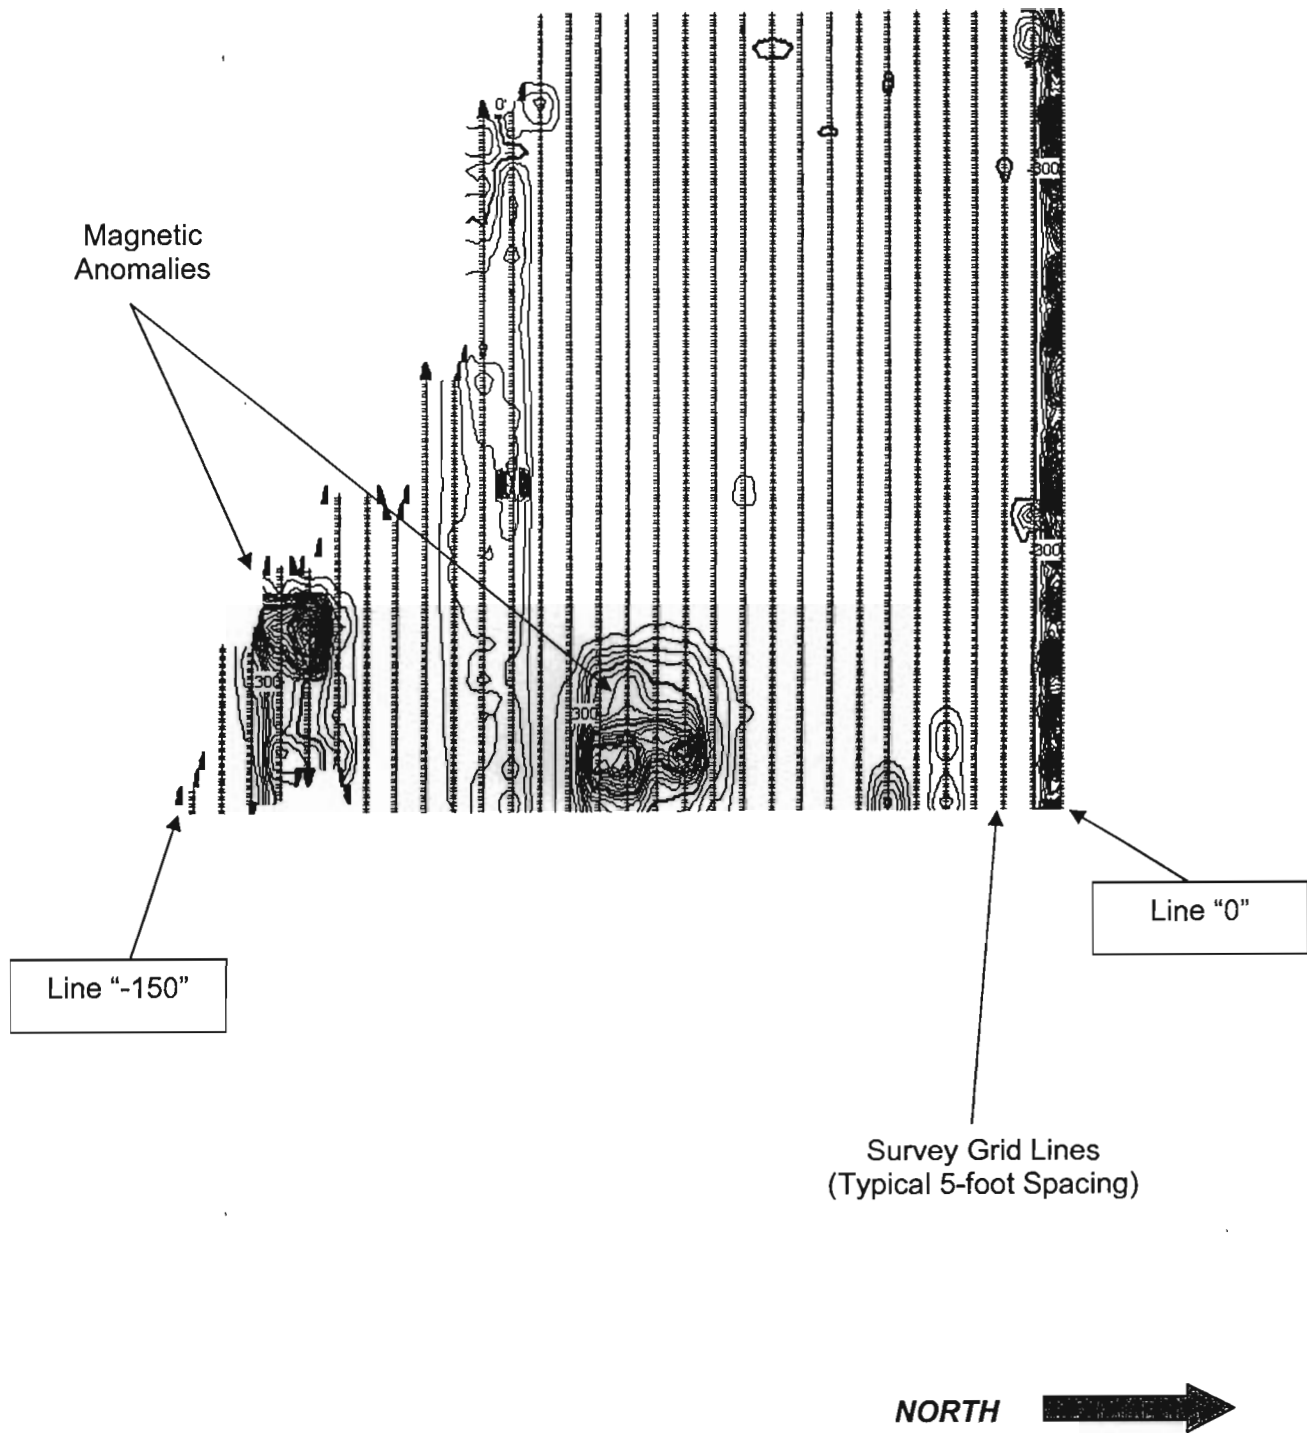
Construction Lending Services, Inc. P.O. Box 272 Buffalo, New York 14205	EM-61 (Magnetometer) Survey – Section "B" Former Ameron Facility 111 Colgate Avenue, Buffalo, NY
Project No.: 04CLS161.90 Date: 06/07/2004	Differential Channel Data – Plan View Contour Interval = 300 milliVolts

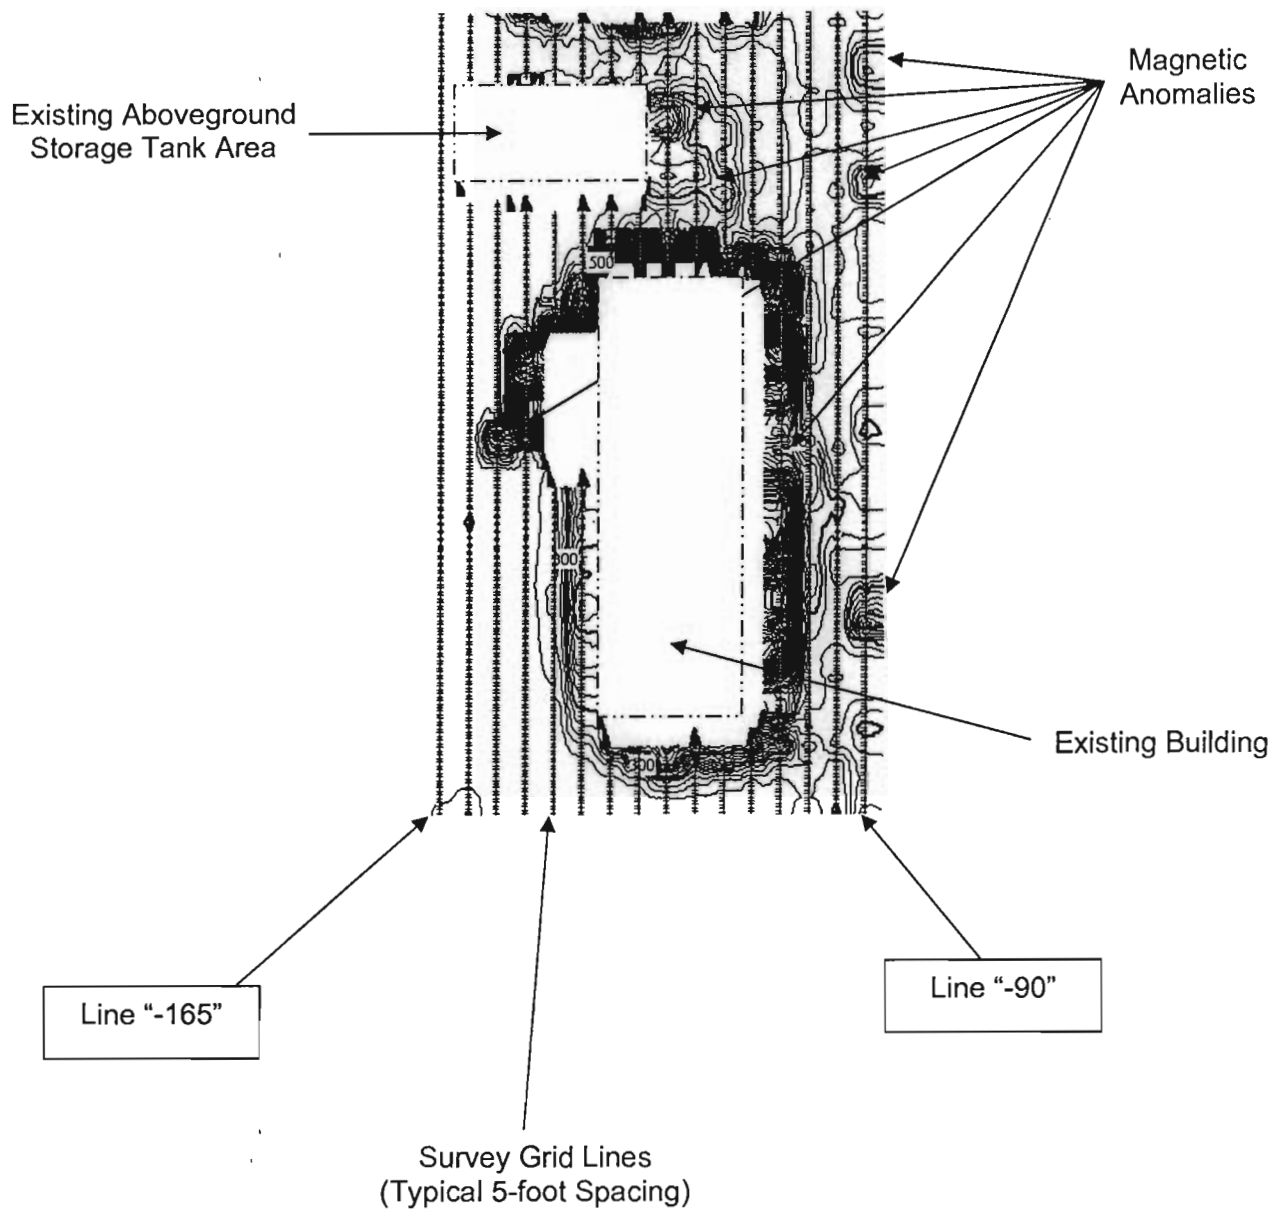
<p>Construction Lending Services, Inc.  P.O. Box 272  Buffalo, New York 14205</p>	<p>EM-61 (Magnetometer) Survey—Section "C"  Former Ameron Facility  111 Colgate Avenue, Buffalo, NY</p>
<p>Project No.: 04CLS161.90  Date: 06/07/2004</p>	<p>Differential Channel Data – Plan View  Contour Interval = 300 milliVolts</p>

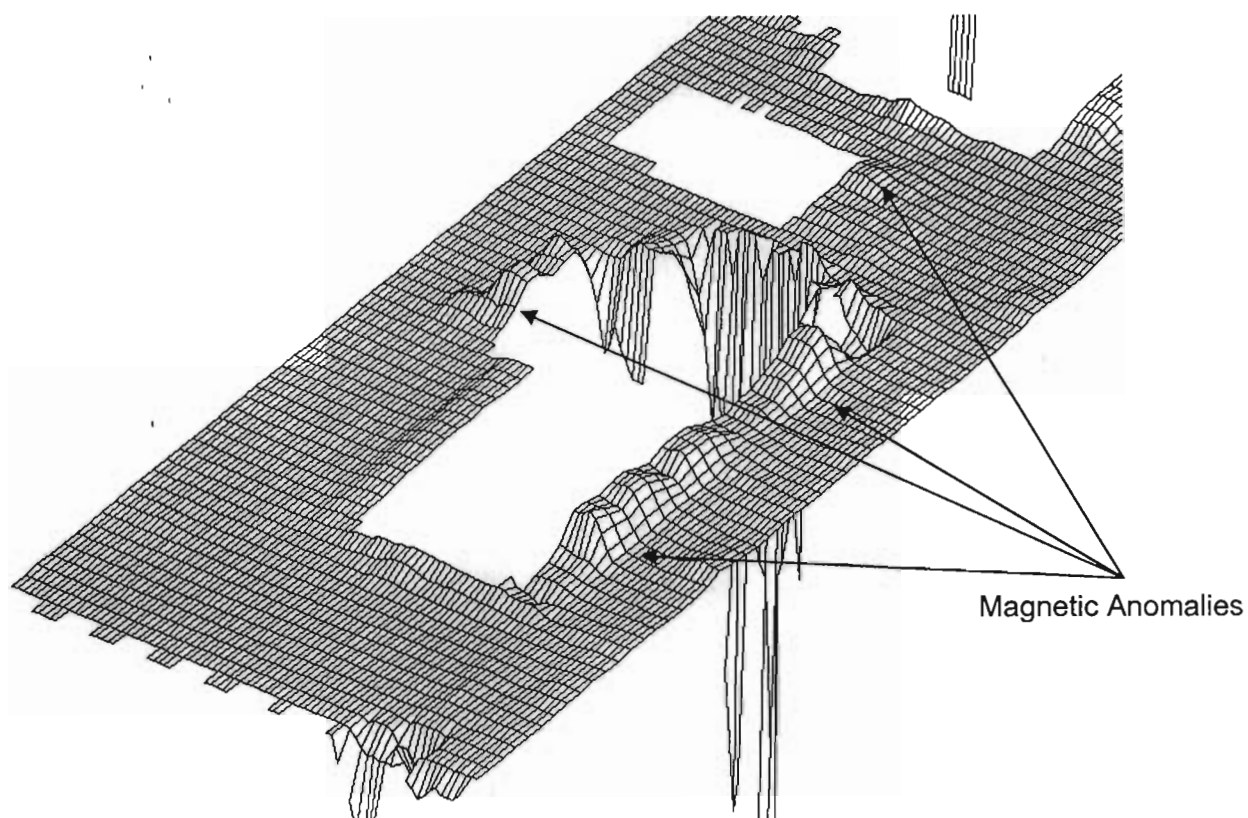
<b>Construction Lending Services, Inc.</b> <b>P.O. Box 272</b> <b>Buffalo, New York 14205</b>	<b>EM-61 (Magnetometer) Survey – Section “C”</b> <b>Former Ameron Facility</b> <b>111 Colgate Avenue, Buffalo, NY</b>
<b>Project No.: 04CLS161.90</b> <b>Date: 06/07/2004</b>	<b>Differential Channel Data – 3D View</b> <b>Angle of Viewing: a=35, e=35</b>
