2020 PERIODIC REVIEW REPORT

Bern Metal Corporation NYSDEC ID: 915135

LiRo Engineers, Inc. (LiRo) has prepared this Periodic Review Report (PRR) on behalf of the City of Buffalo (COB) to summarize the post remedial status of the New York State Department of Environmental Conservation (NYSDEC) Brownfield Cleanup Program (BCP) Site No. 915135, located at 22 Bender Street in the City of Buffalo, Erie County, New York ("Site"; see Figure 1).

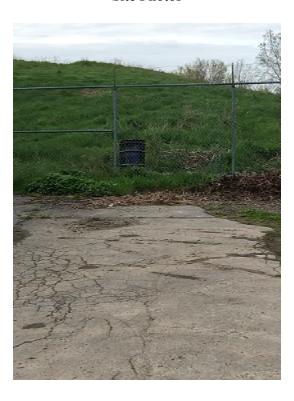
Photo No. 1 – Nearly empty drum to be removed from site.

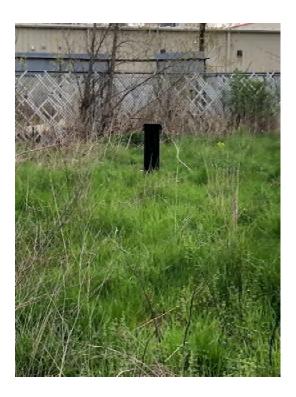
All five Site monitoring wells were found to be in good condition. A new steel lockable pro-casing was installed at RD-3/RD-3R in January of 2020.

Photo No. 2 – Monitoring well RD-3/RD-3R with new protective casing and repaired PVC riser.

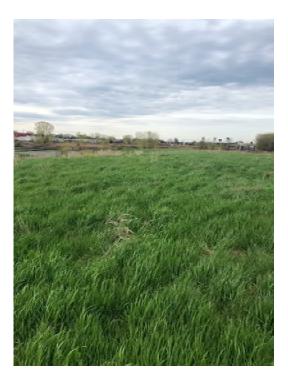
During the inspection of the final cover system, one inactive rodent burrow was found in the southern side of the landfill between RD-1 and RD-2. The vegetative cover was found to have substantial overgrowth. Erosion, vehicle ruts, ponding water, tree and brush growth and protruding objects were not observed.

Photo No. 3 – View of vegetative growth on top of landfill.

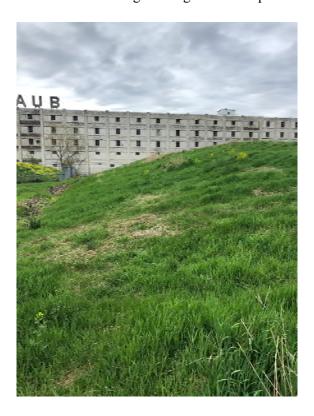
During the inspection of the stormwater drainage system, Japanese Knotweed and shrub roots were observed within the perimeter drainage ditch. The vegetation has been cut down and there is no evidence of blockage in the ditch.

Photo No. 4 – View of Northern side of Landfill and drainage swale.

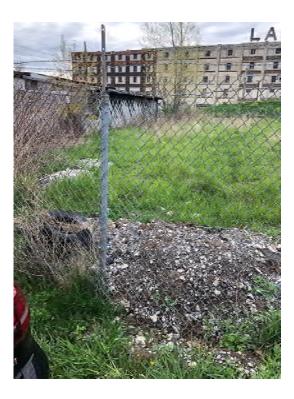
Photo No. 5 – View of repaired breeching in fence

During the inspection a breech was observed in the perimeter fence near RD-2. The breech in the fence was repaired by the City of Buffalo on May 20, 2020.

- Animal burrow backfilled with soil; and,
- The breech of the Site perimeter fencing has been repaired.

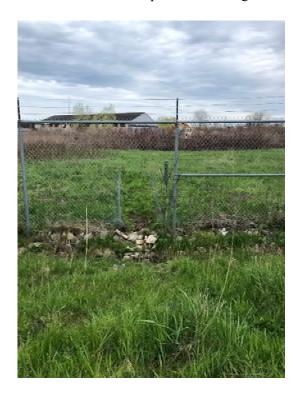
Photo No. 6 – View of breeching in fence at RD-2

- Site inspections should continue to be performed annually during the spring and prior to end of the next certifying period;
- Groundwater monitoring should be performed during the certifying period ending in May 2022, as approved by NYSDEC;
- Breech in the perimeter fencing should be repaired (completed as noted below)
- The vegetative cover on the landfill cap should be moved annually;
- Baiting and trapping for rodent control should be initiated each spring;
- Backfilling of rodent burrows should be completed following removal of rodents; and,
- Periodic removal of vegetation from the perimeter drainage ditch to reduce the risk of vegetative spread onto the landfill cap.
