ENGINEERING INVESTIGATIONS AT INACTIVE HAZARDOUS WASTE SITES

PHASE 1 INVESTIGATION

Sleepy Hollow Campgrounds (Feitshans)

Site No. 915136

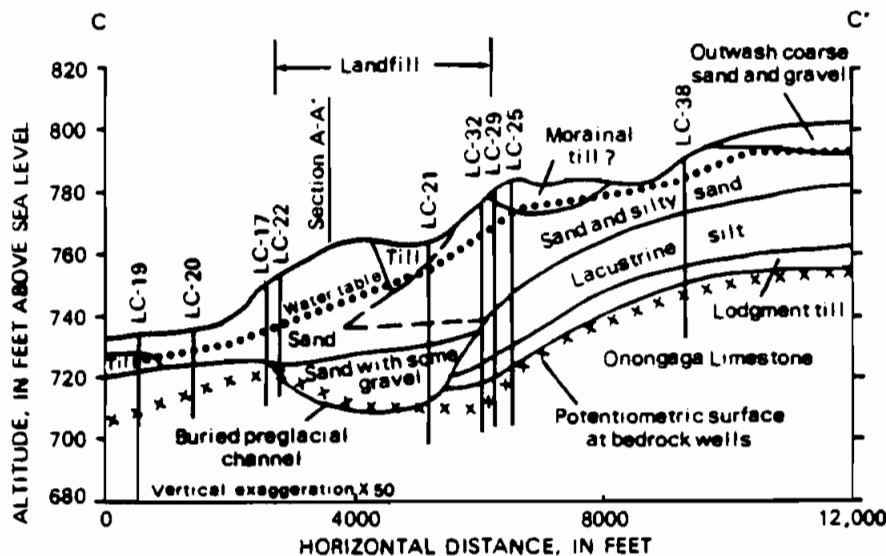
Figure 3C.--Geologic section C-C' through southern part of Clarence-Lancaster-Newstead area. (Location is shown in fig. 2.)

Several borings in the southeastern part of the area reveal 20 to 30 ft of well-sorted stratified outwash sand and gravel underlain by 10 to 15 ft of lacustrine silt and sandy silt that is in turn underlain by 2 to 12 ft of

lodgment till. (See section C-C' in fig. 3 and map in fig. 4.) A gravel pit in the central area near Jones and Stage Roads exposes morainal deposits of sand and gravel with large boulders of Onondaga Limestone (sec. B-B' in fig. 3). The morainal sand and gravel disappears near Stage Road south of Clarence. A large amount of the outwash and morainal deposits have been extracted by sand and gravel mining.

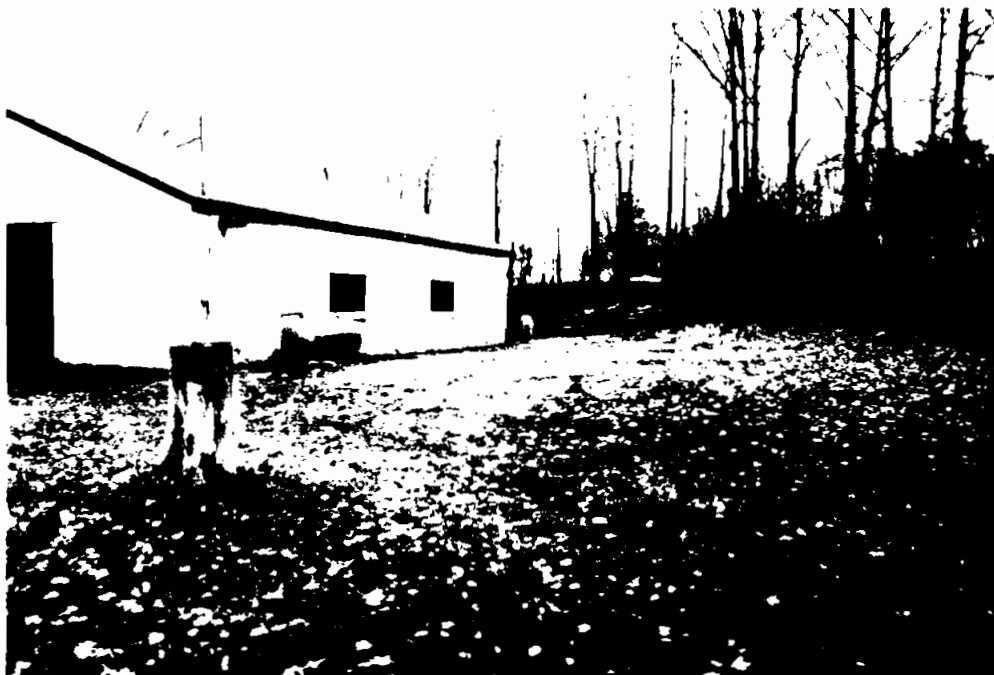
1.

Main well near garage building.

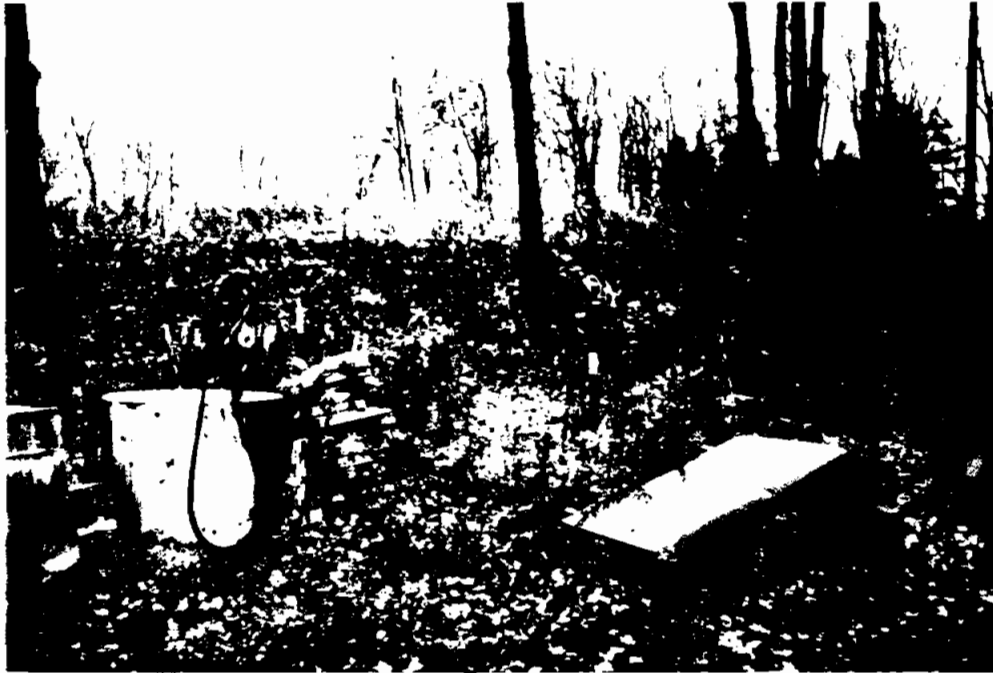
3.

Fuel tanks behind garage - diesel (above ground);
gas (underground).

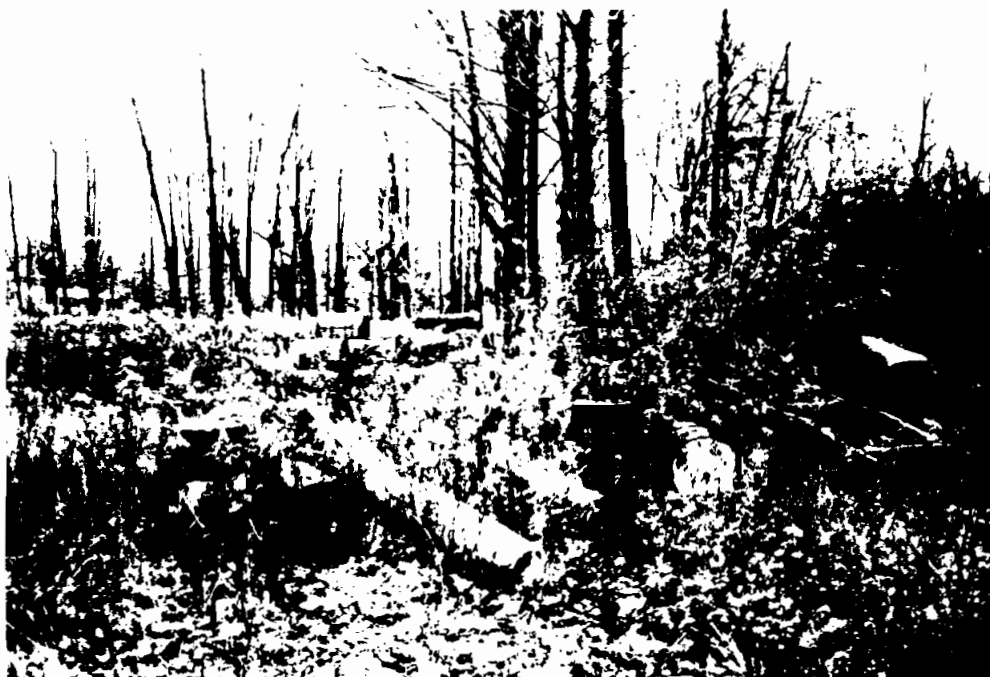
5.

Two drums in foreground containing liquid;
drums in background are empty.

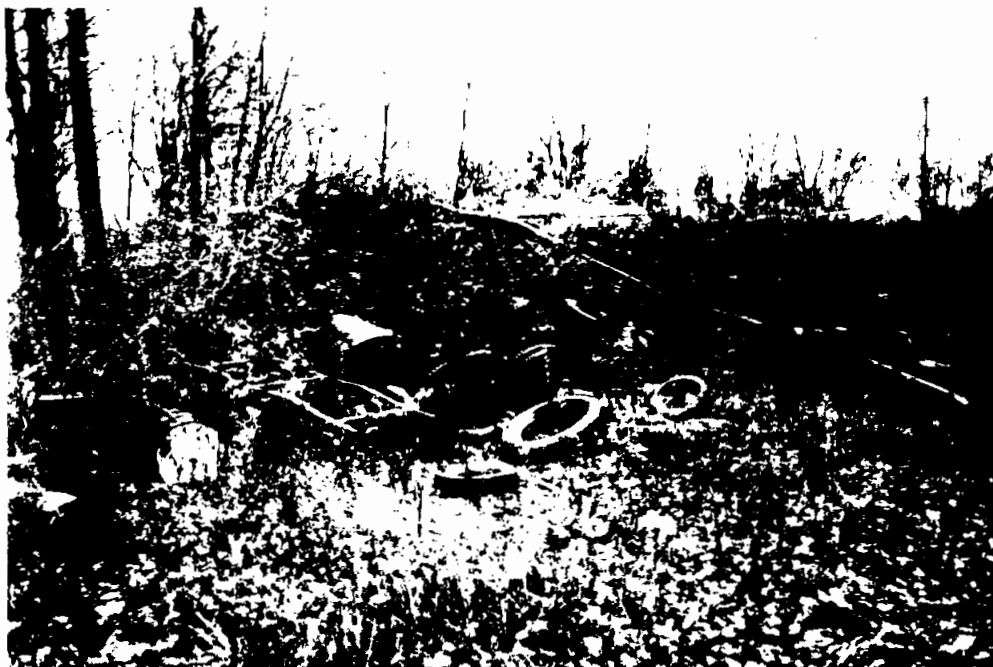
6.

Two drums containing liquid.
