## Final Report Interim Removal Action

**Newstead Superfund Site**  
8471 Fletcher Road  
Town of Newstead, Erie County, New York

CERCLA Site No.: NYD986883387  
Order on Consent No.: 02-2006-2023

December 2007

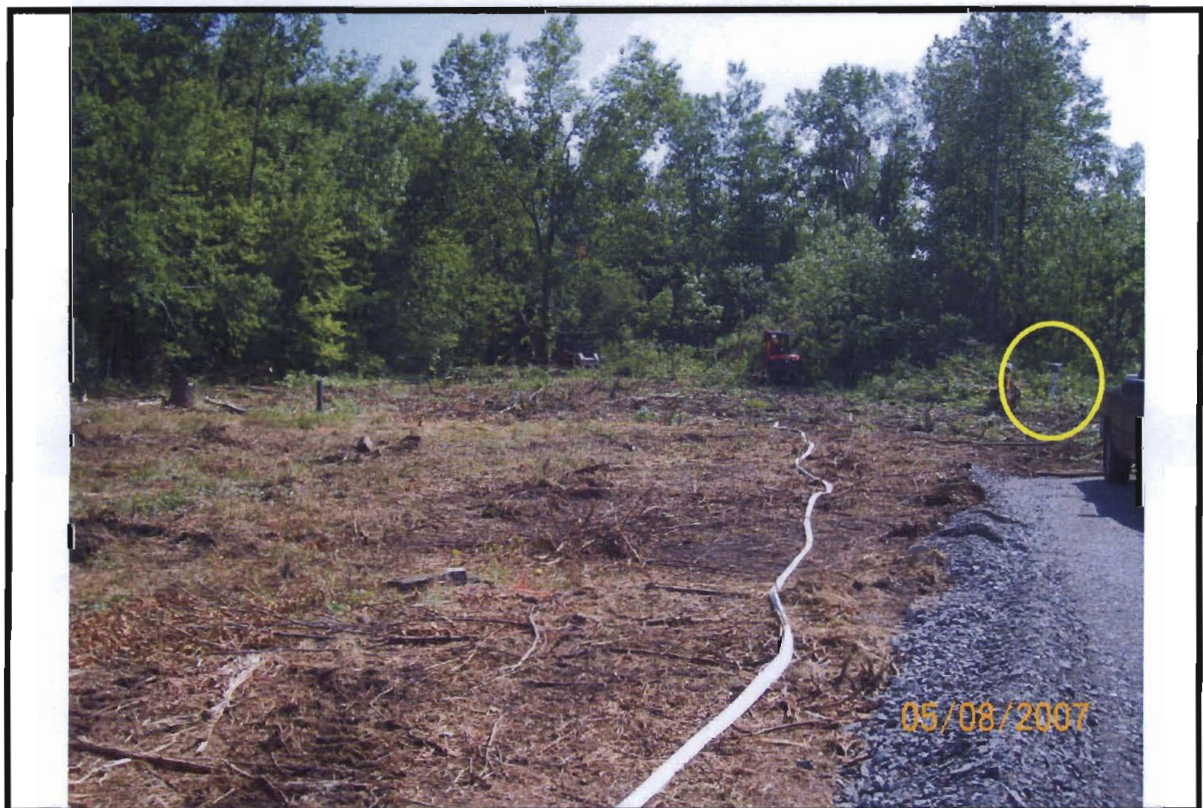
Photograph 2. Brush removal of the northeastern portion of the property. Note the air monitor in the photograph background.

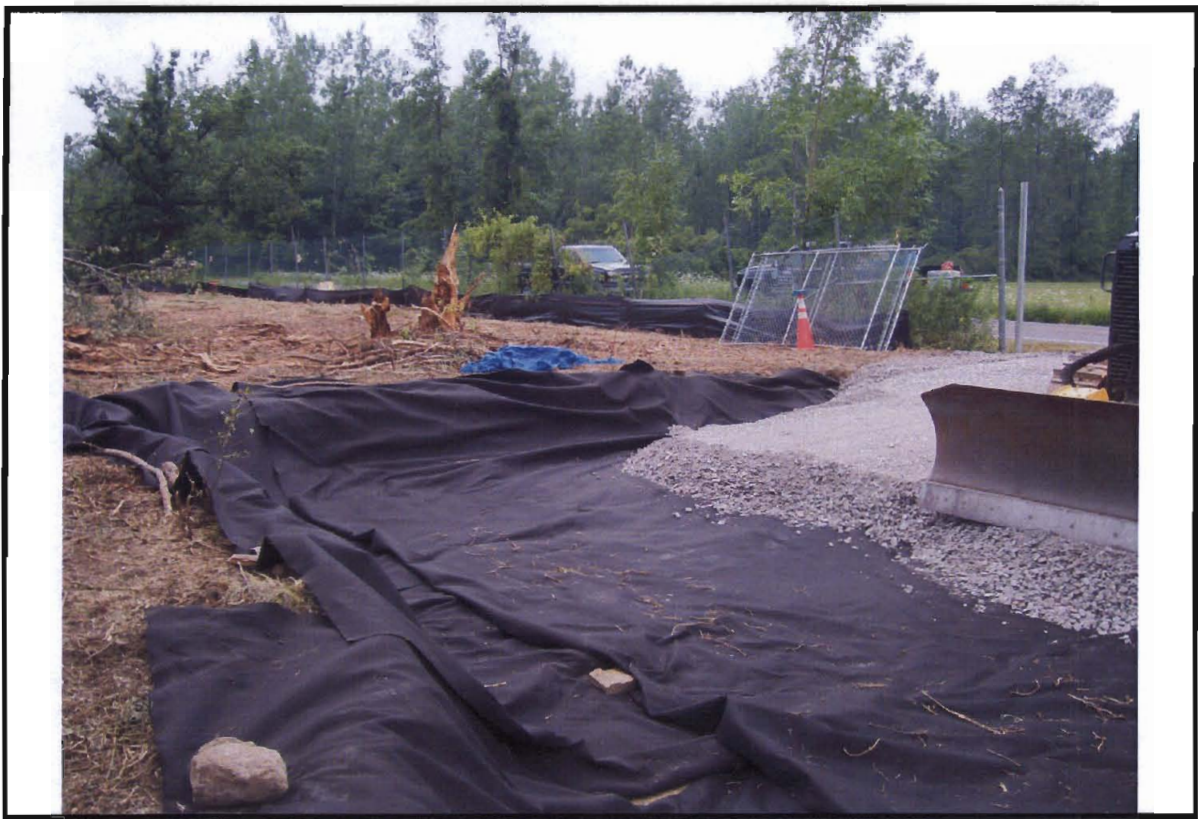
Photograph 3. Construction of the access road and decontamination pad.

Construction of the new access road began on August 3, 2007. The existing entrance location was extended approximately 100-feet east onto the Site from Fletcher Road following the excavation of underlying contaminated soils. Soil removed during the excavation for the access roadway was staged on and covered with polyvinyl sheeting on-site until analysis of representative soil samples were received from the laboratory for the determination of proper disposal requirements. A non-woven geotextile fabric was placed in the roadway excavation and covered with a 12-inch layer of two-inch run of crushed stone, followed by a layer of medium stone fill placed on top. All roadway materials were compacted with a smooth drum vibratory roller.

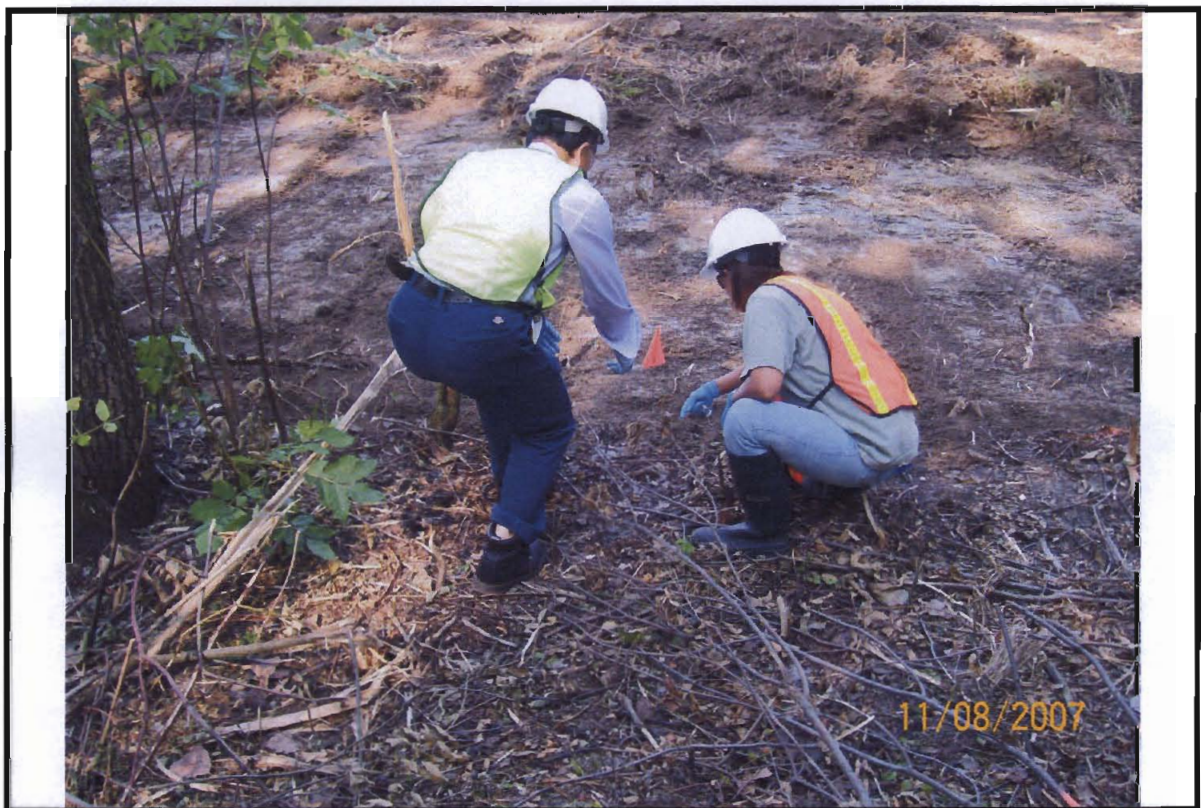
Photograph 4. Post-excavation soil sampling conducted by ERM with split samples taken by USEPA's REAC representative.

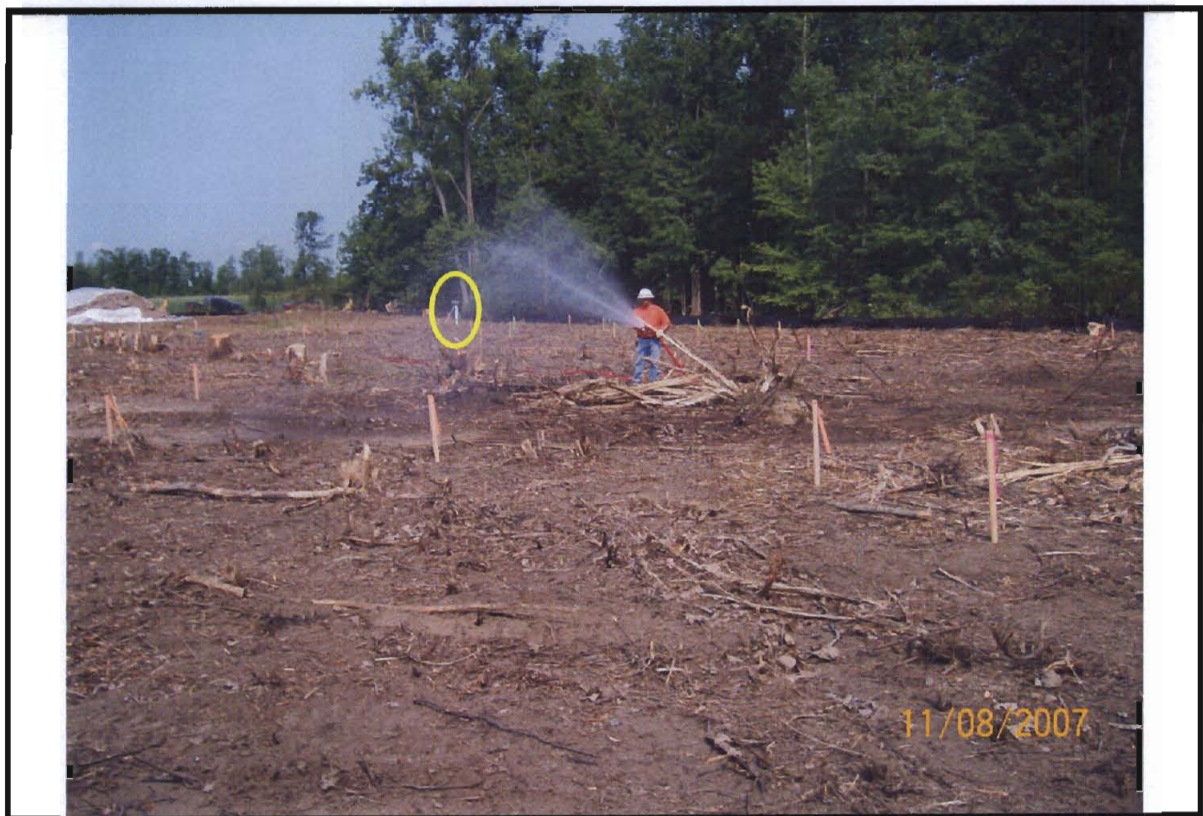
Photograph 5. Dust control conducted during excavation activities with air monitor in the background.

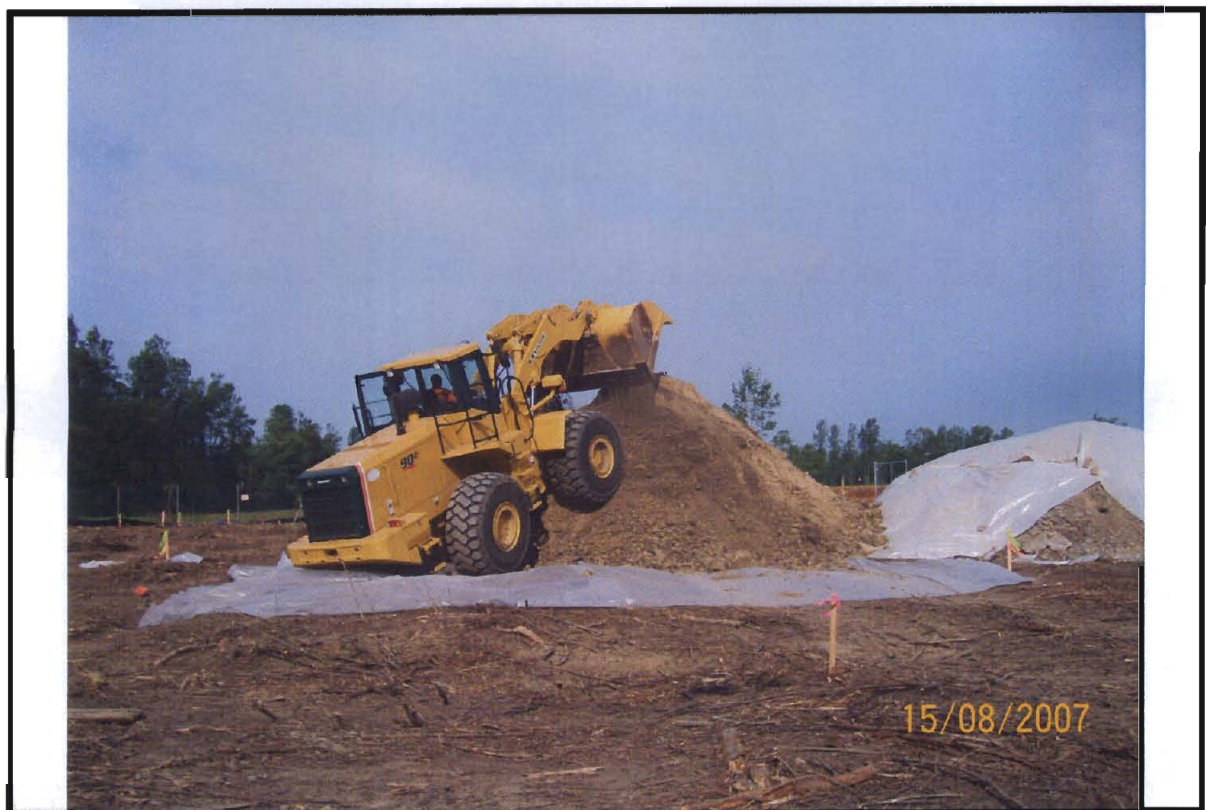
Photograph 6. Soil staging from excavation activities.

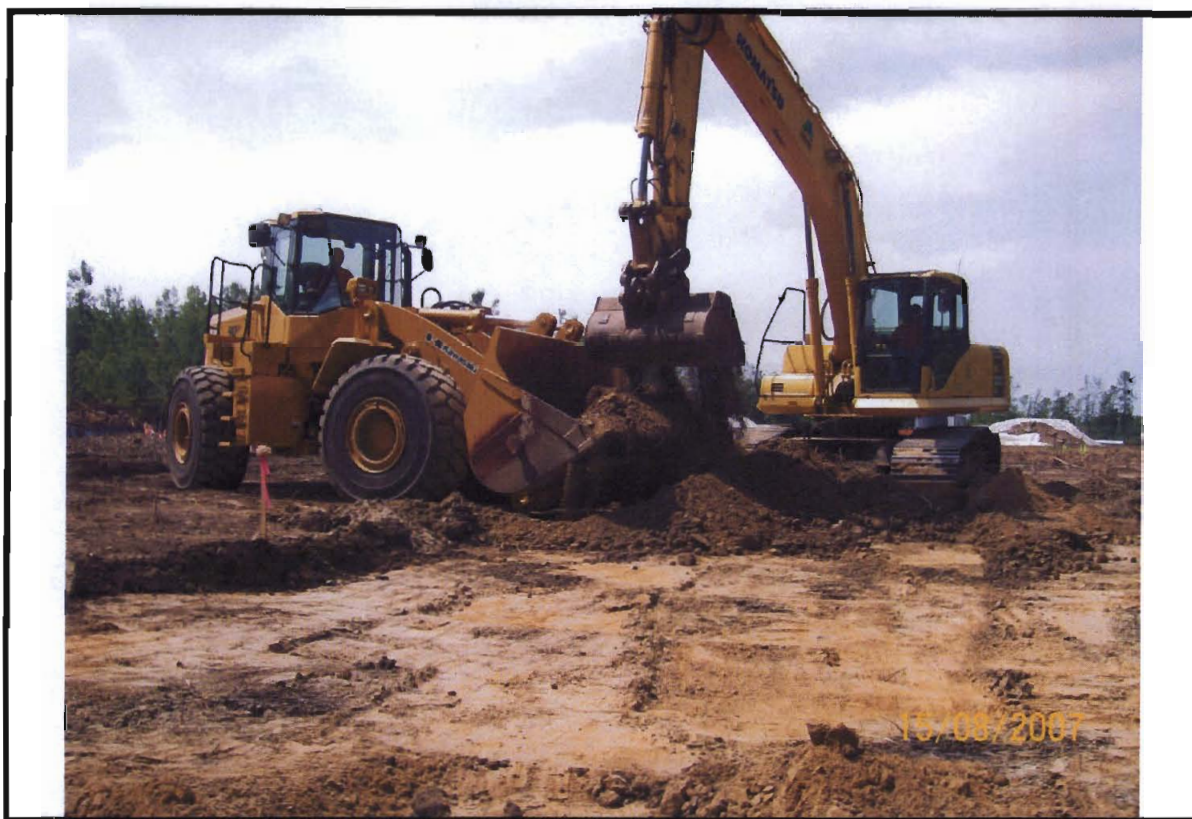
Photograph 7. Excavation of the central portion of the property.

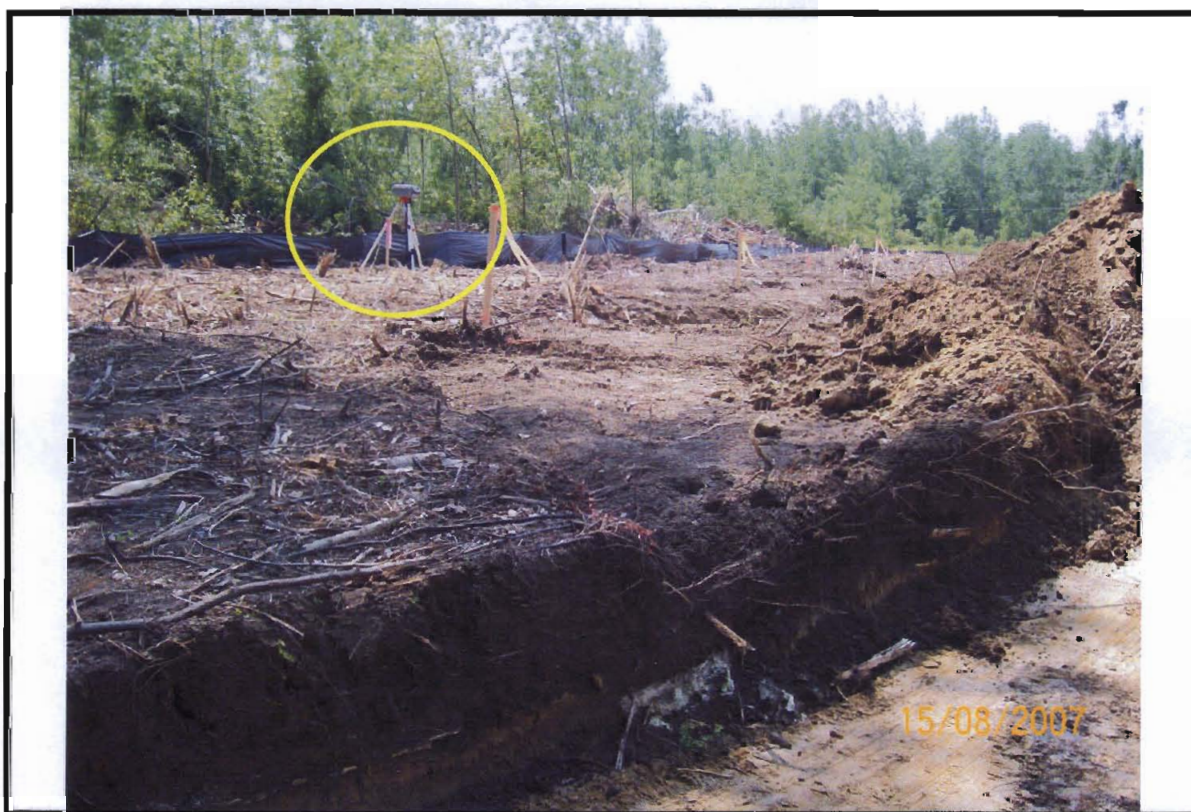
Photograph 8. Community air monitoring equipment located in the southern central portion of the excavation area.

Air monitoring was performed during all ground intrusive activities to ensure that the surrounding community was not adversely impacted during on-site activities. A MiniRAE 2000 handheld VOC monitor was used in conjunction with three TSI DustTrak Aerosol monitors for conducting real-time air monitoring for VOCs and respirable dust levels at the perimeter of the EZ. Readings from the three monitors were recorded based on a 15-minute averaging time concentration. During the course of the ground activities, no air exceedences were noted. Data from the DustTrak monitors were routinely downloaded to an onsite laptop computer for data archiving. Data charts from the three DustTrak monitors for all sample events are included as Appendix C to this report.

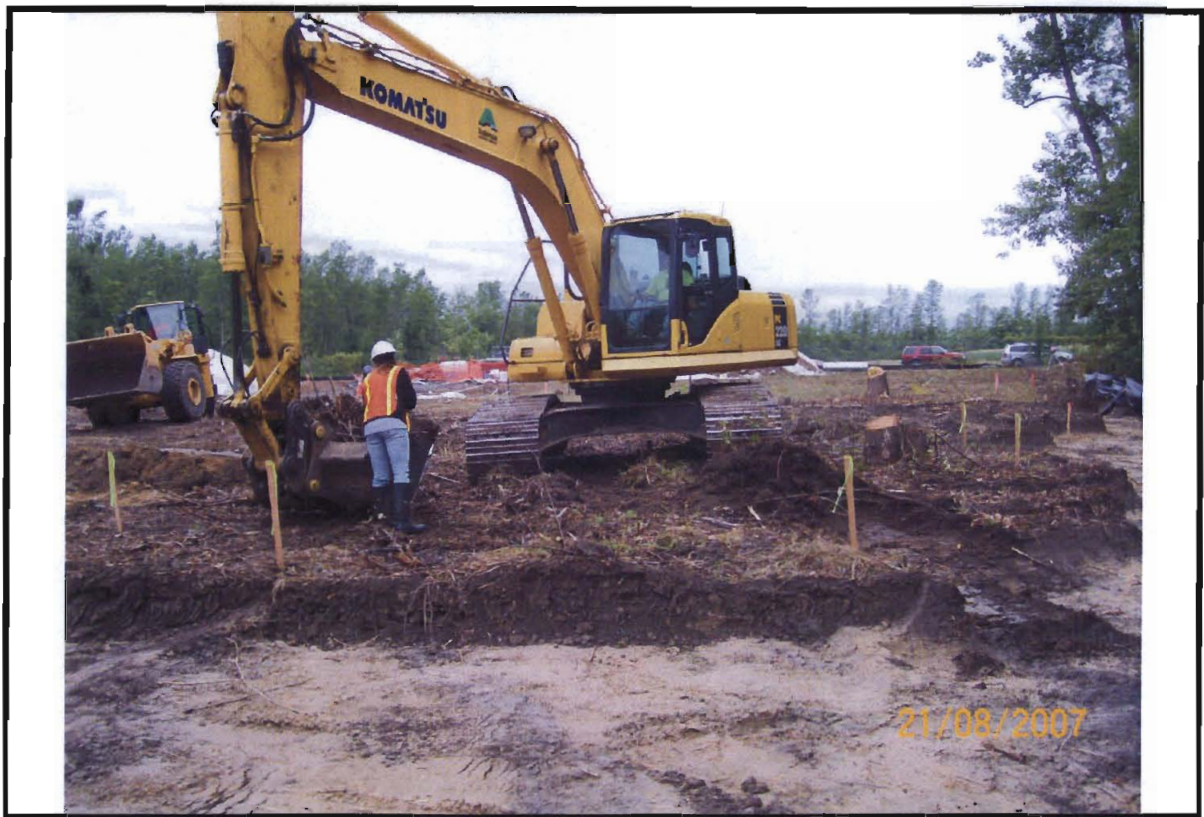
Photograph 9. PID readings taken from the excavator bucket during soil removal.

Excavation of the Site began on August 14, 2007. In accordance with the EPA-approved work plan, soils that were visually observed to contain paint waste and/or paint waste debris, or if PID readings taken during excavation activities identified a concern; these soils were excavated and prepared for proper off-site disposal. ERM RCM's work plan initially included direct ship of excavated soils; however, approval of waste profiles for the selected disposal site, Allied Waste (Niagara Falls, NY) delayed this approach to soil disposal. While awaiting approval from Allied Waste, excavated soils were staged on and covered with polyvinyl sheeting on site. Staged soils were sampled at a rate of one sample per 100 cubic yards and were segregated as either non-hazardous waste for disposal or hazardous waste. Soils deemed to be hazardous waste were stabilized on-site in accordance with the EPA-approved IRAWP prior to off-site disposal.

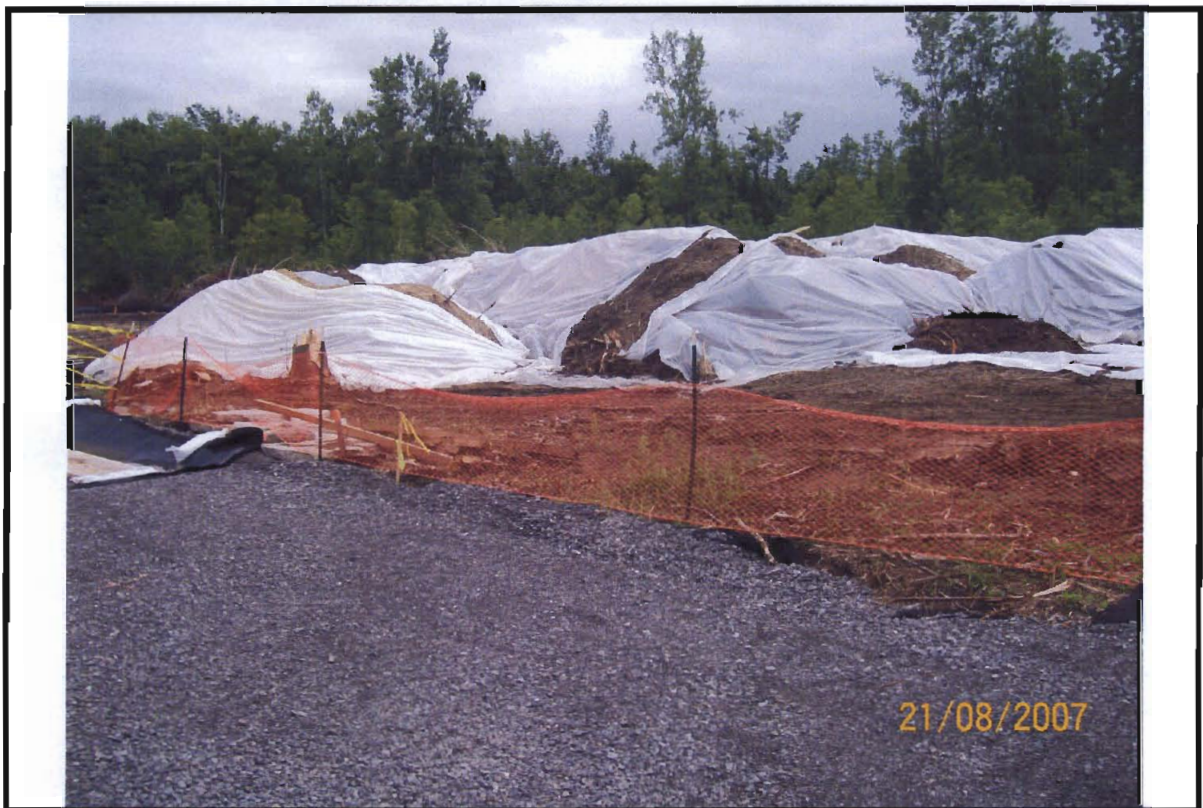
Photograph 10. Staged soil from excavation activities. Site access road in the foreground.

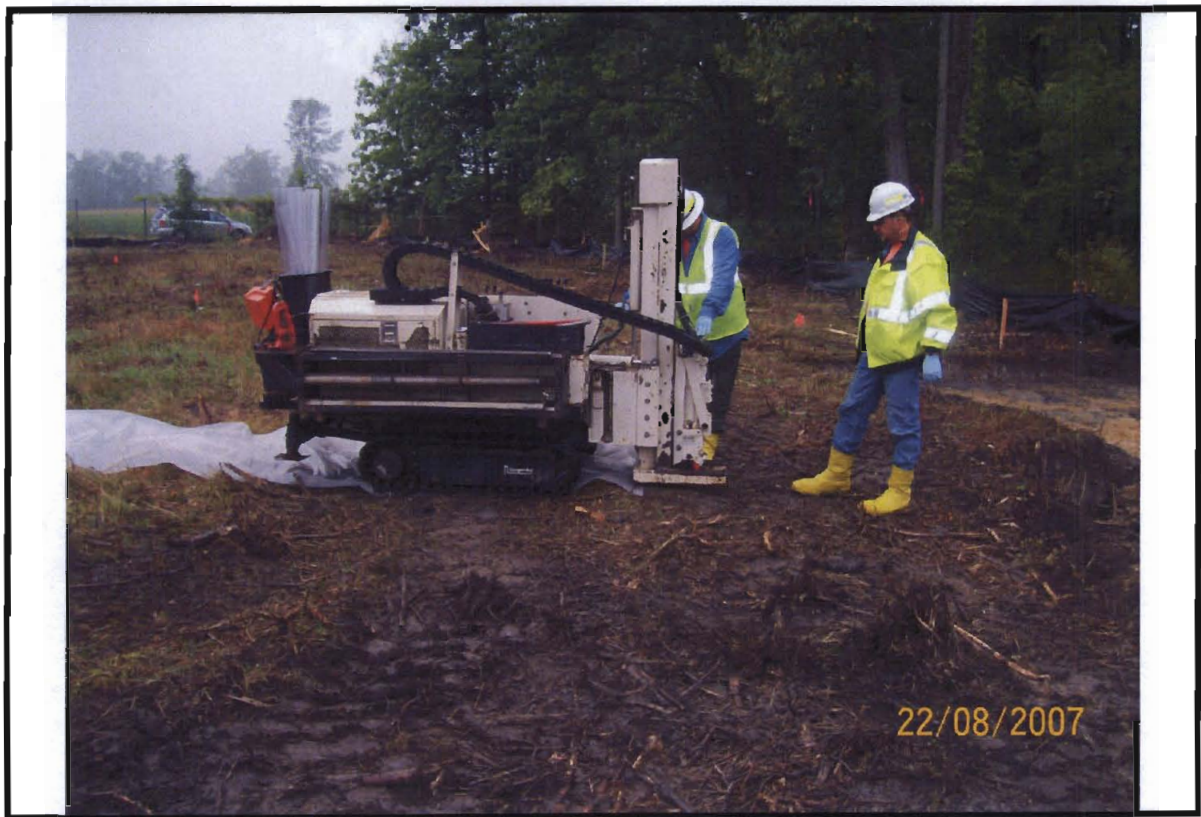
Photograph 11. PCB sampling via Geoprobe.

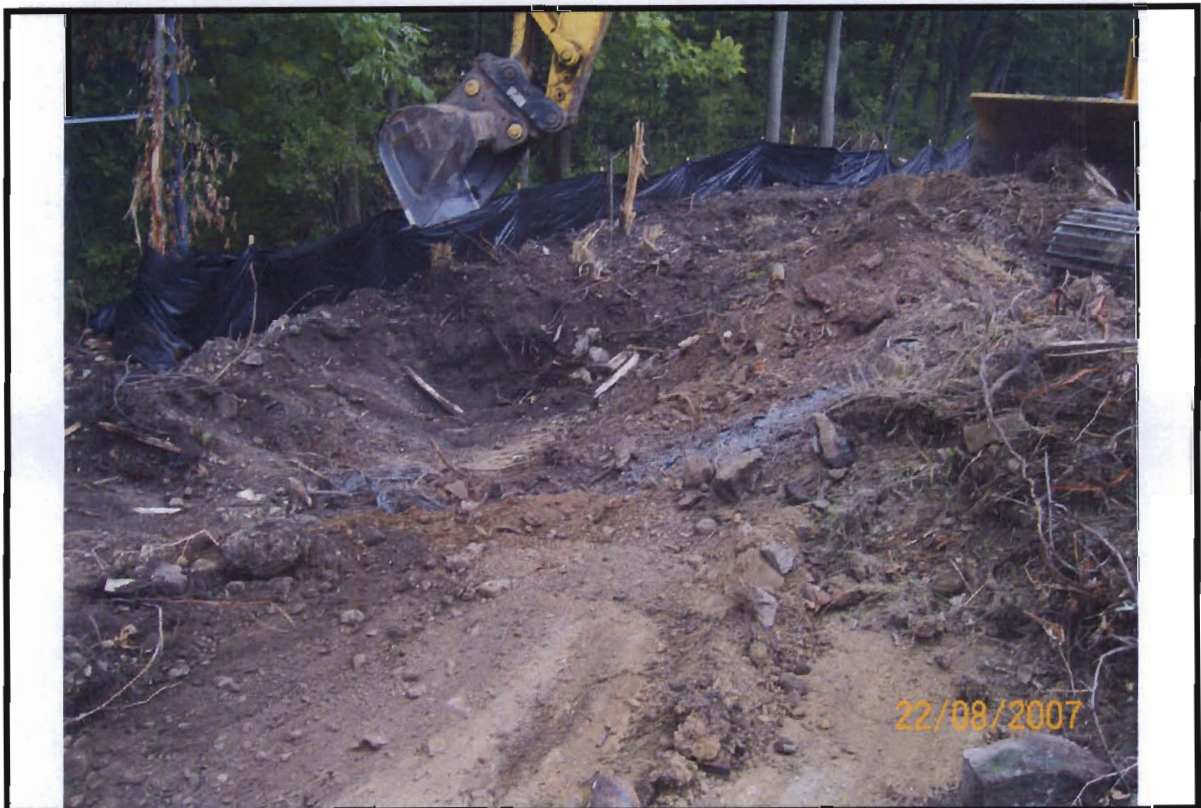
Photograph 12. Excavation of the north/northwestern wall face.

A small volume of paint waste and debris was observed along portions of the northwest wall face, within Quadrants 39, 33, and 27. Additional excavation of the sidewalls of portions of Quadrants 39, 33, and 27 was performed in 5-foot horizontal increments to the excavation depths for each quadrant, until no visual or instrumental signs of paint waste were observed or recorded. In some portions of the wall face, the excavation activities reached the approximate northern Property limits.

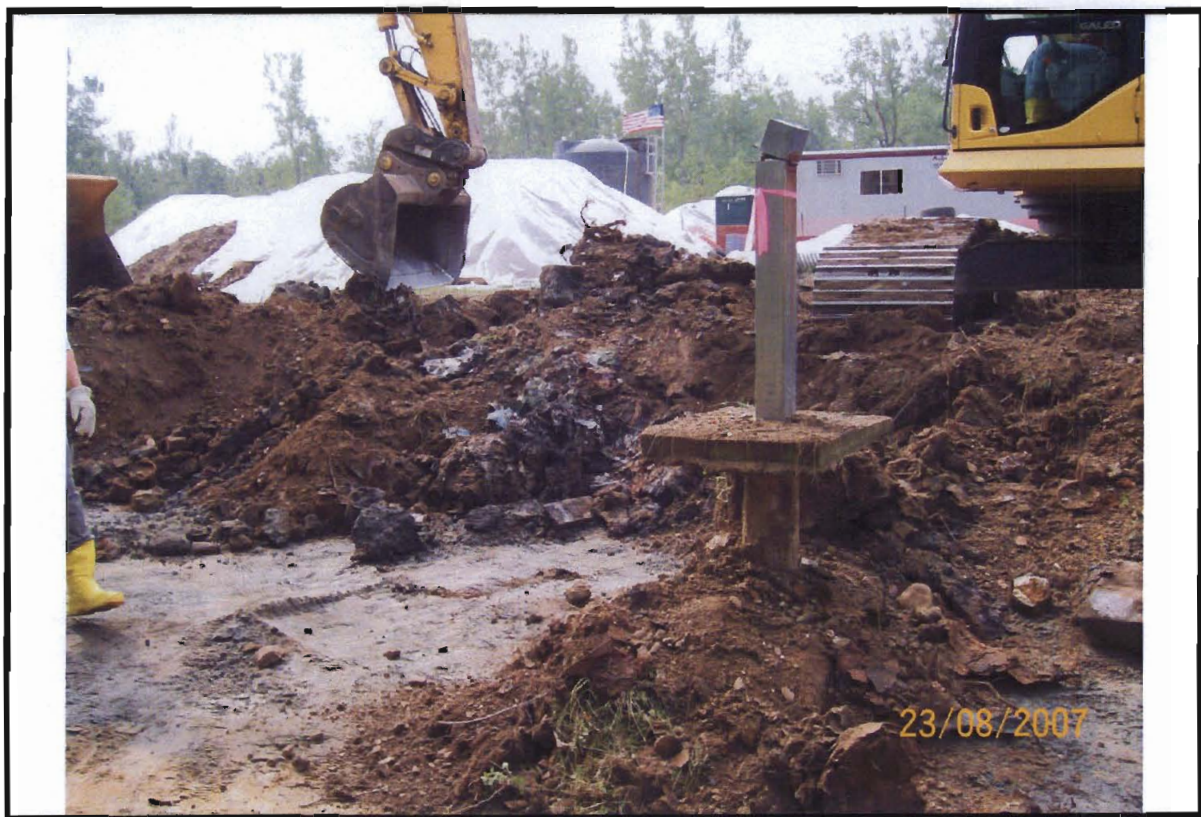
Photograph 13. Excavation of the northwest corner near MW2A-93 and MW2B-93.

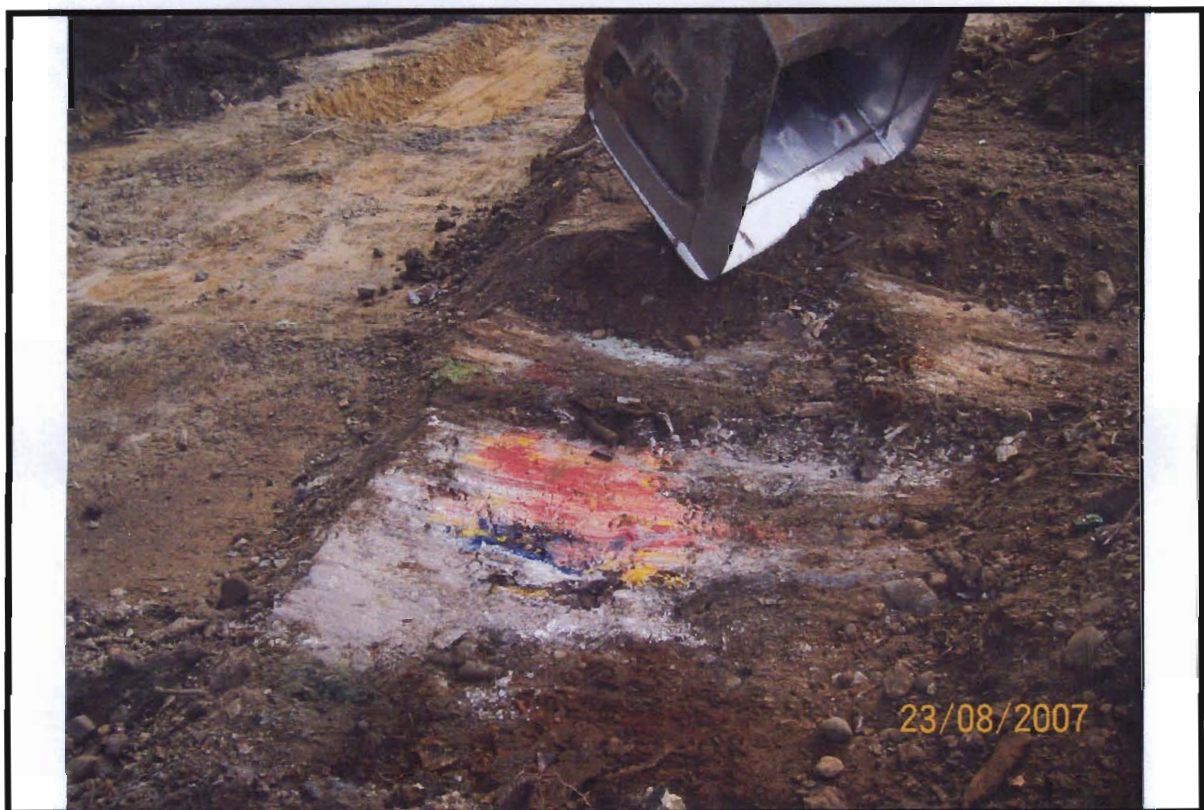
Photograph 14. Visible paint waste in the northwest corner of the contaminated waste layer.

As excavation activities in the Continuous Waste Layer proceeded, extensive paint waste and debris was visually observed within this area. Additional soil excavation was performed based on visual observations of paint waste or debris or by PID readings taken during excavation. Additional excavation of the sidewalls of portions of Quadrants 39, 33, and 27 was performed in 5-foot horizontal increments to the excavation depths for each quadrant, until no visual or instrumental signs of paint waste were observed or recorded, or the excavation activities reached the approximated northern Property limits.

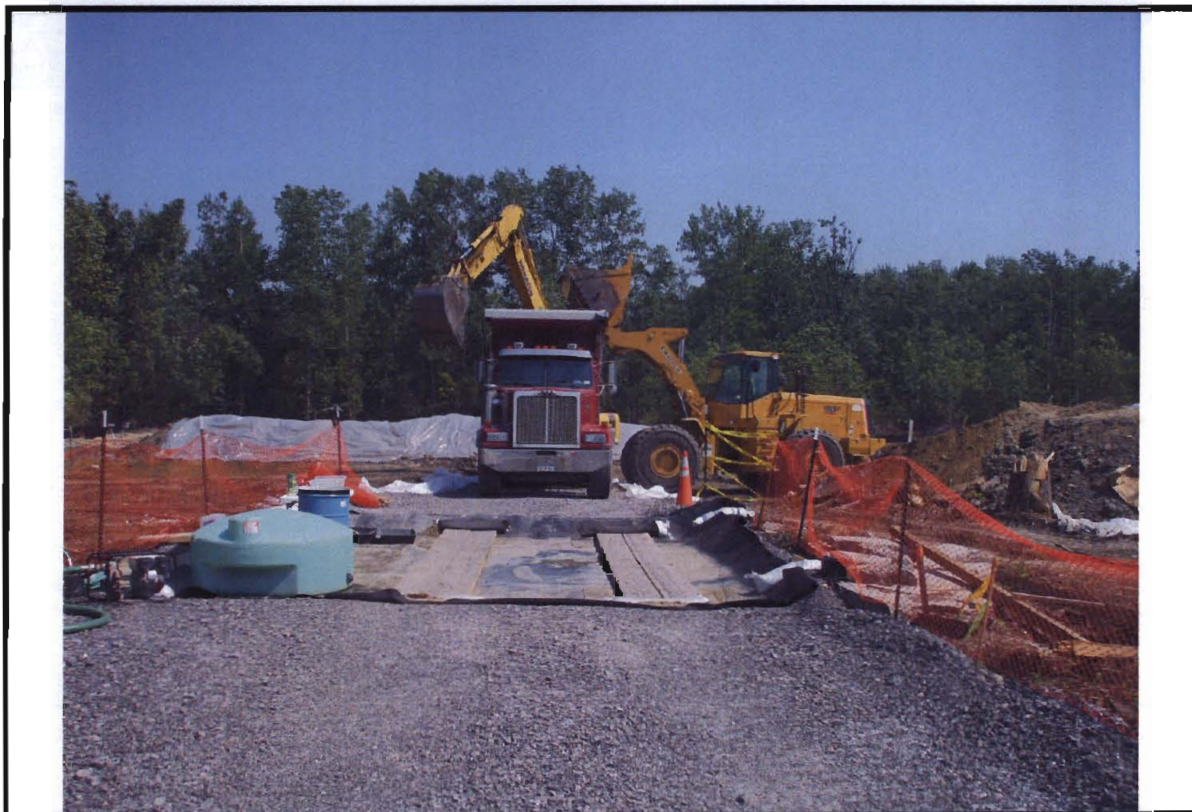
Photograph 15. Off loading of the staged soil. Decon pad and access road in foreground.

Approximately 7,018 tons of non-hazardous soils were loaded for disposal at the Allied Waste landfill in Niagara Falls, New York. This volume of material was disposed in 358 tandem truck loads. Transporters of non-hazardous waste materials were permitted for general transportation of sanitary wastes or as required by New York State for the transport of Special Waste.

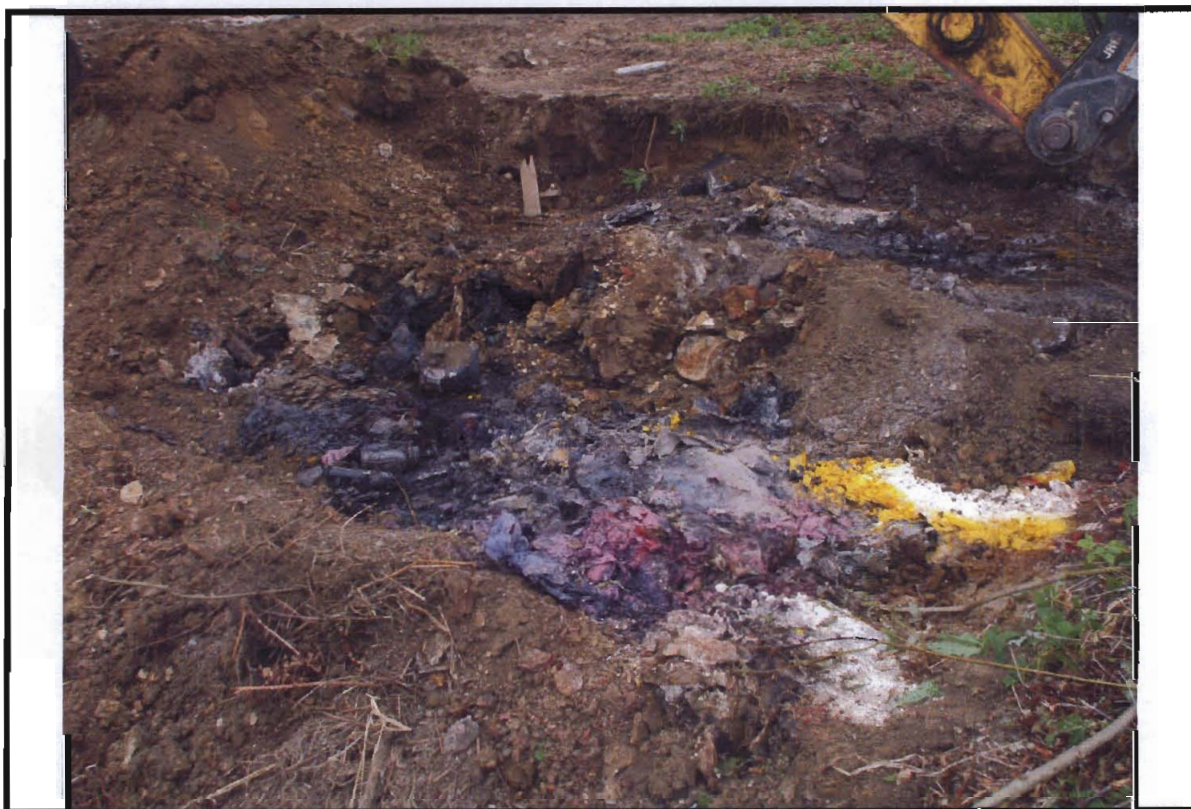
Photograph 16. Visible paint waste located due north of the access road near Fletcher Road in the contaminated waste area.

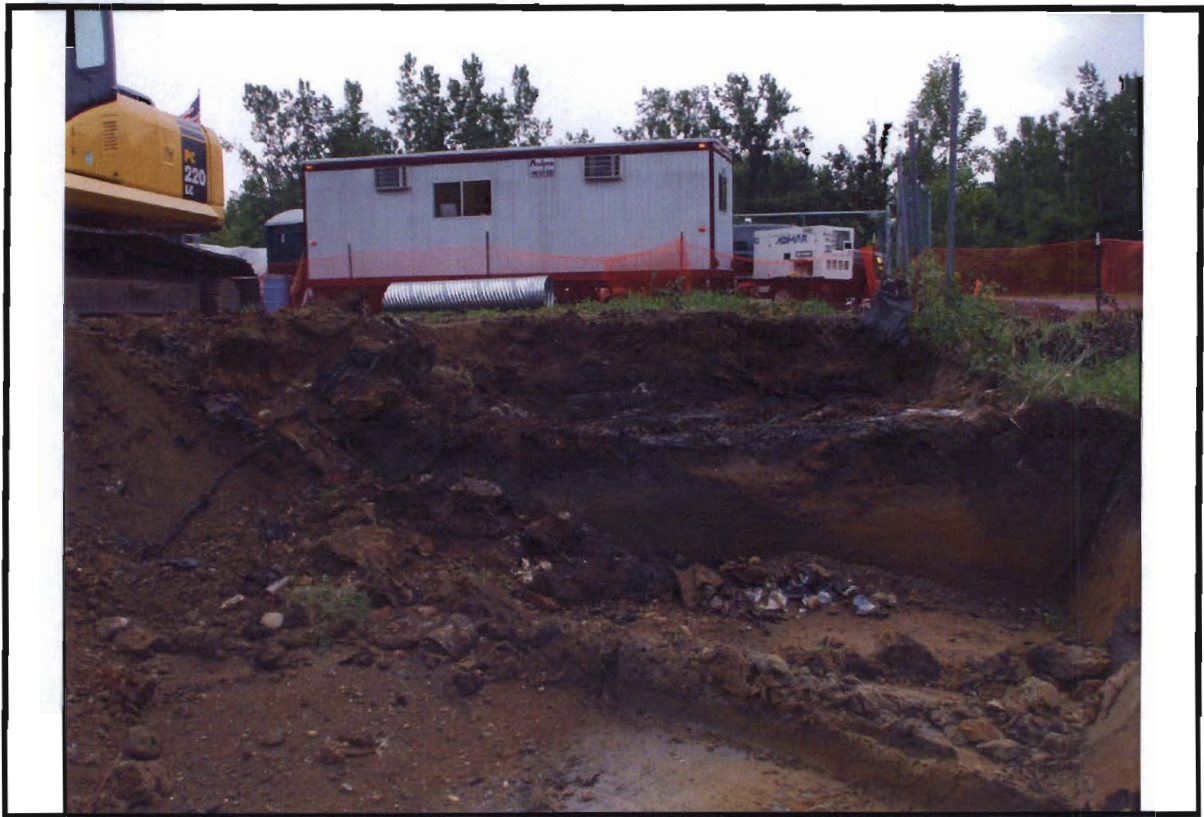
Photograph 17. Excavation of the contaminated waste layer, near Fletcher Road. Paint waste and debris are visible.

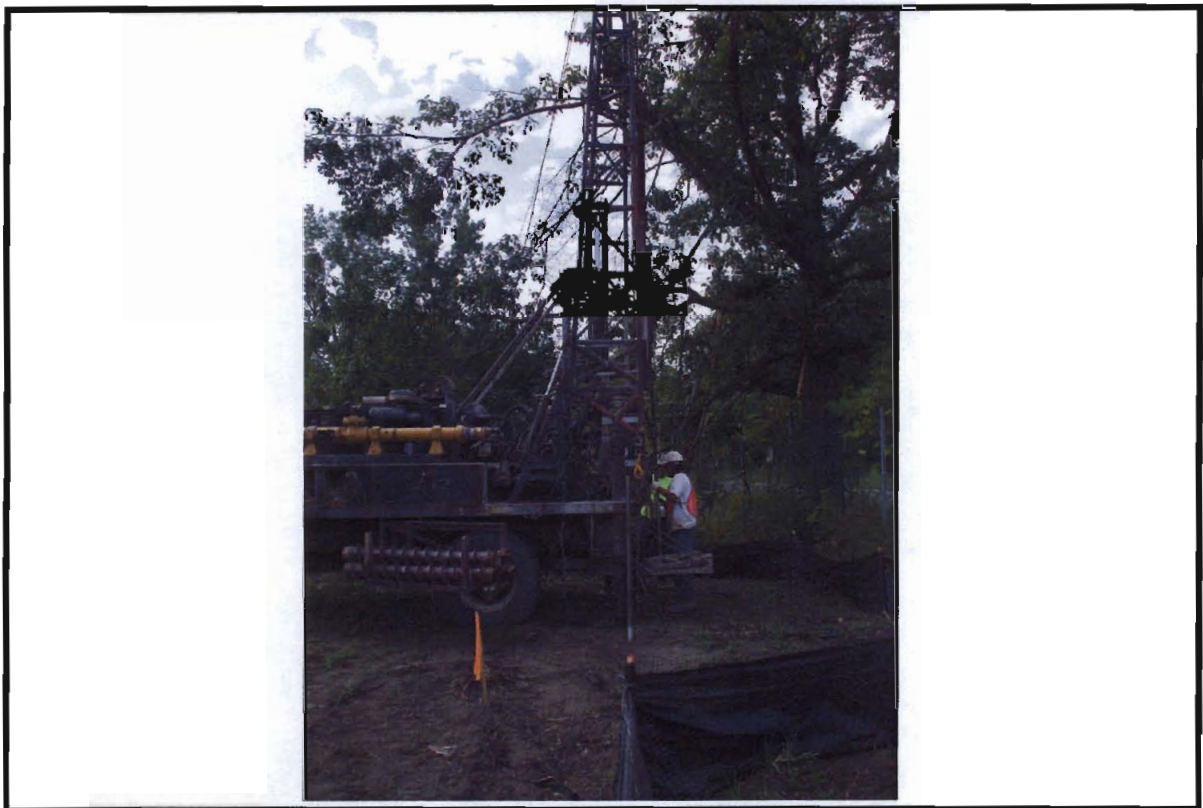
Photograph 18. Monitoring well installation in the southwestern portion of the property (MW5A-07).

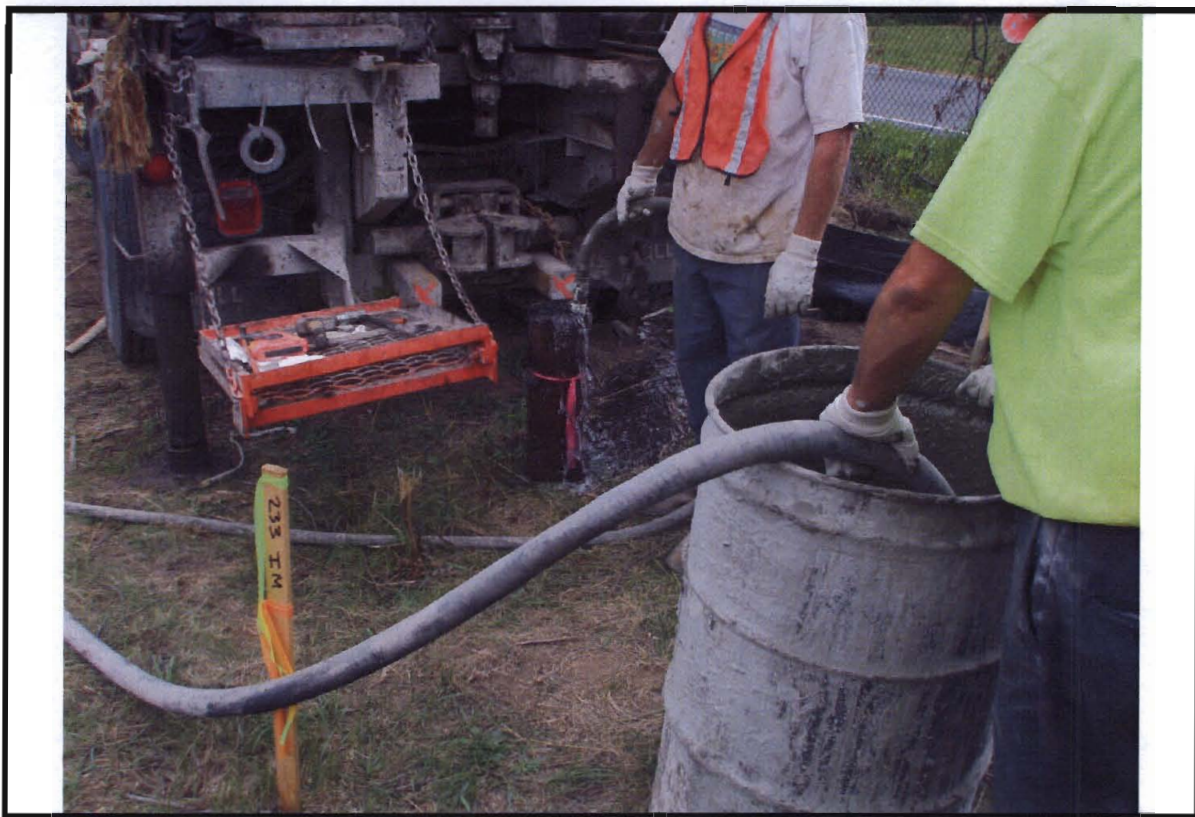
Photograph 19. Well decommissioning of the on-site water supply wells.

The previous residence located on-site used two supply wells. On September 4, 2007, in accordance with the EPA-approved PRGMP, these wells were decommissioned and abandoned following NYSDEC's *Groundwater Monitoring Well Decommissioning Procedures*, May 1995, and *Water Supply Well Decommissioning Recommendations*, December 2003. Buffalo Drilling tremie-grouted both wells to depths of approximately 67 feet below ground surface. A third well was uncovered during excavation activities in the Surface Contamination Area also near the location of the former residence. ERM RCM abandoned this well by filling the top of the well to a depth of five feet, bgs, with a bentonite grout mixture.

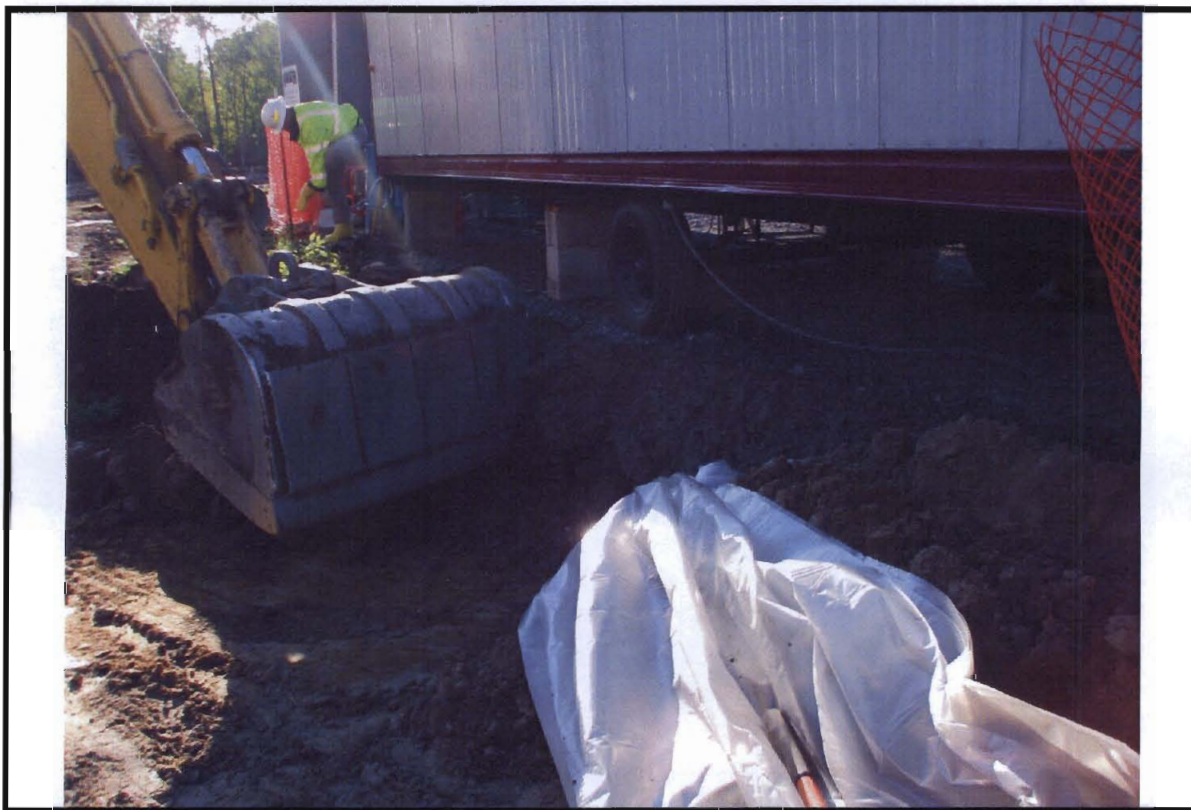
Photograph 20. Excavation of the contaminated waste layer north of access road and site construction trailer.

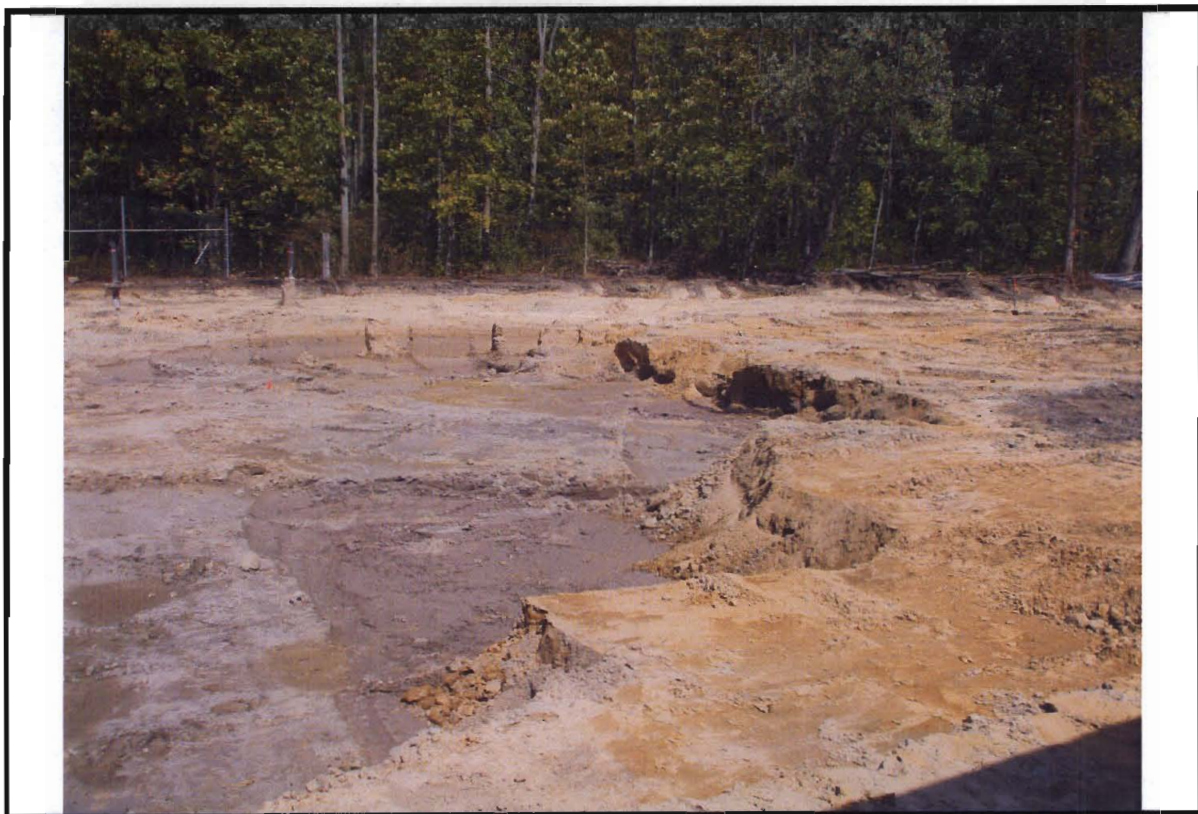
Photograph 21. Finished excavation of the contaminated waste layer.

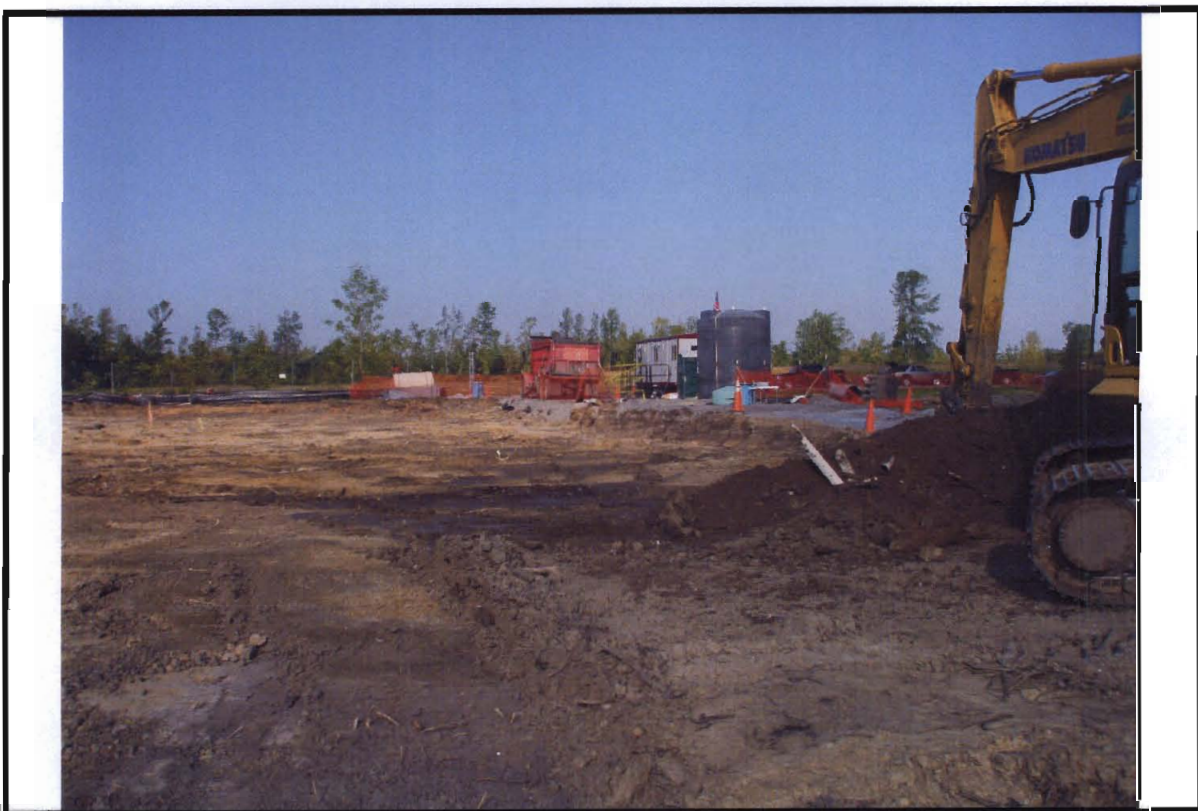
Photograph 22. Looking west across the southern extent of the surface contamination area.
