## Final Report Interim Removal Action

**Newstead Superfund Site**  
8471 Fletcher Road  
Town of Newstead, Erie County, New York

CERCLA Site No.: NYD986883387  
Order on Consent No.: 02-2006-2023

December 2007

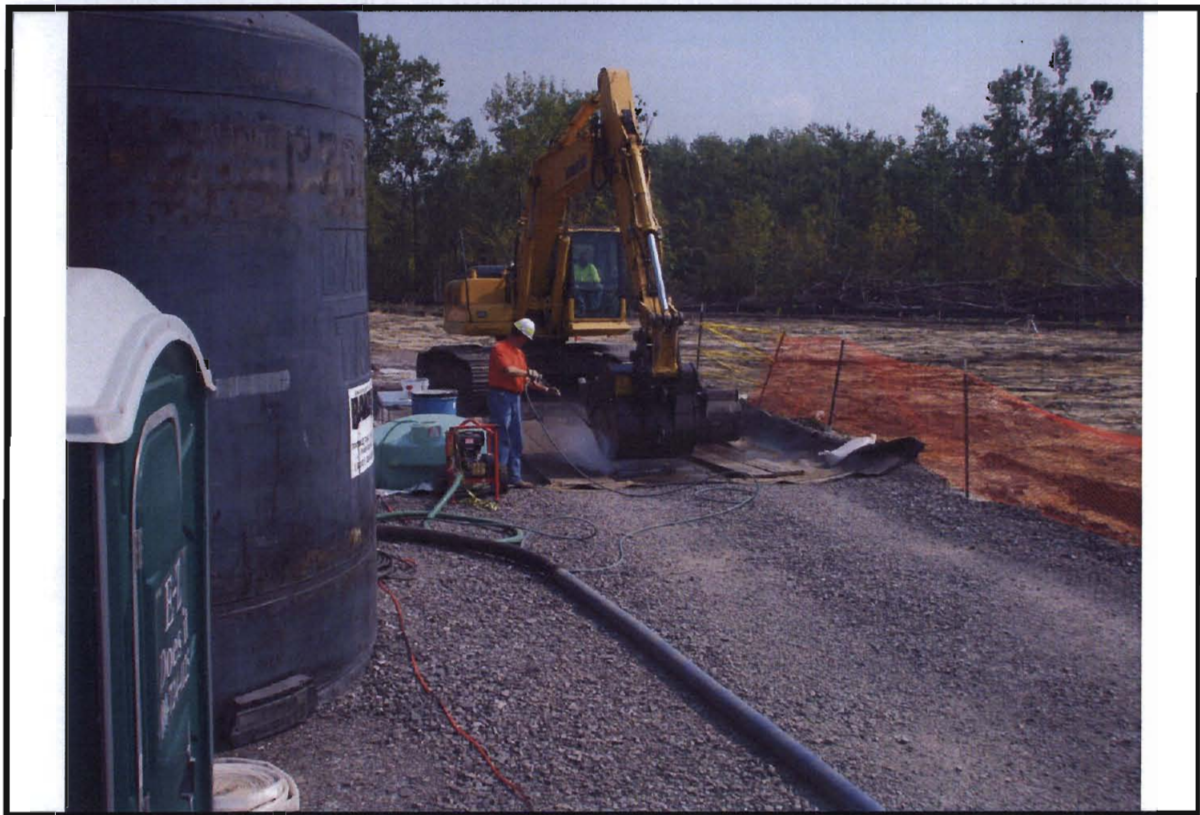
Photograph 23. Excavator decon activities.

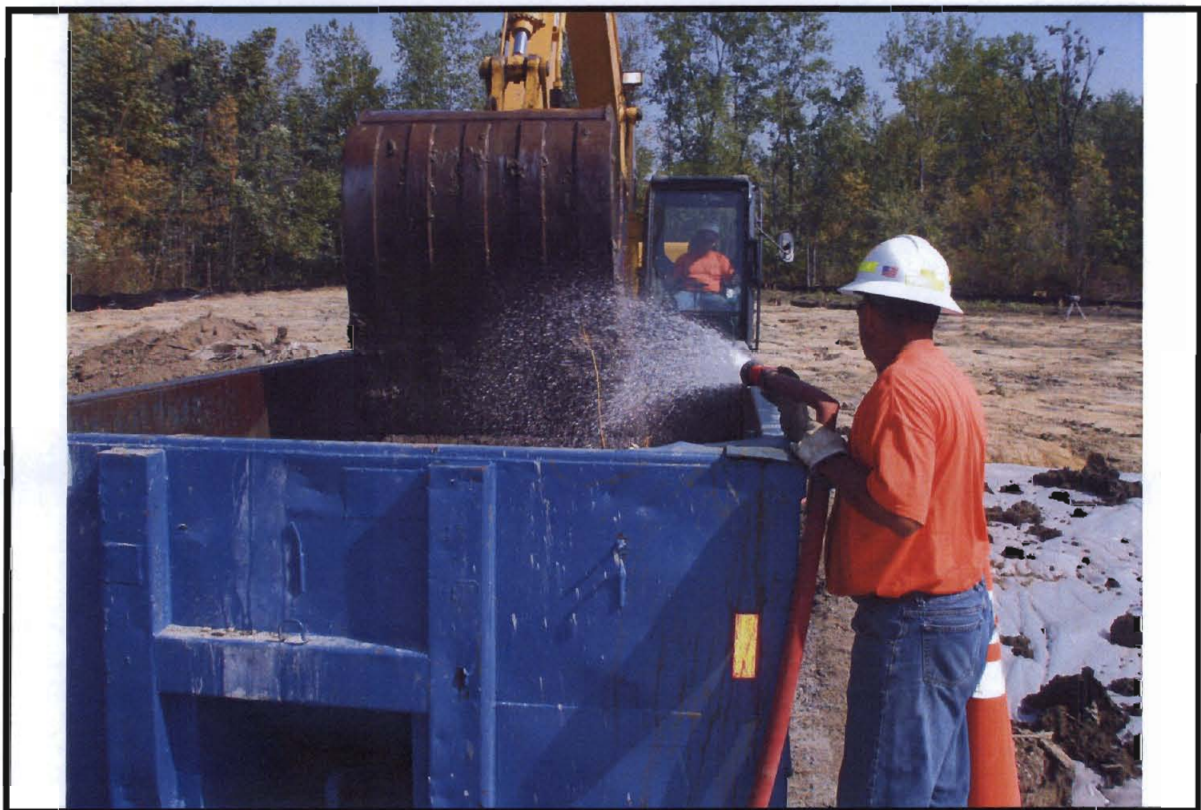
Photograph 24. Stabilization of the hazardous soil excavated from the northern wall face.

Hazardous soils were stabilized in accordance with the procedures and admixtures identified in the IRAWP. The volume of characteristically hazardous material excavated from the Site was approximately 530 cubic yards versus the initial estimate of approximately 220 cubic yards. Once stabilized, the soils were allowed to cure for no less than 28 days, re-sampled for TCLP metals analysis to verify that the stabilized material had been rendered non-hazardous. Once analytical results and appropriate disposal approvals were received, the stabilized materials were disposed off-site at the Allied Waste facility in Niagara Falls, New York.

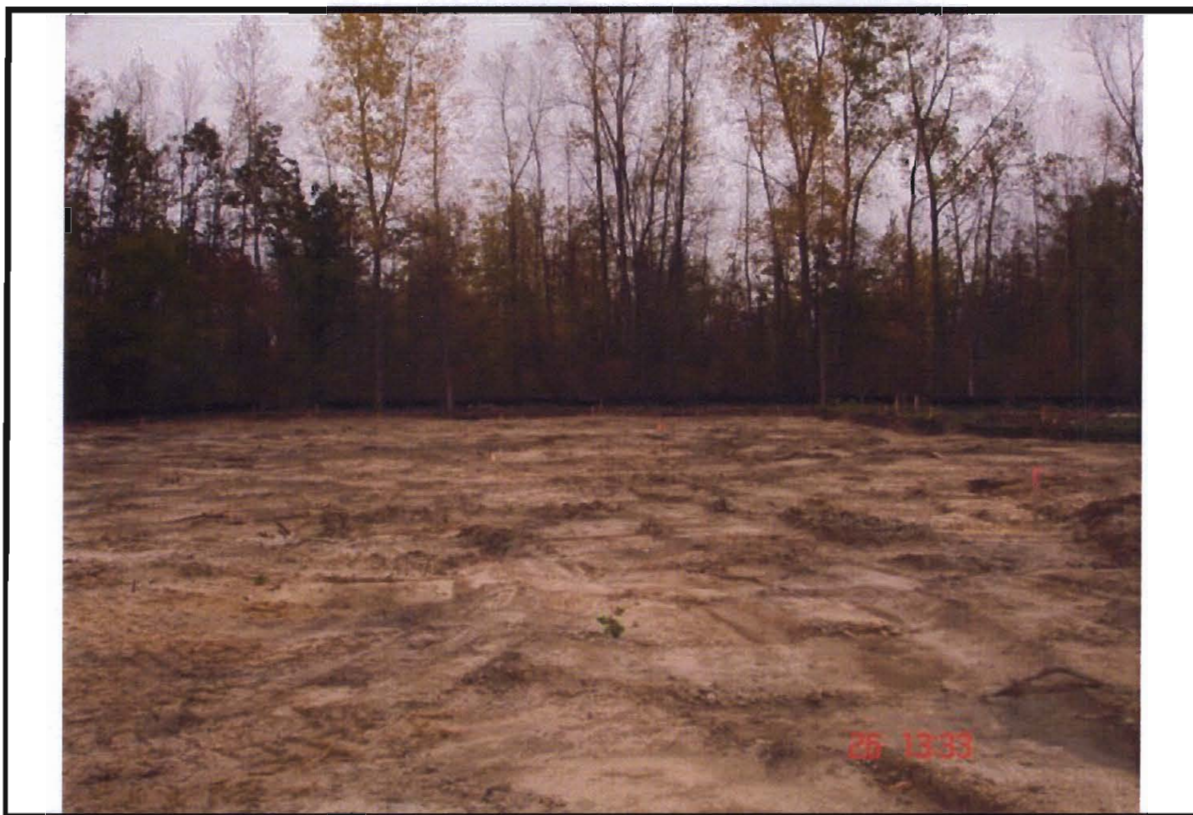
Photograph 25. Looking east across the excavation area before backfilling of the site.

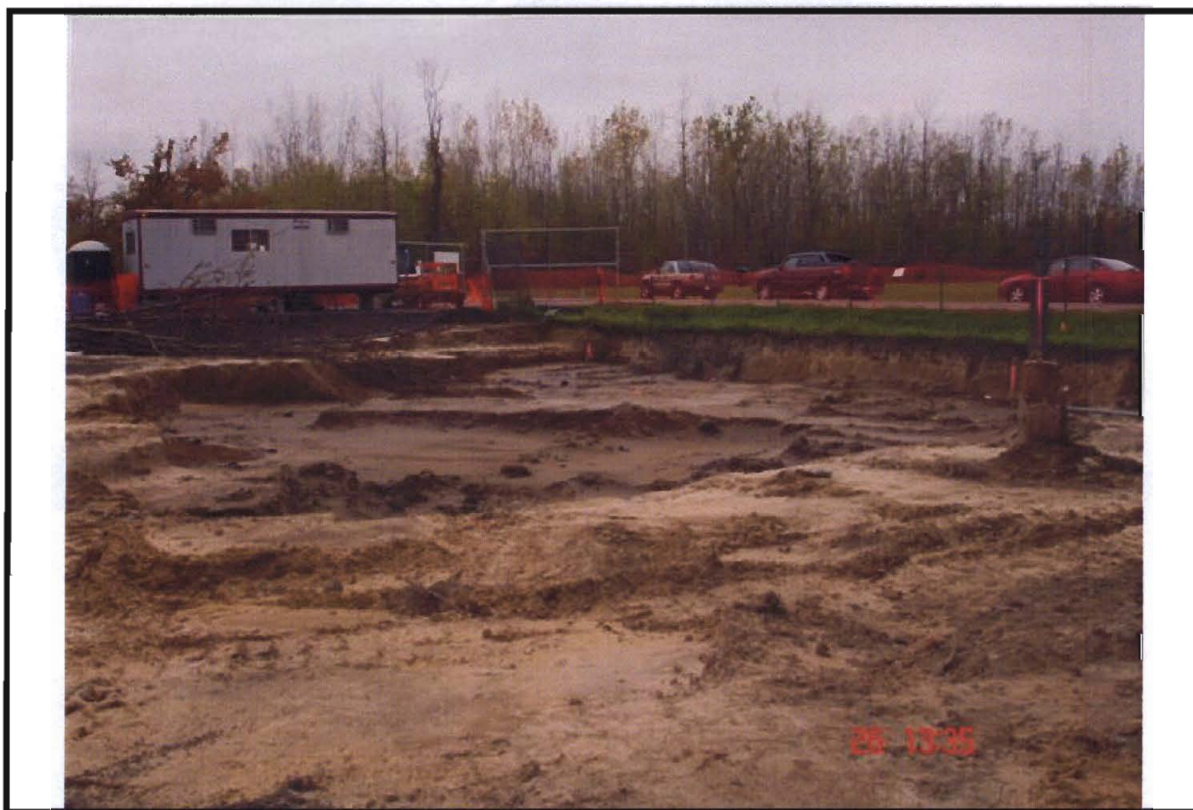
Photograph 26. Looking southwest across the former contaminated waste layer area toward Fletcher Road, before backfilling began.

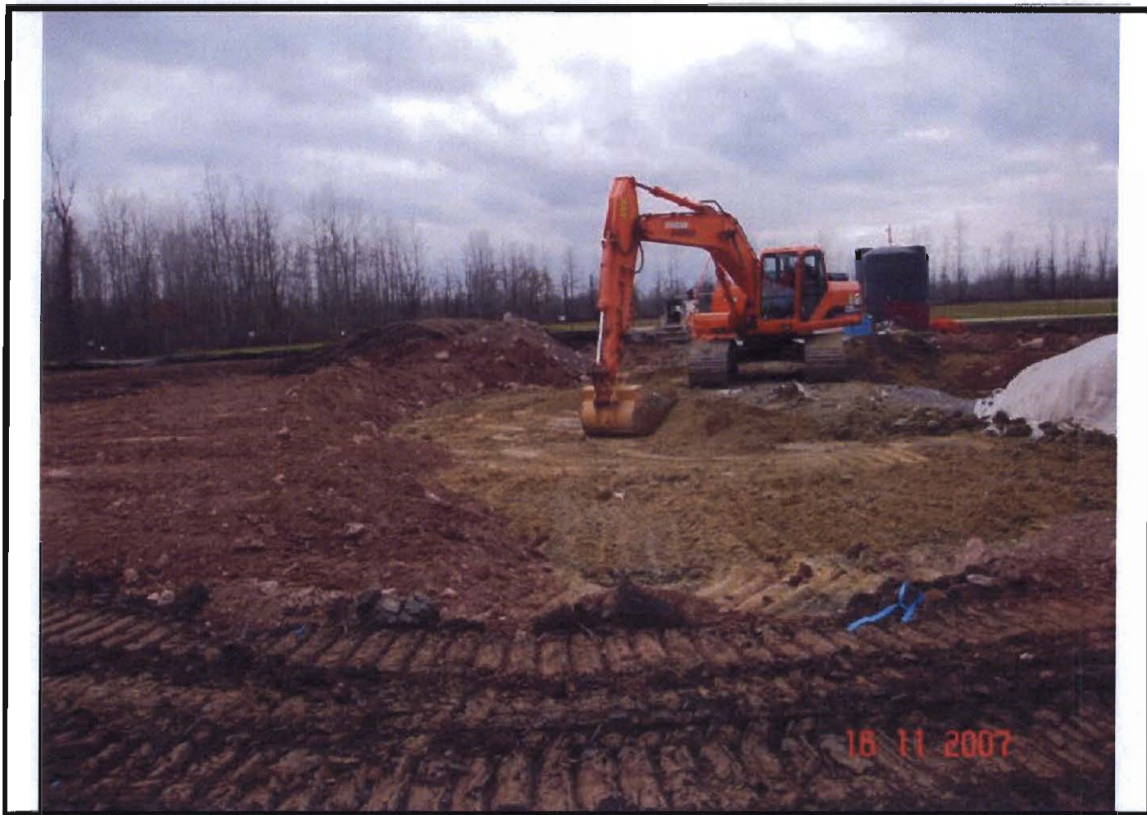
Photograph 27. Final grading of top soil before hydro-seeding can begin.

The on-site excavation areas were graded to be consistent with the original topography and drainage considerations. The Fletcher Road ditch was restored to a condition deemed acceptable to the Erie County Highway Department. All support facilities including the decontamination pad and any containerized wash water or other waste generated during excavation activities were removed from the Site and properly disposed before project closeout. Following grading and removal of the support facilities, the excavation area was hydro-seeded by Stonewood and Waters.

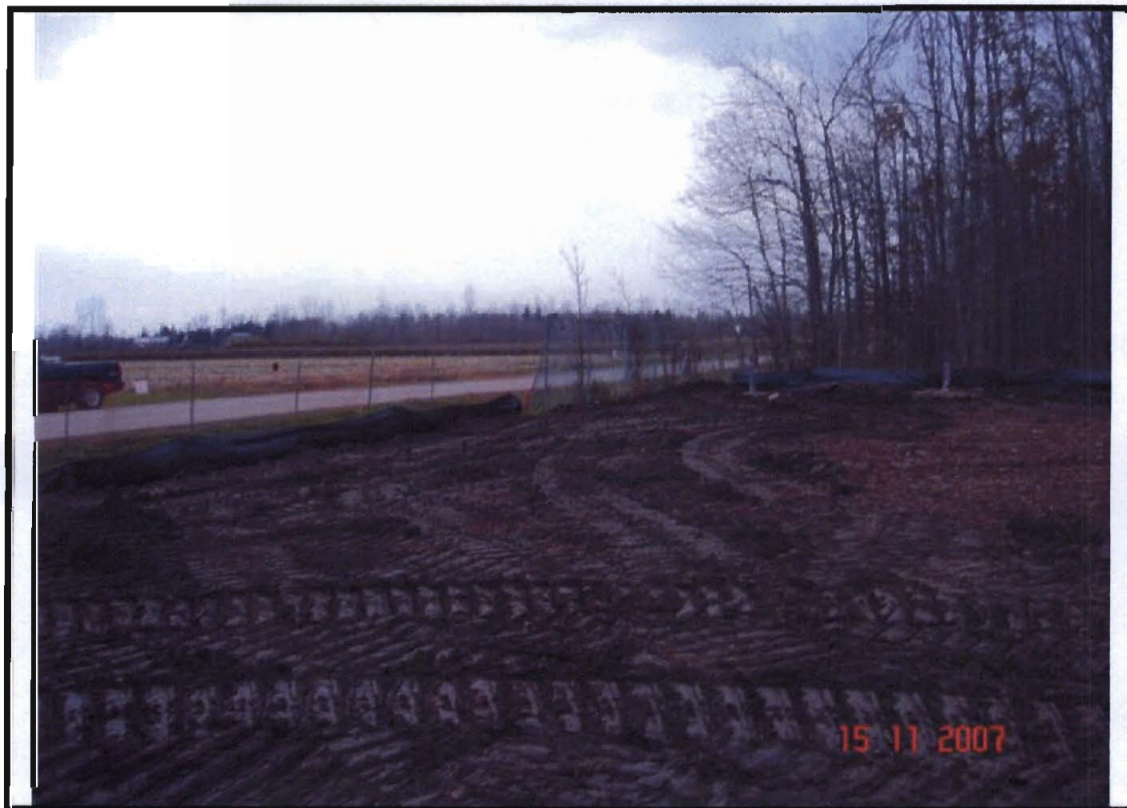
Photograph 28. View of northwest corner after grading (former contaminated waste layer area).

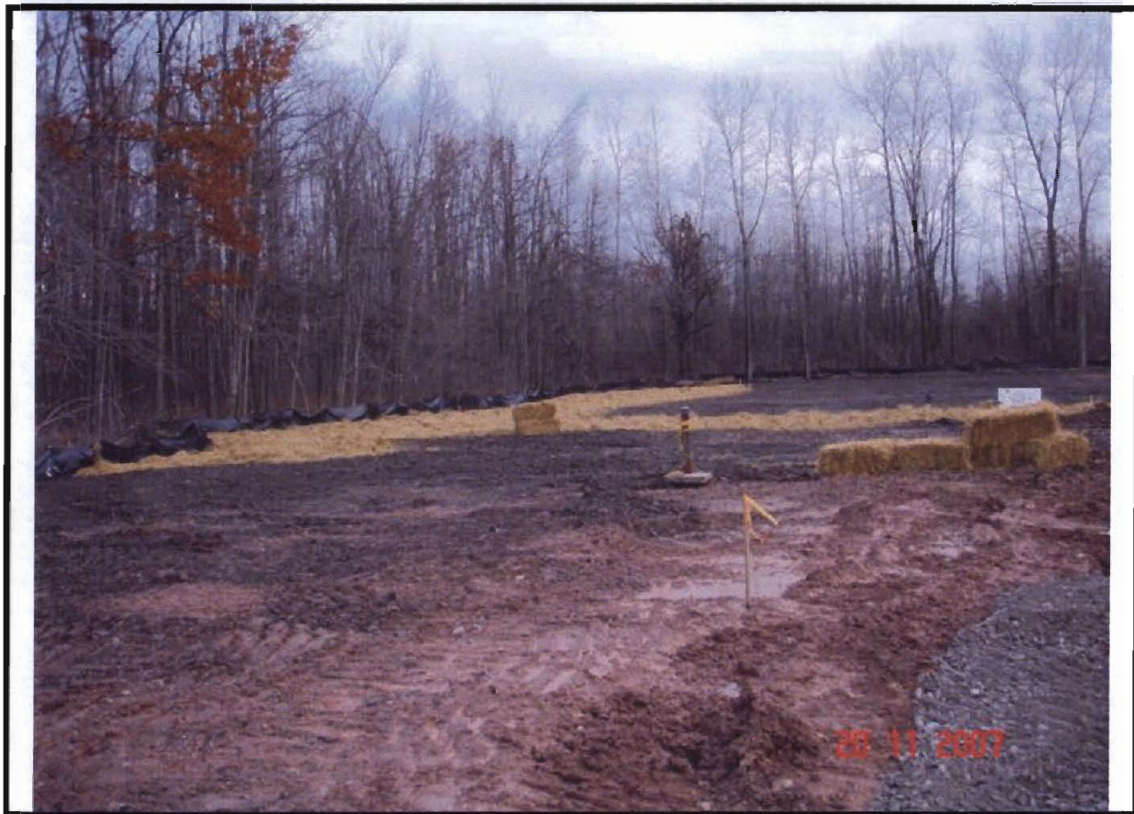
Photograph 29. Wetland restoration area.

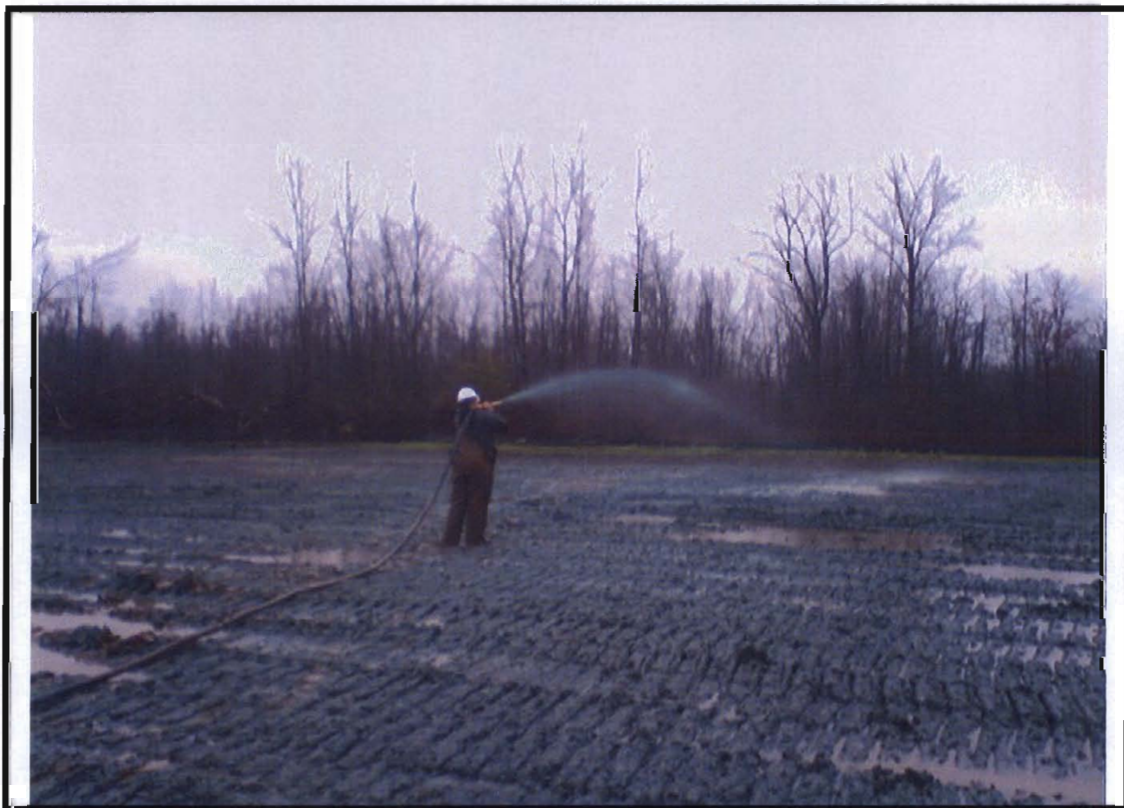
Photograph 30. Hydro-seeding of the property after final grading.
