**Re:    *National Grid Dewey/Kensington Service Center (Site #915144)***  
***2023 Annual Groundwater Monitoring Report***

# 2023 Annual Groundwater Monitoring Report

National Grid Dewey/Kensington Service Center  
93 Dewey Avenue, Buffalo, NY 14214  
915144

January 2024

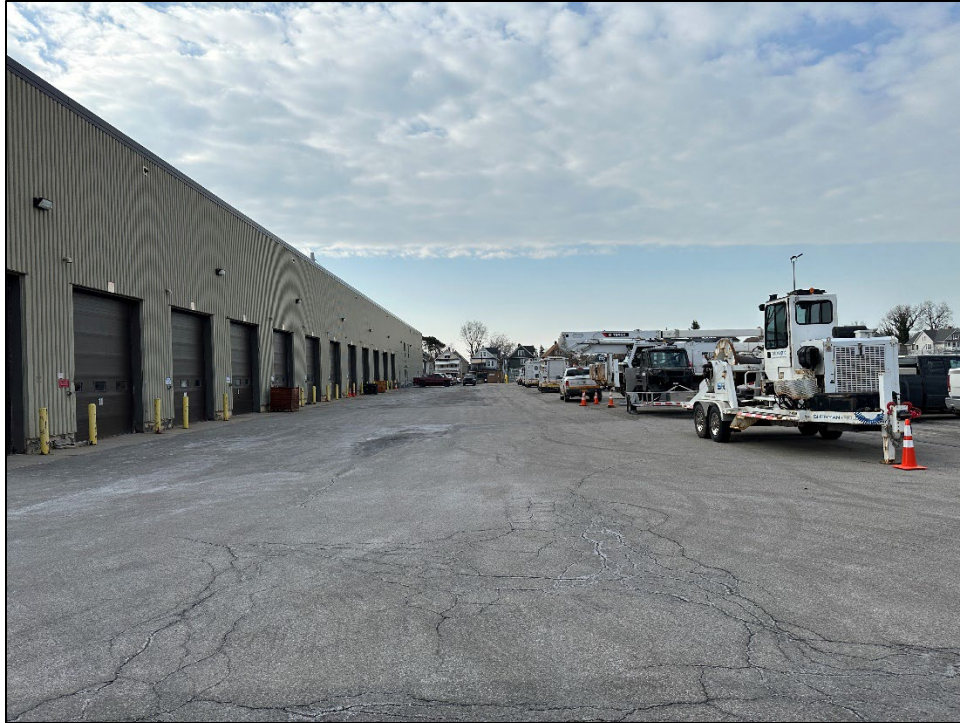
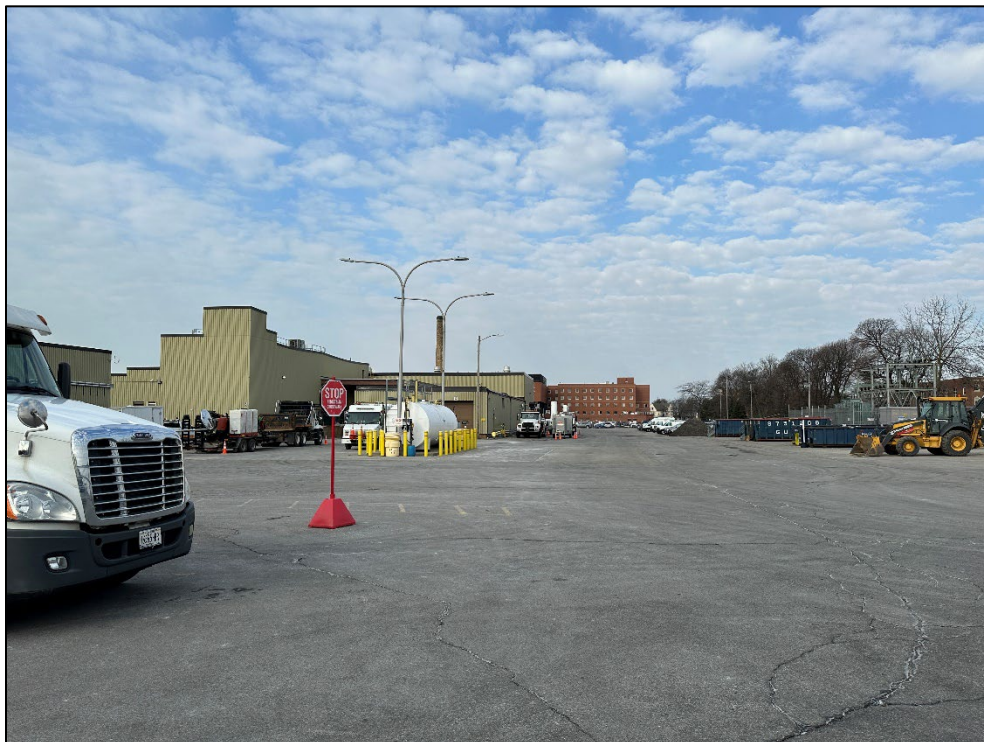
Site Conditions on March 21, 2023

Manways MW-20, MW-21 and MW-24 that were replaced in June 2022 looked good. MW-6 is secure but the concrete pad is cracked.

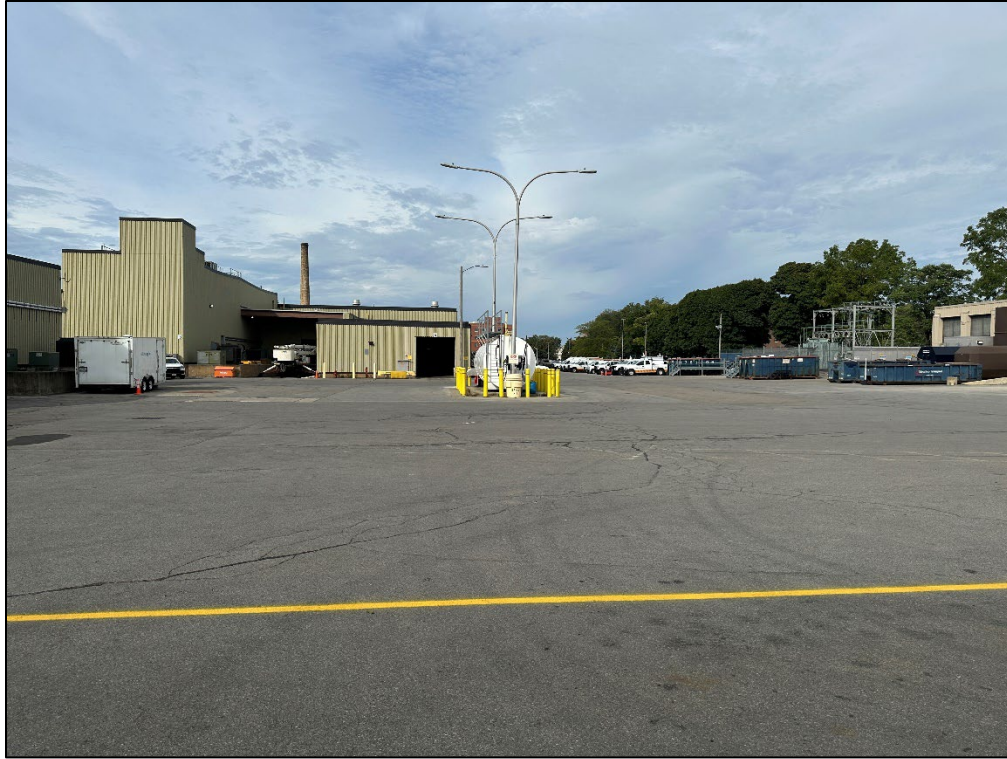
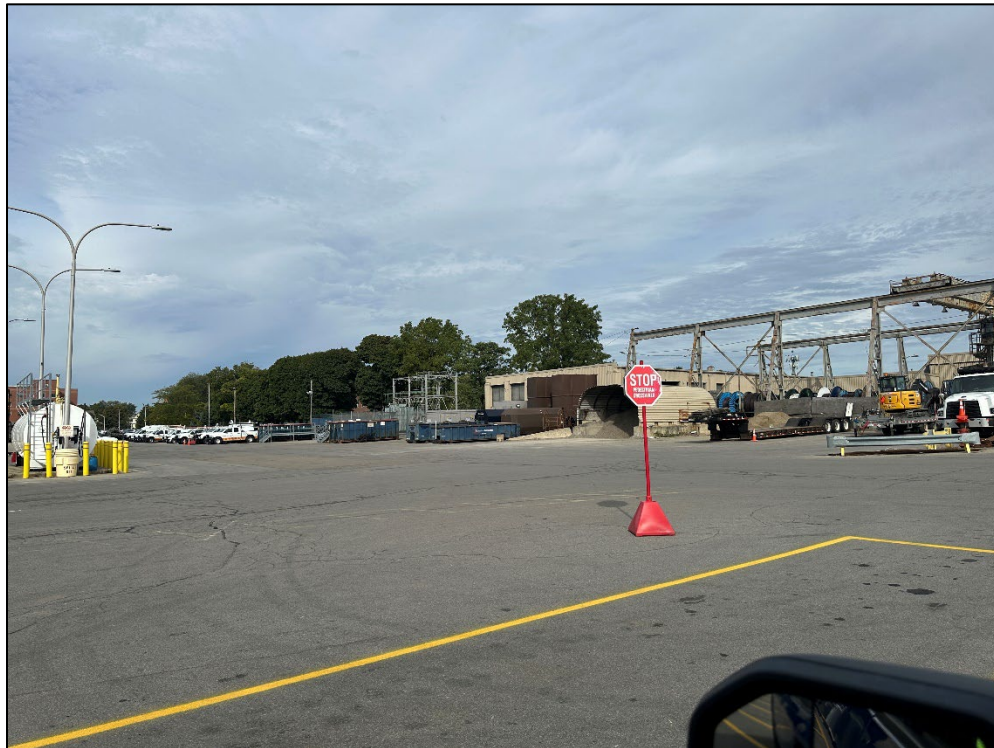
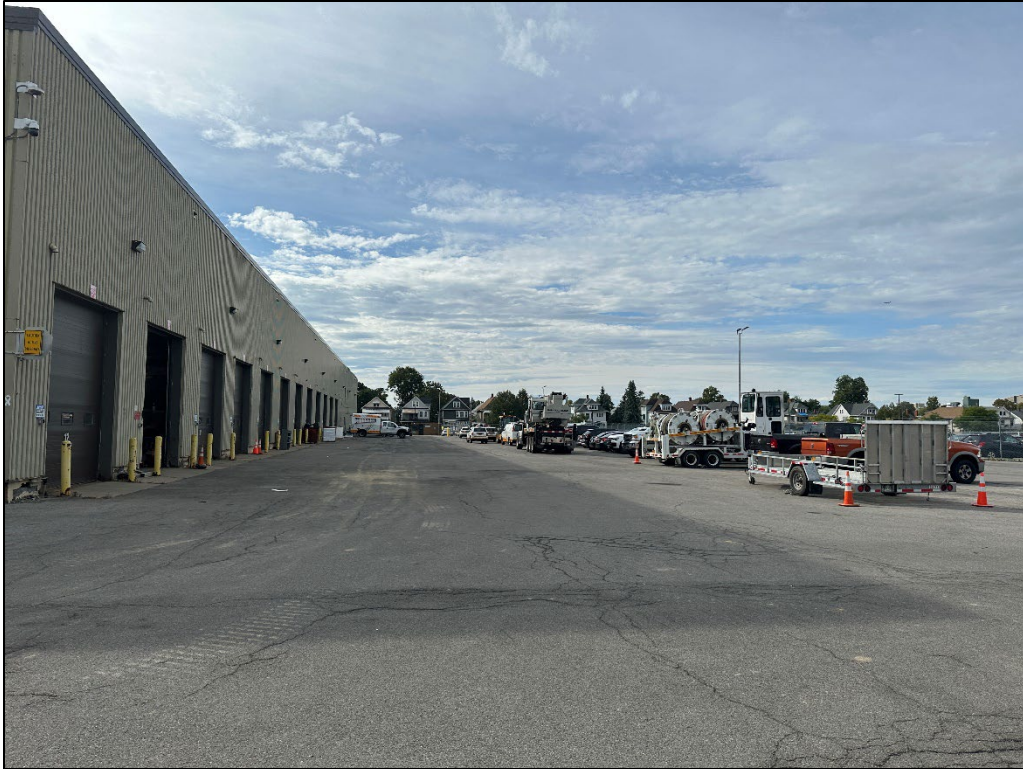
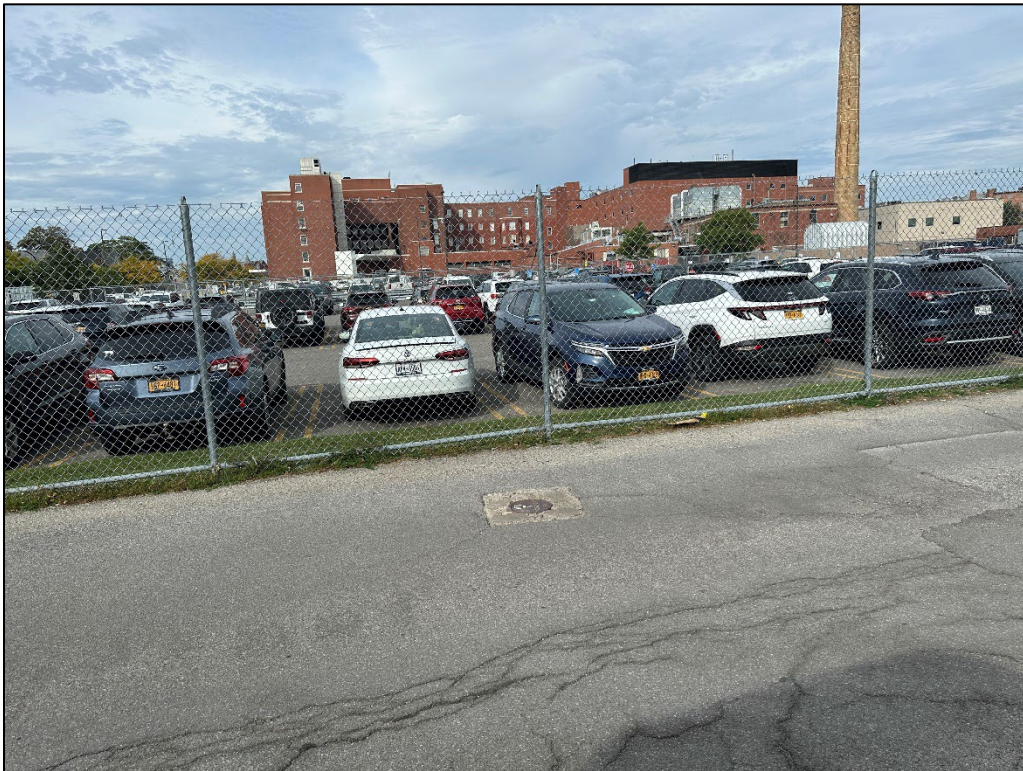
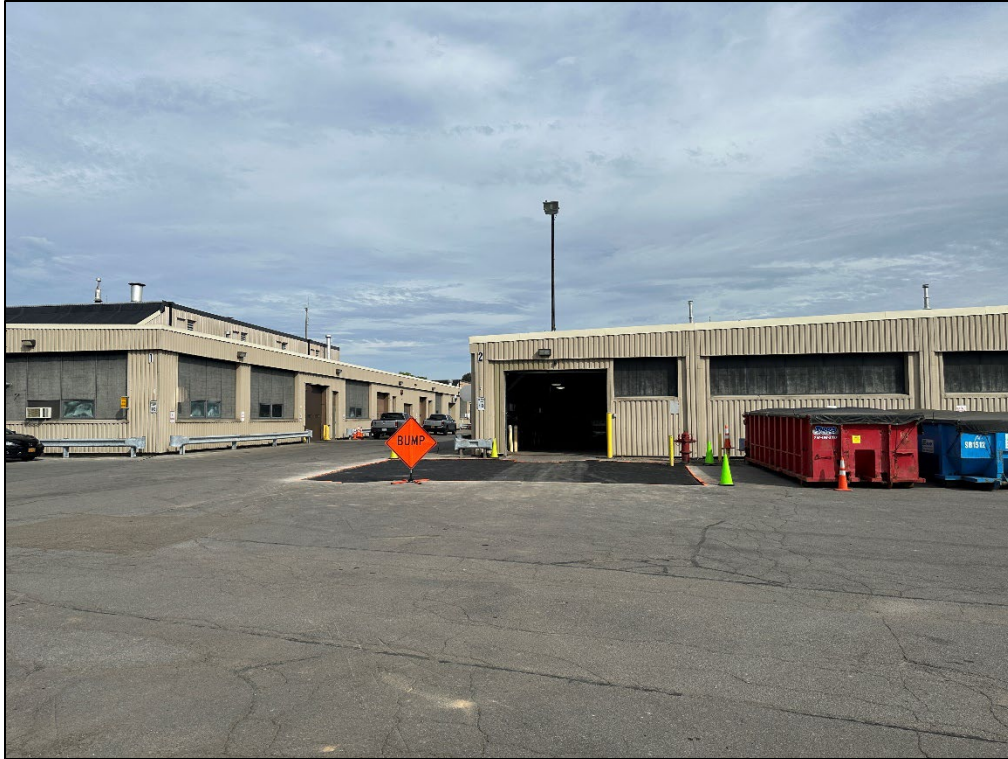
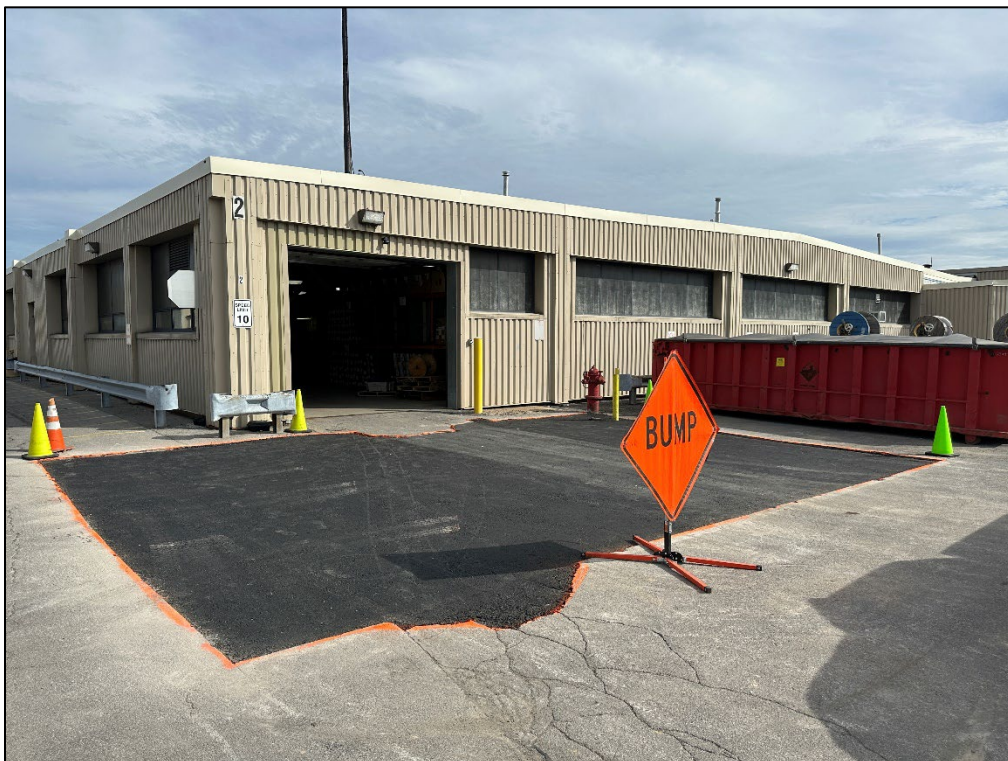
Site Conditions on September 28, 2023

Manways MW-20, MW-21 and MW-24 that were replaced in June 2022 looked good.  
Manways MW-6 and MW-25 are secure but the concrete pads are cracked.
