**TYCO / SCOTT AVIATION FACILITY
LANCASTER, NEW YORK**

**PHASE II ENVIRONMENTAL SITE
INVESTIGATION SUMMARY REPORT**

June 2004

Earth Tech Project No. 76482

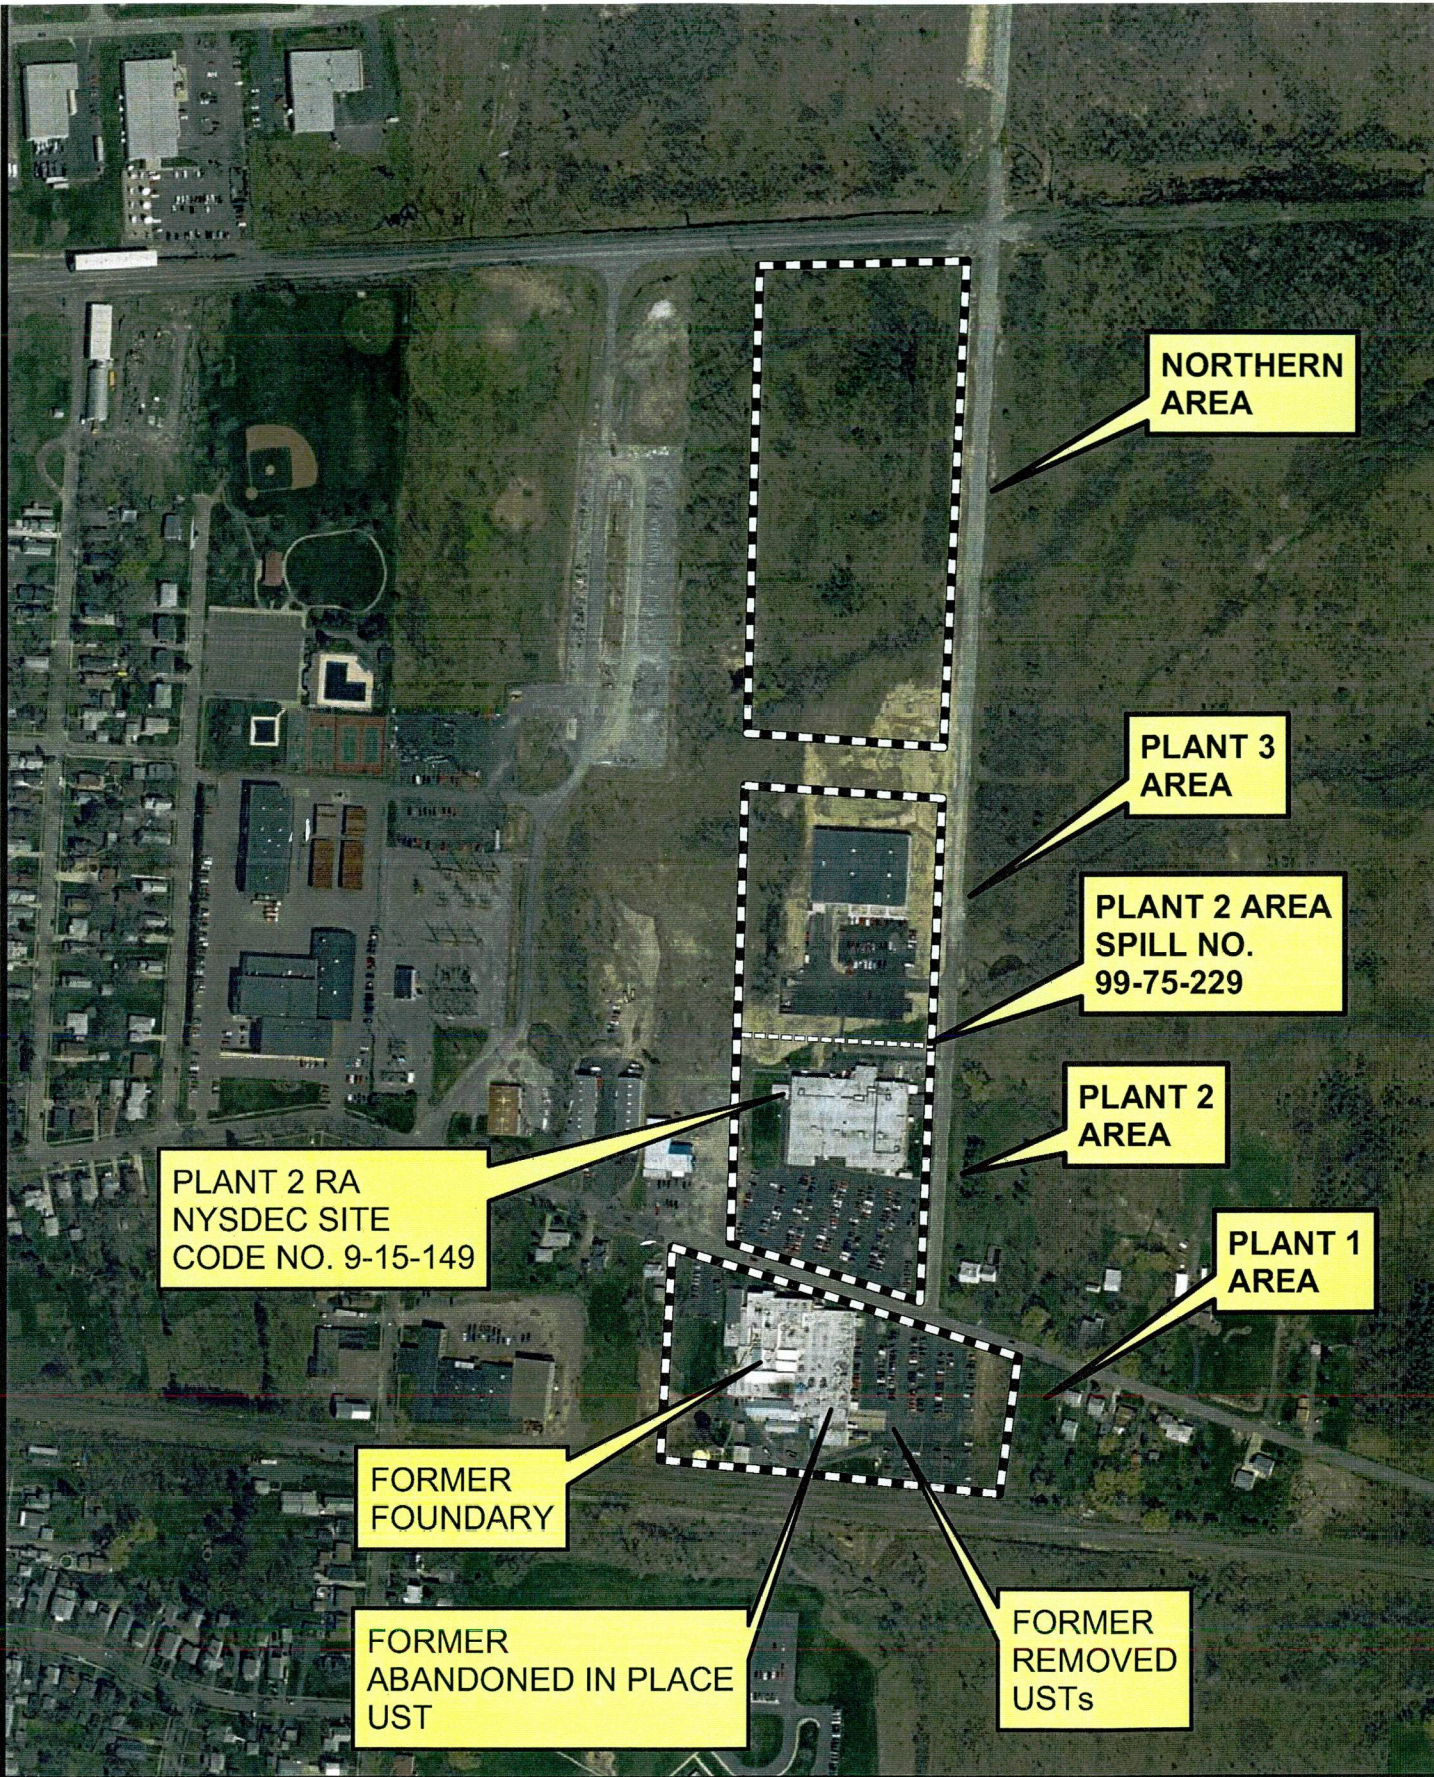
TYCO - SCOTT AVIATION
Lancaster, New York
PHASE II SITE INVESTIGATION
SITE LAYOUT

The overall property is comprised of several adjoining parcels as presented in Figure 1. Although the property is comprised of multiple adjoining parcels, for convenience of discussion in this summary report, the property has been broken into three general areas: northern property (area north of plant 3, essentially undeveloped); Plant No. 2/Plant No. 3 area (developed parcels north of Erie Avenue, west of Walter Winter Drive, south of northern property); and Plant No. 1 area (developed area south of Erie Avenue). The approximate area of the overall plant property is 25-acres (the plant), about one-third of which is improved as buildings or parking areas. (Additional detail regarding parcel identification can be found in the Phase I Environmental Site Assessment Report (Earth Tech, April 12, 2004.))

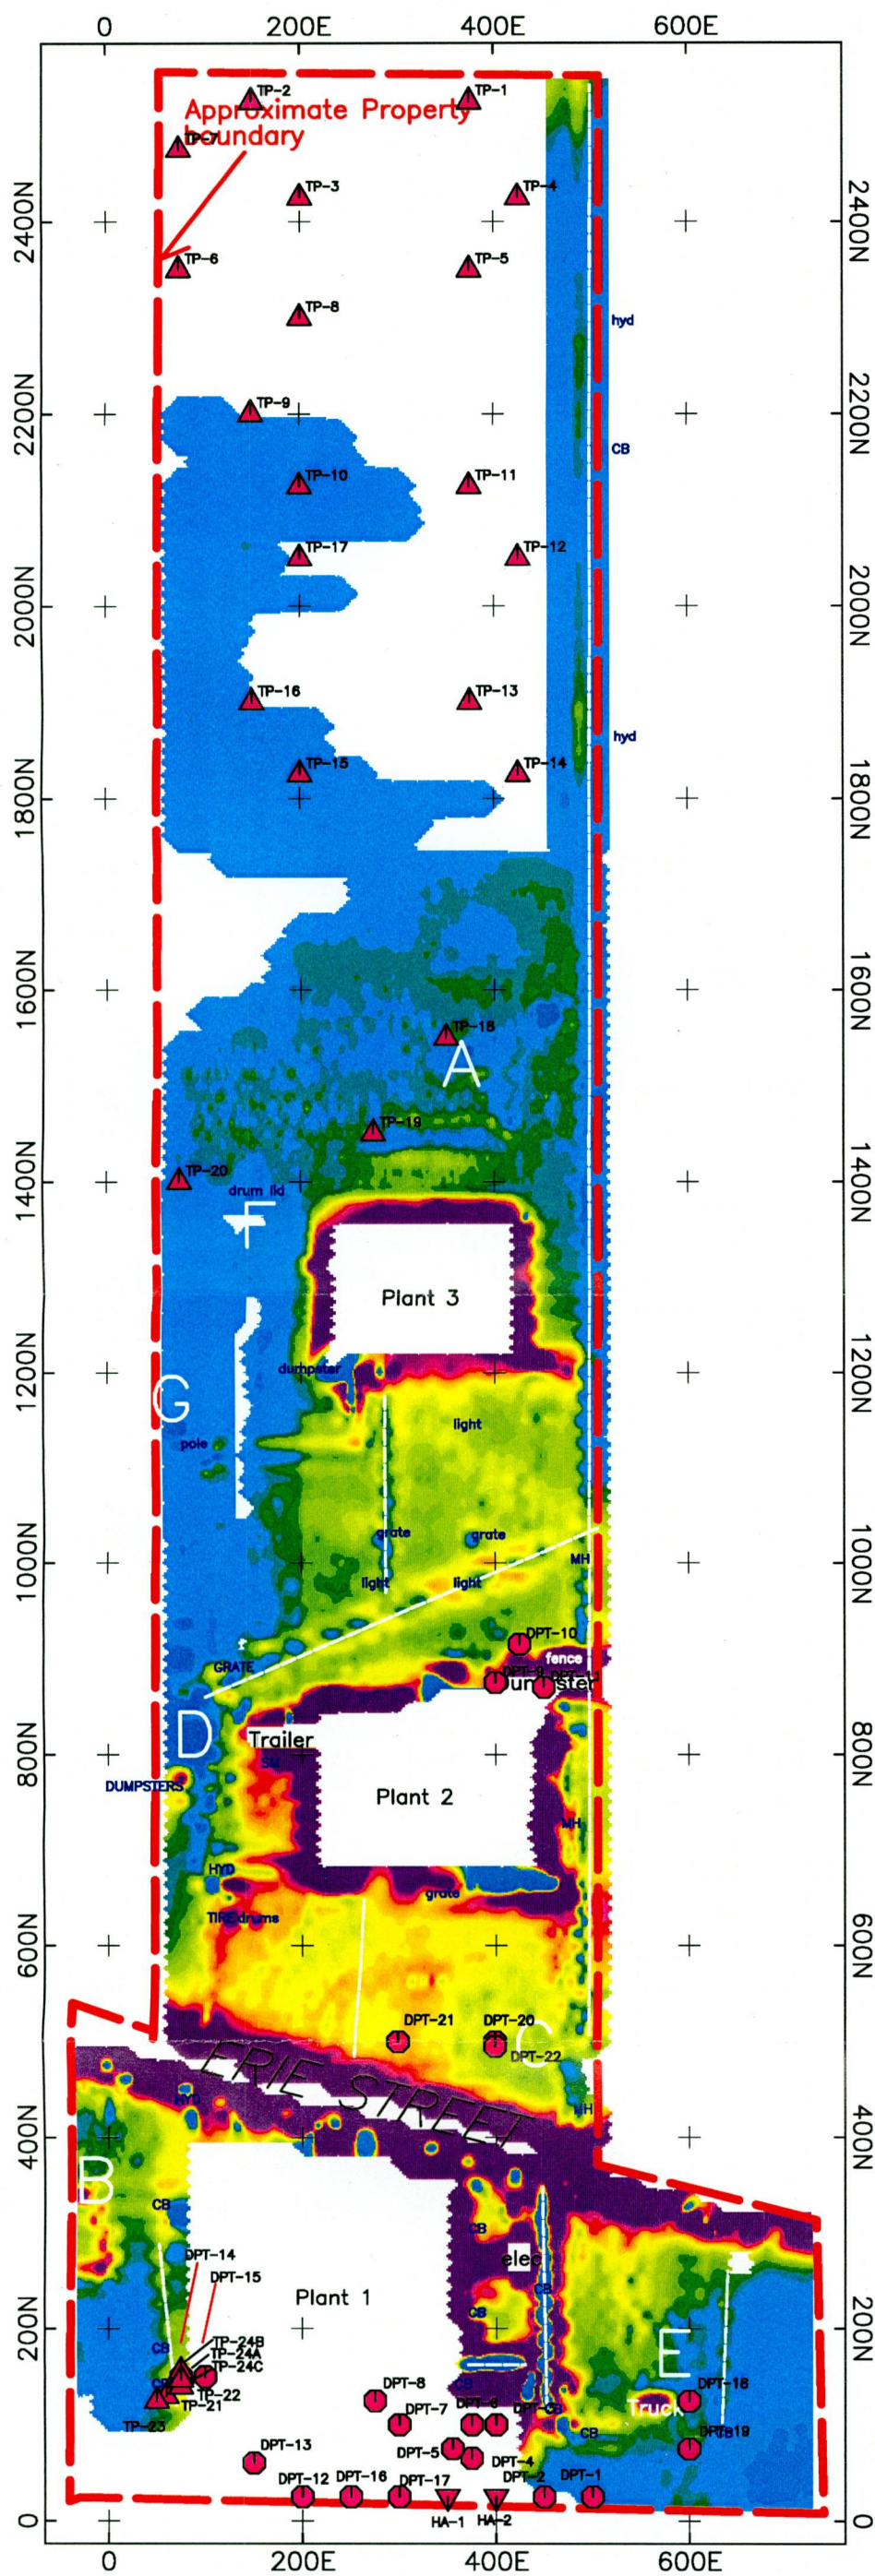
EM31 Conductivity Data
(mS/m)

Interpretation of the raw geophysical data resulted in the identification of seven anomalies, labeled A through G (refer to Appendix I for additional detail). All anomalies were determined to be attributable to non-hazardous sources, as follows:

- Anomaly F – Presence of a single, steel drum lid observed on surface. No other indications of buried metal observed.
- Anomaly G – Presence of steel guy wire adjacent to a utility pole observed.

The geophysical conductivity and inphase data from the EM31 survey are presented as color contour maps in Figure 1 and 2, respectively. Conductivity values at the site were observed to range from below 0 mS/m to over 70 mS/m. This variation in conductivity may be related to any one or combination of the following conditions:

Anomaly A is an anomalous zone in the eastern portion of a sparsely vegetated field north of Plant 3. Construction and Demolition (C&D) debris were observed coincident with this anomaly. The inphase data is highly variable in this area suggesting the presence of surface or buried metals.

Anomaly B is located in a grassy area west of Plant 1 in close proximity to a neighboring residence. The conductivity data of Figure 1 suggests a linear buried metallic feature. The adjacent property owner indicated that he installed a buried dog fence in this area. If this fence had been energized, it might explain the observed response.

Each of the anomalies identified in the geophysical survey have been adequately explained and do not indicate any areas of concern. No further action is recommended at areas investigated via the geophysical survey.

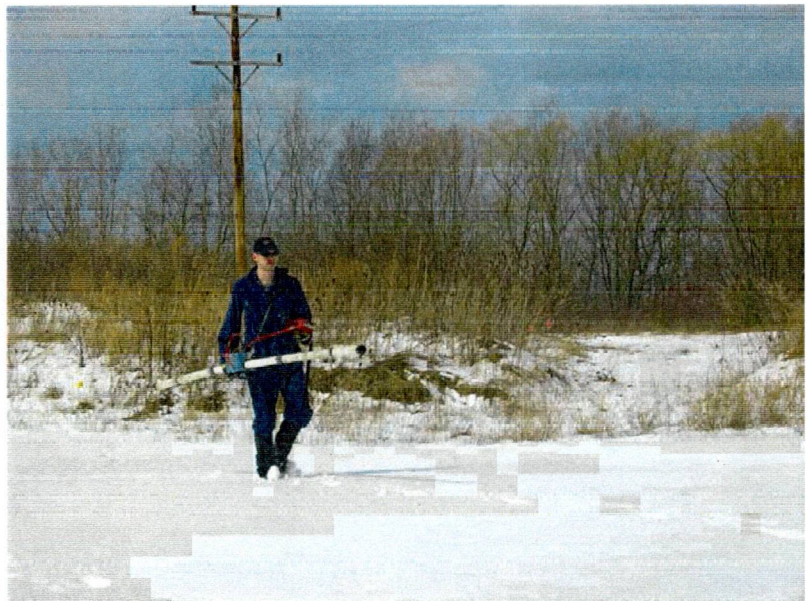
A Geonics EM31 Terrain Conductivity meter was used to measure and record the quadrature component (ground conductivity) and the inphase component of the EM field along the survey lines. The quadrature component of the EM field is a measurement of the apparent ground conductivity. The inphase component of the EM field is sensitive to metallic objects. Comparison of the quadrature component of the EM field data (expressed in units of milliSiemens per meter (mS/m)) and the inphase component data (expressed in units of parts per

EM31 in use at the site

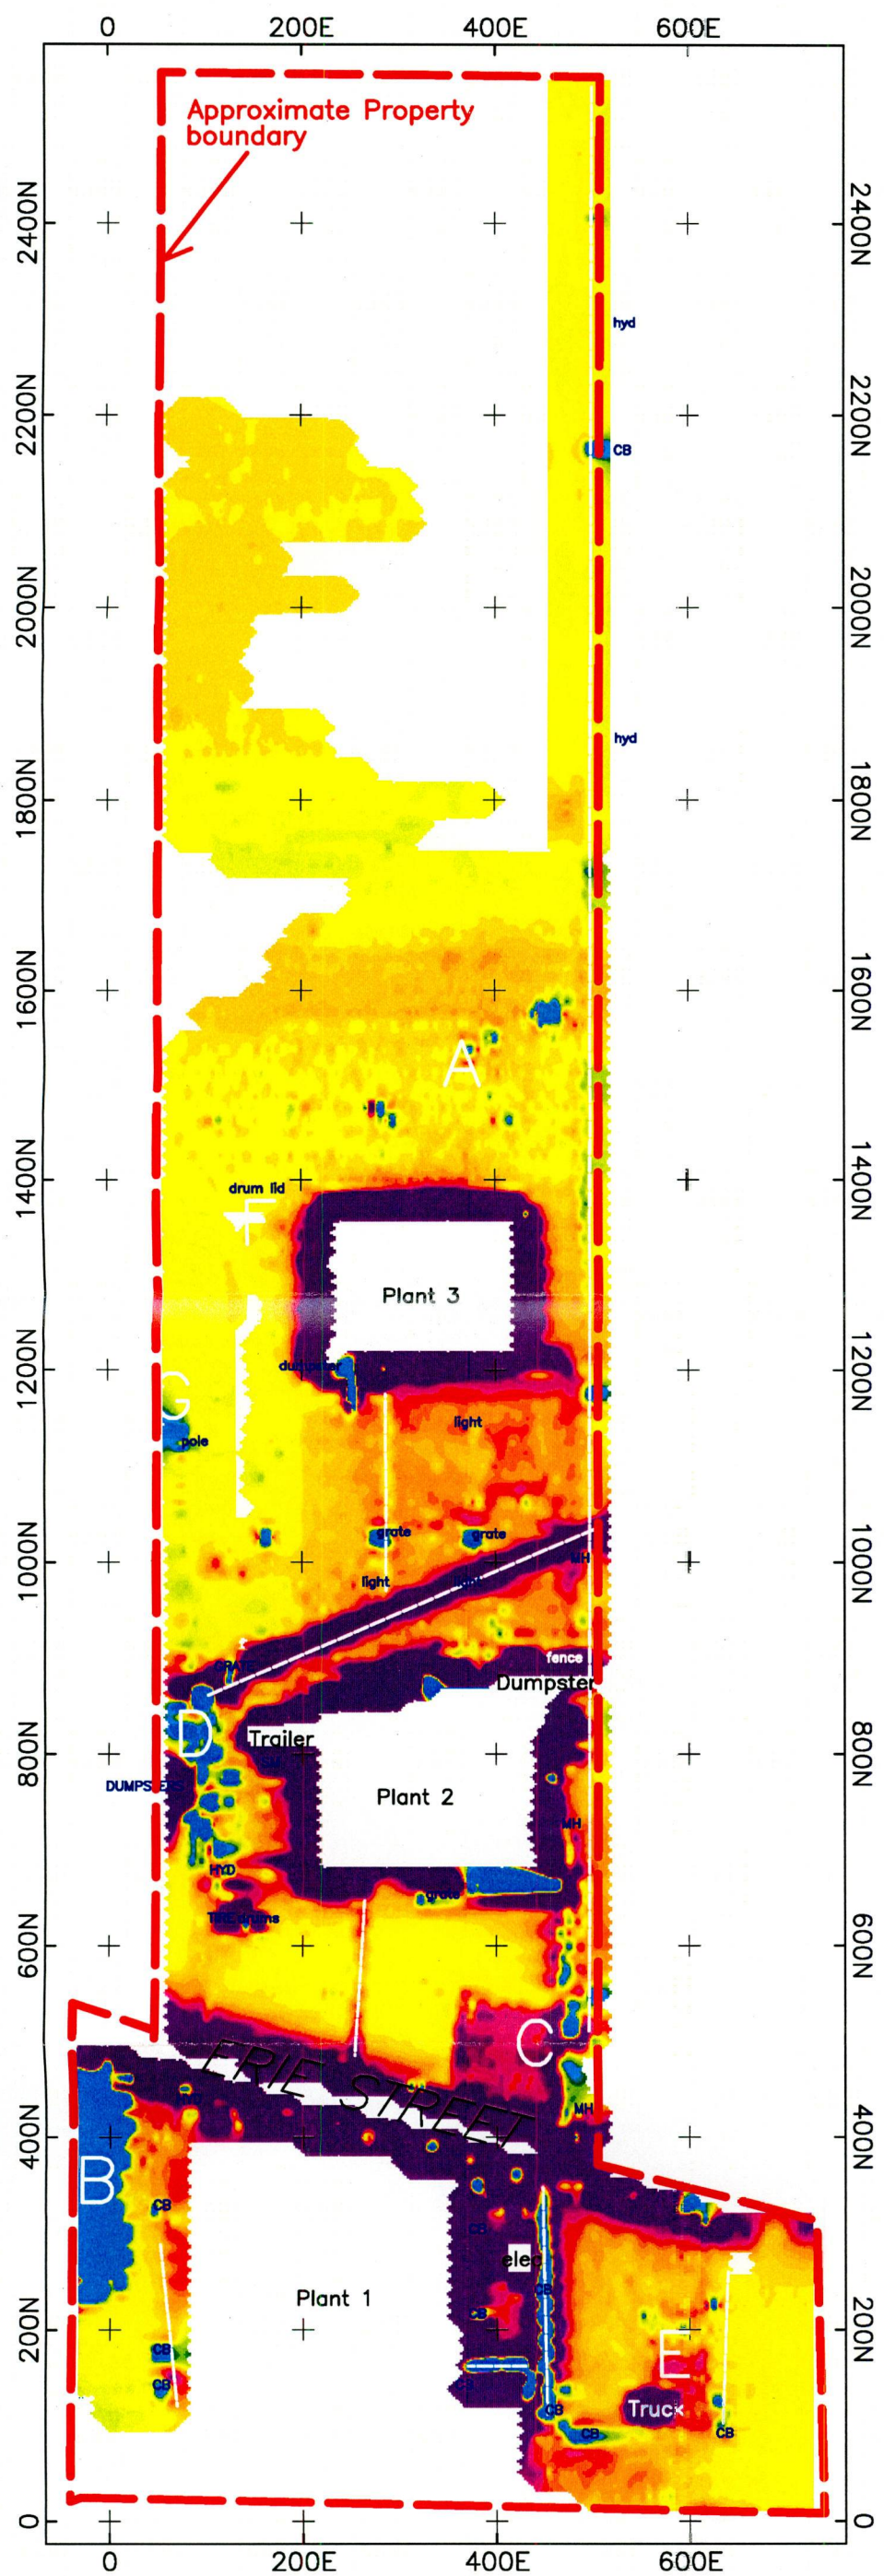
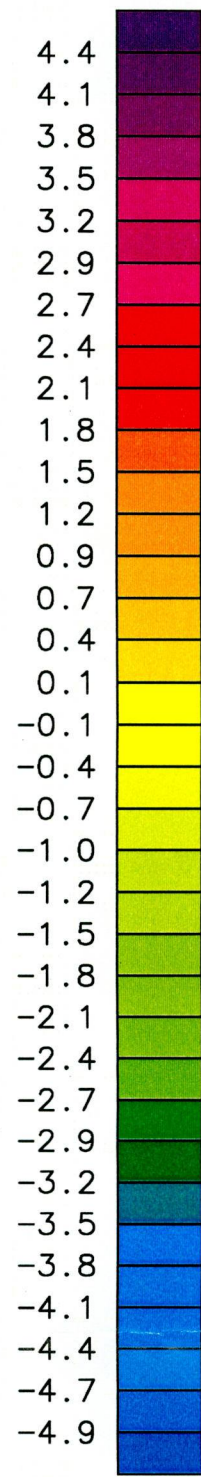
Inphase Response
(ppt)

Anomalous Areas D, F, and G are located near the western property boundary in the Plant 2 and Plant 3 areas. These anomalies are characterized by inphase values (and to a lesser extent, conductivity values) fluctuating rapidly over a short distance. These areas likely contain buried metals. A drum lid was observed at surface in the vicinity of Anomaly F. A utility pole is present near Anomaly G and this anomaly may be related to a guy wire or buried lines.
