Site Management Plan

Leica Microsystems, Inc.

NYSDEC Site No. 915156

27 August 2020

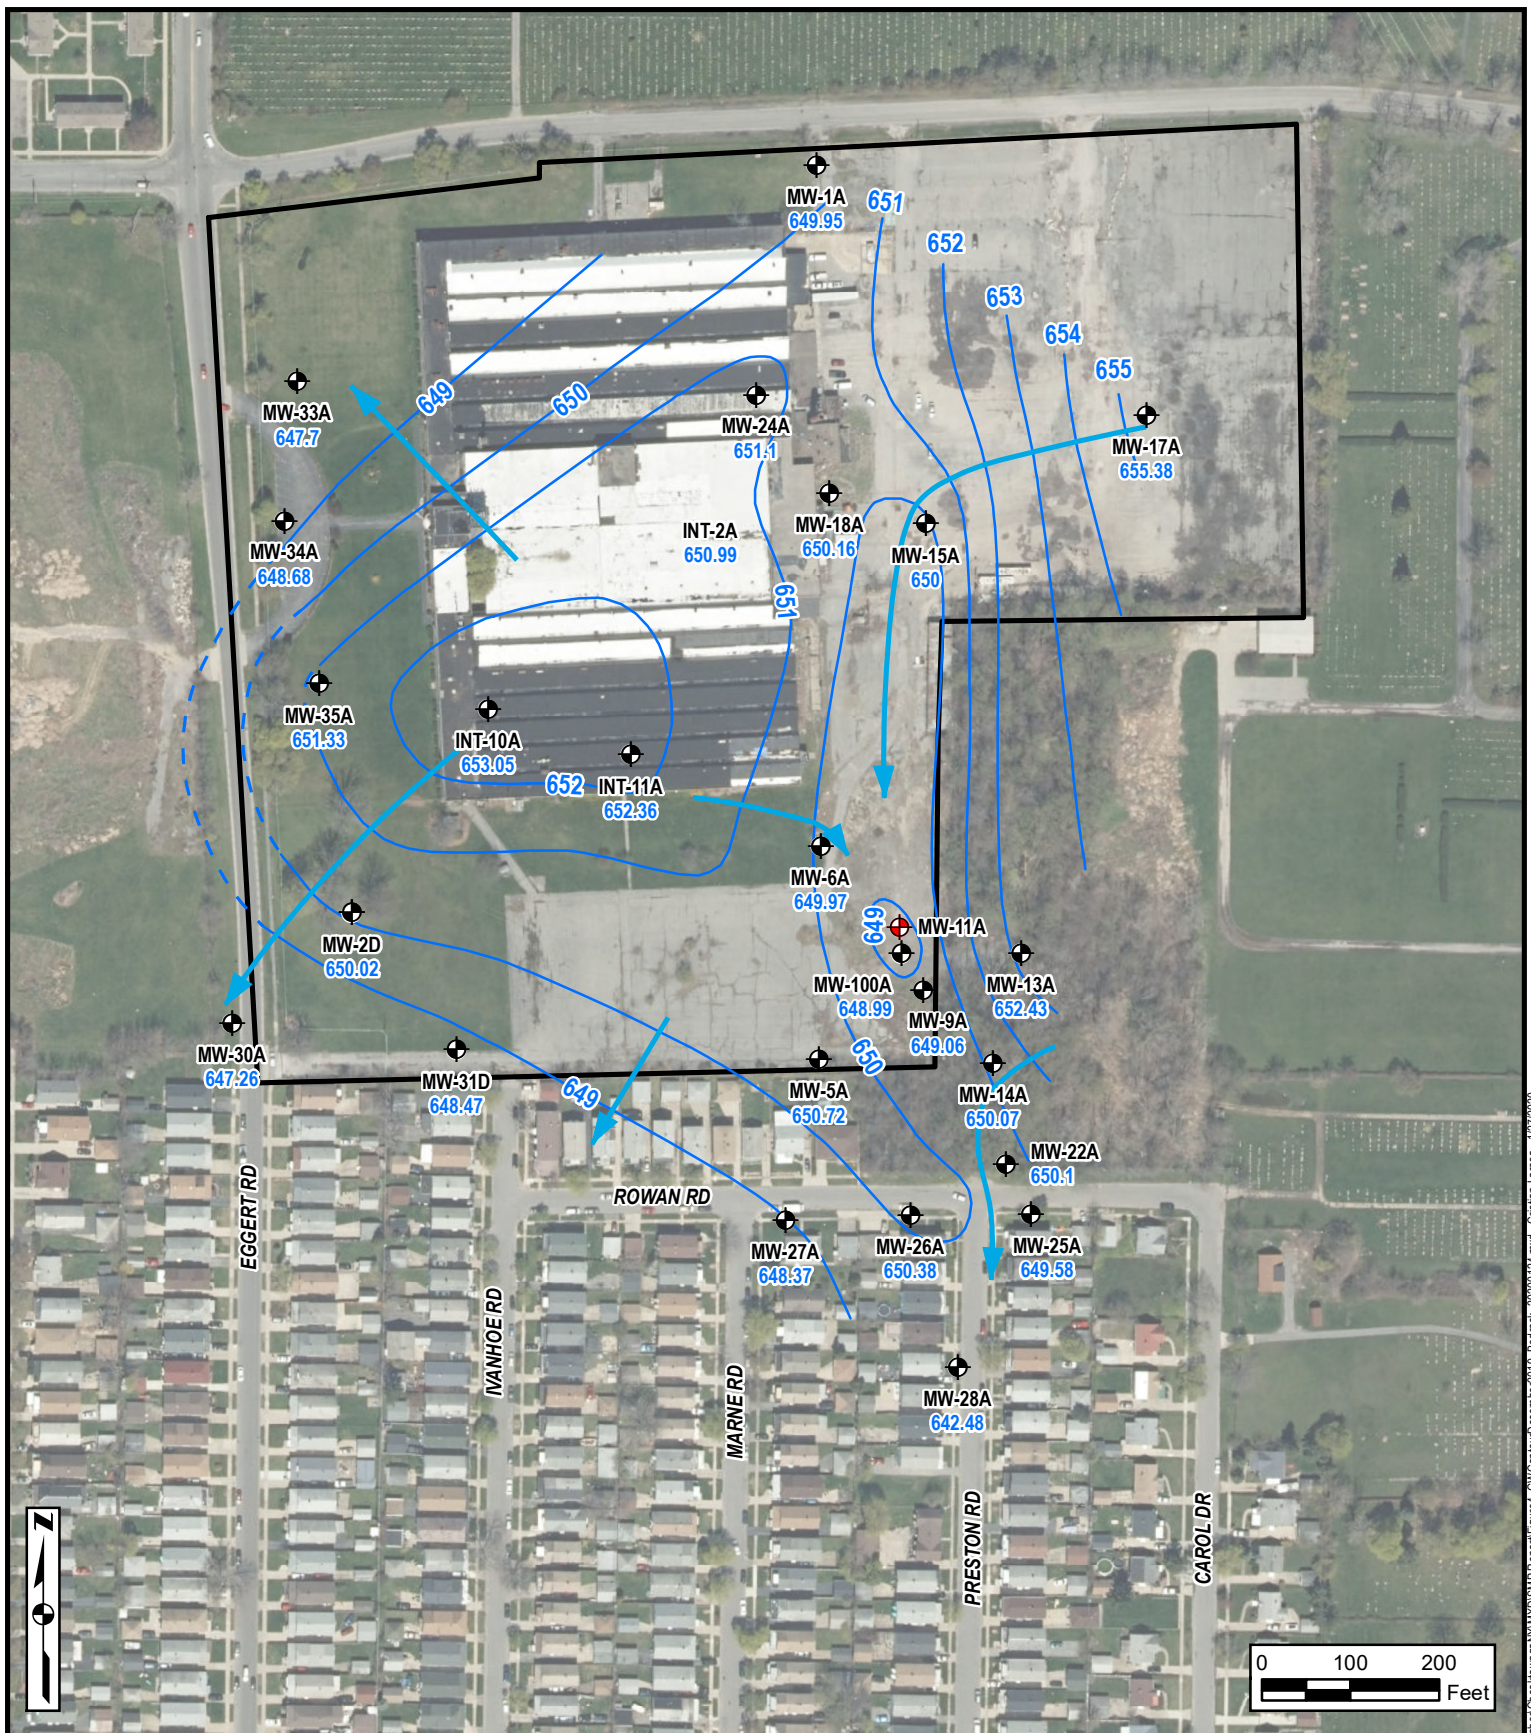
Figure 3: December 2019 Overburden
Groundwater Elevation Contour Map
Former Leica, Inc. Facility
203 Eggert Road
Cheektowaga, New York

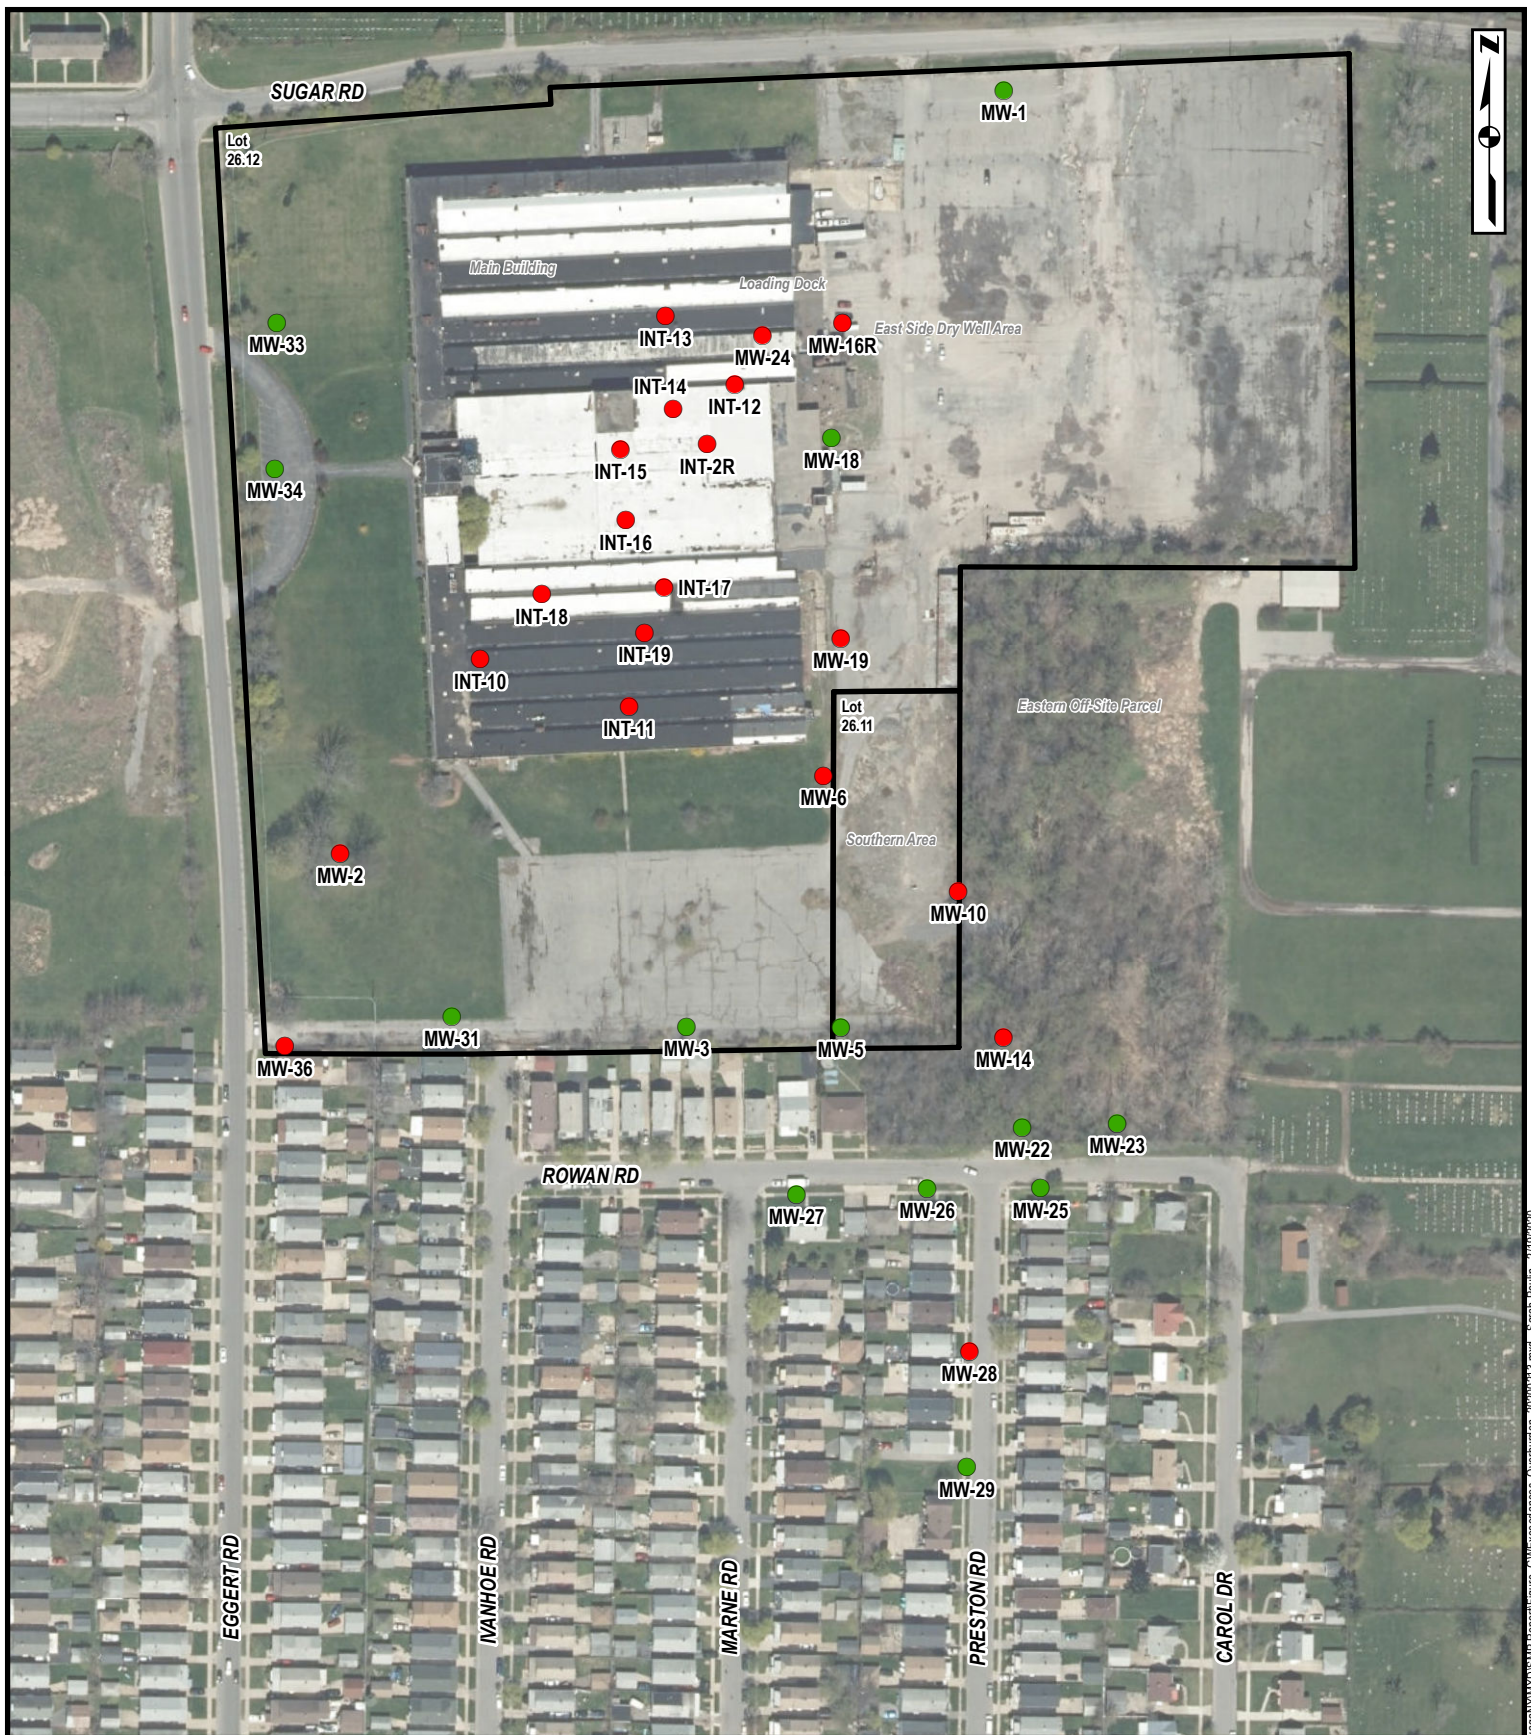
Figure 4: December 2019 Bedrock Groundwater Elevation Contour Map
Former Leica, Inc. Facility
203 Eggert Road
Cheektowaga, New York

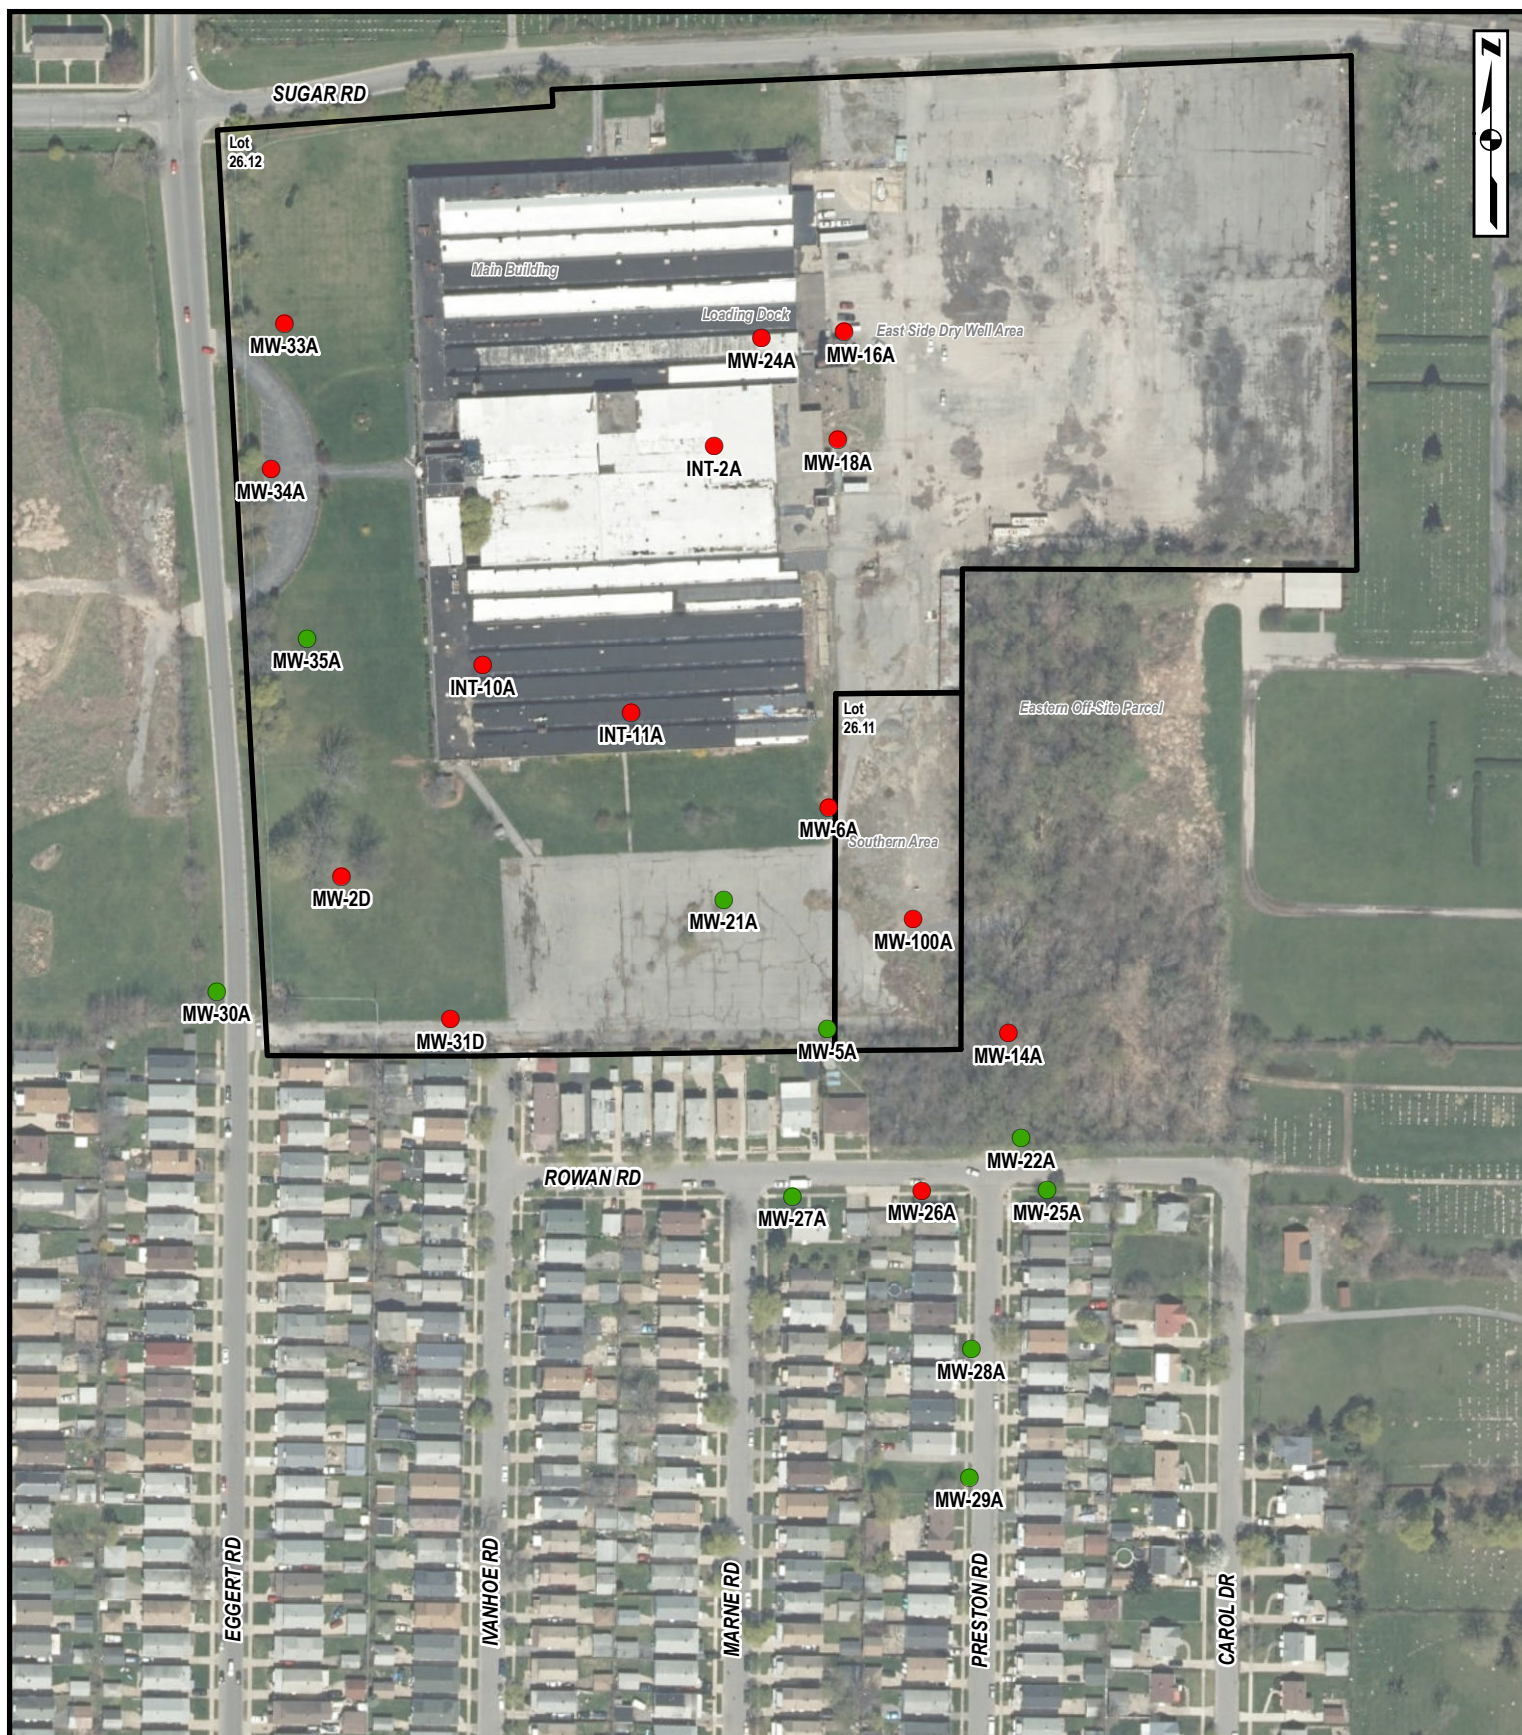
Figure 6: Summary of Contaminants of Concern in Overburden Groundwater
 Former Leica, Inc. Facility
 203 Eggert Road
 Cheektowaga, New York

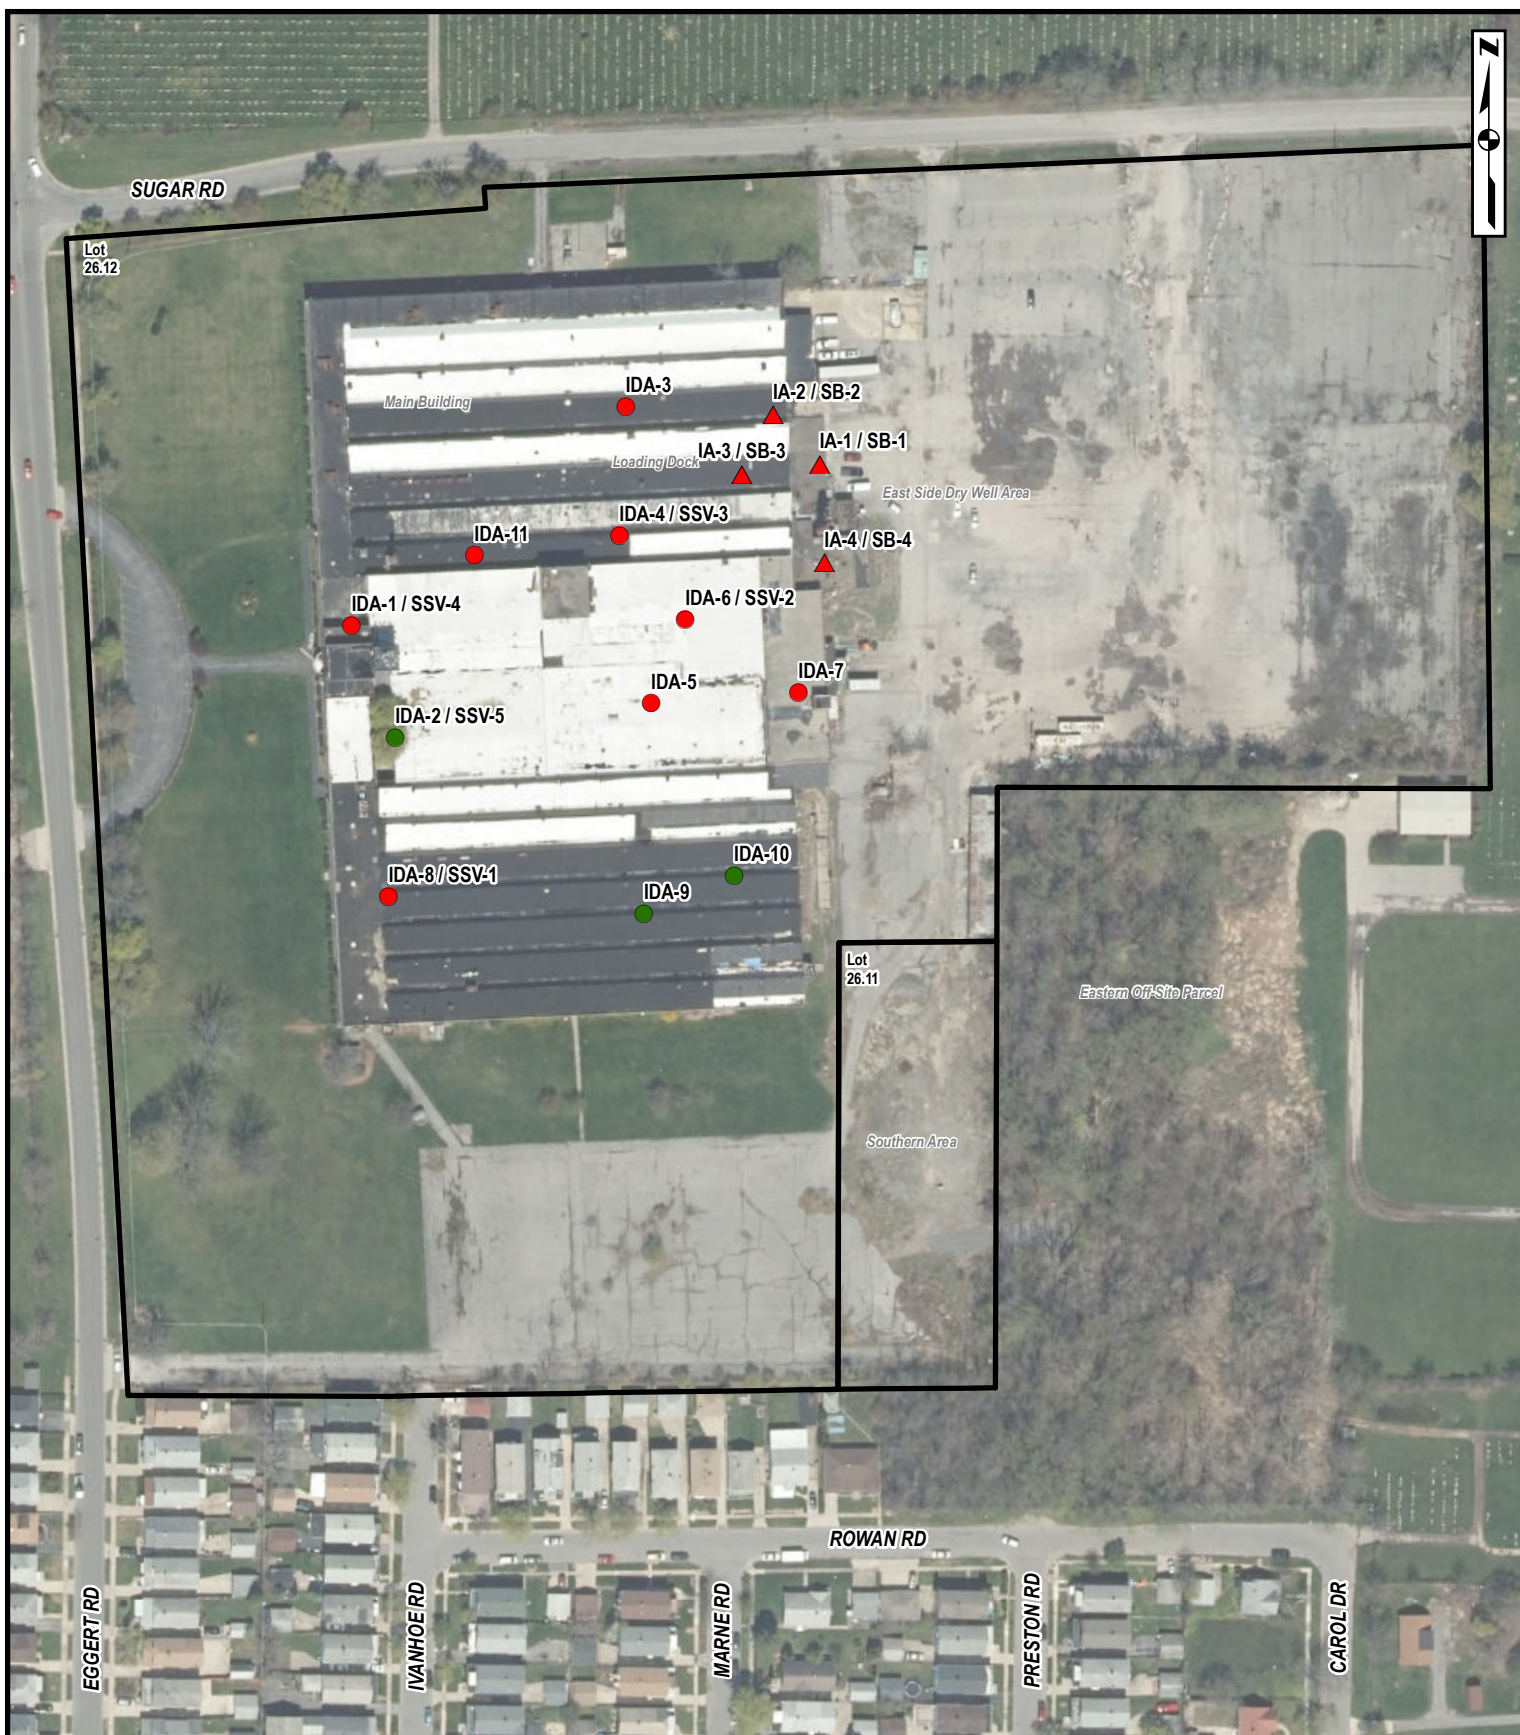
Figure 7: Summary of Contaminants of Concern in Bedrock Groundwater
 Former Leica, Inc. Facility
 203 Eggert Road
 Cheektowaga, New York

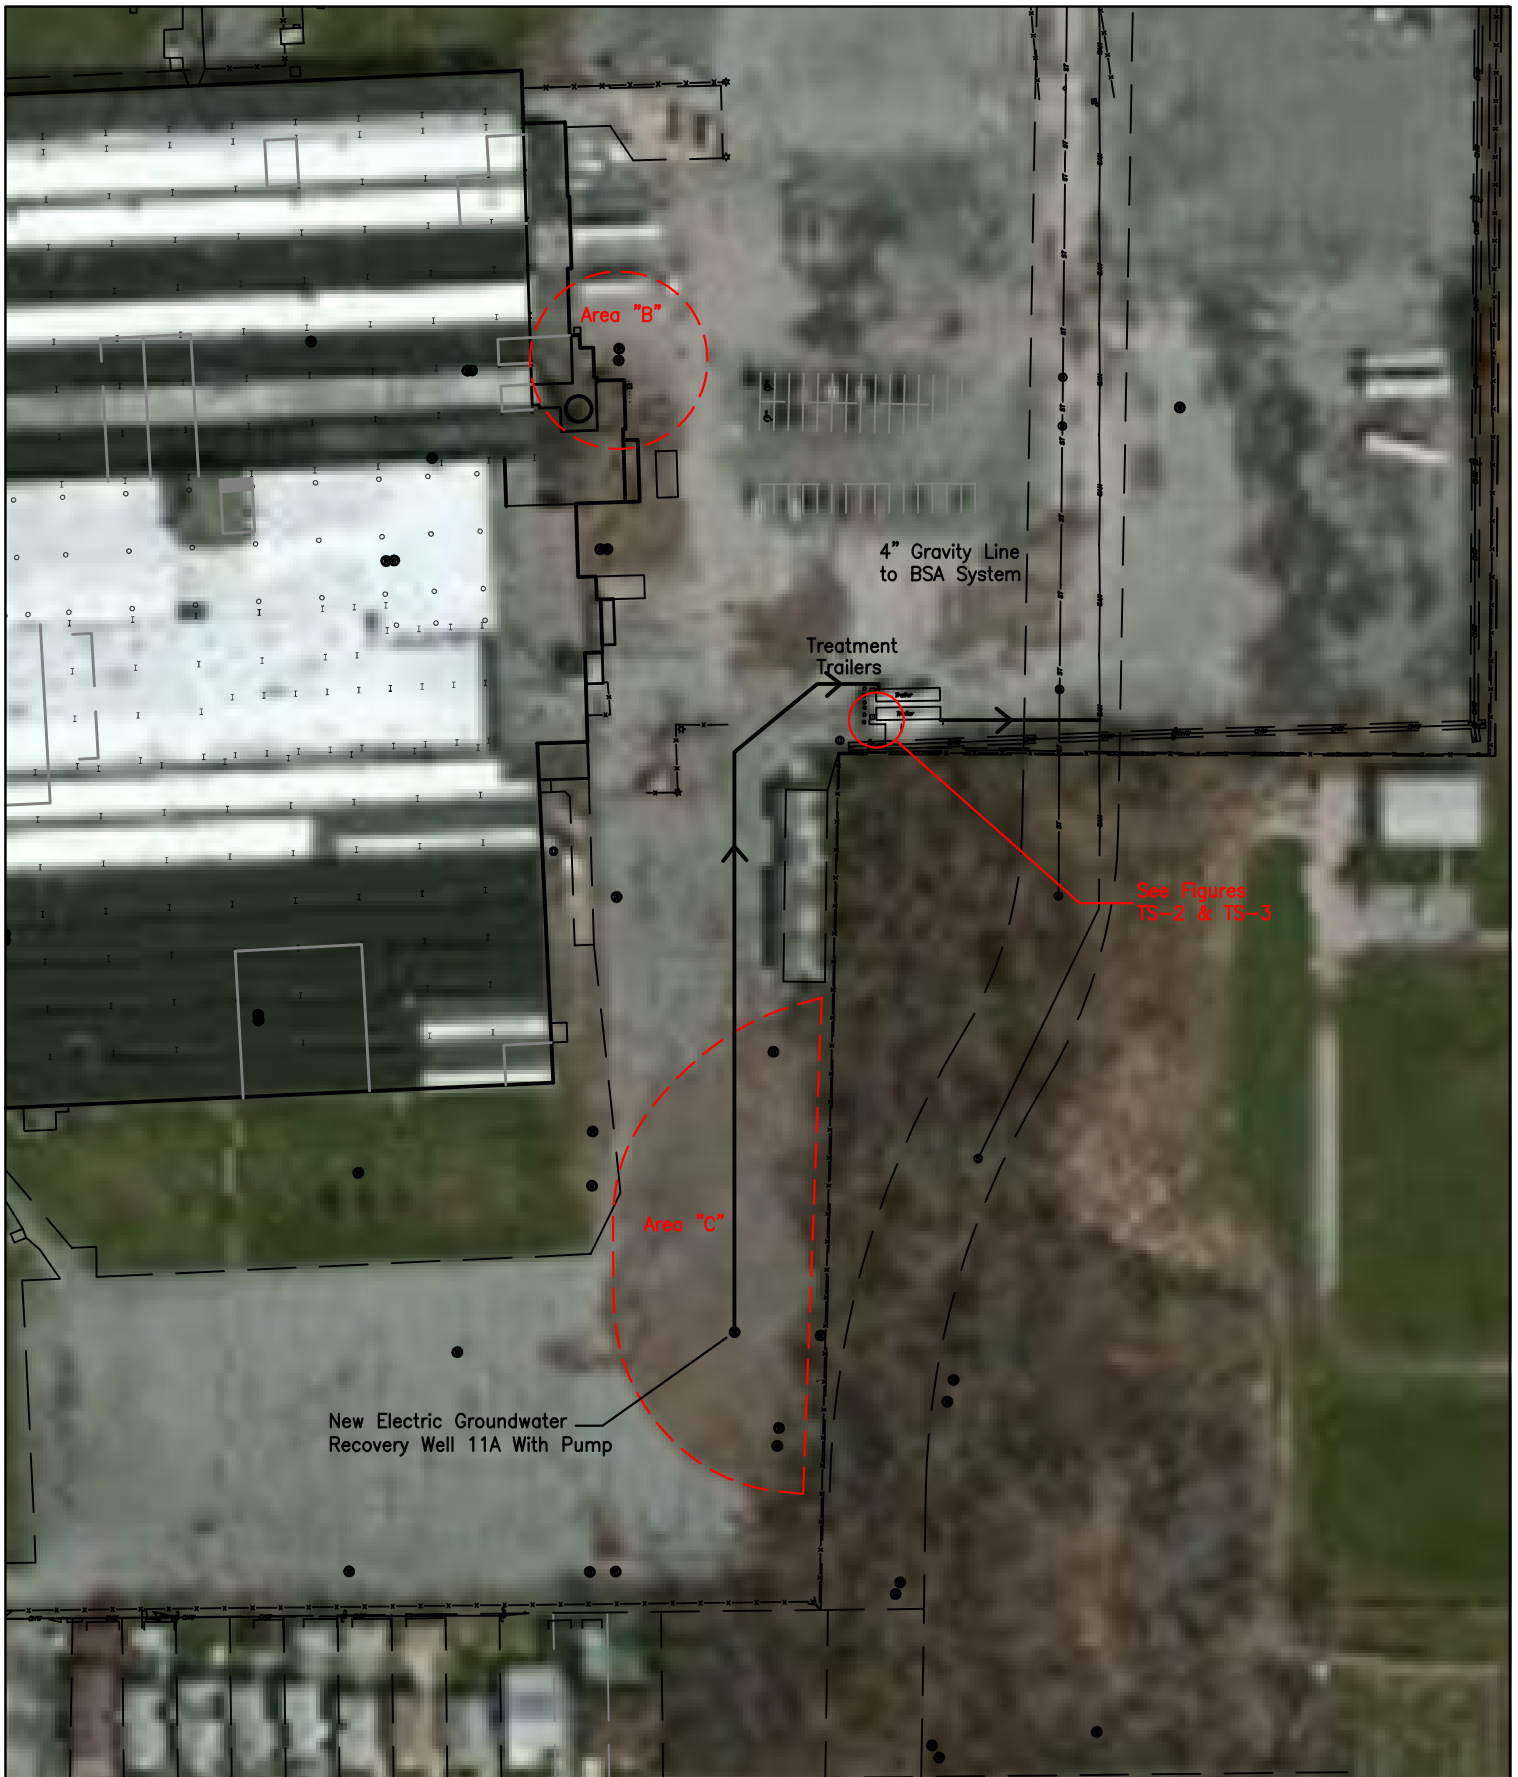
APPENDIX E GROUNDWATER EXTRACTION SYSTEM AS BUILT

DOCUMENT CONTROL NO.	PROJECT	LEICA MICROSYSTEMS INC. 203 EGGERT RD CHEEKTOWAGA, NY

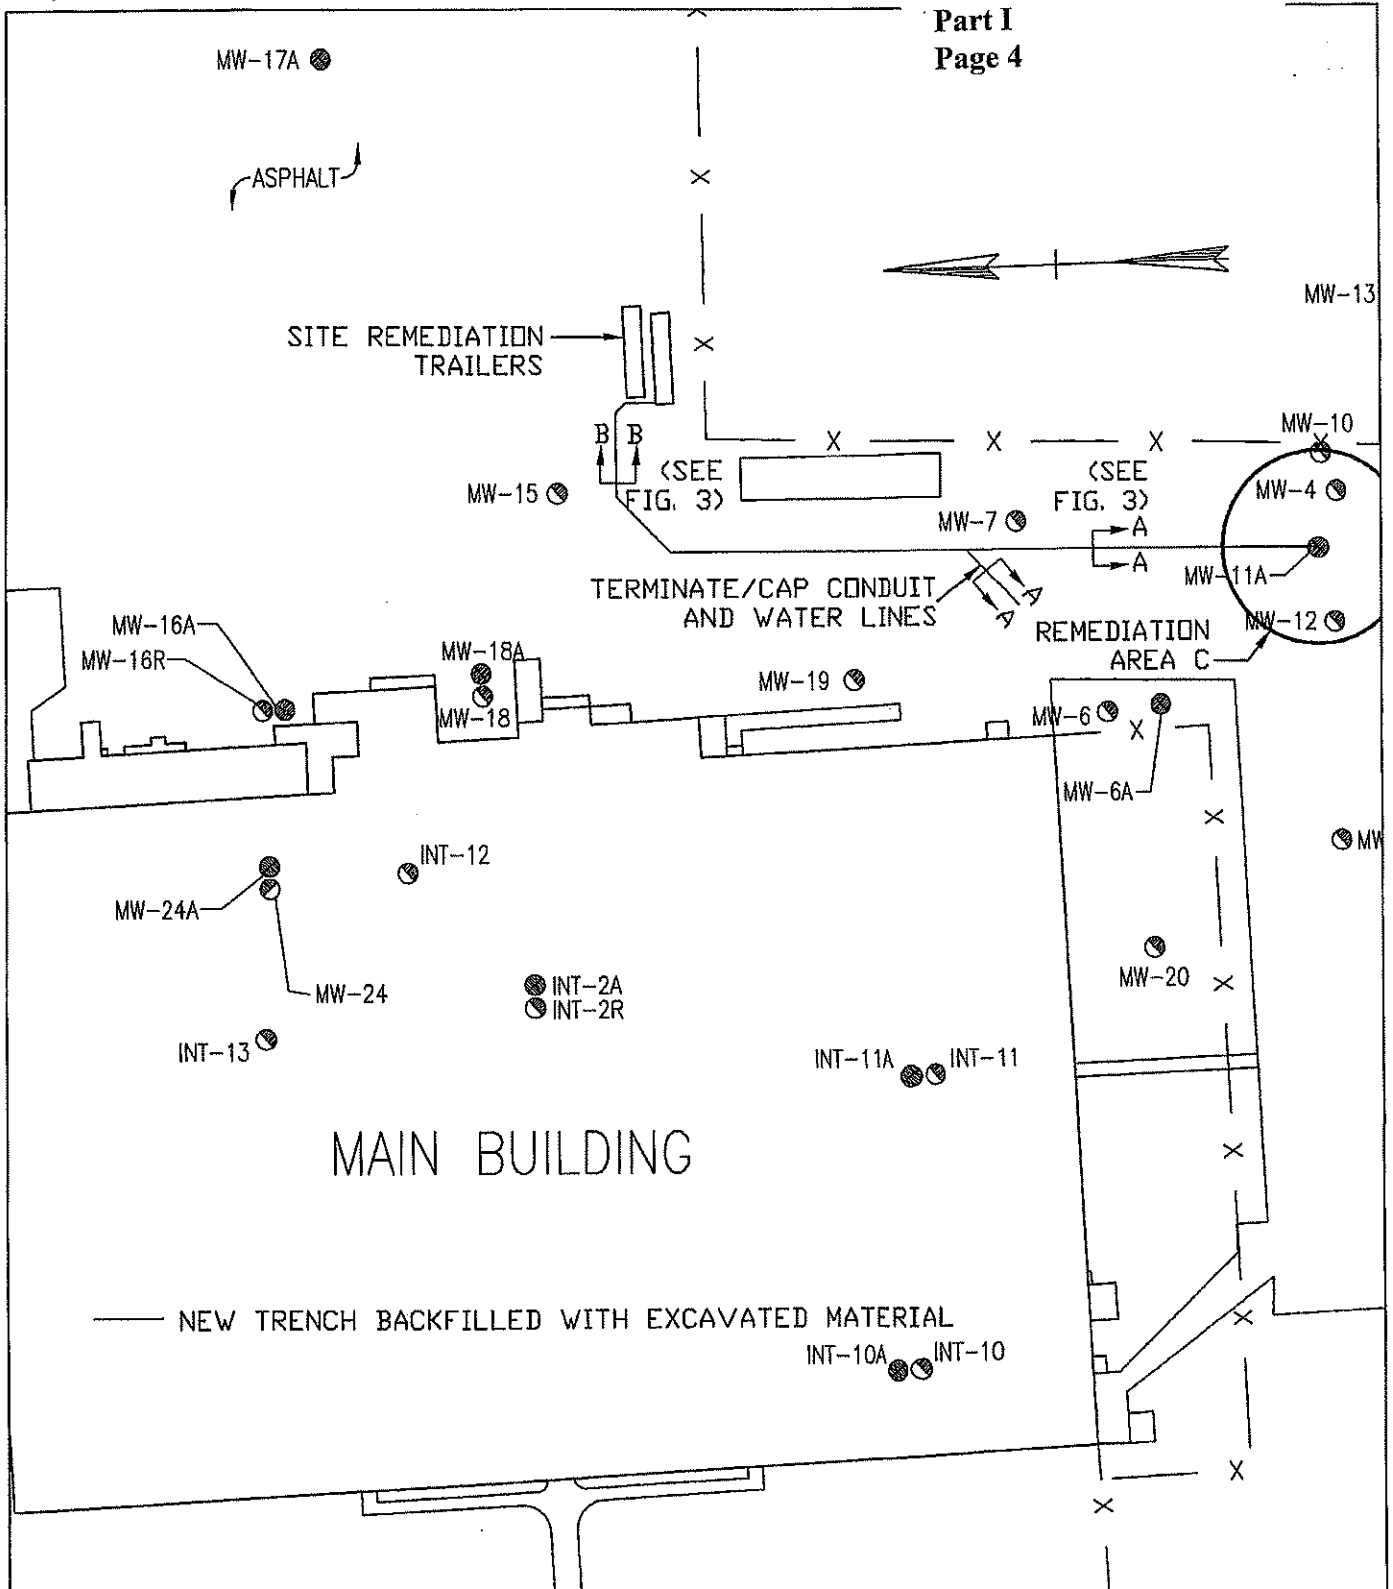
DOCUMENT CONTROL NO.	PROJECT	LEICA MICROSYSTEMS INC. 203 EGGERT RD CHEEKTOWAGA, NY	ENERGYSOLUTIONS 984 SOUTHFORD RD MIDDLEBURY, CT. 06762 (203)797-8301	PROJECT # 187016
REVISION NO.				FILENAME:
	DRAWING	AS BUILT SITE PLAN AND TRENCH LOCATIONS		SCALE: 1" = 100'
				DATE: 5/24/16
				BY: DRS CK: MC
				FIGURE # AB-2
