DAILY OBSERVATION REPORT

Report No.: Phase 2 - 006* EEEPC Project File: EN-003229-0001-06TT0 Date: Friday, 07/19/13
(* Daily Observation Report No. - Days from NTP)

Re: "Pilot" Bio-remediation Injection Phase 2 – Task 6

Site: Mr. C's Dry Cleaners Site

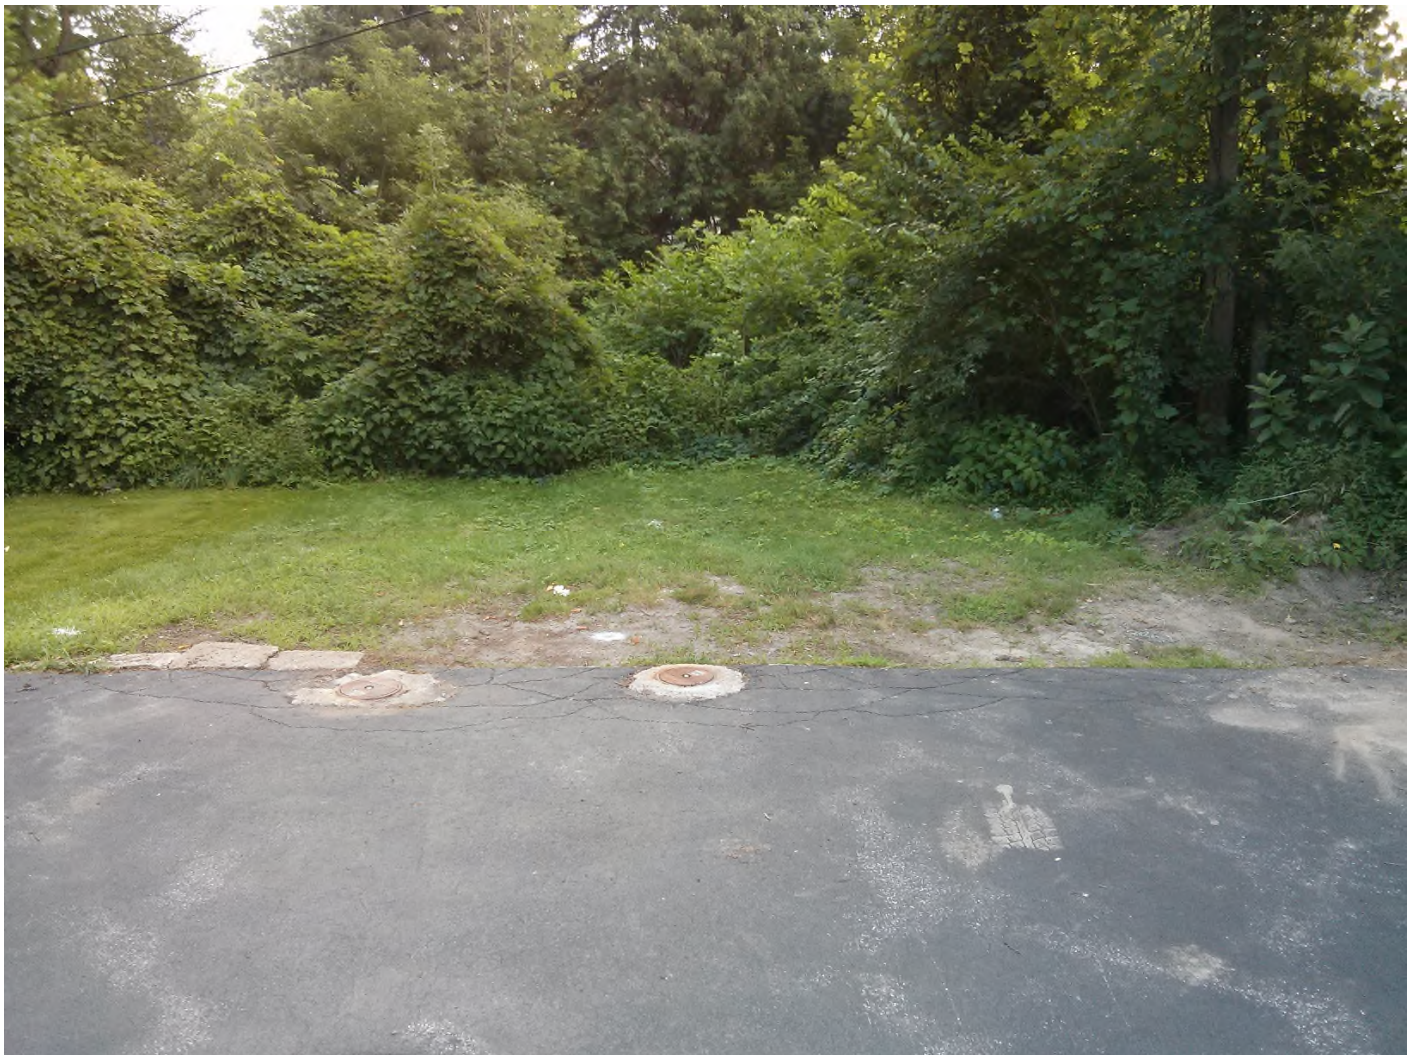
Date	Photo ID	Description
7/19/13	IMG_20130719_071309.JPG	Zone 2 prior to disturbance - looking north
7/19/13	IMG_20130719_090643.JPG	View of geoprobe injections at point 2-R - looking east
7/19/13	IMG_20130719_090822.JPG	View of geoprobe injections at point 2-R - looking east
7/19/13	IMG_20130719_101737.JPG	MPI-6S with new J-Plug installed
7/19/13	IMG_20130719_105152.JPG	View of geoprobe injections at point 2-T - looking east

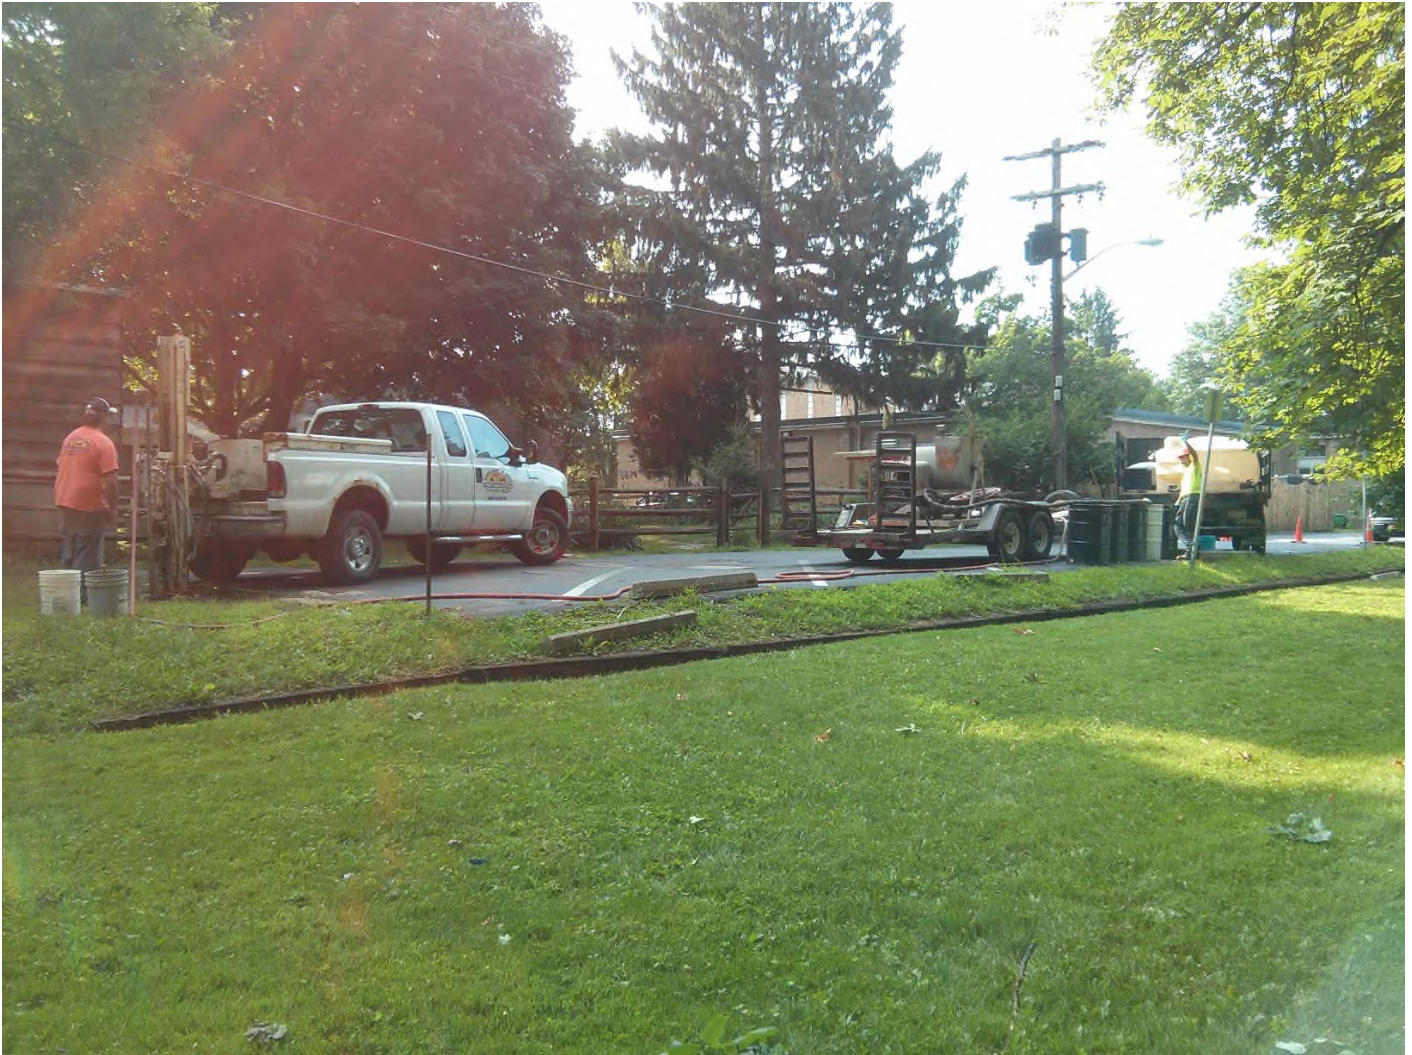
IMG_20130719_090643.JPG

- 0850 hrs - Nature's Way mixed injection solution. Injection begun at direct push injection point 2-R.
- 1010 hrs - Injection at point 2-R completed. 200 gallons of the BDI Plus/Nitrogen sparged water was injected at a rate of 3 GPM, and 5-10 psi pressure at the pump discharge. Borehole was filled with bentonite chips. N. Gingrich initiated drilling at direct push injection point 2-T.

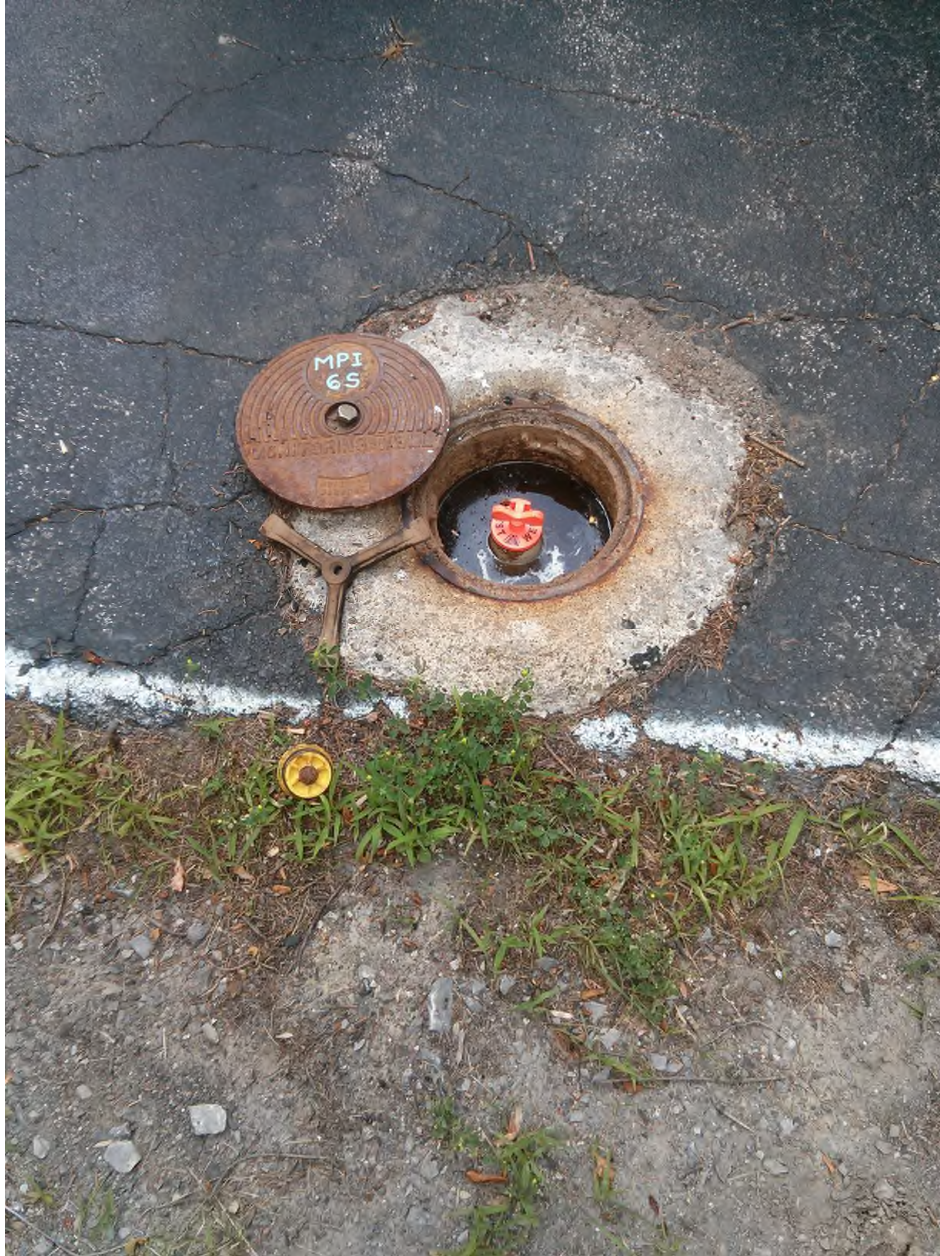
IMG_20130719_101737.JPG

- At 0800 hrs, observed the well casing of MPI-6S full of liquid. N. Gingrich noted it was sticky and installed a J-Plug on the well. N. Gingrich mentioned that this occurred during the Phase 1 injections as well.
- S. Gingrich mentioned that the meter in the Mr. C's treatment building is potentially inaccurate and is underestimating the total water usage.
- S. Gingrich mentioned that there was about a half a liter of BDI Plus remaining. This excess BDI Plus was added to the injection solution for the direct push injection point 2-T.
- EEEPC to return to the site on Monday, July 22, 2013, to review the demobilization and note and contact Nature's Way of any required restoration items.

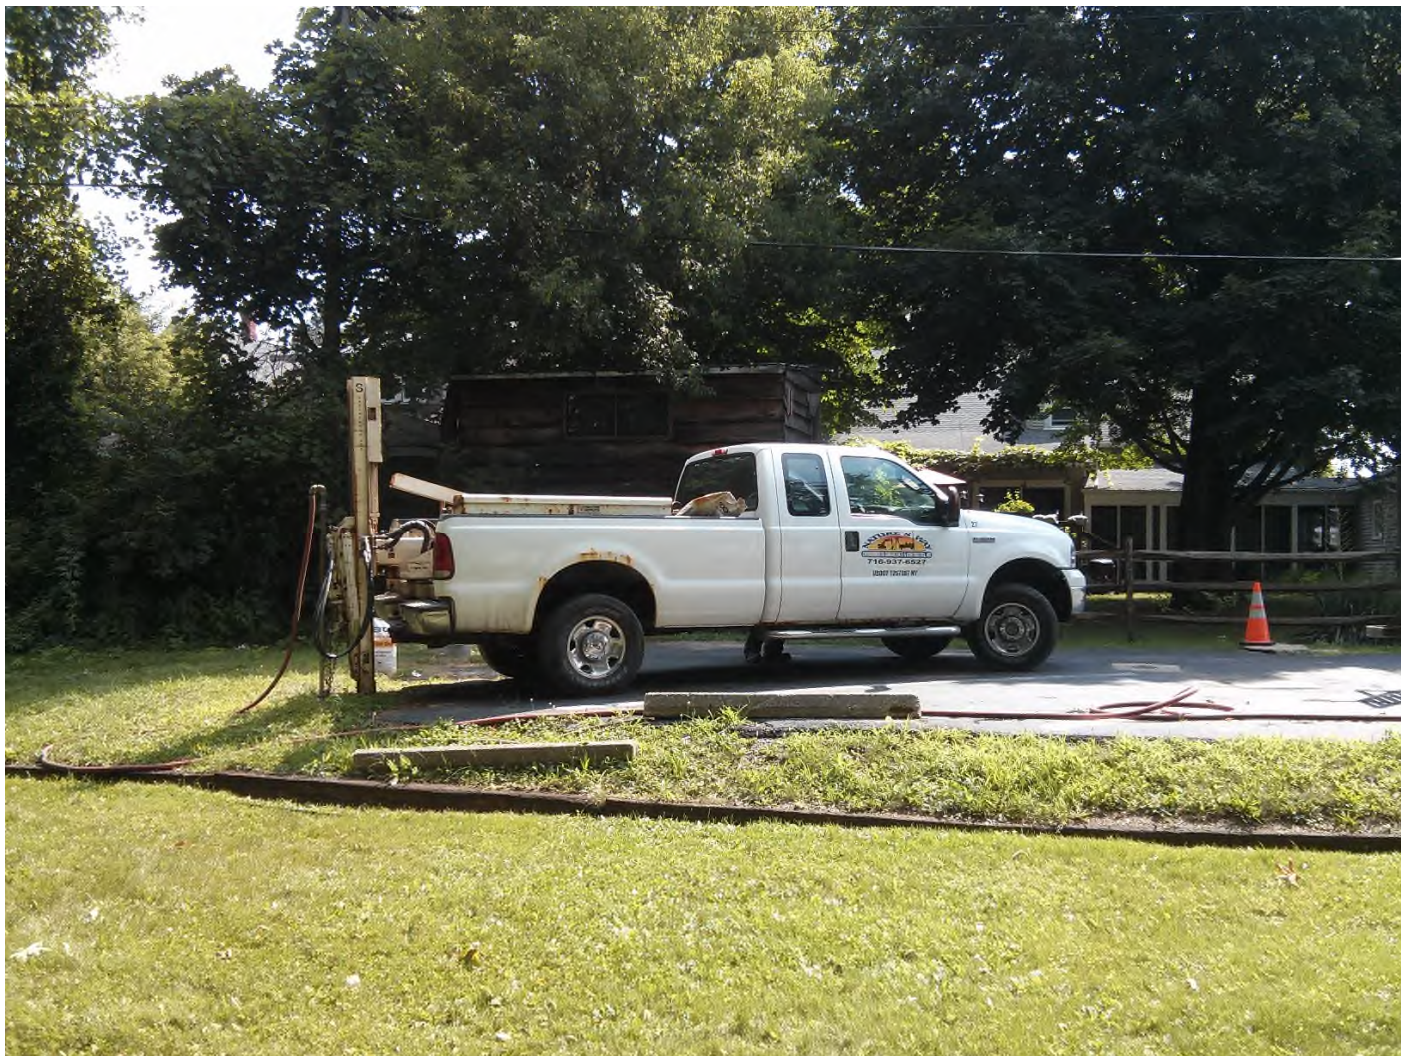
IMG_20130719_105152.JPG

- 1050 hrs - Nature's Way mixed injection solution. Injection begun at direct push injection point 2-T.
- 1200 hrs - Injection at point 2-T completed. 200 gallons of the BDI Plus/Nitrogen sparged water was injected at a rate of 3-4 GPM, and 5-20 psi pressure at the pump discharge. Borehole was filled with bentonite chips. S. Gingrich stated that demobilization will be completed in the afternoon. Informed Traci (Intrepid Auto) and R. Alessi (Library) of expected time of completion for demobilization.

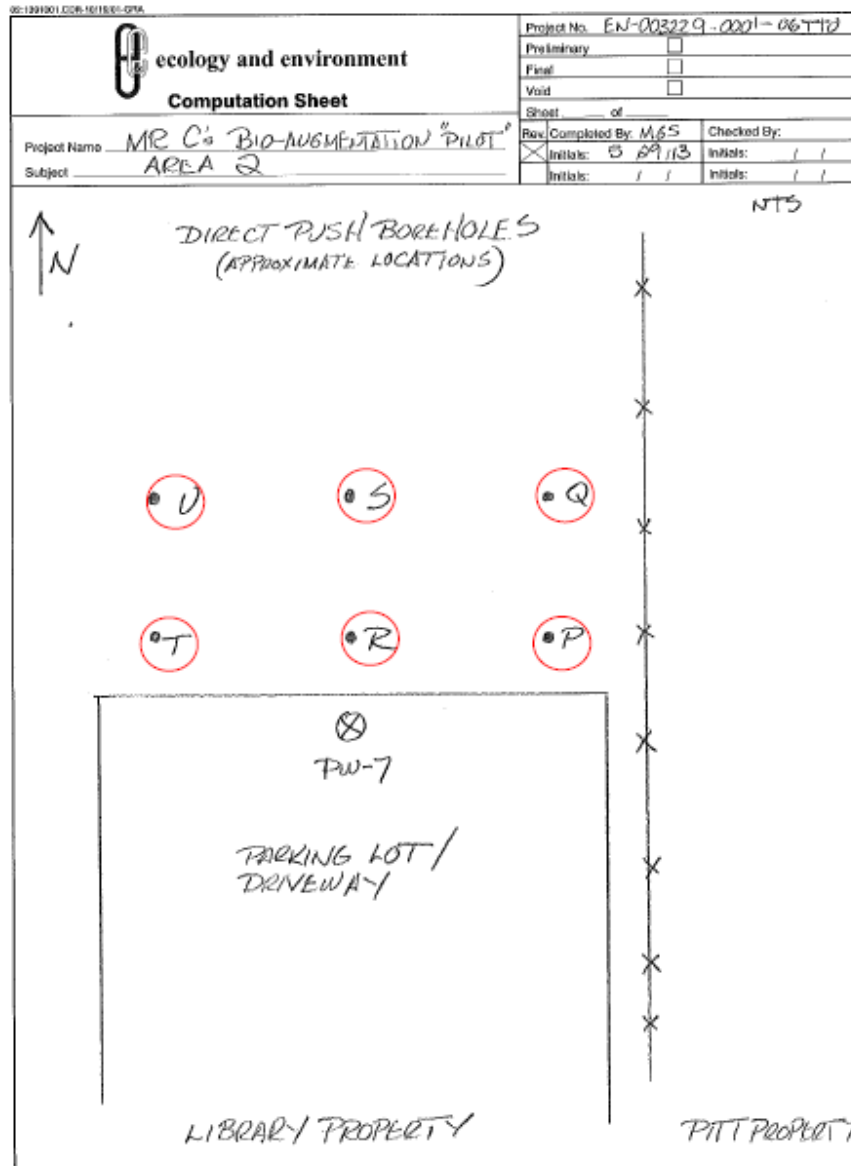
D. Offsite (Zone 2) – Injection Progress Drawing

- 0820 hrs - N. Gingrich initiated drilling at direct push injection point 2-R. See project item D of the DOR for borehole location information. S. Gingrich used a DO meter to measure the water in the large tank in the fenced off work area east of Whaley Ave. 5.70 mg/L.

MPI-6S Location (Behind Library)
