**2009  
Periodic Review Report  
Mr. C's Dry Cleaners Site  
NYSDEC Site No. 9-15-157  
Village of East Aurora  
Erie County, New York**

**April 2010**

**ECOLOGY AND ENVIRONMENT ENGINEERING, P.C.  
368 Pleasant View Drive  
Lancaster, New York 14086**

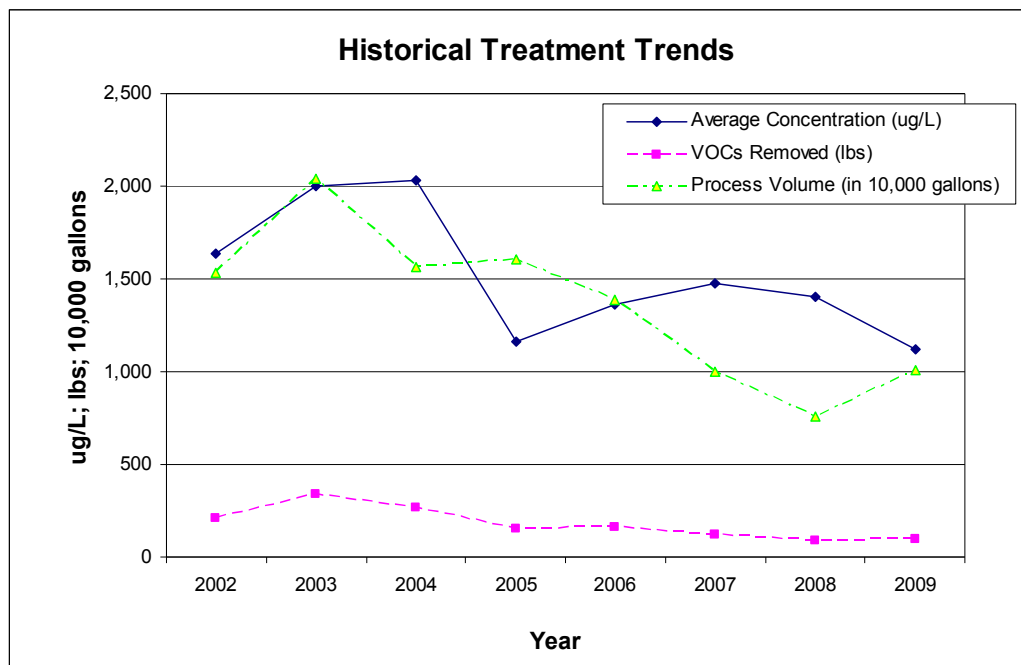
Figure 4-1 Historical Treatment Trends – Mr. C's Site

Both the amount of cVOCs removed and the total process volume have generally been decreasing since 2002; however, in 2008, the process volume treated increased from 2007 (see Figure 4-1).
