Re: Monitoring Well Network Improvements Close-out Report for the Mr. C's Dry Cleaners  
Site in East Aurora, New York (NYSDEC Site No. 9-15-157)

This report summarizes the activities completed to install eleven monitoring wells (two new wells and nine replacement wells) and decommission six monitoring wells to improve the monitoring well network at the Mr. C's Dry Cleaners site, as described in the scope of work (SOW) prepared by Ecology and Environment Engineering, P.C. (EEEEPC) in October 2011. The work was performed by the standby remedial contractor Groundwater and Environmental Services, Inc. (GES), of Cheektowaga, New York, under a New York State Department of Environmental Conservation (NYSDEC) standby remedial services contract (Contract Number C100900). GES subcontracted the drilling work to Quality Inspection Services, Inc. (QIS), of Buffalo, New York, and surveying work for the new well locations was performed by Clear Creek Land Surveying, LLC, of Springville, New York.

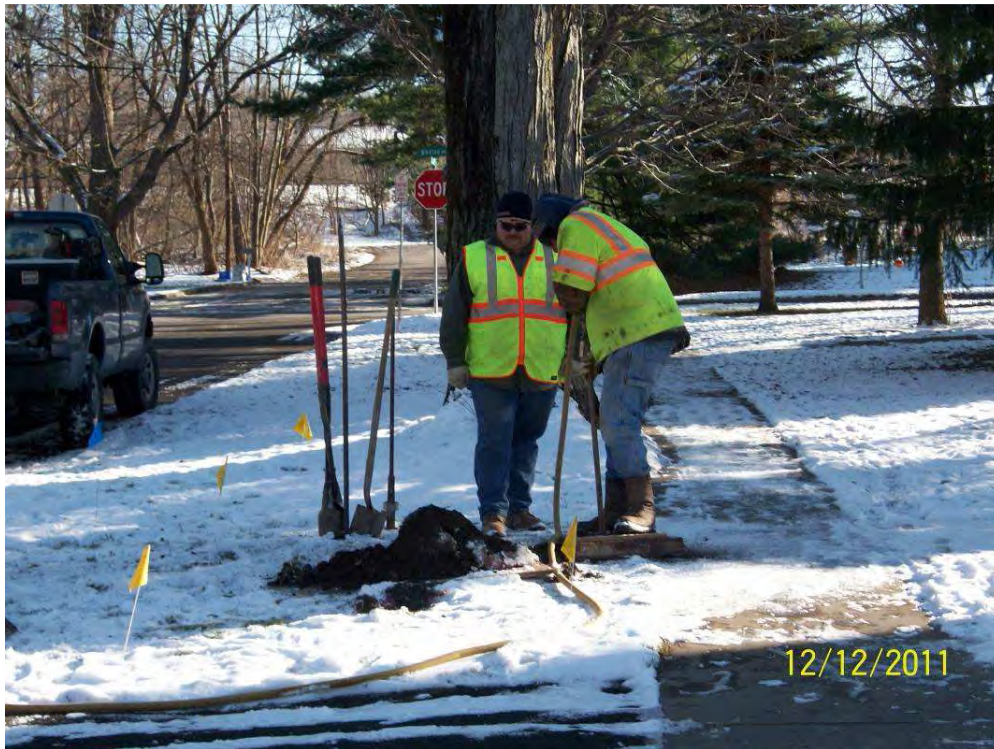
Figure 1: View of hand clearing at MPI-14B-R (Looking East)

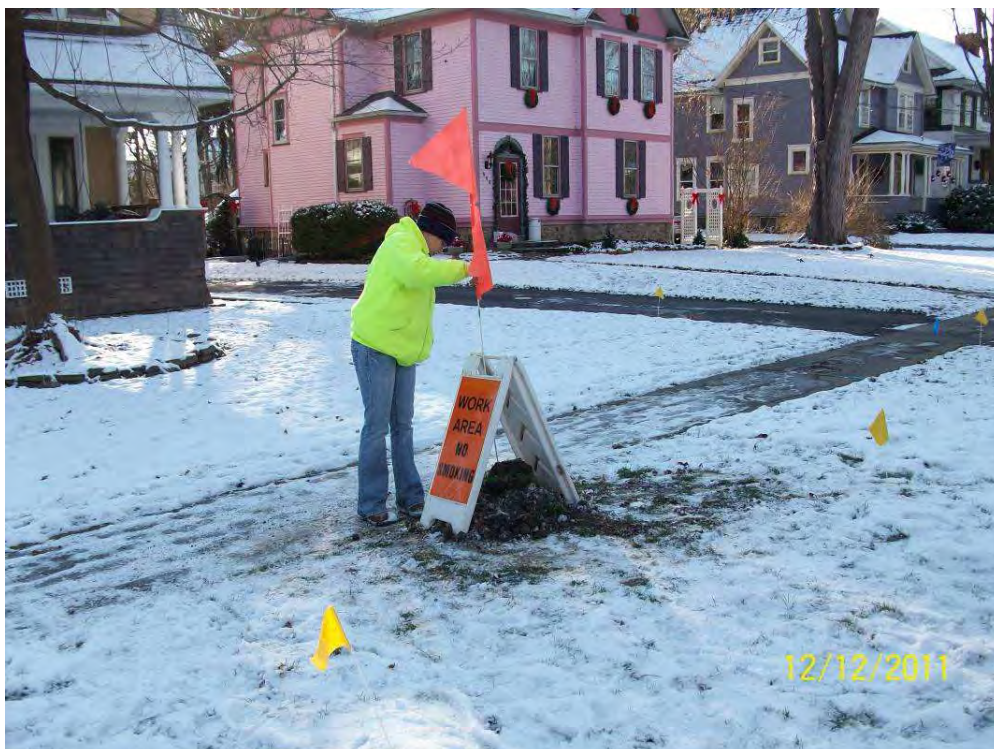
Figure 2: View of finished hand clearing at MPI-13B-R (Looking SW, PM)

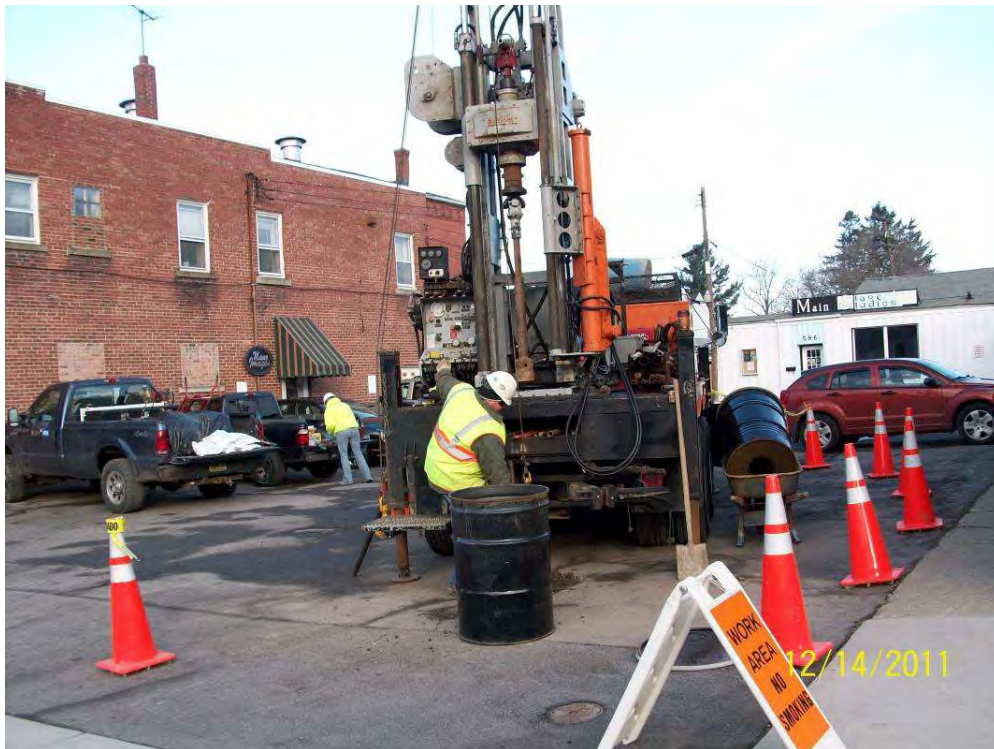
Figure 1: View of Well MPI-71-R Installation (Looking North AM)

Larry Roedl (EEEEPC) arrived on site and met with the contractor from (QIS), and Nicole Jarzyniecki (GES). Nicole held a site tailgate safety meeting. After the meeting QIS, started to drill MPI-7I-R to the same depth that MPI-7 was drilled to. QIS completed the installation of well MPI-7I-R. QIS filled MPI-7 with grout to 5 feet below the surface. The grout will set overnight to harden so when the casing on the well is removed it will not leak into the new well.

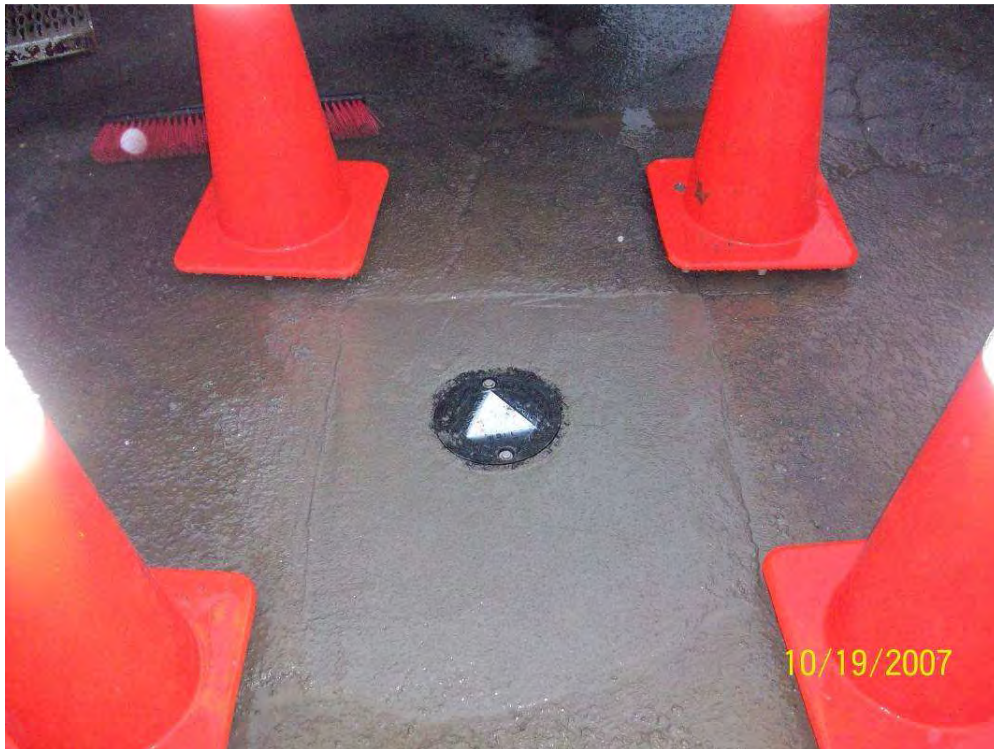
Figure 3: View of Looking down at finished monitoring well MPI-7I-R (pm)

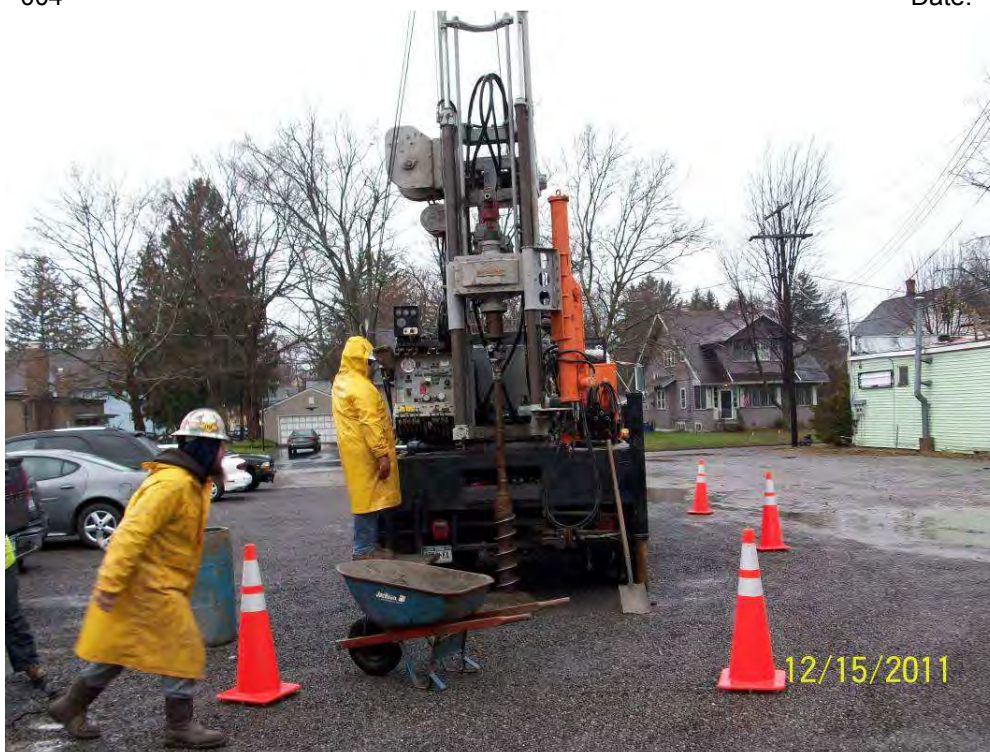
Figure 1: View of drilling at EE-4 (Looking West AM)

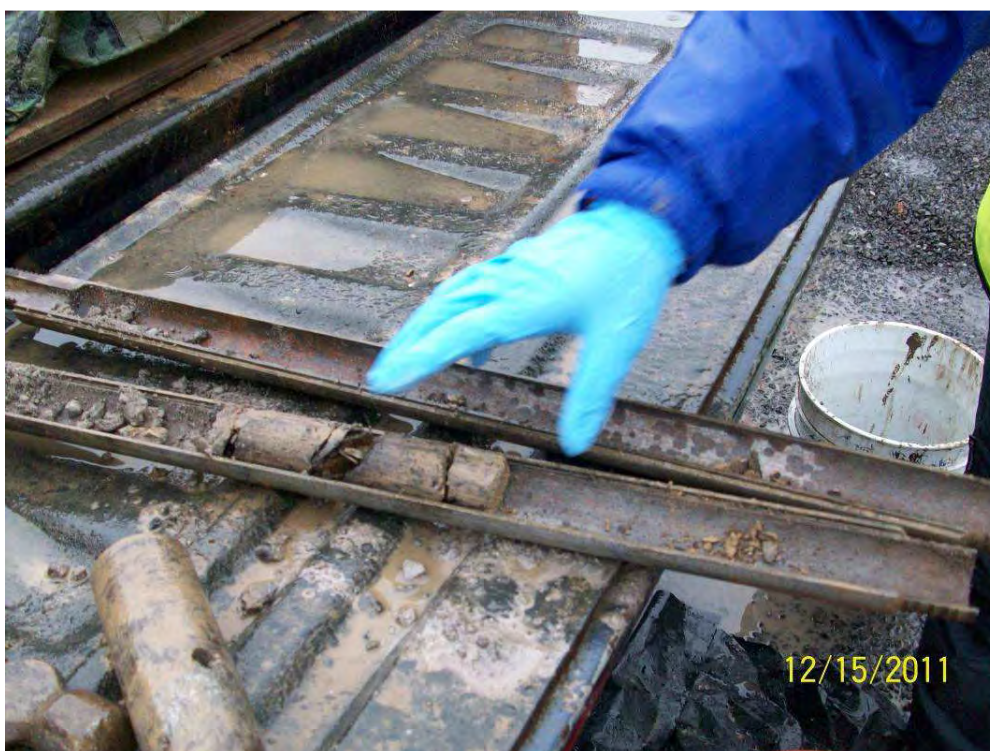
Figure 2: View of split spoon core 2'-4' bgs at EE-4 (AM)

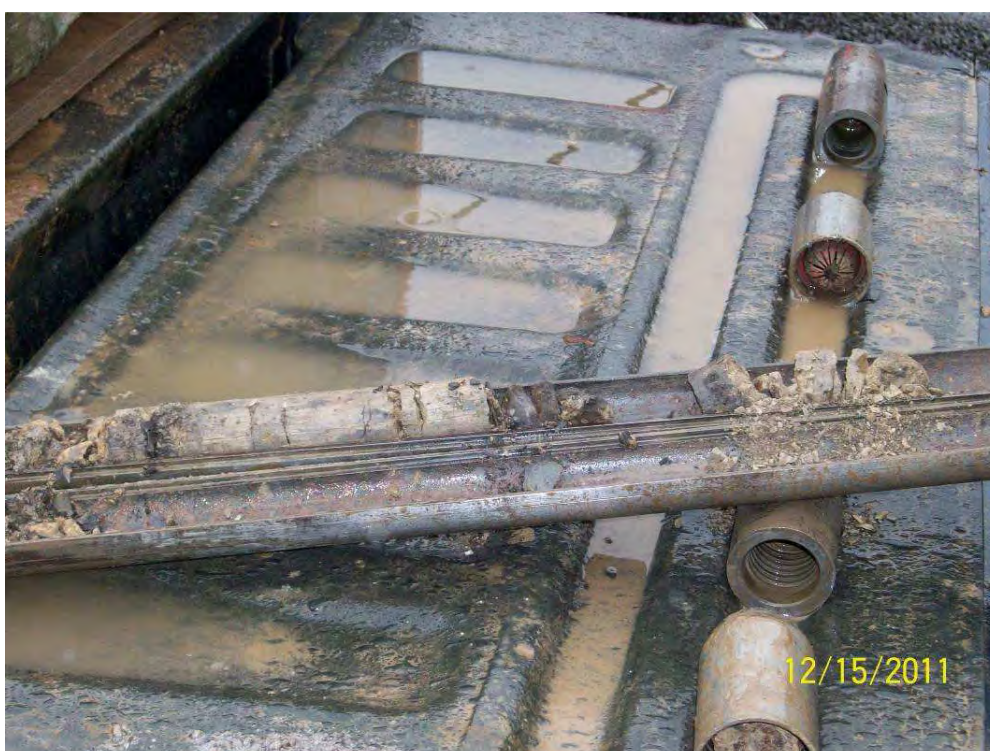
Figure 4: View of split spoon core 6'-8' bgs at EE- 4 (AM)

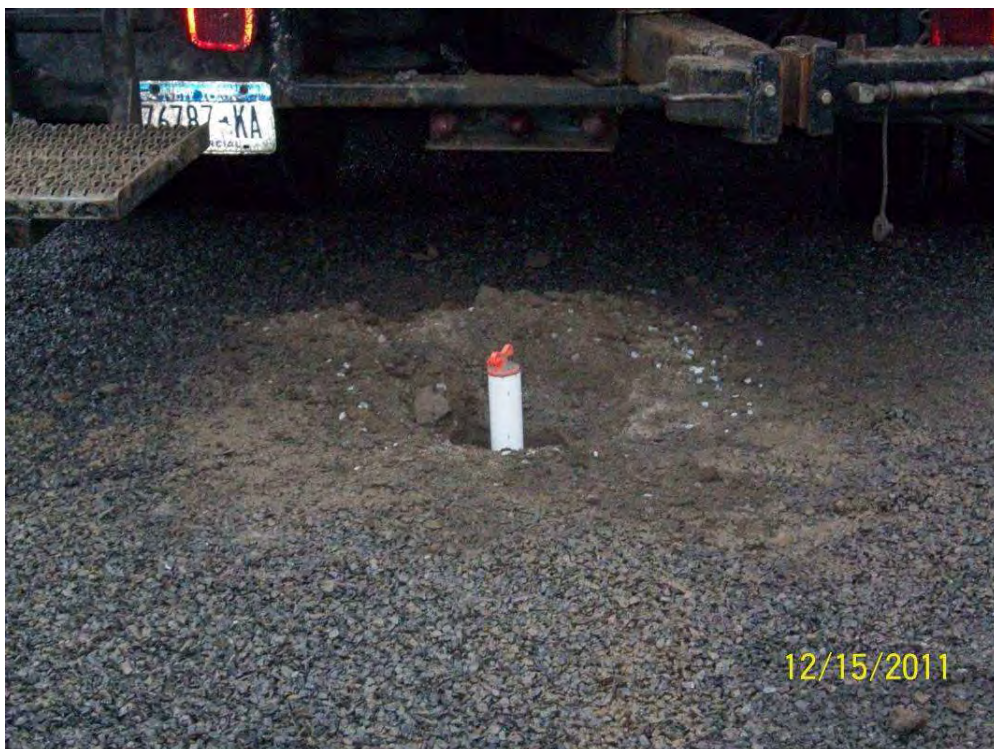
Figure 8: View of EE-4 well construction for the day (Looking West AM)

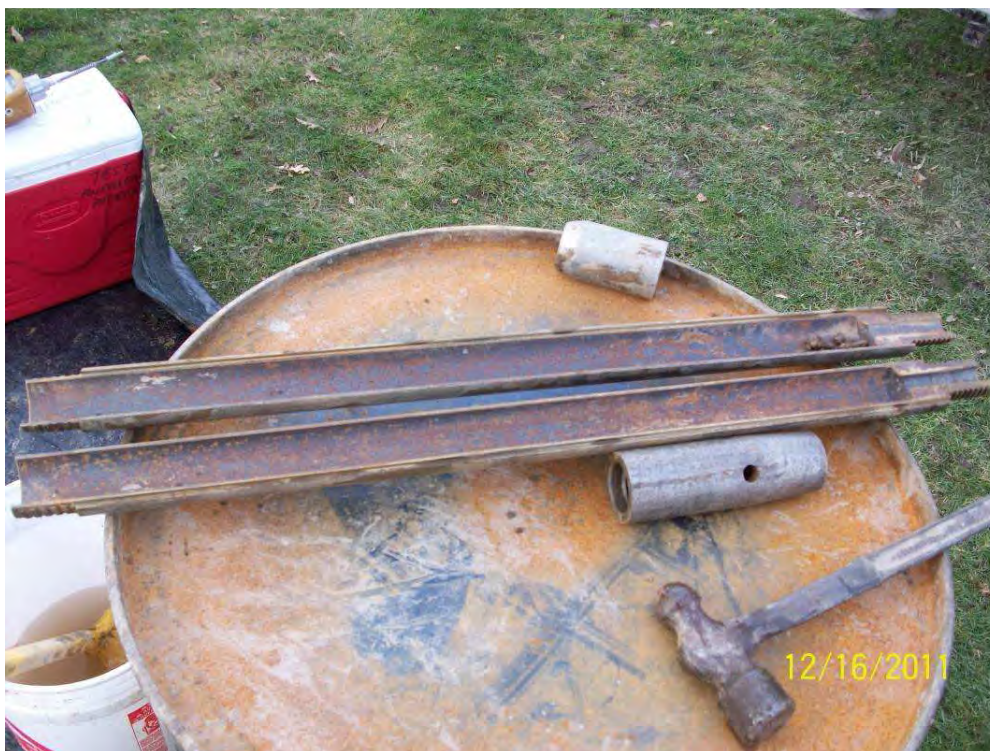
Figure 5: View of split spoon core 5'-6' bgs at EE-3 (No Recovery)

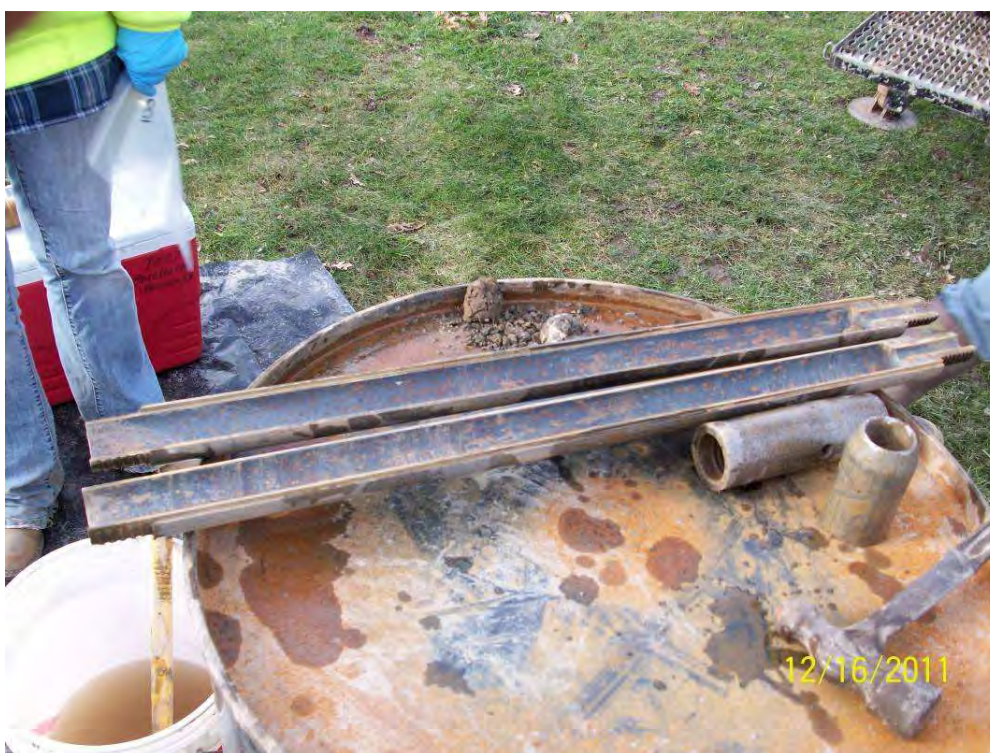
Figure 6: View of split spoon core 6'-8' bgs at EE-3 (No Recovery)

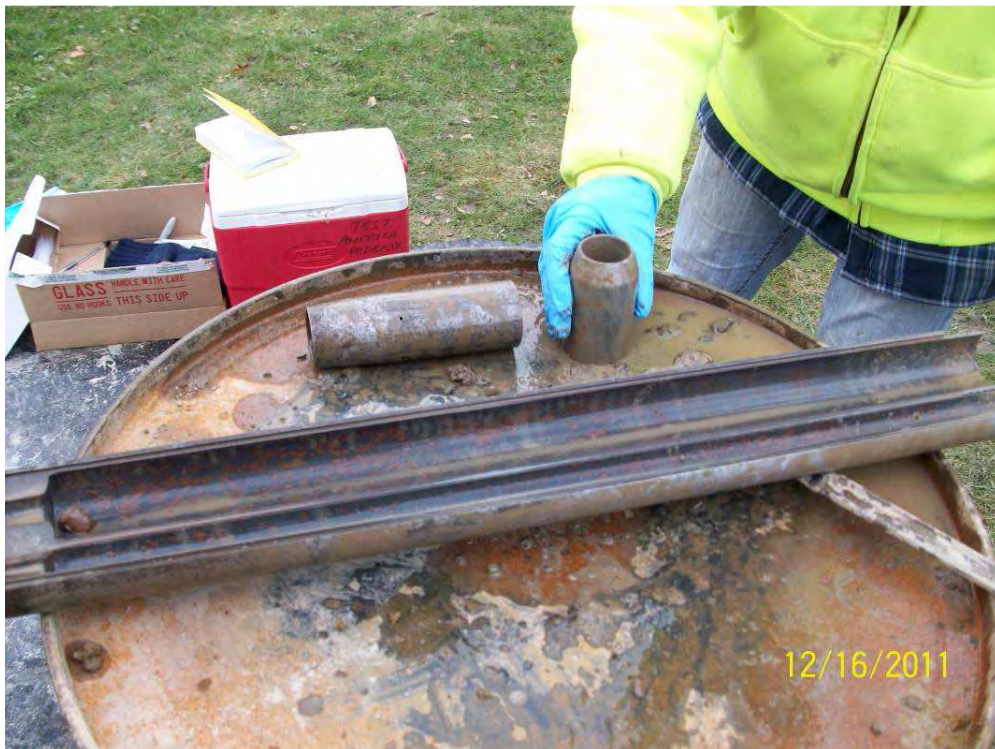
Figure 12: View of split spoon core 18'-20' bgs at EE-3 (No Recovery)

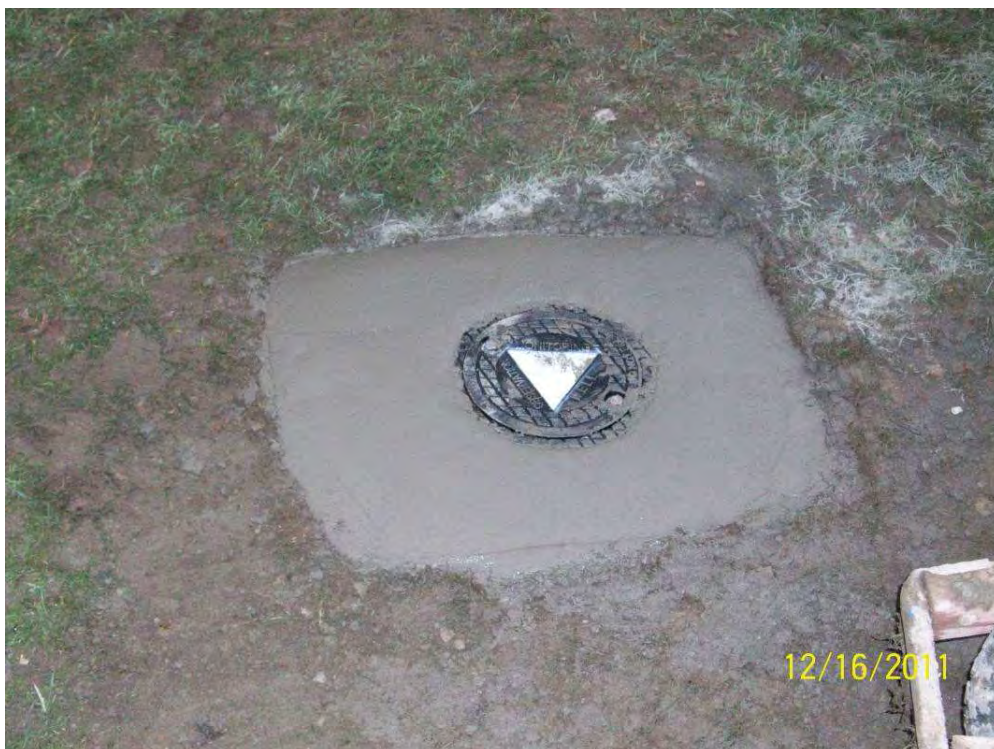
Figure 18: View of Finished Well Pad at EE-3

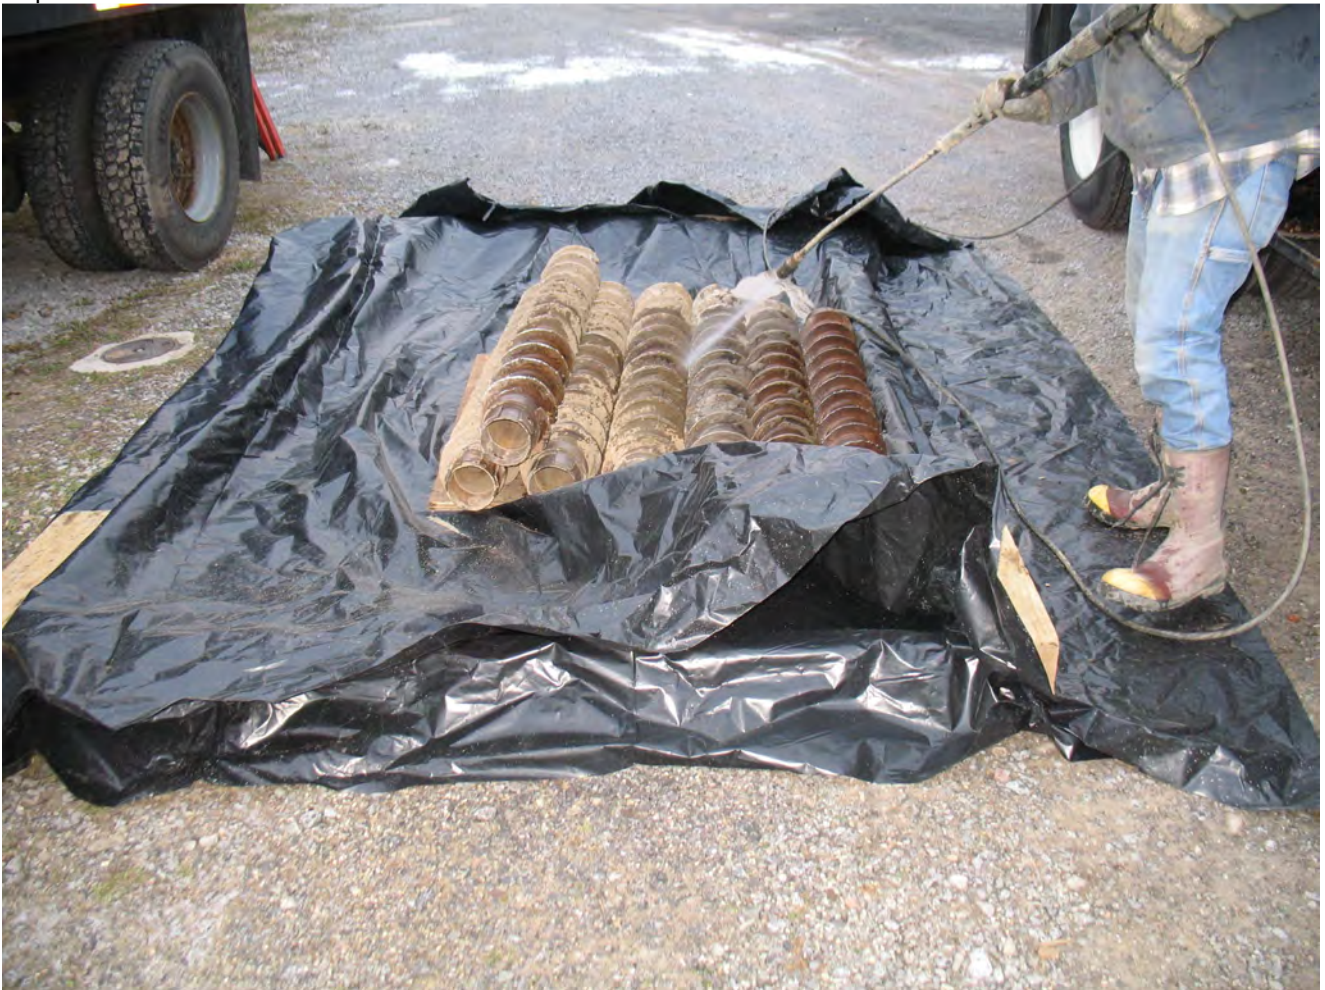
Figure 1: Decontamination pad in parking lot at intersection of Main St. and Whaley Ave, looking South.

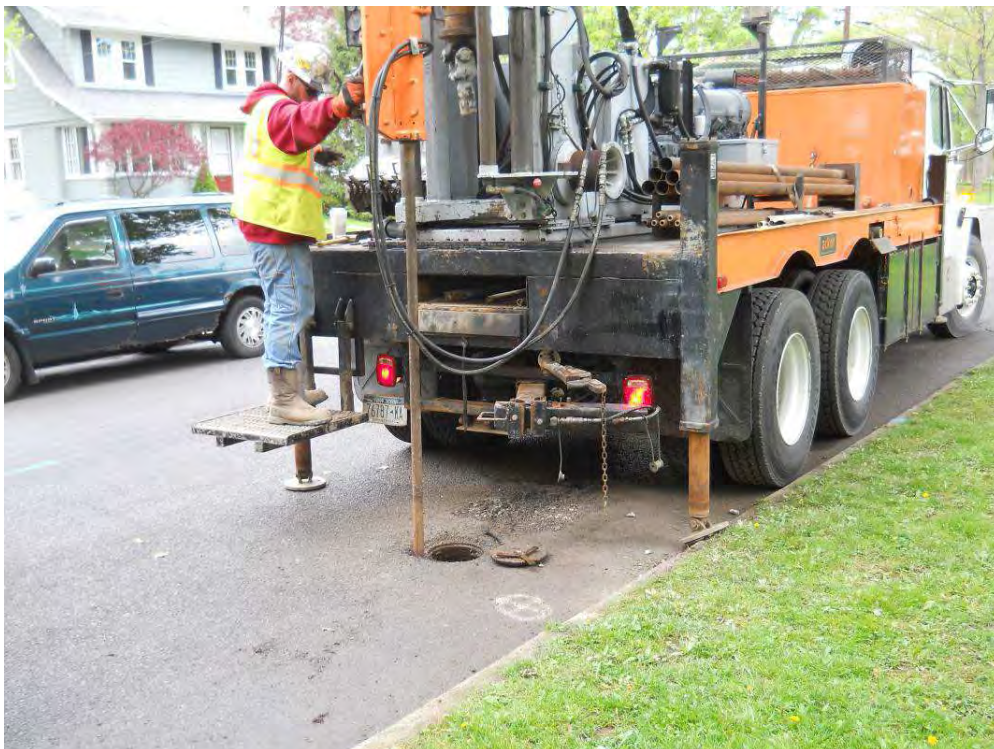
Figure 4: View of removal of MPI-13B manway by slam bar around the cast iron ring (Looking SSE, AM)

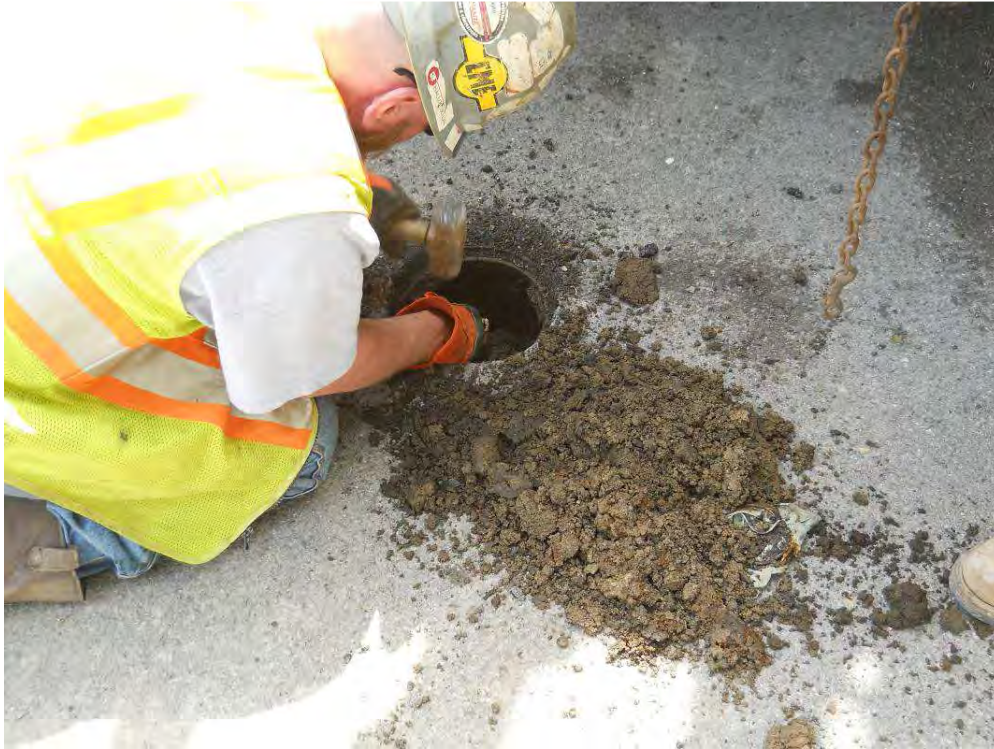
Figure 7: View of removal of cub box at ESI-5 (Looking down, PM)

- Well casings for wells ESI-5, MPI-8S, and MPI-13B, which were in the ROW, were not removed during decommissioning due to the potential to damage the asphalt road by over-drilling or pulling of the casing. This was acceptable to the NYSDEC PM.

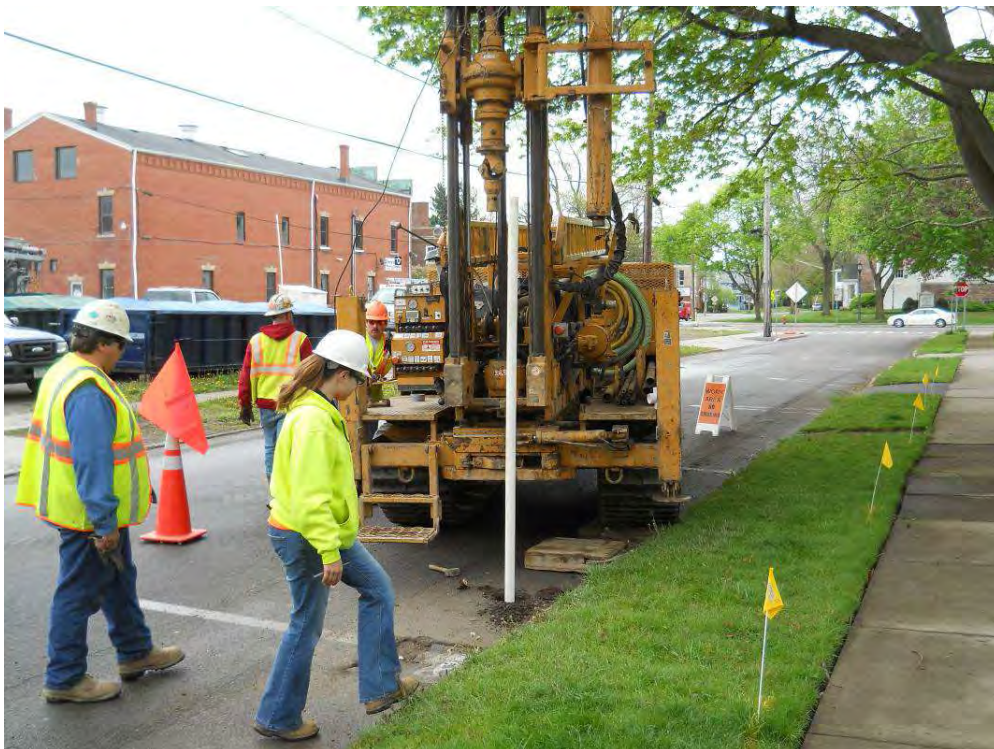
Figure 10: View of installation of well riser at MPI-8S (Looking W, PM)

Replacement monitoring wells ESI-5-R, MPI-8S-R, MPI-9S-R and MPI-13B-R were re-installed from May 7 through May 8, 2012. Each of the replacement monitoring wells were constructed using 2-in Schedule 40 polyvinyl chloride (PVC) well casing with 0.10 slot screens. ESI-5-R was set to a total depth of 15 ft bgs with a screened interval from 5 to 15 ft bgs. MPI-8S-R was set to a total depth of 18 ft bgs with a screened interval from 8 to 18 ft bgs. MPI-9S-R was set to a total depth a total depth of 18 ft bgs with a screened interval from 8 to 18 ft bgs. MPI-13B-R was set to a total depth of 31.5 ft bgs with a screened interval from 16.5 to 31.5 feet ft bgs.

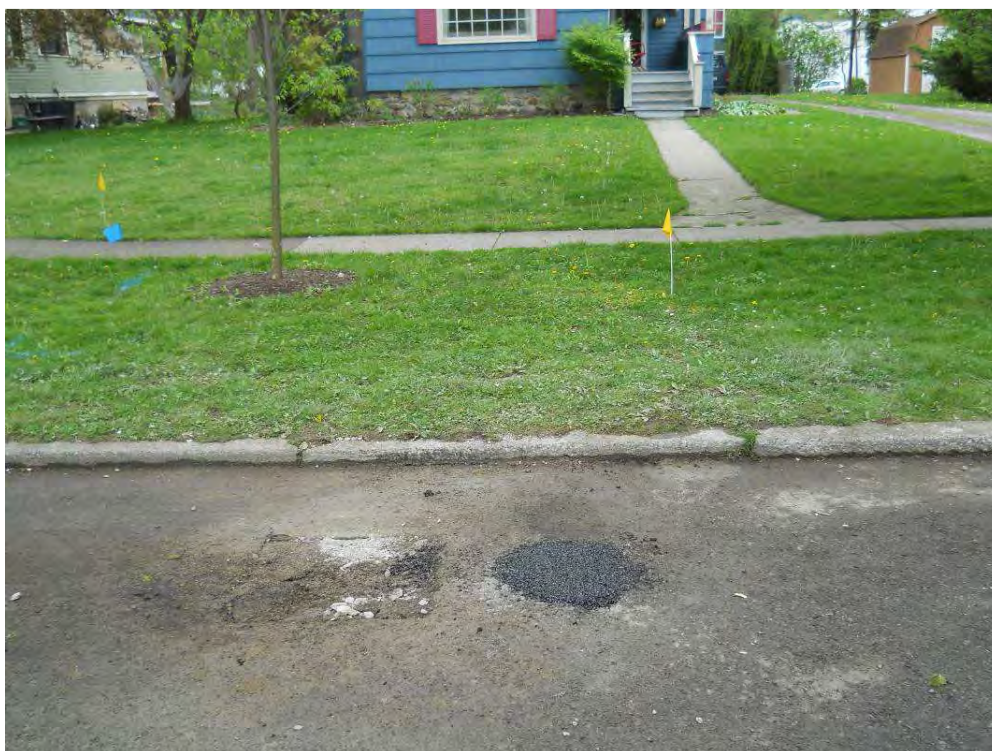
Figure 12: View of patched MPI-13B after decommissioning of the well (Looking W, PM)

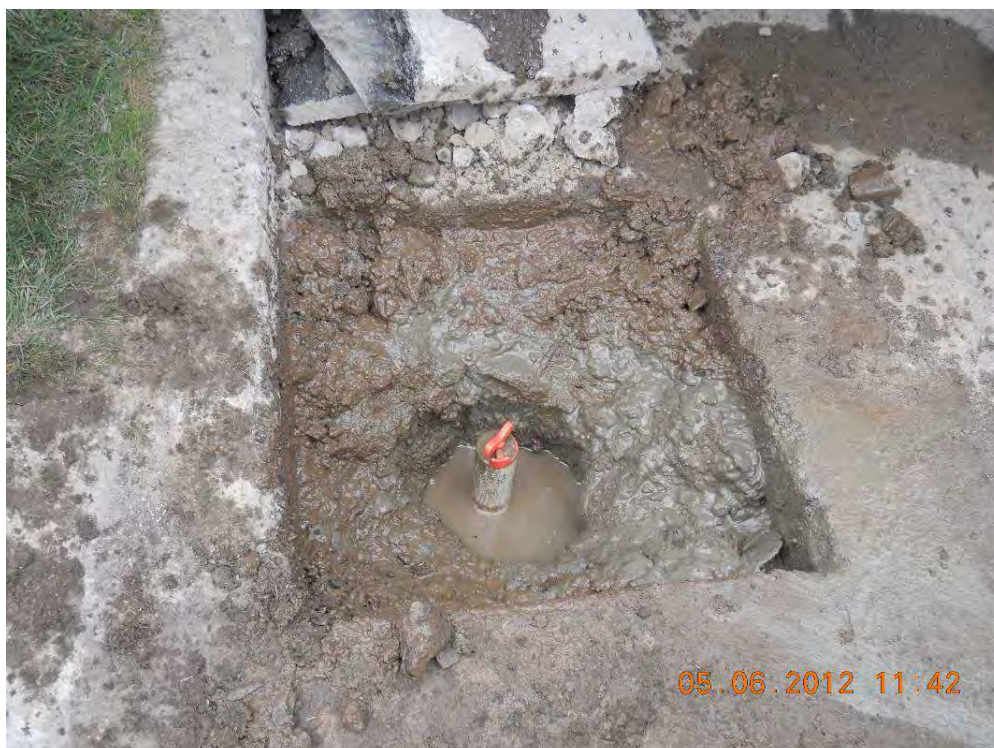
Figure 4: View of grout at MPI-9S-R (Looking NE, AM)

A sand pack was placed from the bottom of each well boring to approximately 2 ft above the top of screen, followed by approximately 2 feet of bentonite, and tremmie grouted above the bentonite to approximately ½ to one ft bgs. Each well was finished with an approximately 2 x 2 ft concrete curb box and flush mount protective road box. Well construction details can be found on the subsurface logs in **Appendix B**. Additionally, due to no records of the former MPI-7I boring logs, soils were logged for MPI-7I-R during drilling. The soil log can also be found on the subsurface logs in **Appendix B**.

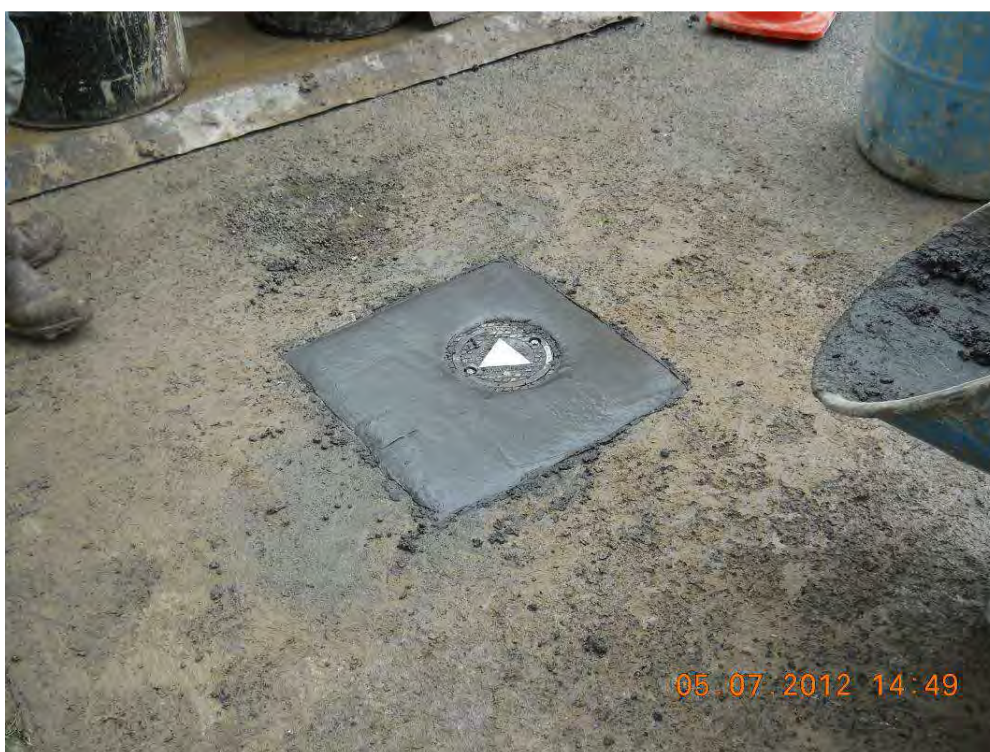
Figure 6: View of MPI-13B-R after construction of well pad (Looking SW, PM)

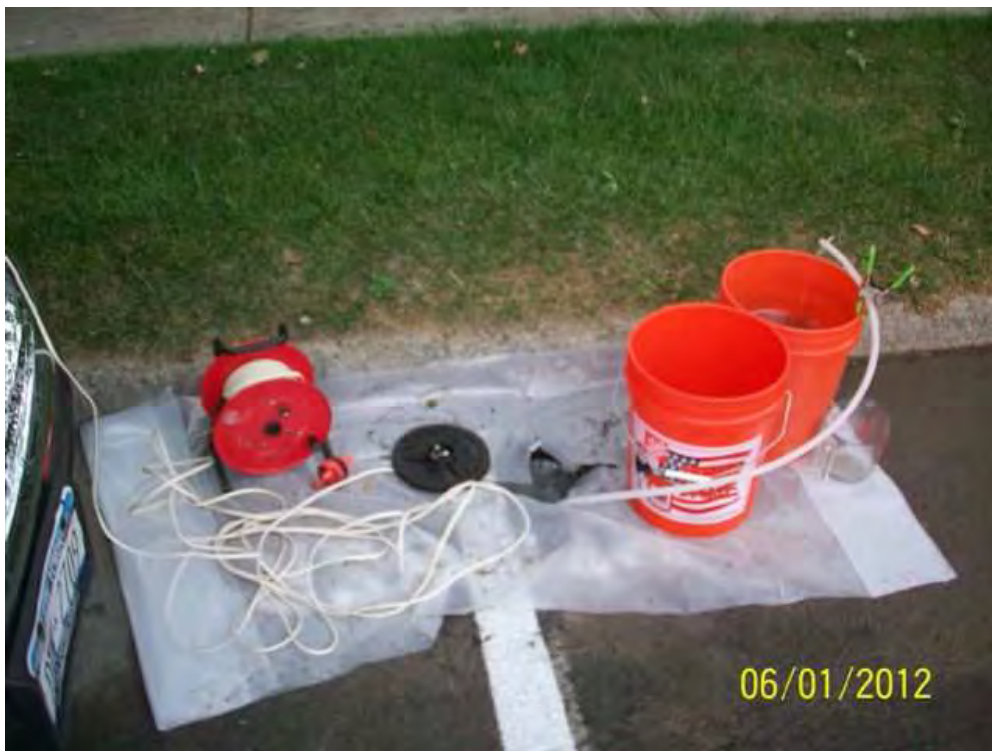
Figure 5: View of development of well MPI-8S-R (Looking N)

On January 23 and 24, 2012, GES personnel developed the new and replacement monitoring wells (EE-3, EE-4 ESI-2-R, MPI-2S-R, MPI-7I-R and MPI-14B-R). On May 24, 2012, GES personnel developed replacement monitoring wells (ESI-5-R, MPI-8S-R, MPI-9S-R and MPI-13B-R). Turbidity, pH and conductivity were recorded, using a Horiba U52-2 Water Quality Meter (Horiba). The wells were gauged for total depth and depth-to-water (DTW) prior to beginning well development. The wells were pumped to develop, using a wale pump, and DTW was measured throughout the development. Each well was developed until a turbidity of 50 nephelometric turbidity units (NTUs) or less was observed, and pH and conductivity stabilized (measurements within 10% of each other for three consecutive measurements). Readings were collected approximately every 10 minutes or less until water cleared and approximately every 5 minutes to confirm stabilization of parameters. Once development by the above described parameters was complete, an additional 5 well volumes were removed. Following development of each well, development water was pumped into the sump of the onsite treatment system. For well development details, please see the well development records in **Appendix D**.

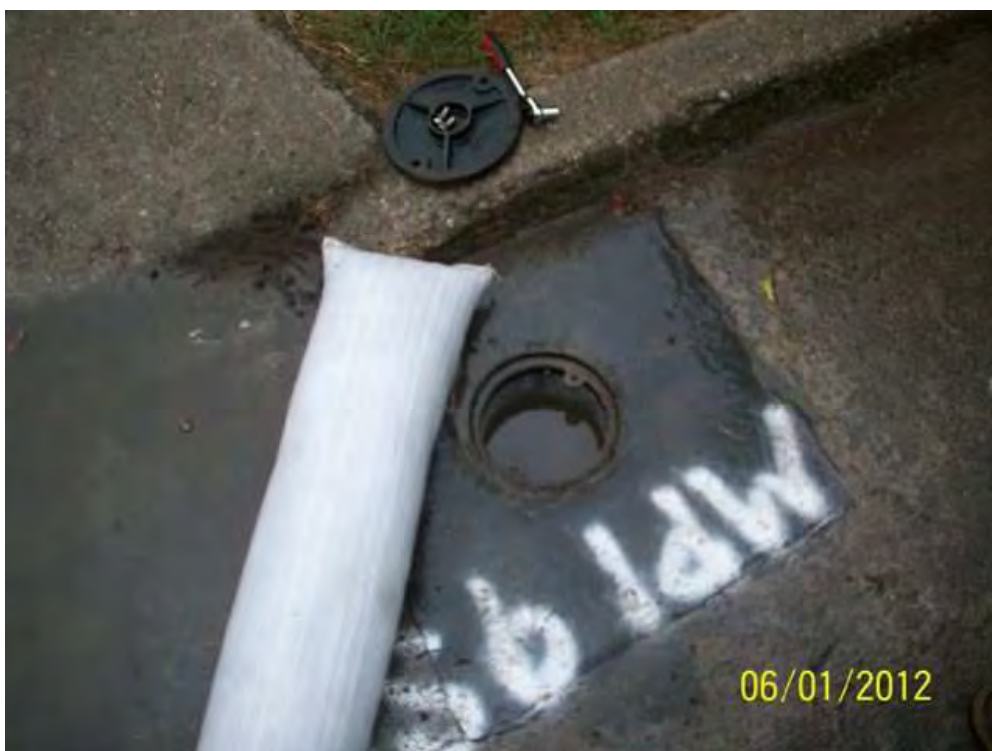
Figure 6: View sand bag to deflect rainstorm runoff from filling well vault at MPI-9S-R (Looking N)

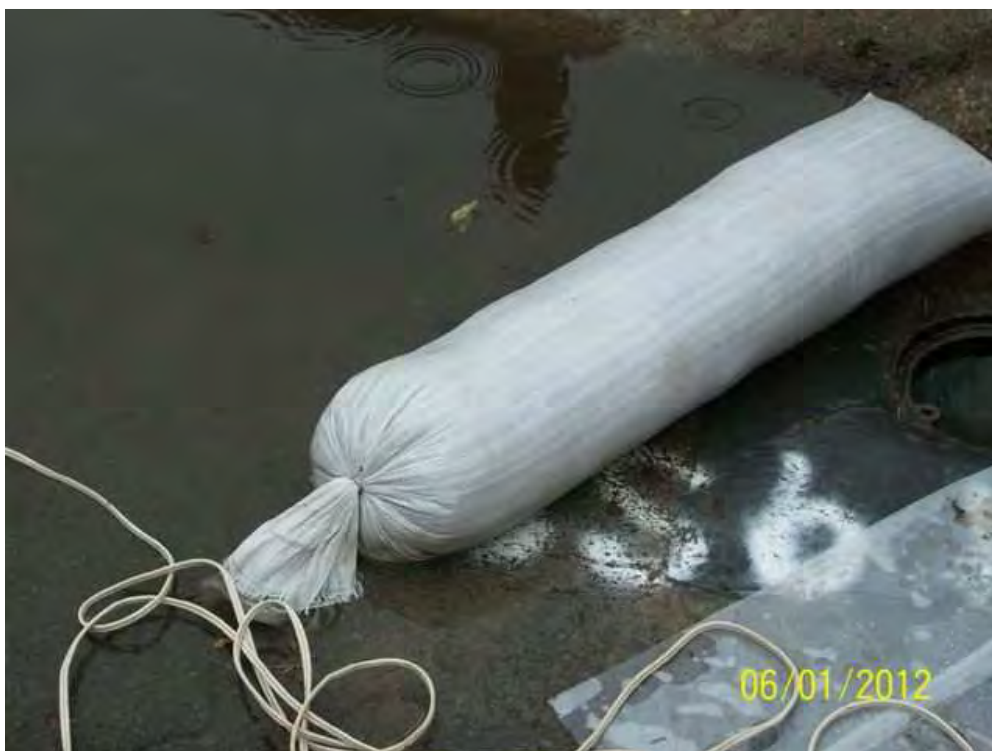
Figure 8: View of pooling of water behind sand bag at MPI-9S-R (Looking NW)
