Re: Mr. C's Dry Cleaners Site, Contract # D007617, Site # 915157
January Operations, Maintenance, and Monitoring Report

TREATMENT SYSTEM OM&M
October 2016

SYSTEM REPAIR PHOTOS
1 of 1

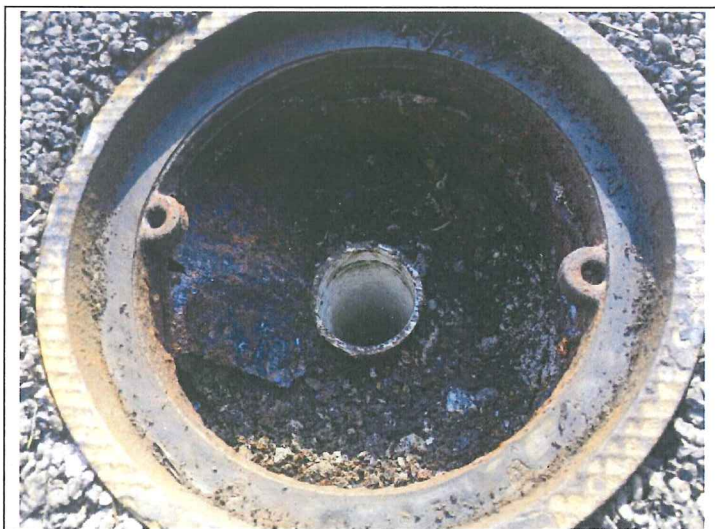
PZ-1B has surface concrete damage from winter conditions. PZ-4B, PZ-6A and PZ-6C have been damaged by Town of Aurora. PZ-4B has been improperly repaired by the Town of Aurora.

1. PZ-4B showing snowplow damage to inner ring

Shut Down Treatment System	Shut down system for evaluation of ground water gradient.	Feb-16
Repair PZ-4B	Inner ring of piezometer was severely damaged by Town of Aurora snowplow truck. Talked to Town personnel. Related that they would address problem in the spring. Inner ring must be replaced.	in progress

PZ-4B was replaced by the Town of Aurora.

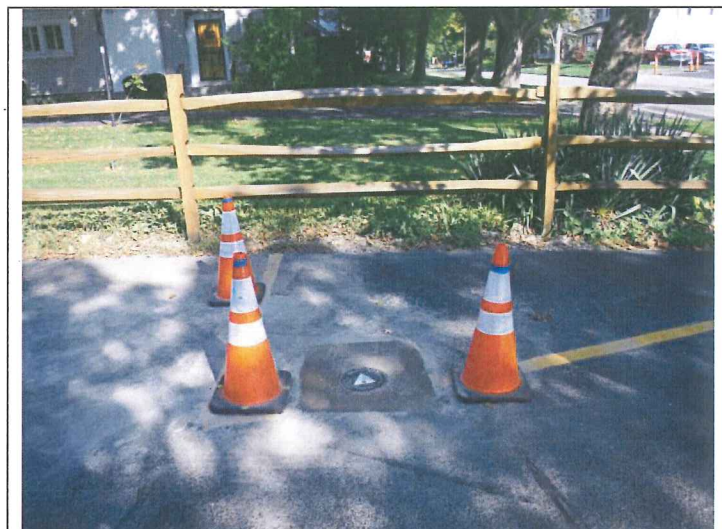
2. PZ-4B after Town of Aurora installed replacement road box

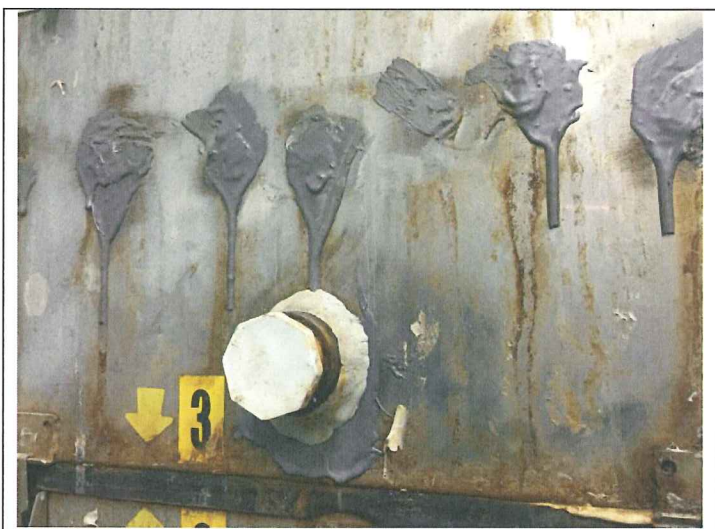
3. Air Stripper showing epoxy repairs on corroded areas

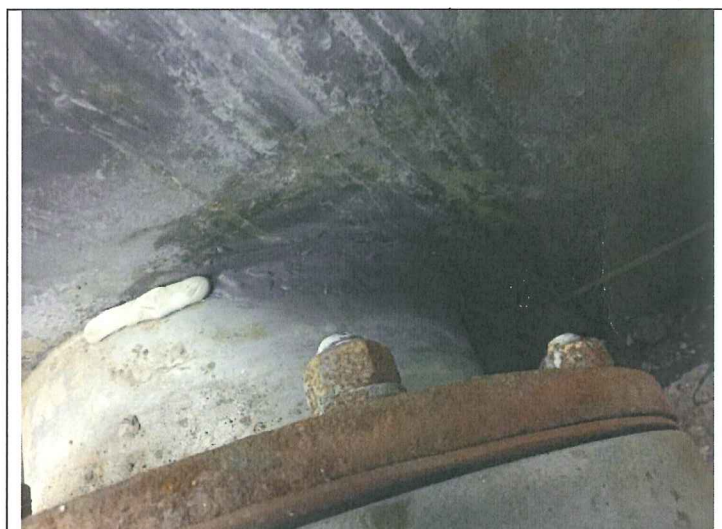
4. Air Stripper effluent fitting showing epoxy repairs

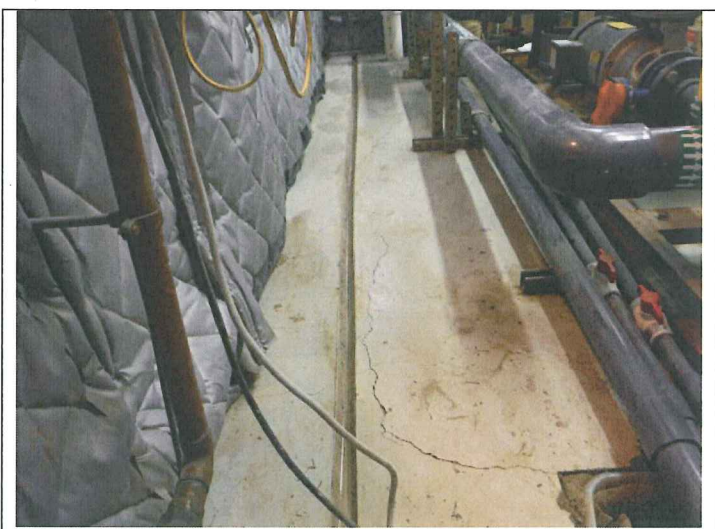
5. Liquid Containment Trench along south wall of Treatment Room

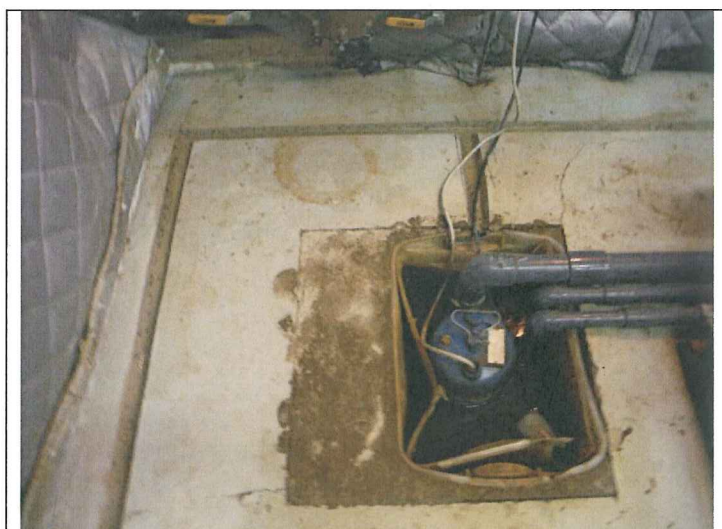
6. Liquid Containment Trench at southeast corner of the Treatment Room

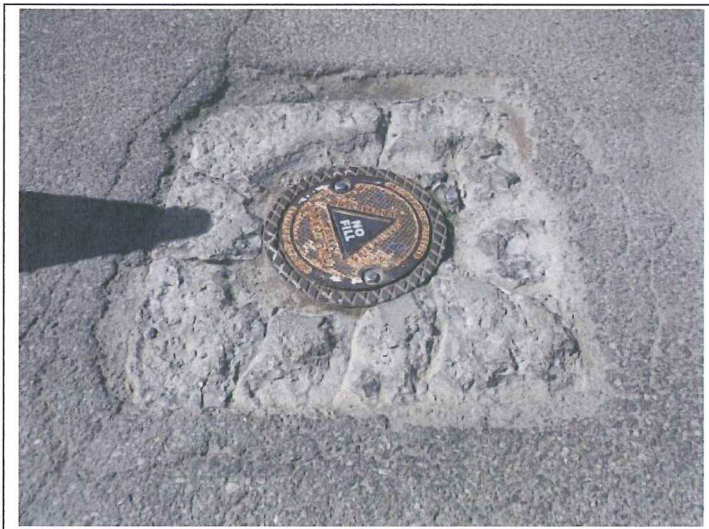
1. PZ-1B showing concrete damage from winter conditions

- Performed repairs on PZ-1B, PZ-6A and PZ-6B.

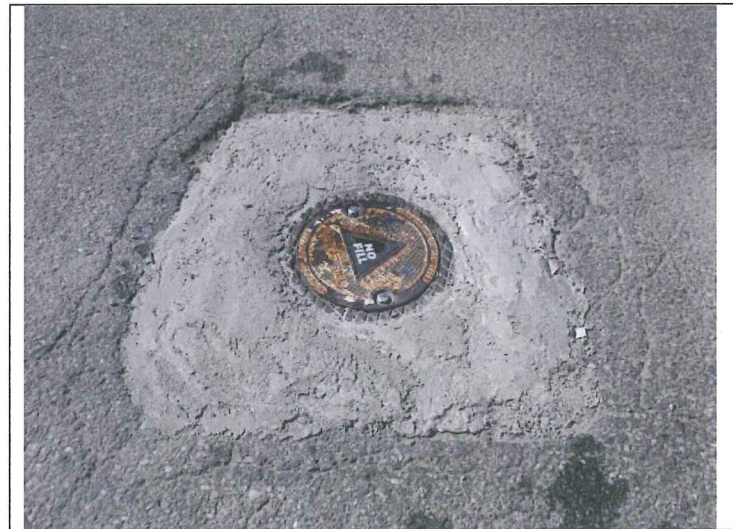
2. PZ-1B after concrete repair with MG-KRETE

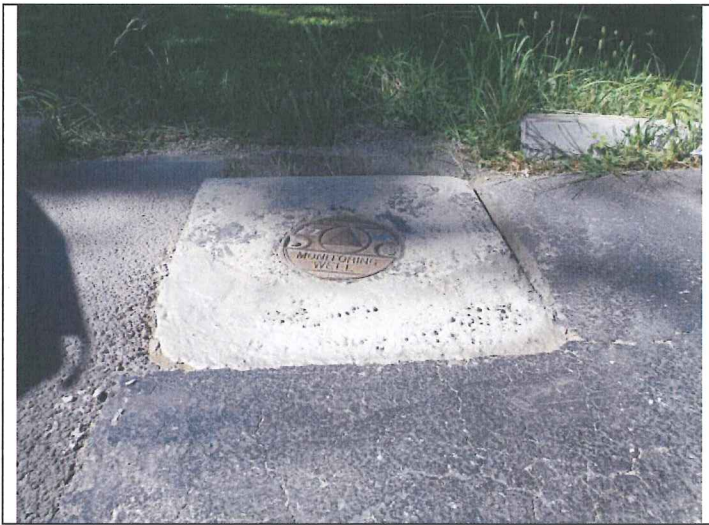
3. PZ-6A after snowplow damage repair with MG-KRETE

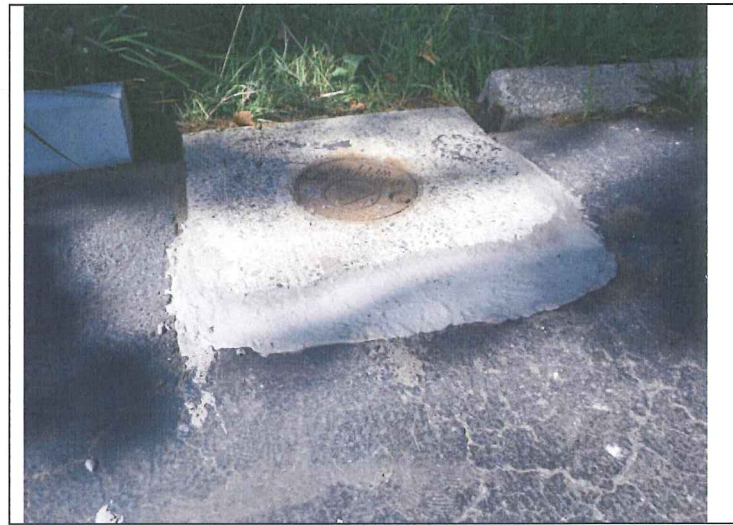
4. PZ-6C after snowplow damage repair with MG-KRETE

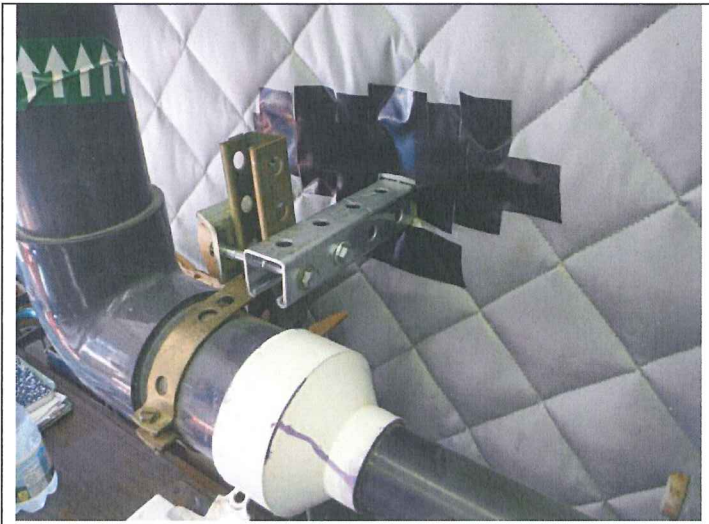
5. Close up of middle brace installed on the Effluent Pipe

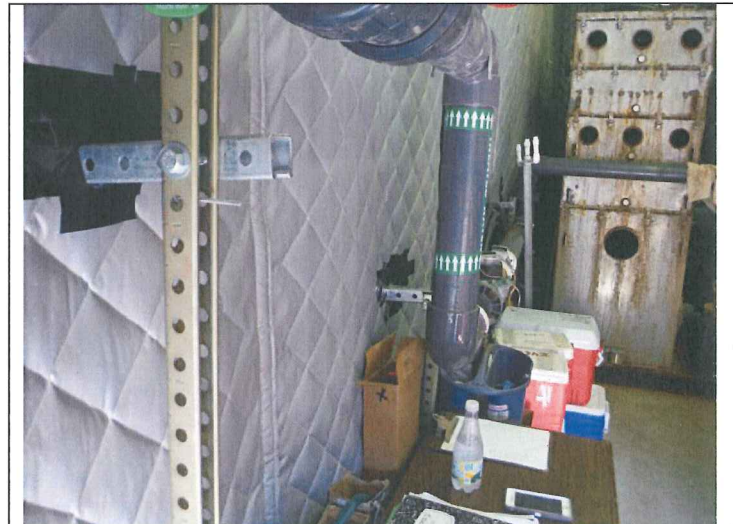
6. Overview showing all three braces on the Effluent Pipe
