BUFFALO CORPORATE CENTER

Re: Mr. C's Dry Cleaners Site, Contract # D009807, Site # 915157 September 2020 Operations, Maintenance, and Monitoring Report

Ecology and Environment Engineering and Geology, P.C. (E&E) is pleased to provide the September 2020 Operations, Maintenance, and Monitoring (OM&M) Report for the Mr. C's Dry Cleaners Site, NYSDEC Site # 915157, located in the Village of East Aurora, New York.

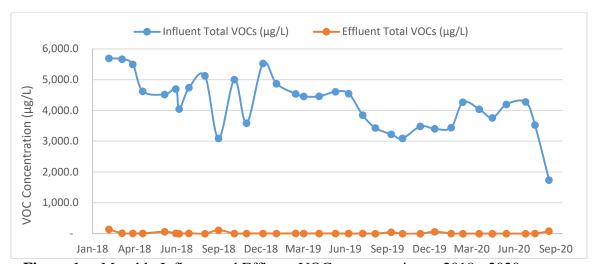
Figure 1: Monthly Influent and Effluent VOC concentrations - 2018 - 2020.

- The analytical summary results of the September 2, 2020 samples revealed the total volatile organic contaminant concentrations of the influent to be 1,740.0 µg/L and the

concentration of total volatile organic contaminants in the effluent was 78.5 µg/L. The summary of influent and effluent contaminant concentrations for the September 2020 sampling are presented in <u>Table 3</u>. <u>Figure 1</u> shows the influent and effluent VOC concentrations during each sampling event in 2018, 2019, and 2020.

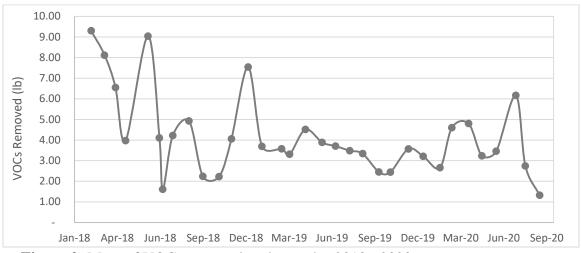
Figure 2: Mass of VOCs removed each month - 2018 - 2020.

• The Mr. C's treatment system, based on the total flows from the uptime operations, removed 1.26 lbs. of targeted contaminants from the groundwater between September 1, 2020 through September 28, 2020. The cleanup effectiveness for September 2020 was approximately 95.49%. The calculations and data for the month are presented in Table 3. The mass of VOCs removed each month throughout 2018, 2019 and 2020 is shown in Figure 2.

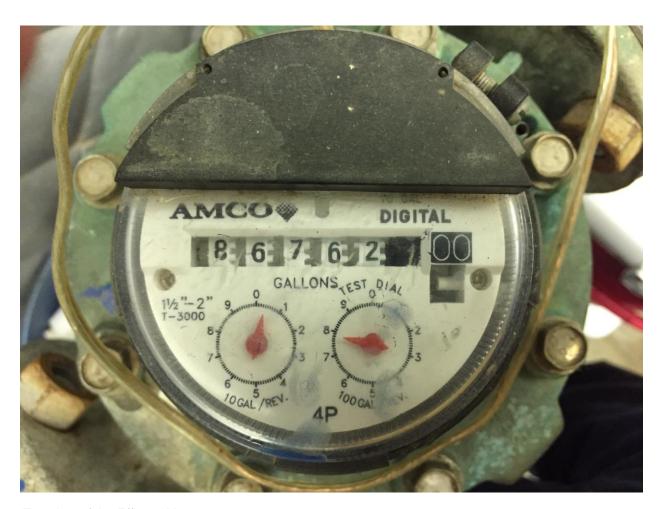
Top view of the Effluent Meter.

Effluent Meter	Clean Effluent Meter inside	in progress				
Fan Shroud is broken	Shroud over fan unit of Outdoor Store is broken - it is located down alley between two buildings and is approximately 12' high.	in progress				
Check SVE Fans	Check on status of subslab fan units	in progress				
MPI-5S is Damaged	MPI-5S was damaged by snowplow. Notified Intrepid Auto and had their maintenance personnel fill inner ring with gravel as a temporary fix. Replace inner ring.	in progress				
MW-8 is Damaged	MW-8 was damaged by a snowplow. Let IA, Inc. know and have their maintenance personnel fill inner ring with gravel as a temporary fix. Replace inner ring.	in progress				
Inventory Equipment in Treatment Room	Check that equipment left in the Treatment Room In February is still there. MISSING: Rolling Box, Large Air Pump and Redux Can.	in progress				
PZ-7D is buried under gravel	Piezometer has been buried under hard packed gravel by snowplows during Winter months. Locate pizometer with metal detector and excavate.	Sep-20

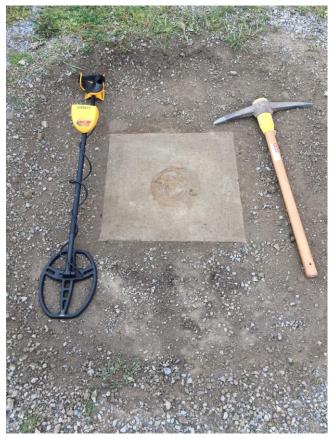
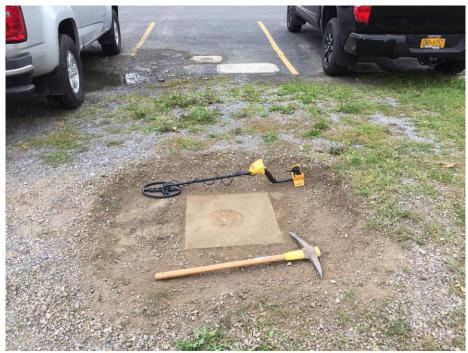
MR. C's DRY CLEANERS SITE - OM&M PIEZOMETER PZ-7D LOCATED - Sep '20 PAGE 1

PIEZOMETER PZ-7D WAS LOCATED UNDER STONE/GRAVEL IN PARKING LOT.
