Enclosure 2
NEW YORK STATE DEPARTMENT OF ENVIRONMENTAL CONSERVATION
Site Management Periodic Review Report Notice
Institutional and Engineering Controls Certification Form

2018 Periodic Review Report

Former Gastown Manufactured Gas Plant Site
Tonawanda, Erie County, New York

NYSDEC Site Number: 915171

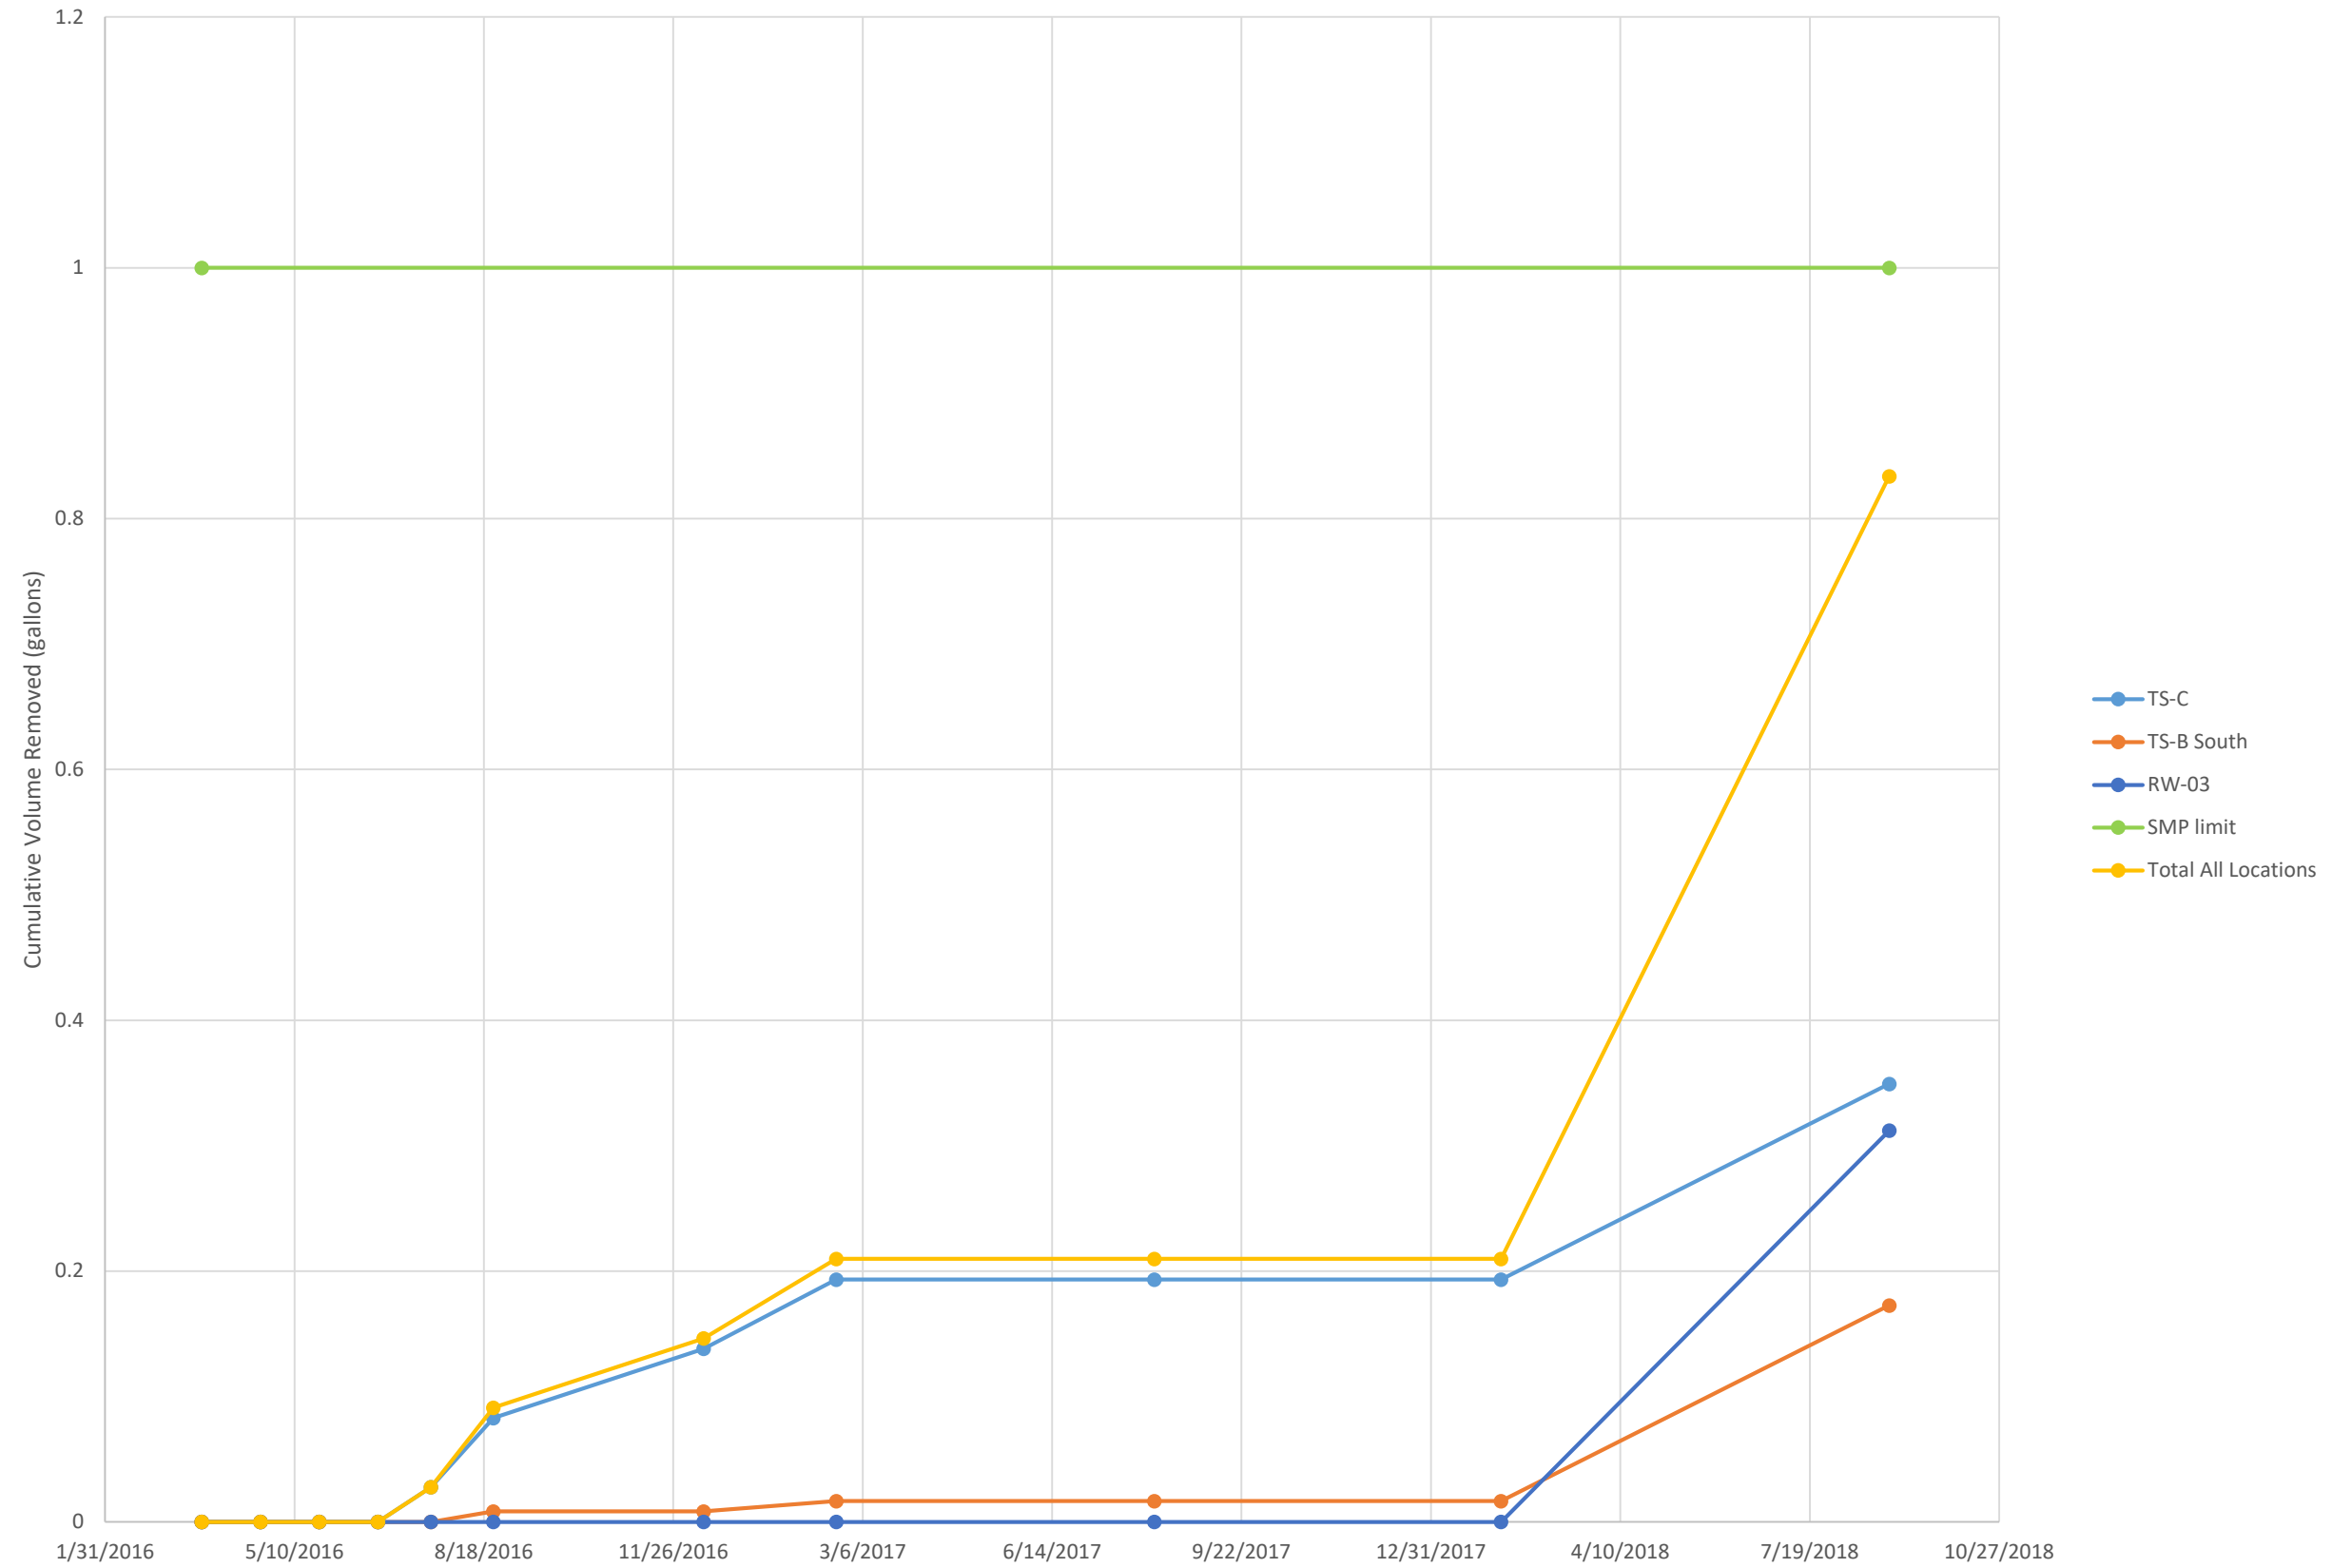
Cumulative NAPL Volume Removed

As part of the remedy, NAPL recovery wells and collection trenches have been installed. The wells are installed west of the Site and the trenches are located north of the Site along Tonawanda Creek, and adjacent to the Sportsman's Club east of the Site. The intent of the wells and trenches is to collect any residual recoverable NAPL that may be present, as well as residual recoverable NAPL that may migrate to these areas due to natural or man-made effects, precluding potential impacts to the surrounding areas. Since 2016, when NAPL monitoring began, approximately 0.83 gallons of NAPL have been recovered from all locations. Table 1 and Figure 5 summarize the NAPL monitoring performed since 2016. As shown on Table 1 and Figure 5, NAPL was last removed in August 2018.

To date, there have been approximately 0.83 gallons of NAPL recovered from the NAPL monitoring locations. According to the SMP, after a period of five years, if there is no significant volume of NAPL recovered (less than 1 gallon cumulatively from all three trenches), then the NAPL monitoring program will be discontinued. After two and a half years of monitoring to date, the NAPL volume appears to be within that limit.
