**TECHNICAL ENFORCEMENT SUPPORT
AT HAZARDOUS WASTE SITES**

PROJECT: EPA CONTRACT NO.: 68-01-7331
DOCUMENT NO.: T934-R02-EP-CTAM-1
SUBJECT: Final Report for EPA Work Assignment R02002/934
CAPT LOIS Inspection
Pratt and Lambert
Buffalo, New York
Document Control No.: T934-R02-FR-CRCM-2

FINAL REPORT
CAPT LOIS INSPECTION
PRATT AND LAMBERT
BUFFALO, NEW YORK

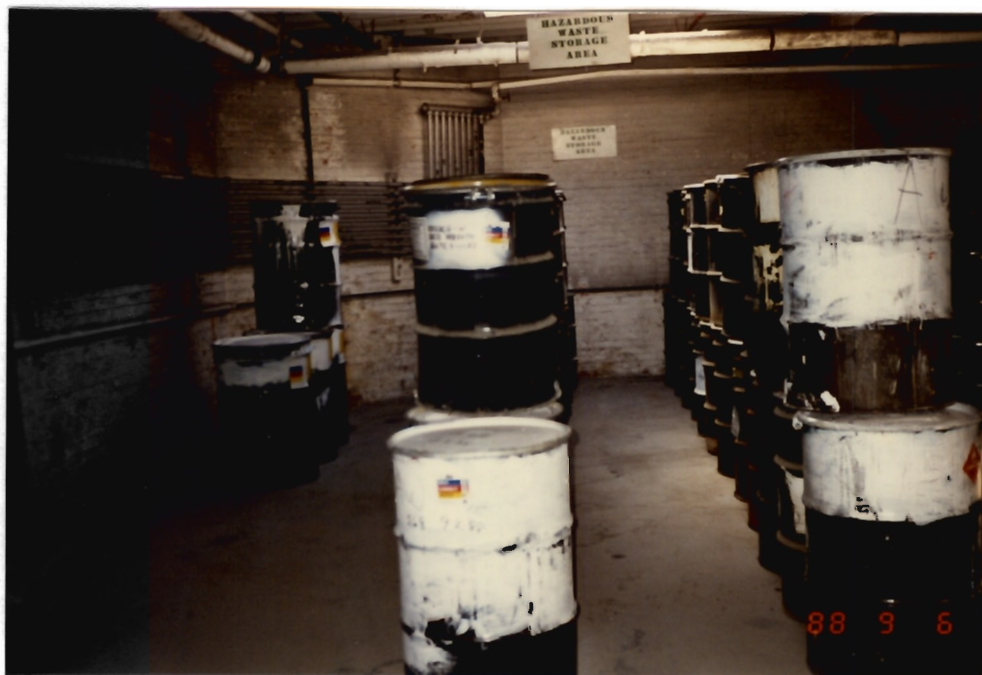
Photo No. 1

P & L stores containers of hazardous waste in this area, located on the first floor of Building 27 of the main plant. The area covers 450 square feet (P & L, 1980). The storage area has a concrete floor and has no floor drains or curb. P & L also stores raw materials in an adjacent open area (Photo No. 1).

P & L reported that no known releases had occurred in the area (P & L, 1986a). During the site visit, no sign of spills was observed in this area.

Date: 09/06/88 Picture Taken By: Eddy Lin Direction Facing: East
Picture Description: Container storage area A

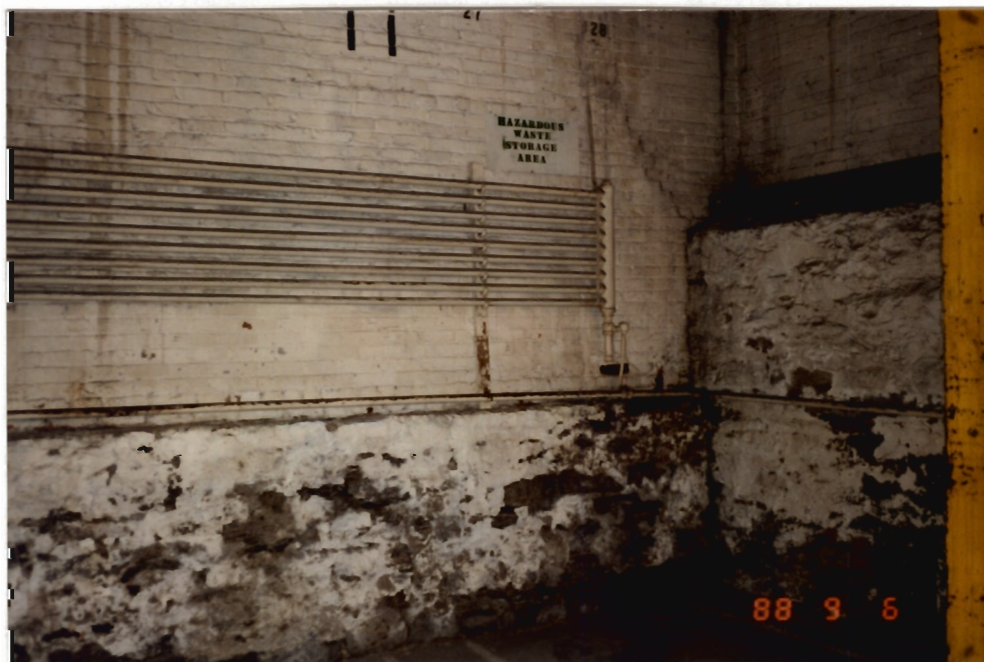
Photo No. 2

P & L stores containers of hazardous waste in this area, located inside on the first floor of Building 2 of the main plant. Container storage area B, shares the same room as an indoor tank farm and covers 480 square feet. The entire room is about 3 feet below the grade level. The area has a concrete floor and has no floor drain or curb (Photo No. 2).

P & L reported that no known releases had occurred in the area (P & L, 1986a). Furthermore, P & L determined that the trace amounts of lead in the wipe samples are order of magnitude lower than the EP toxicity lead level. Consequently, P & L determined that the area was free of significant contamination for lead and hexavalent chromium (P & L, 1987). During the site visit, no sign of spills was observed in this area.

Date: 09/06/88 Picture Taken By: Eddy Lin Direction Facing: South
Picture Description: Container storage area B

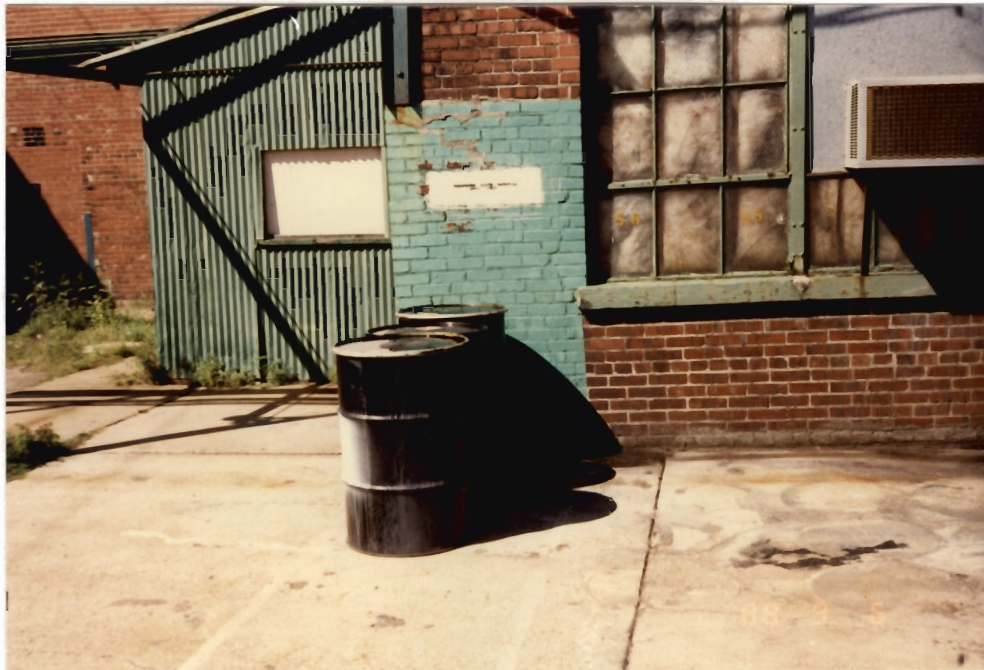
Photo No. 3

P & L accumulates containers of hazardous waste in this area, located outside of building 1A of the industrial plant. The area covers 484 square feet. The area has a concrete pad and has no floor drain or curb (Photo No.3).

P & L reported that no known releases had occurred in the area (P & L, 1986a). Furthermore, P & L determined that the trace amounts of lead in the wipe samples are order of magnitude lower than the EP toxicity lead level. Consequently, P & L determined that the area was free of significant contamination for lead and hexavalent chromium (P & L, 1987). During the site visit, no sign of a spill was observed in this area.

Date: 09/06/88 Picture Taken By: Eddy Lin Direction Facing: West
Picture Description: Container storage area C

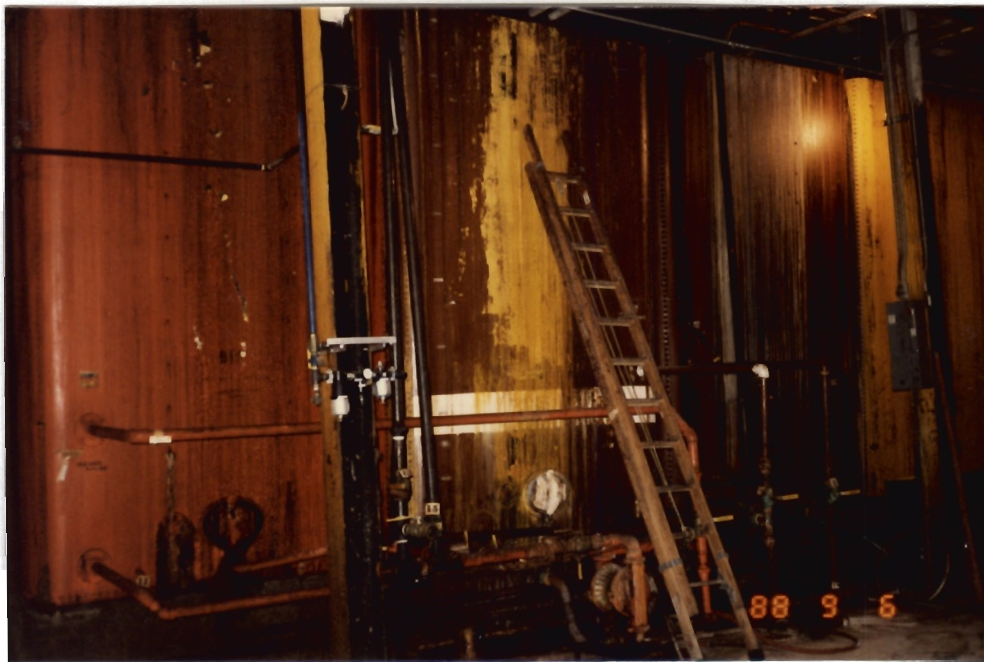
Photo No. 4

- o Building 2
 - Two caustic wash water collection tanks -- 4,000 gallons each (photo No. 4).
 - One scrubber water tank -- 4,000 gallons (Photo No. 5).
 - One blending tank -- 4,000 gallons (Photo No. 6).

Date: 09/06/88 Picture Taken By: Eddy Lin Direction Facing: North
Picture Description: Caustic wash water tanks (yellow tanks)

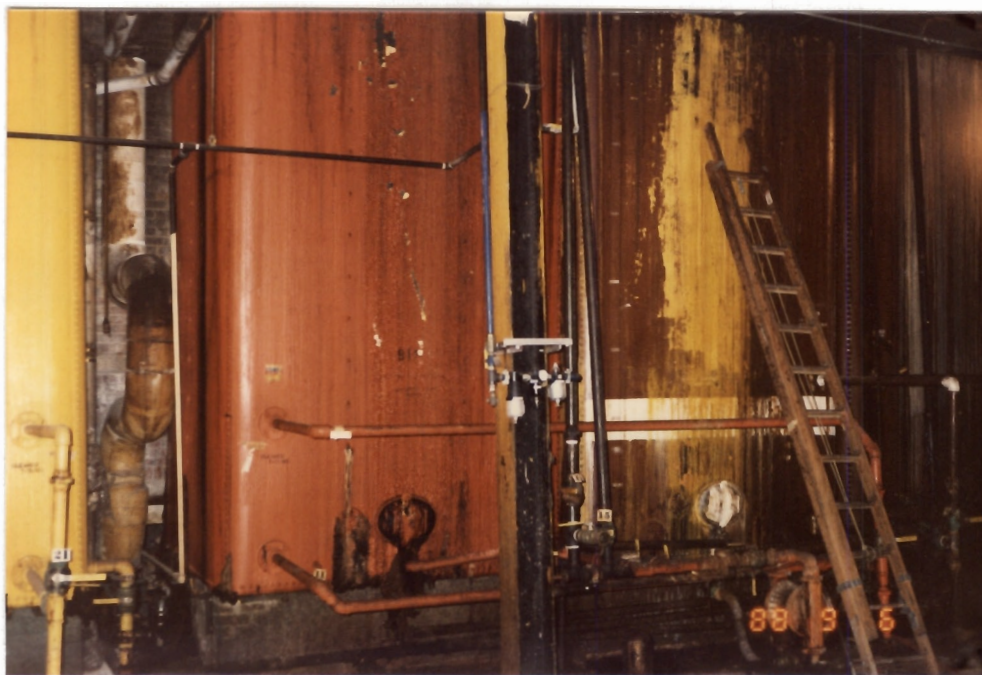
Photo No. 5

Date: 09/06/88 Picture Taken By: Eddy Lin Direction Facing: North
Picture Description: Scrubber water tank (red tank)

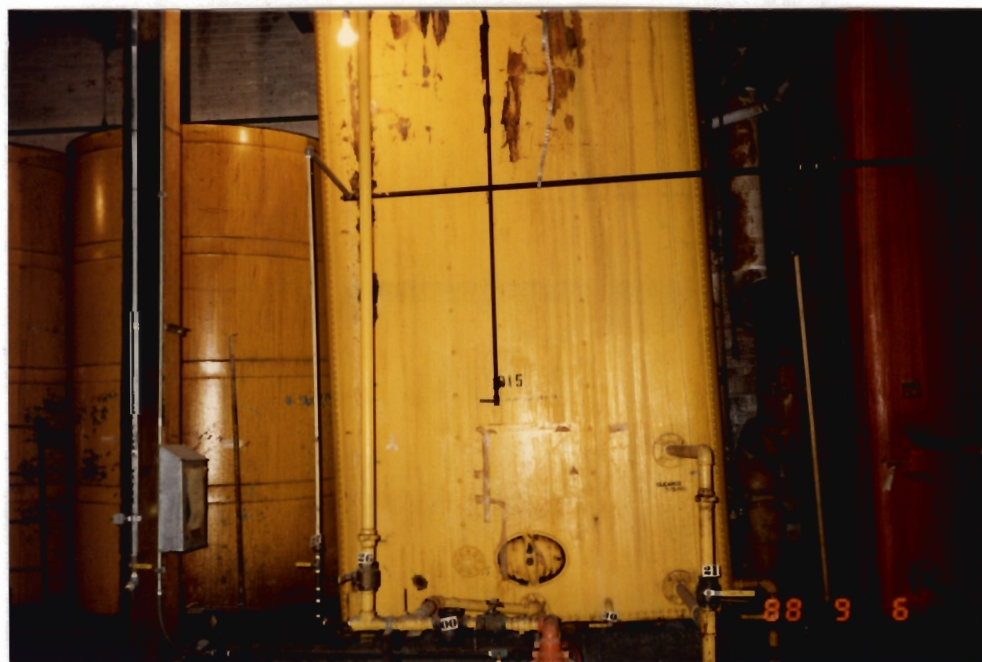
Photo No. 6

Date: 09/06/88 Picture Taken By: Eddy Lin Direction Facing: North
Picture Description: Blending tank (yellow)

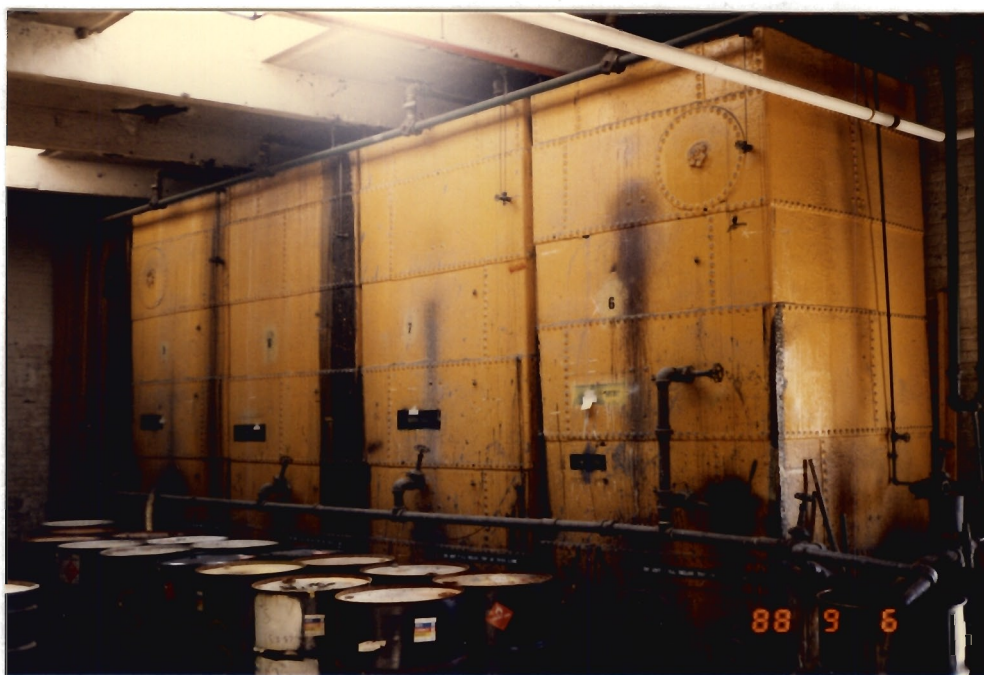
Photo No. 7

- o Building 11
 - Five wash solvent collection tanks -- 2,500 gallons each (Photo No. 7).
- o Building 21
 - Three wash solvent fuel tanks -- 2,500 gallons each

Date: 09/06/88 Picture Taken By: Eddy Lin Direction Facing: South
Picture Description: Wash solvent collection tanks

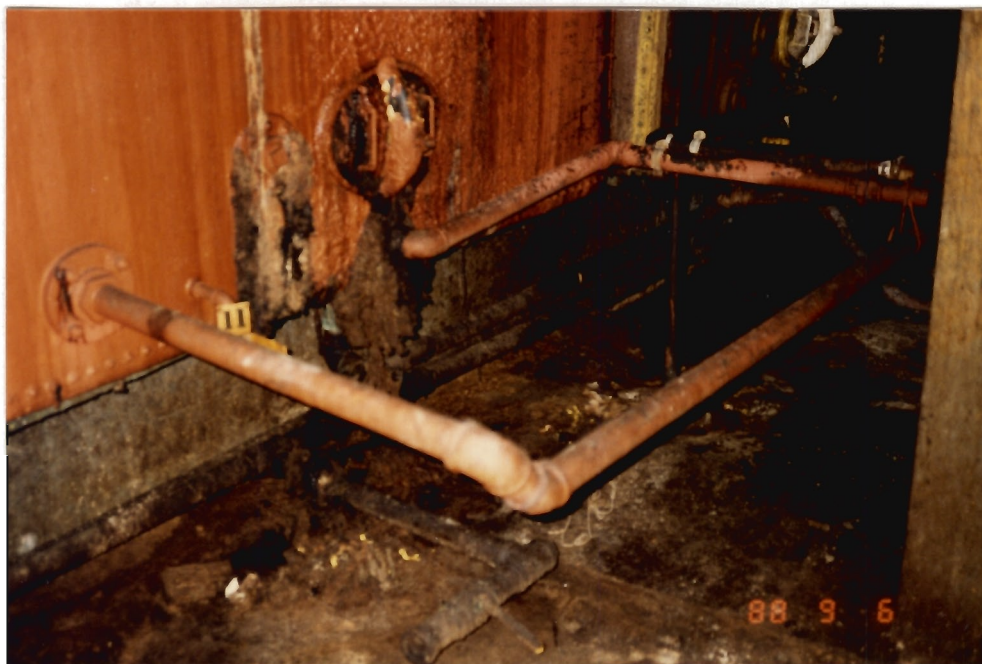
Photo No. 8

At the time of the site visit, PRC observed the sign of spillage on the floor in the building 2 (Photo No. 8). However, the tanks have been in the building for long time, the spillage could occur long time ago. The HNu also showed readings of 5 ppm above background.

Date: 09/06/88 Picture Taken By: Eddy Lin Direction Facing: North
Picture Description: Evidence of spillage in building 2, storage tank area

The floor in the Building 2 is about 3 feet below the ground level. This effectively serves as a containment capacity for the storage tanks. P & L stated if any spill occurred, absorbent will be used to absorb the spillage.

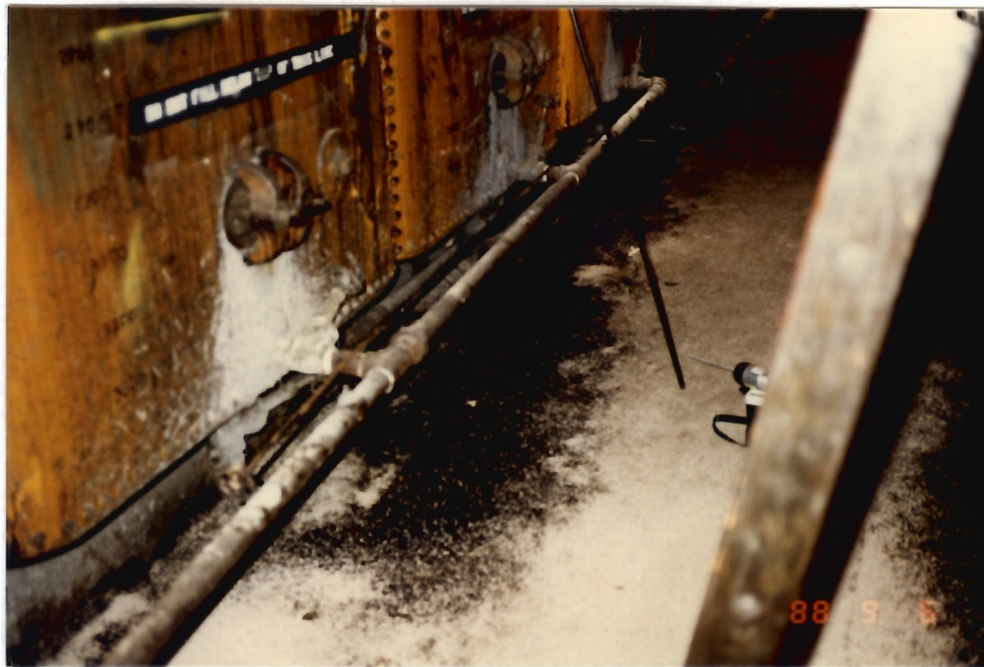
Photo No. 9

No. 2 fuel oil spilled at the P & L facility on December 10, 1987 (NYSDEC, 1987b). According to the NYSDEC Spill Response Form, the spill occurred when a 12,000 gallon tank system failed (NYSDEC, 1987b). The tank is located in a tank farm in Building No. 21. The tank farm is about 6 inches below the ground level. After the spill, P & L used an absorbent to contain the spillage. At the time of

the site visit, the No. 2 fuel residue and absorbent were still on the ground (Photo No. 9). The HNu reading in this tank farm was 5 ppm above the background.

Date: 09/06/88 Picture Taken By: Eddy Lin Direction Facing: West
Picture Description: No. 2 fuel spill in building 21 tank farm
