# **FINAL REMOVAL ACTION REPORT**

## **MORGAN MATERIALS SITE**

Town of Tonawanda, Erie County, New York

May 2021

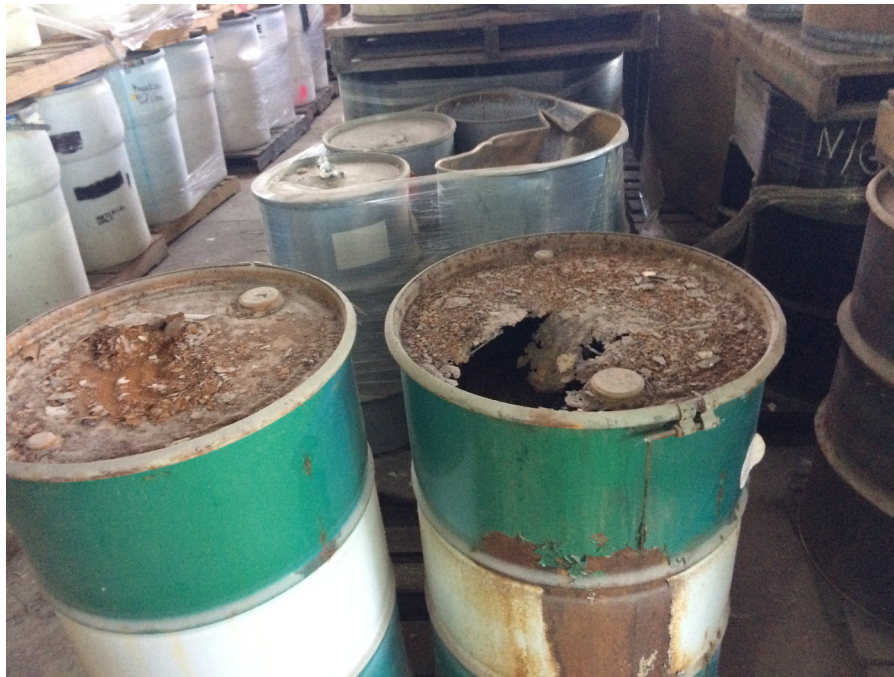
**Photograph 7:** View of damaged drum found in Far Back Room.

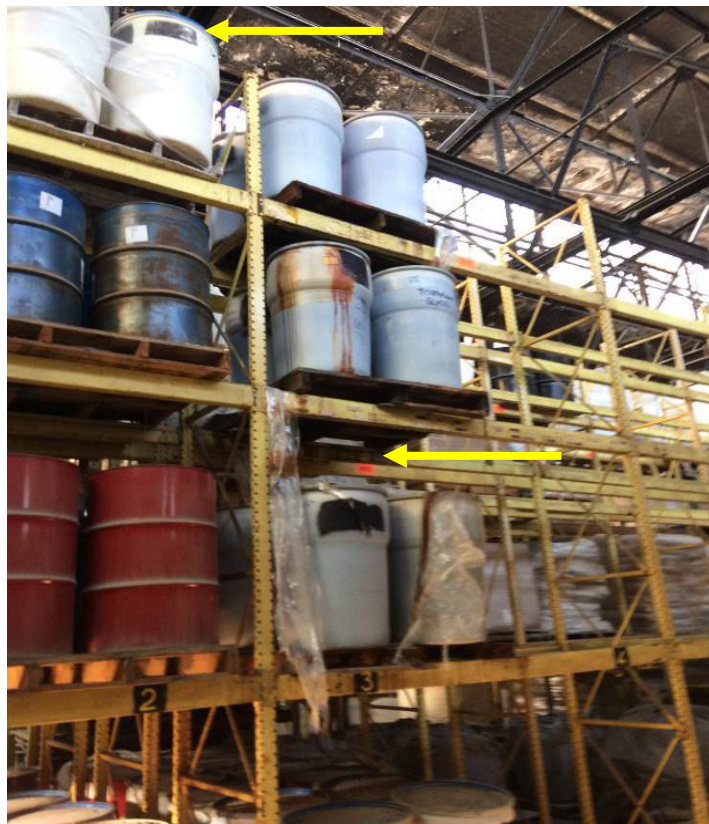
**Photograph 8:** View of drums in Middle Room. Note black paint covering markings on drums.

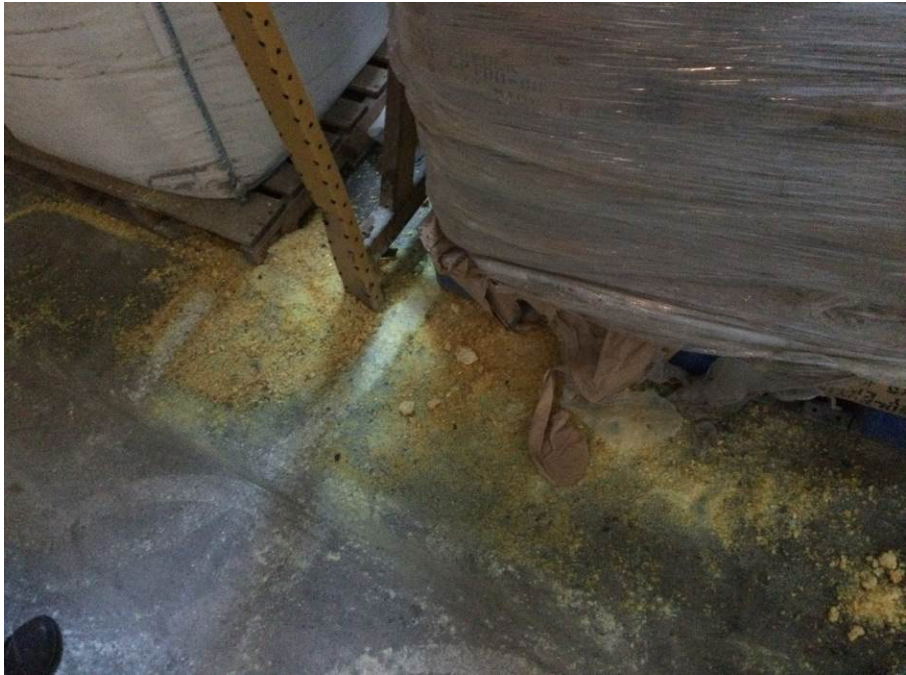
**Photograph 12:** View of spilled contents on floor found in Hallway.

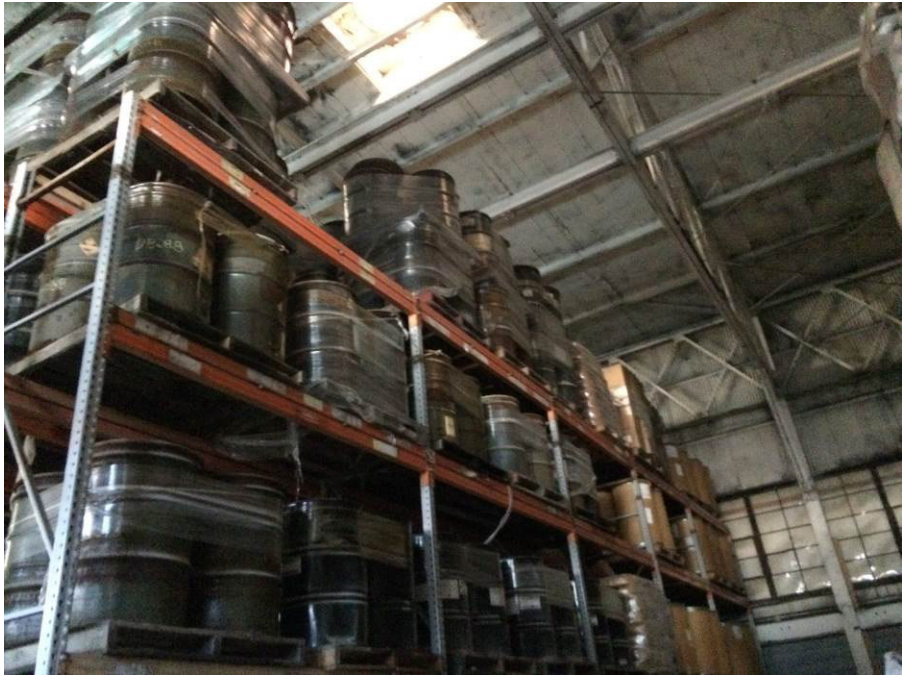
**Photograph 13:** View of stacked drums in Hallway.

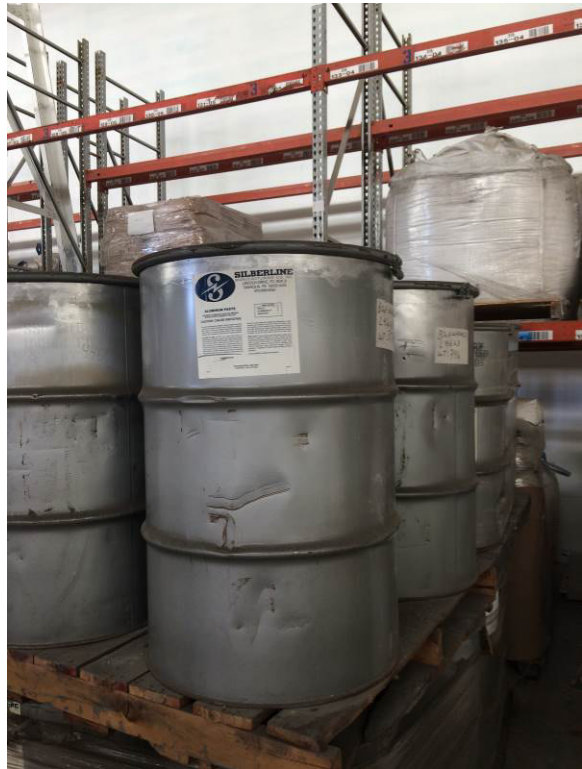
**Photograph 19:** View of damaged drums on pallets in Building D.

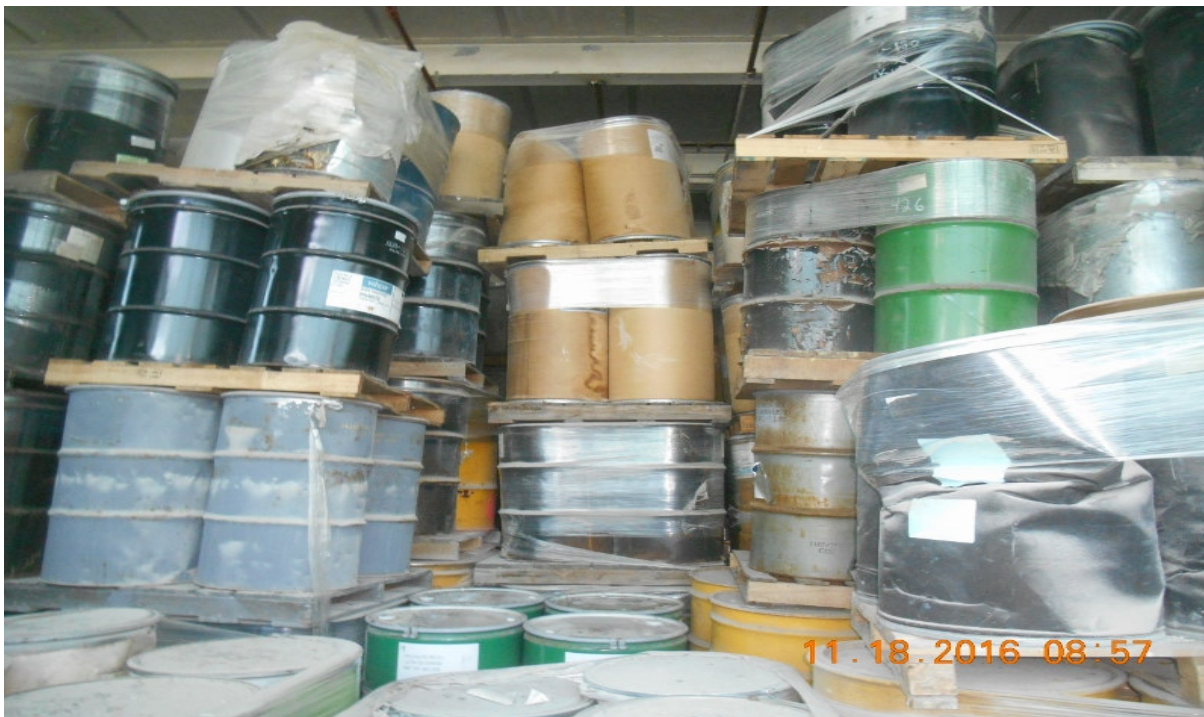
**Photograph 5:** View of drums piled together (flamable, corrosive, etc.) in Warehouse D.

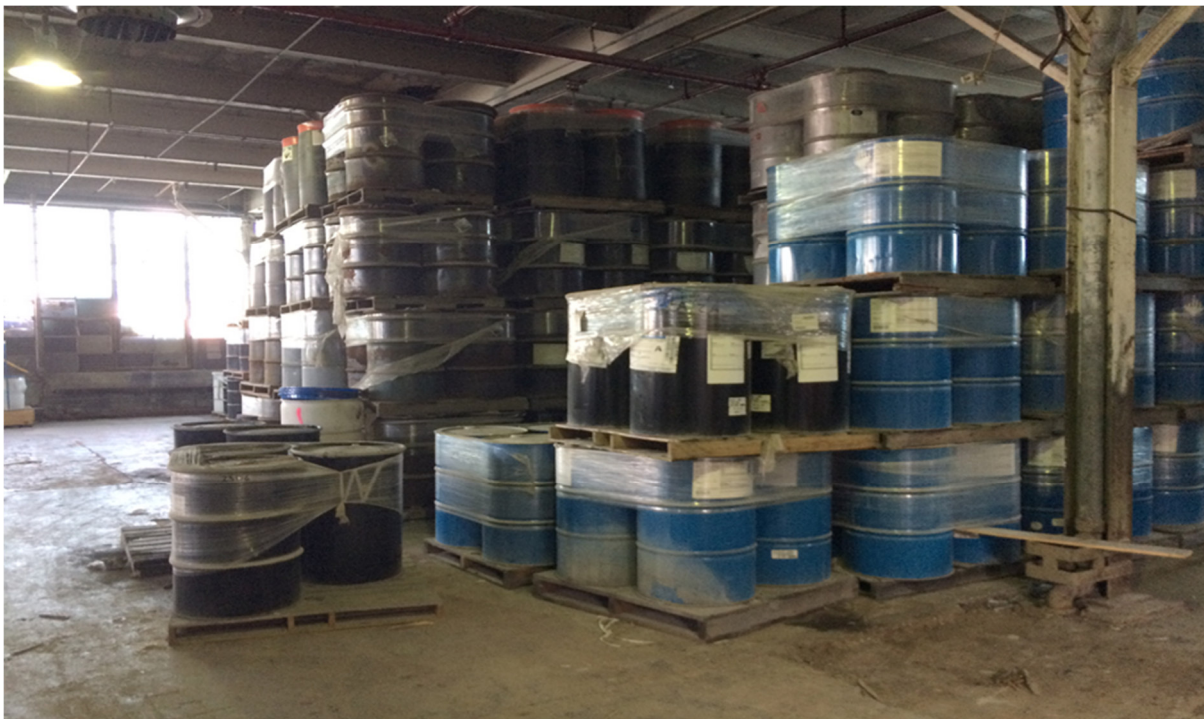
**Photograph 6:** View of the drums piled together (flamable, corrosive, etc.) in Far Back Room.

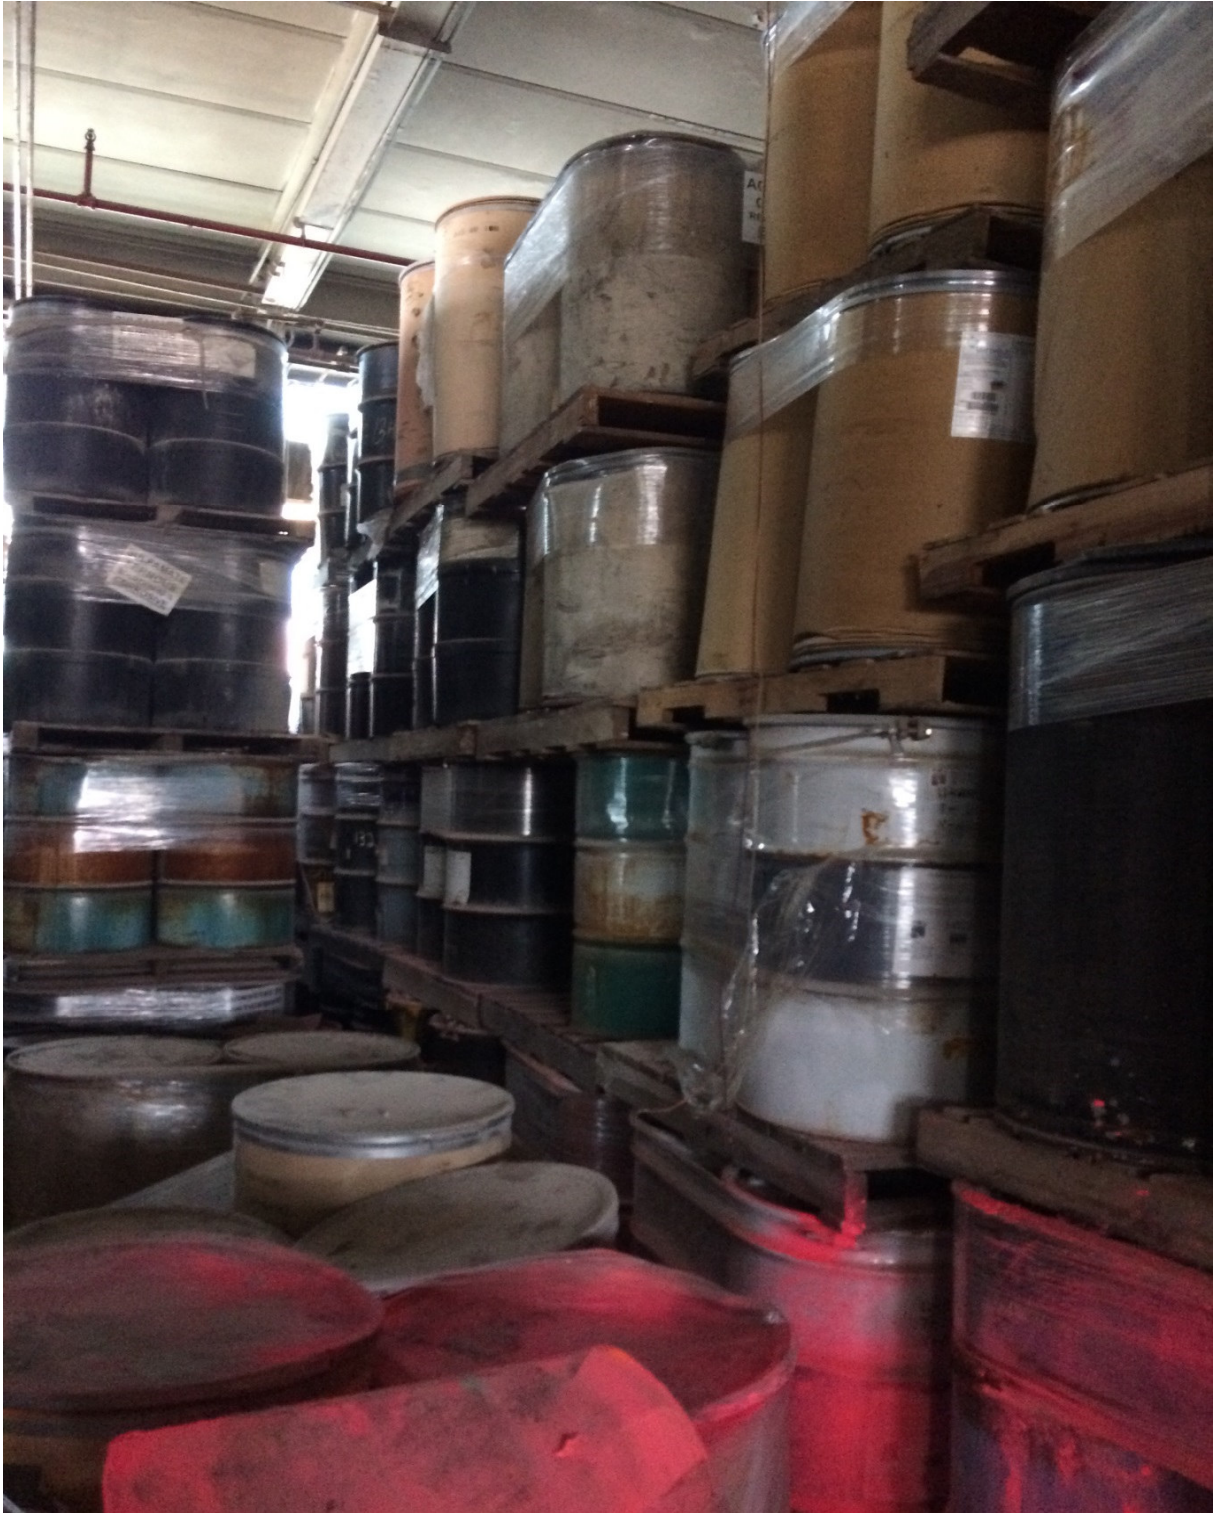
**Photograph 7:** View of overstacked drums (different chemicals) in Warehouse D.

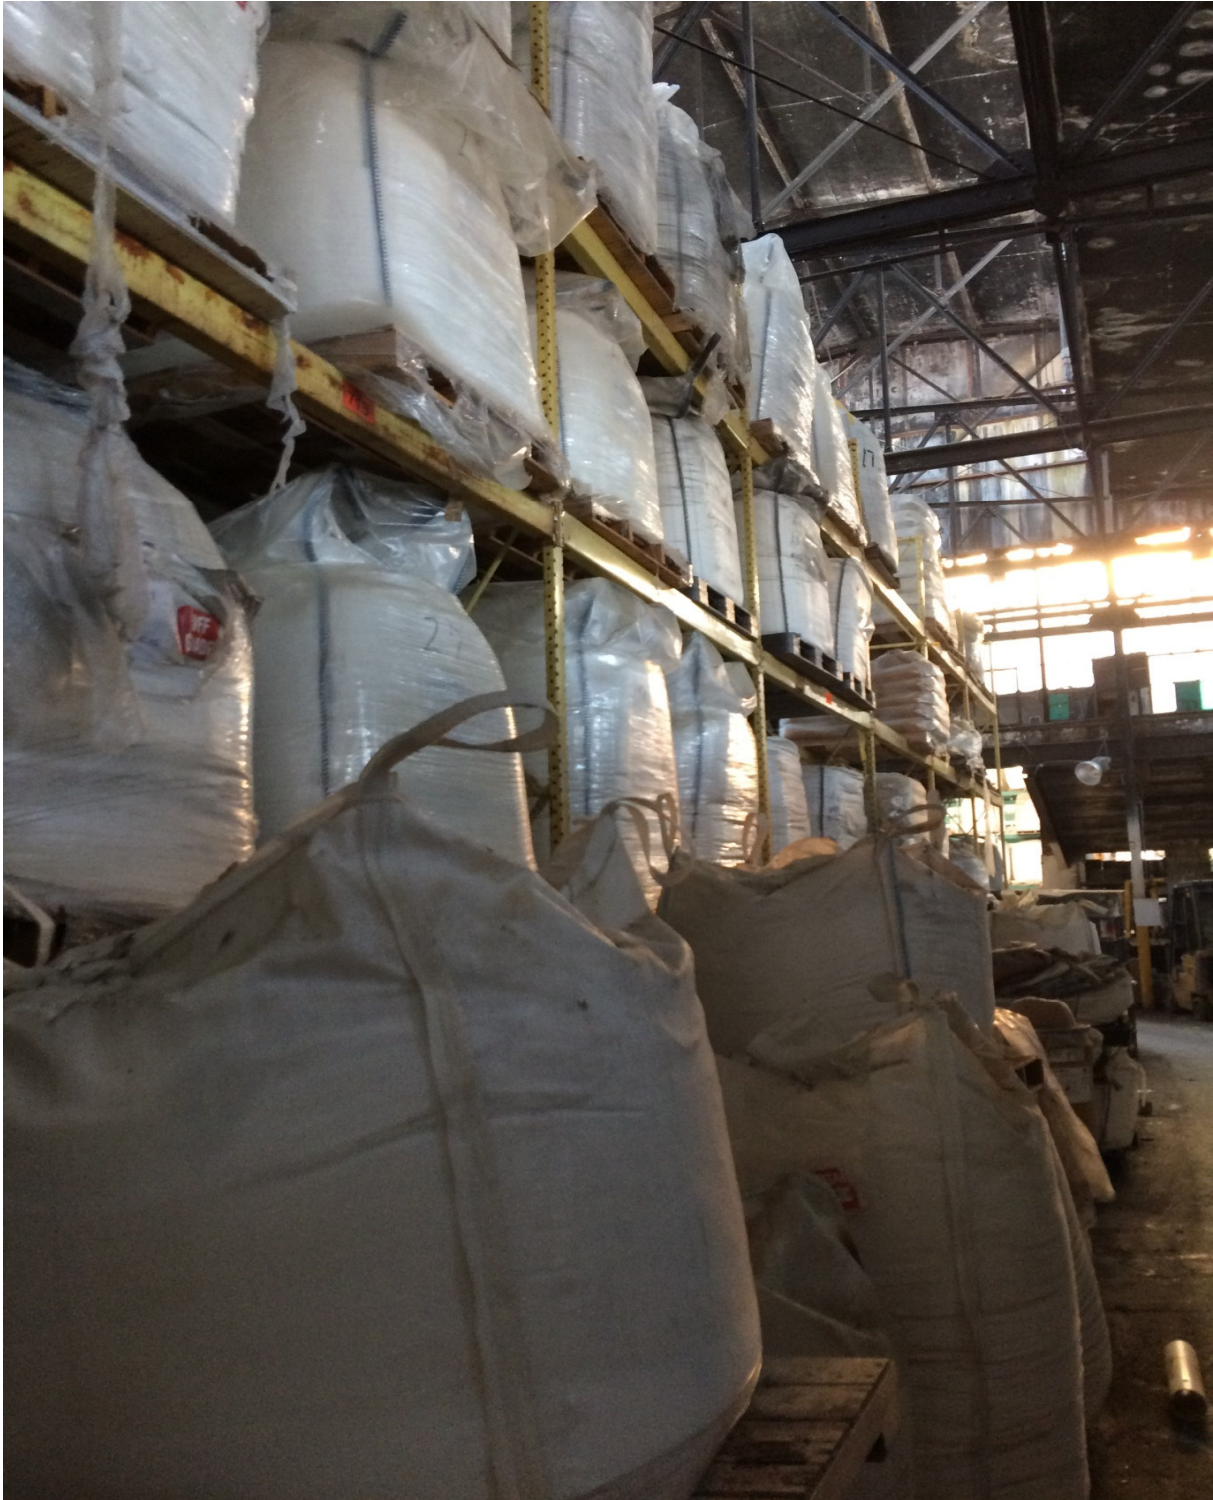
**Photograph 8:** View of material in super-sacks (500 – 2,500 pounds [lbs.]) overstacked in isles in Pigeon Room.

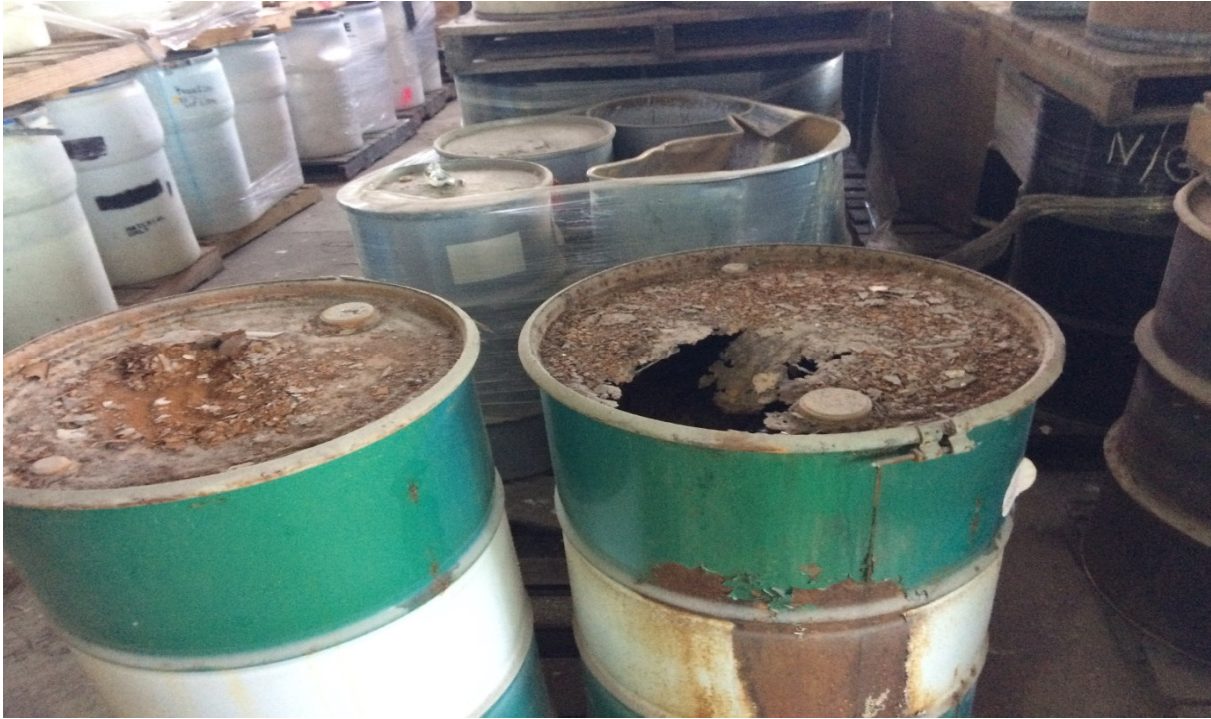
**Photograph 9:** View of deteriorating drums in Far Back Room.

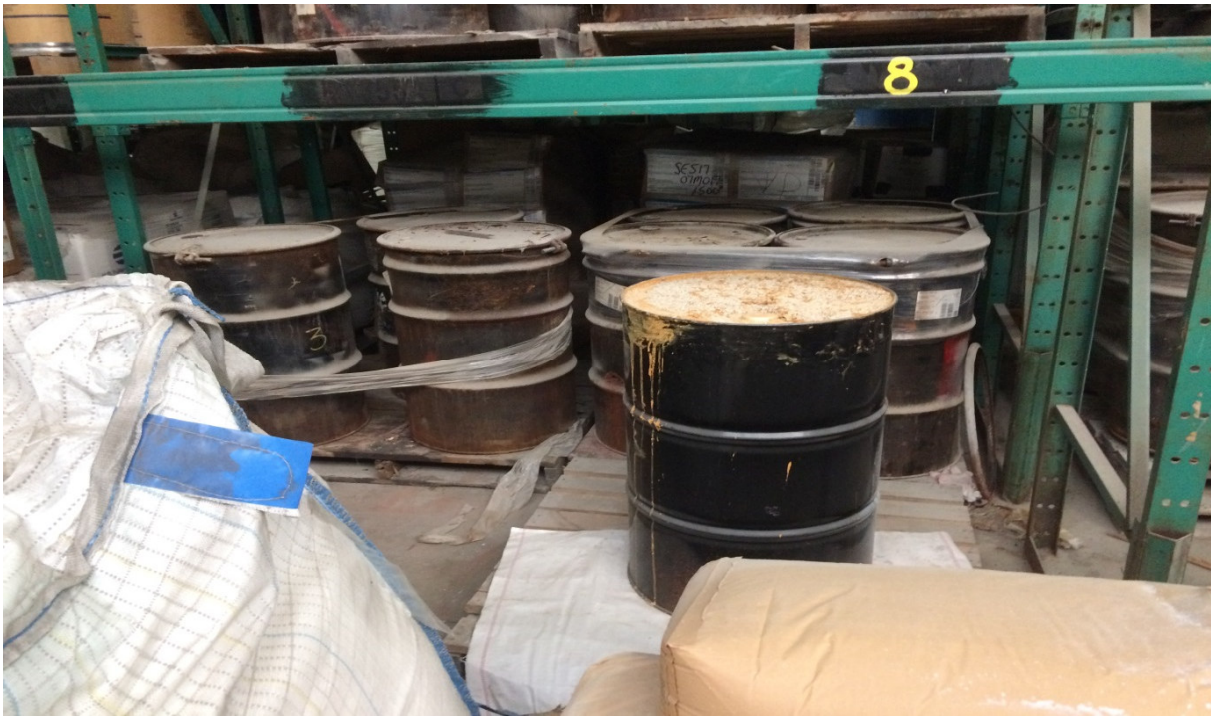
**Photograph 10:** View of the condition of drums in Warehouse C.

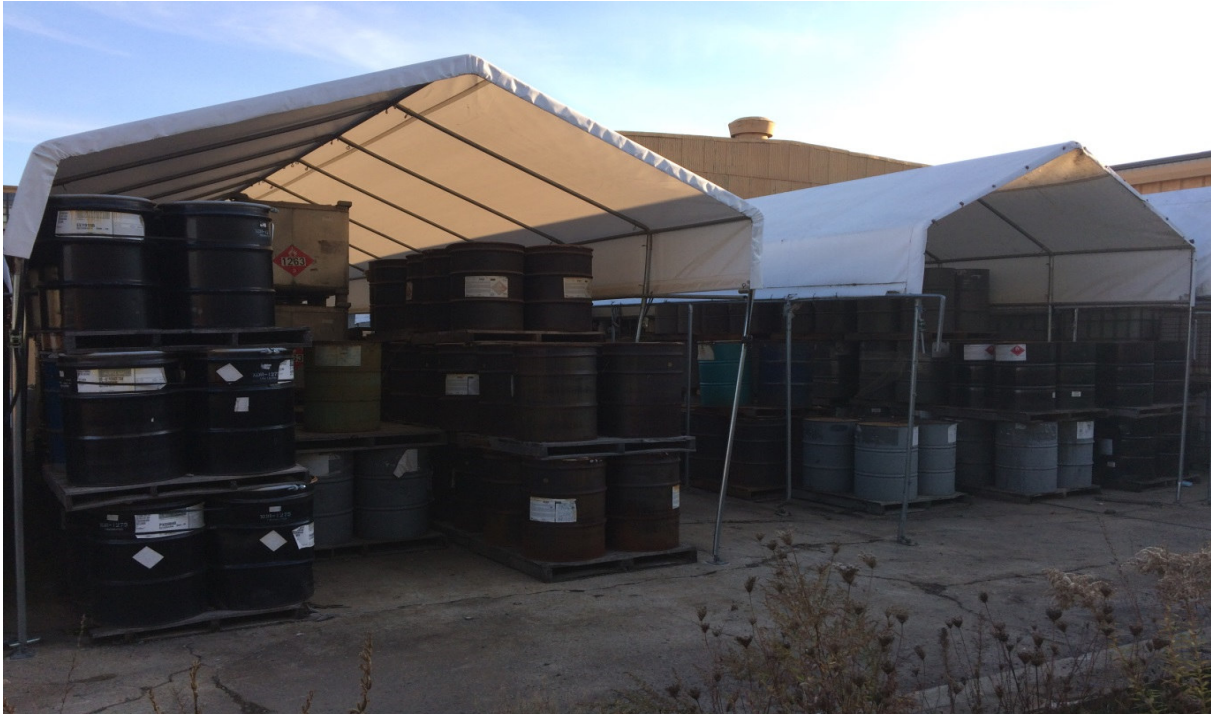
**Photograph 11:** View of material stored outside exposed to environmental elements.

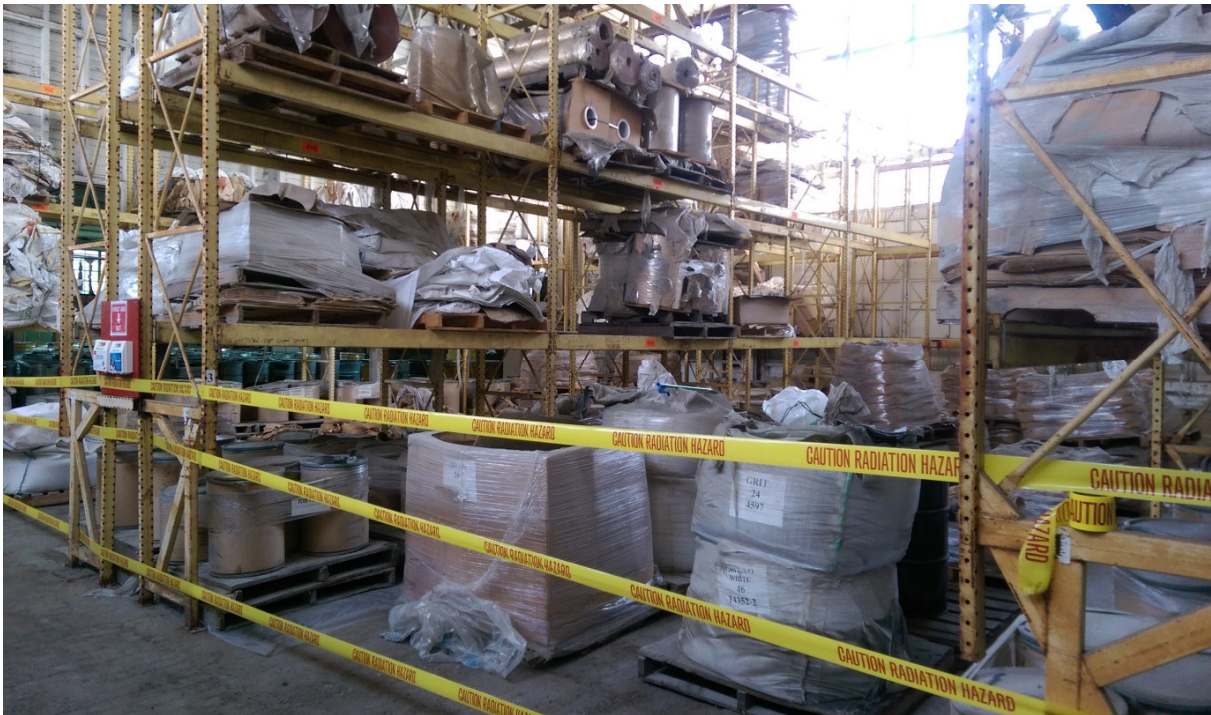
**Photograph 14:** View of low radioactive material stored in Middle Room (Warehouse A)

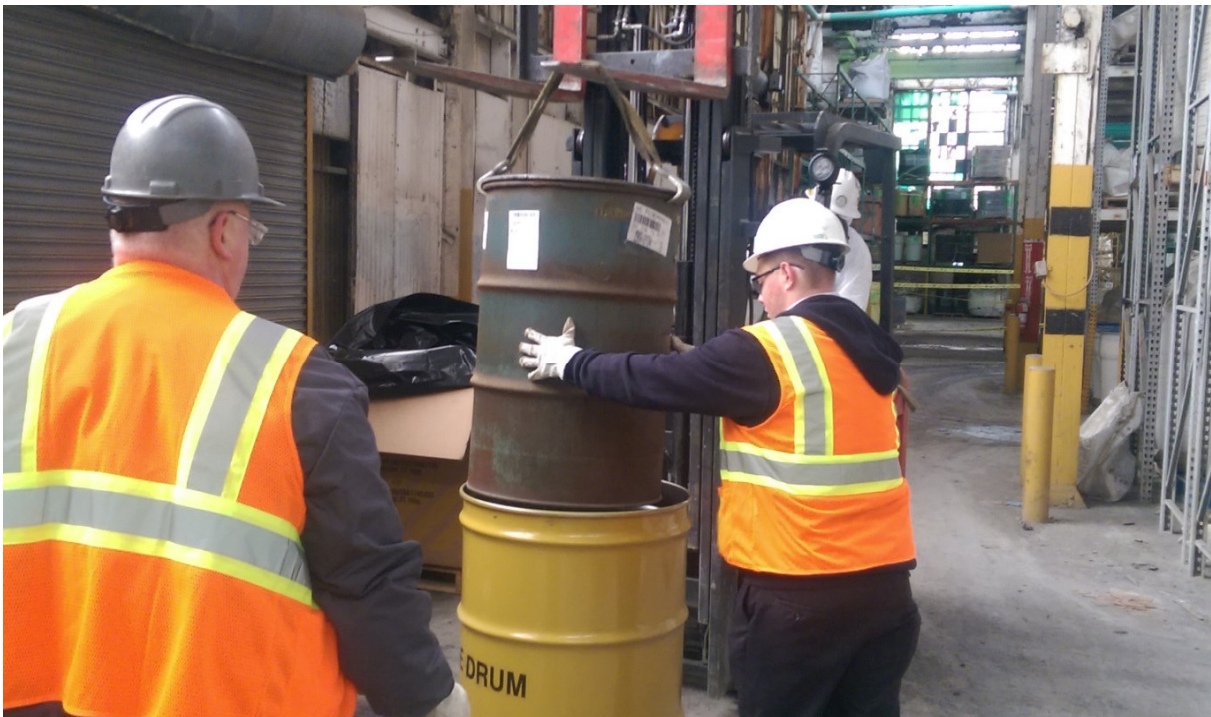
**Photograph 16:** View of drums been overpacked prior to loading by Veolia on behalf of BASF with the assistance of GES.

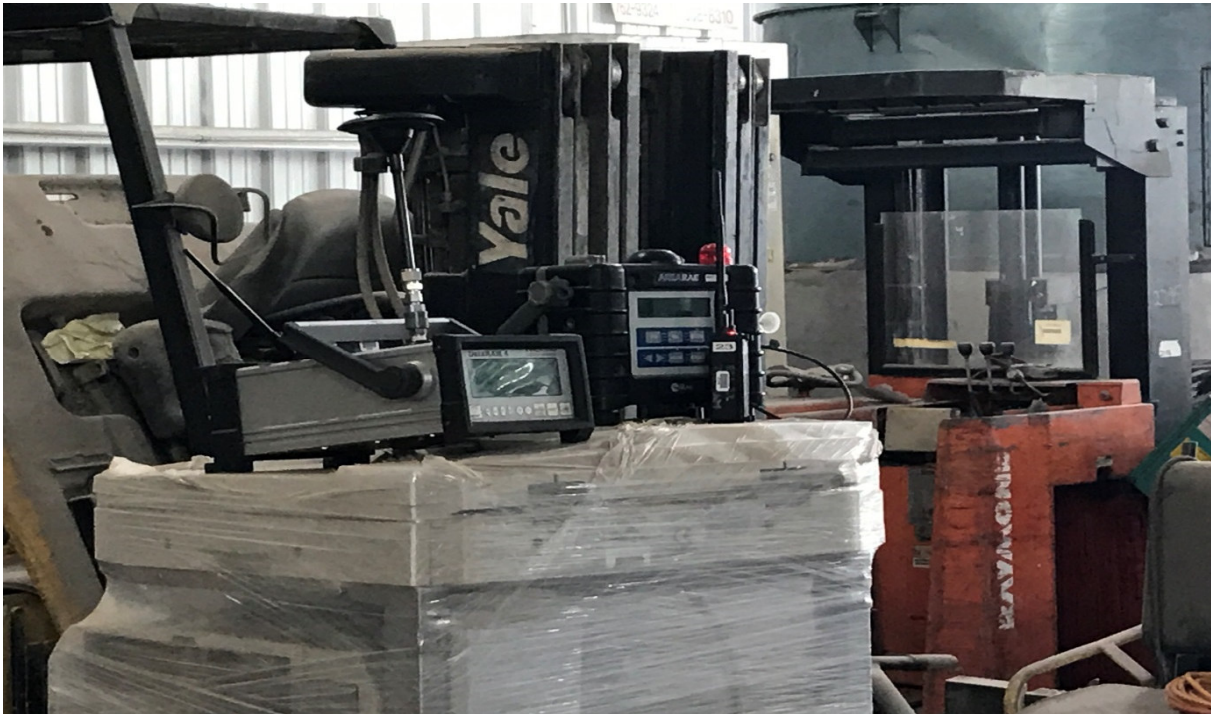
**Photograph 21:** View of air monitoring Station #3 comprising of a Dataram and AreaRAE in Warehouse C.

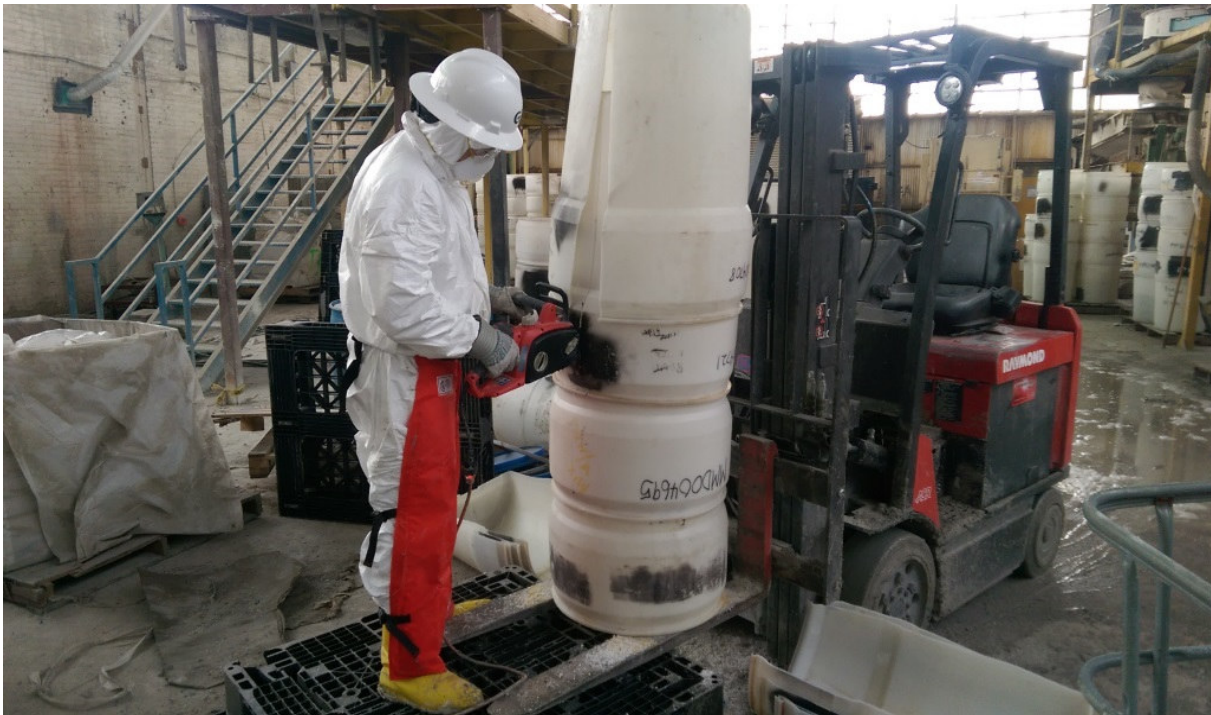
**Photograph 30:** View of poly drums been cut prior to disposal.

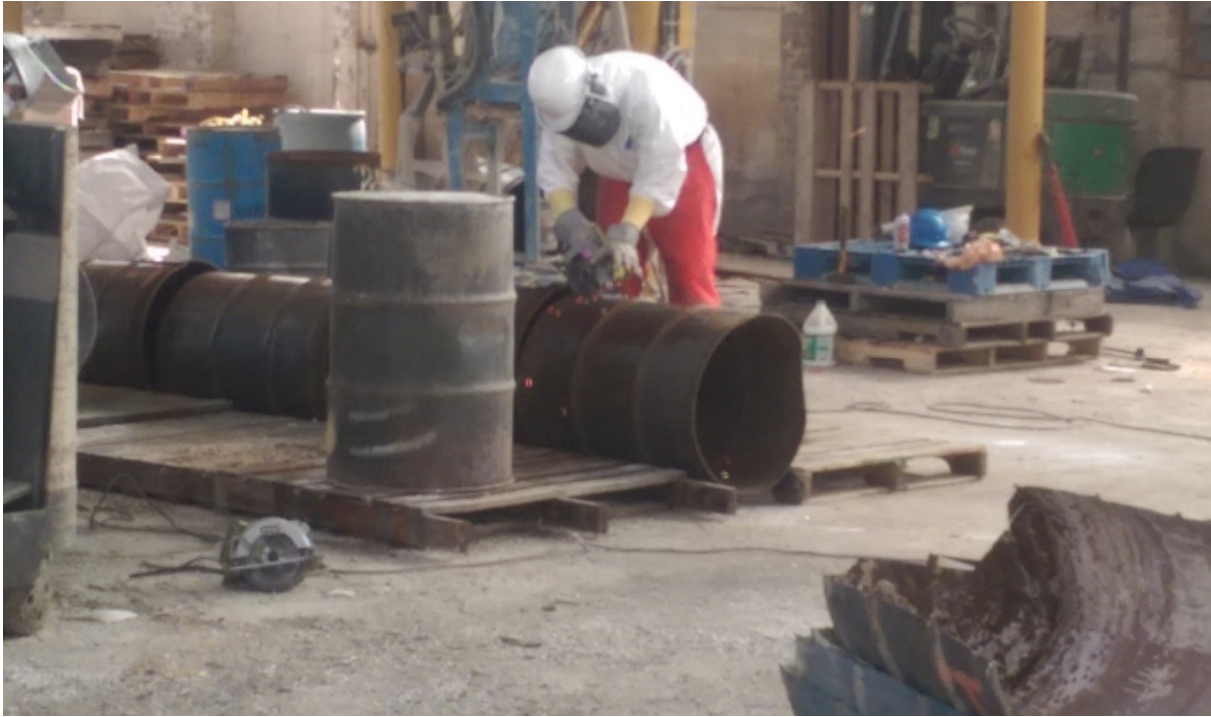
**Photograph 33:** View of metal drums been cut prior to disposal.

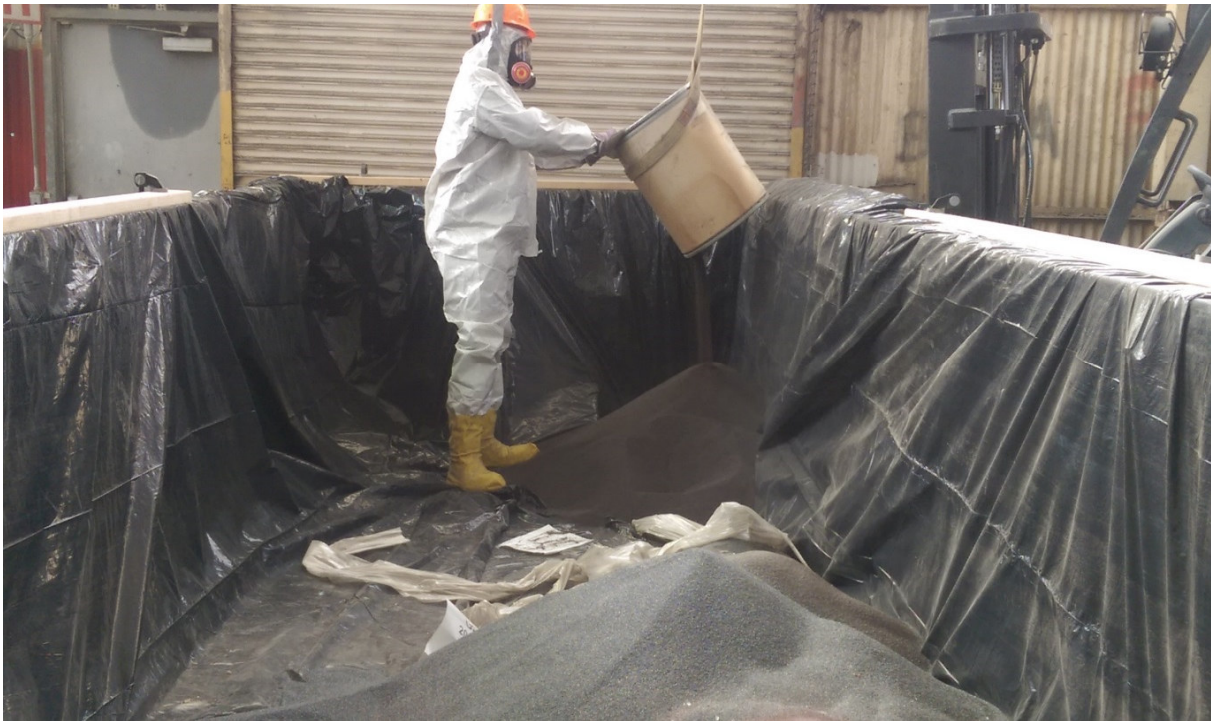
**Photograph 36:** View of grit material being consolidated in lined dumpster staged in Warehouse A for disposal. Disposal facility specified that the grit material should not be containerized.

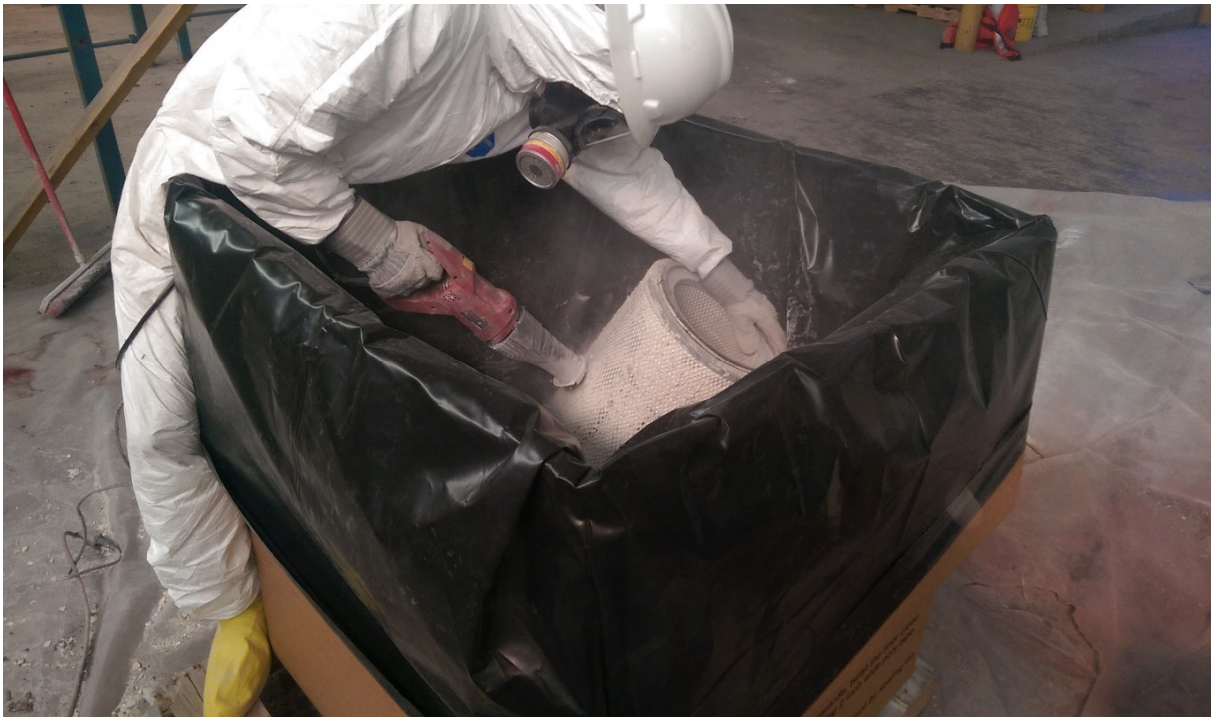
**Photograph 40:** View of used filters in Warehouse D being cut to pieces for disposal.

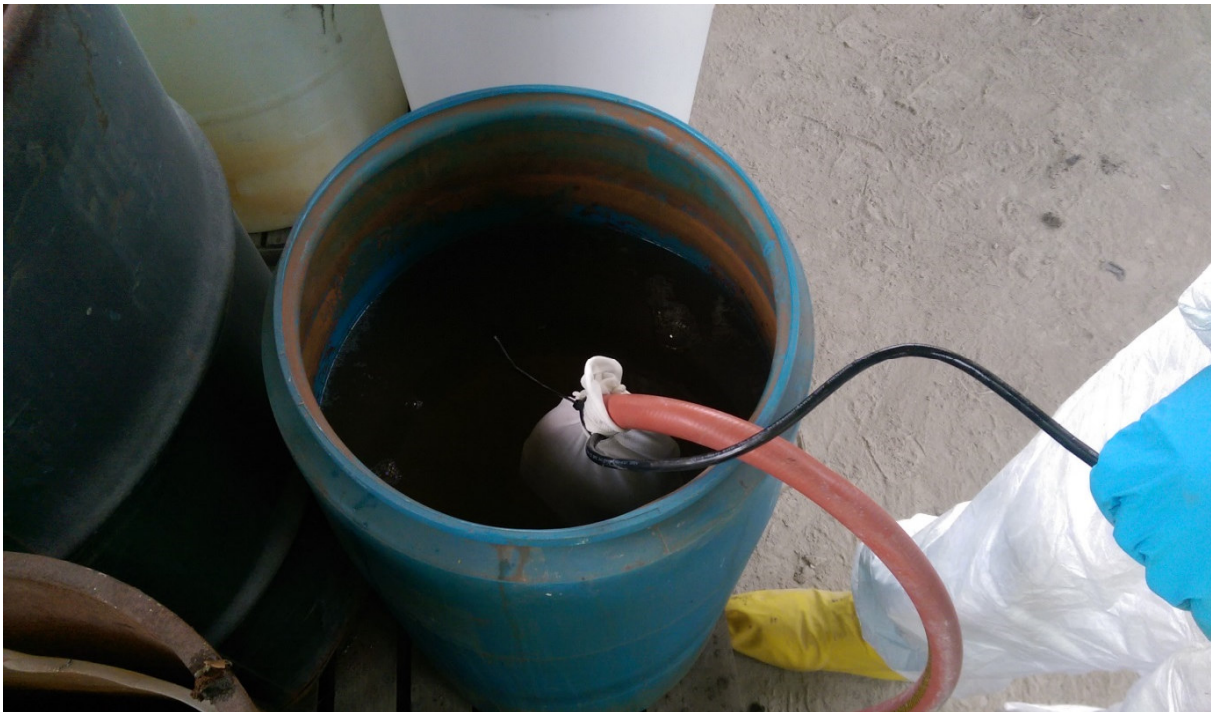
**Photograph 42:** View of water being pumped out of drum, prior to disposal of drums.

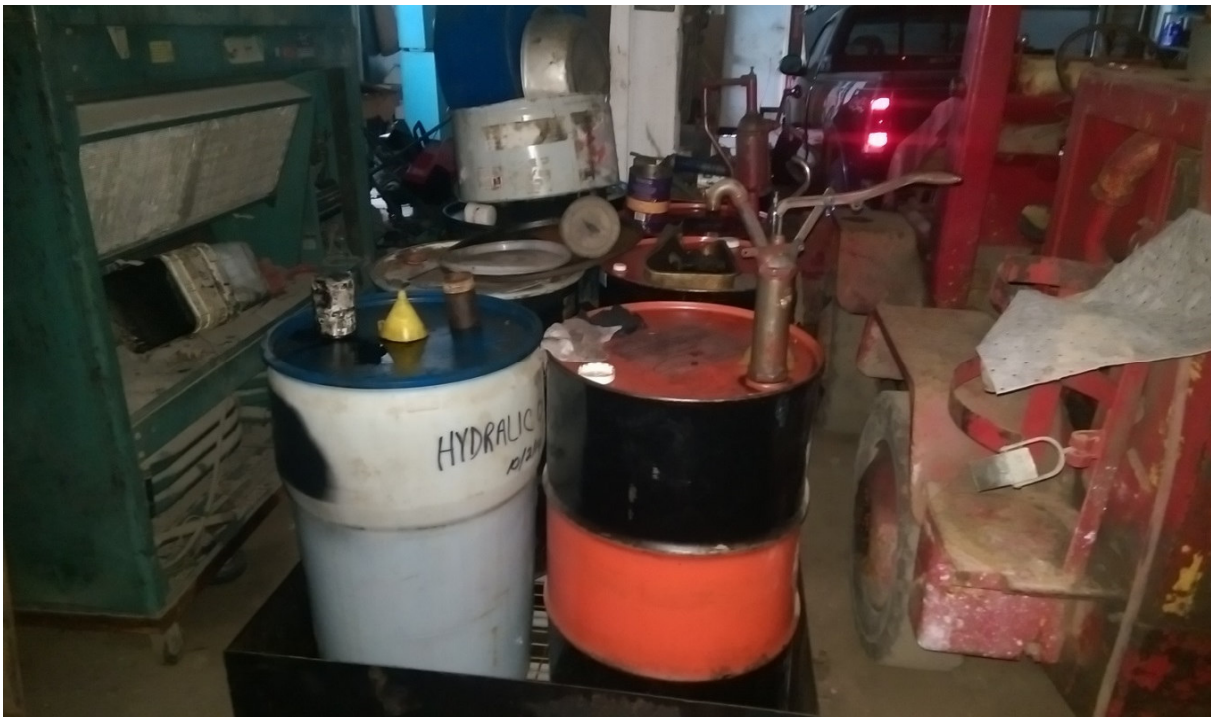
**Photograph 44:** View of petroleum base material (8 drums) found in Warehouse B.

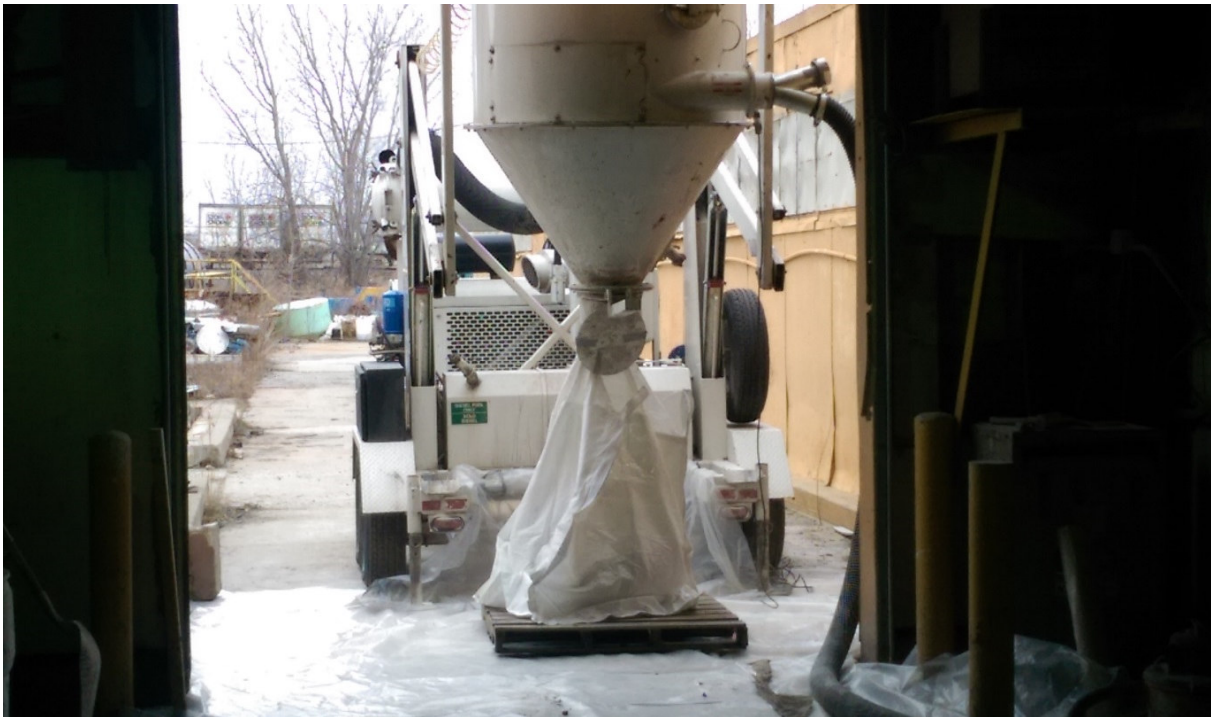
**Photograph 46:** View of powder material being transferred from poly drums to super-sacks using a Vacuum Unit (Hurricane 500-0339 by Industrial Vacuum).

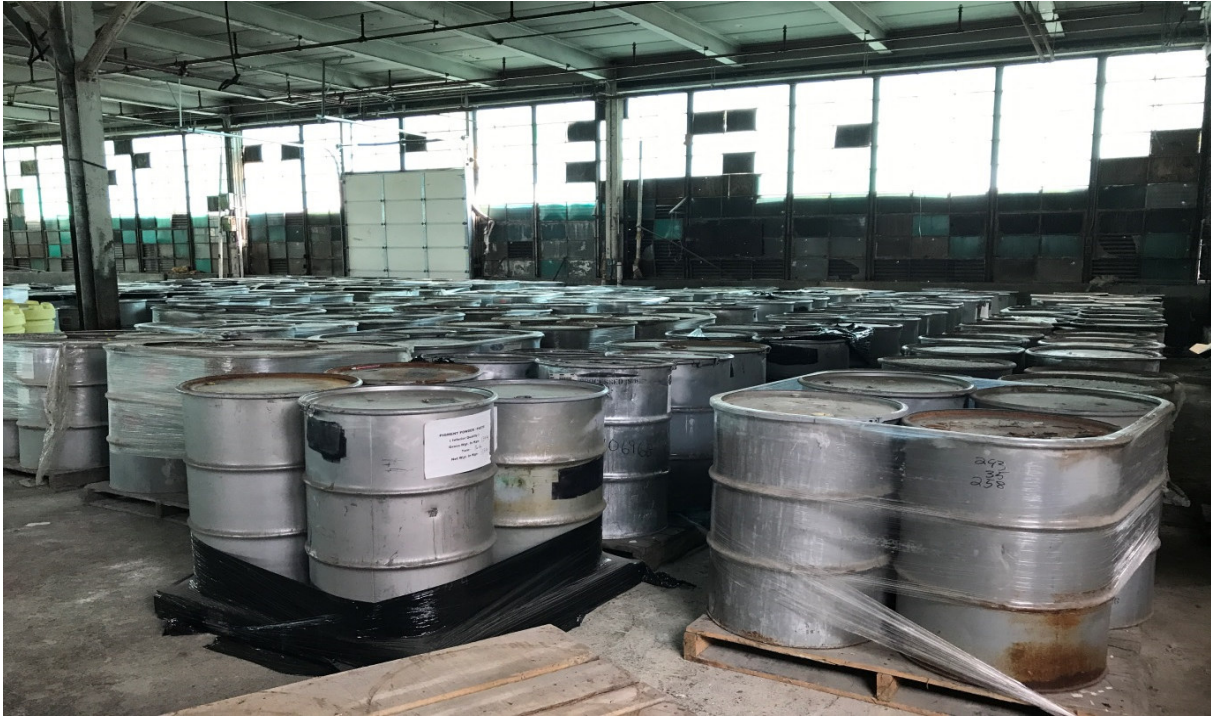
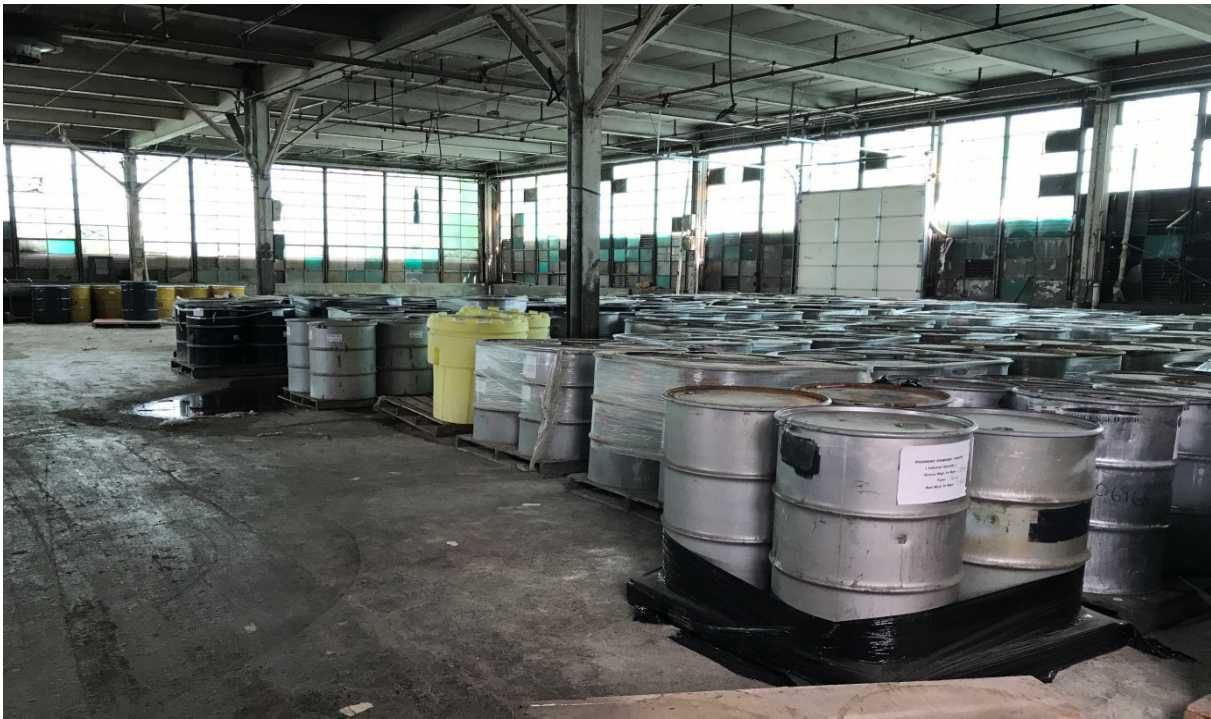
While conducting drum inventory, ERRS and RST 3 found a large number of drums located in the “Far Back Room” (Refer to Attachment A, Figure 3: Facility Layout Map and Attachment C: Photographic Documentation Log, Photographs 49 & 50), which contained aluminum paste (a potentially explosive material). A total of 383 drums of aluminum paste labeled MMD-001207, MMD-001208, MMD-001249, MMD-001250, MMD-002255, MMD-002391, MMD-002978 through MMD-002981, MMD-003281 through MMD-003283, MMD-003782 through MMD-004153 and MMD-004913, were noted at the Site. Aluminum paste is a stable material when in the paste form, but it can react violently (explosive) if it dries up and comes in contact with water, a heat source, oxidizers, or halogenated hydrocarbons (including fire extinguishing agents). For safety reasons, all other drums in the vicinity of the drummed aluminum paste were removed immediately and the area delineated with caution tape. Minimal contact was the established Site protocol for handling of the drummed aluminum paste, and the drums were only to be handled when absolutely necessary.

**Photograph 49:** View of drums in Far Back Room containing aluminum paste.

**Photograph 50:** View of drums in Far Back Room containing aluminum paste.

In an effort to eliminate the hazard posed by the presence of the aluminum paste at the Site, EPA attempted to contact a few manufacturers that utilized aluminum paste for their manufacturing process to ascertain if they would be interested in picking up the aluminum paste for reuse. The EPA contacted Silberline Manufacturing Co. Inc., (Silberline), the manufacturer that showed interest in the aluminum paste, and made necessary arrangements with their representatives to remove the drums with aluminum paste from the Site. On January 24 and 31, 2018, representatives of Silberline were on Site to collect the 383 drums of aluminum paste. Under bills of lading numbers LD3180085, LD3180086, LD3180087, LD3180088, and LD3180089, an estimated 203,500 pounds (lbs.) of aluminum paste was transported offsite in five trucks provided by a transporting company, Top Class LLC., to the Silberline facility in Tamaqua, Pennsylvania.
