# ENGINEERING INVESTIGATIONS AT INACTIVE HAZARDOUS WASTE SITES

## PHASE I INVESTIGATION

**SKW ALLOYS, INC., SITE NUMBER 932001  
TOWN OF NIAGARA, NIAGARA COUNTY**

**June 1989**

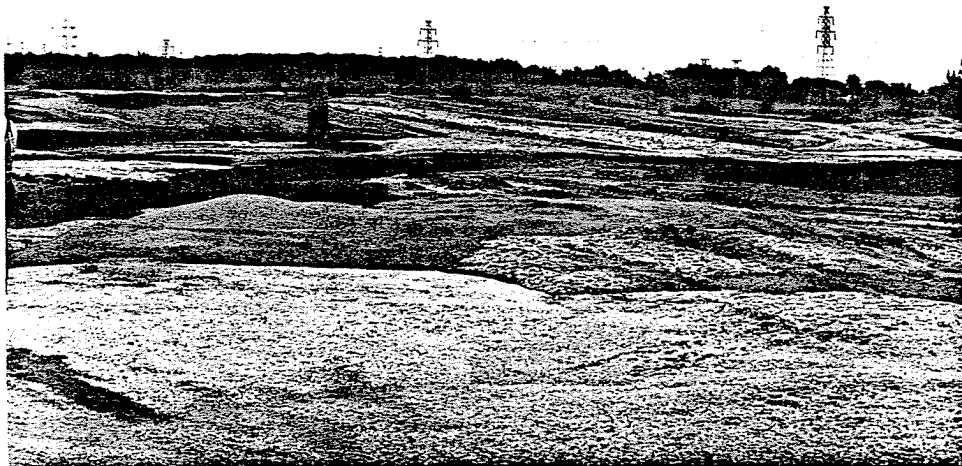
Photographer: D. Sutton  
Date/Time: 8/26/87; 11:30  
Lens: Type:                       
SN:                       
Frame No.: No. 1  
Comments\*: Photo shows dis-  
posal cell No. 2 and leachate  
collection standpipe, looking  
east from access road, also  
shows ferrosilicon dust  
slurried with water in dis-  
posal cell No. 2.

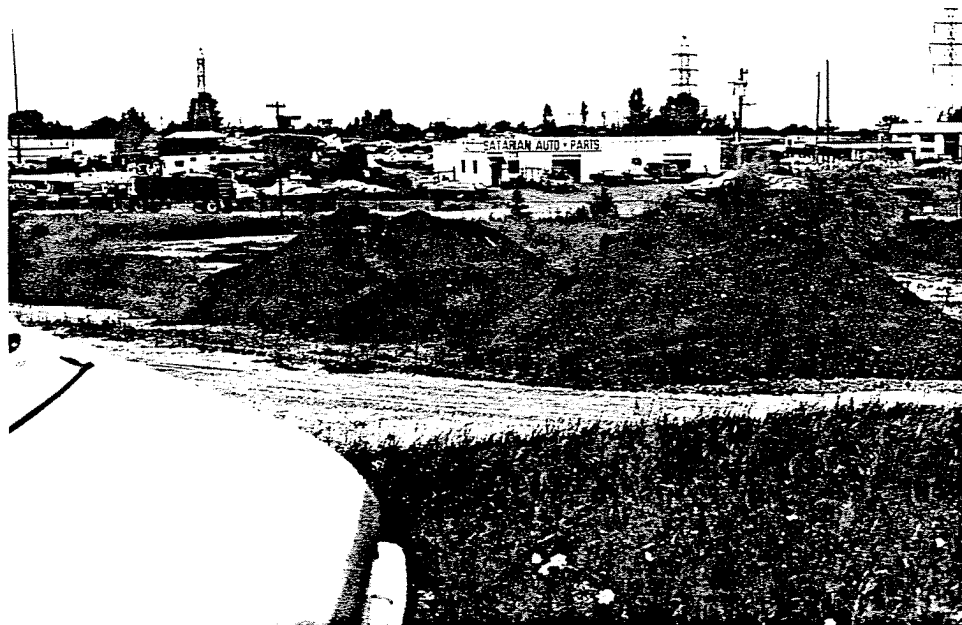
Photographer: D. Sutton  
Date/Time: 8/26/87; 11:35  
Lens: Type:                       
SN:                       
Frame No.: No. 2  
Comments\*: Photo shows  
waste piles of metal, wood  
chips, wood scrap, and bag-  
house dust, looking west from  
access road near disposal  
cell No. 2.

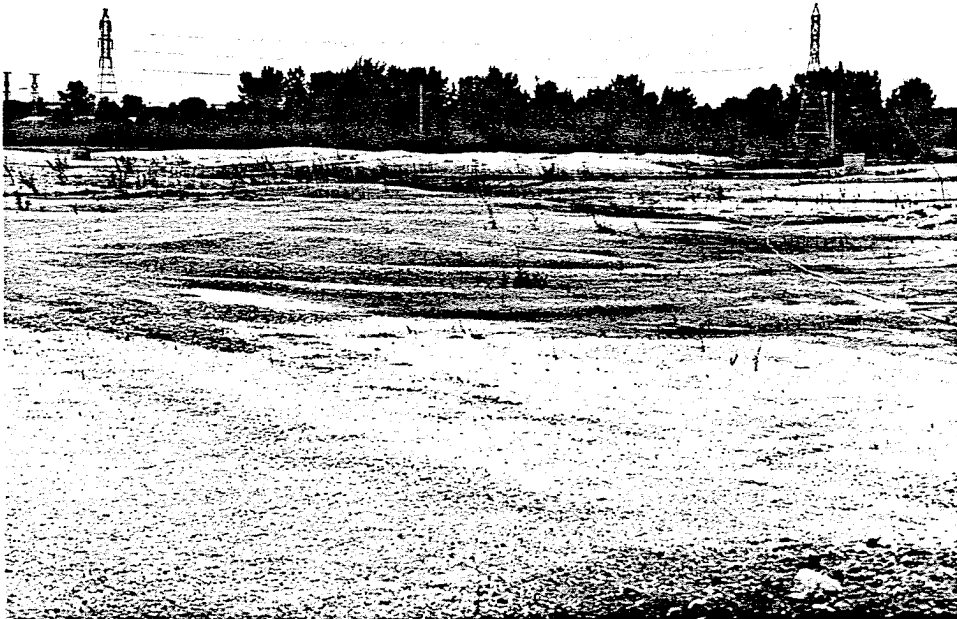
Photographer: D. Sutton  
Date/Time: 8/26/87; 11:40  
Lens: Type:                       
SN:                       
Frame No.: No. 3  
Comments\*: Photo shows  
ferrosilicon dust slurried  
with water and disposed of in  
cell No. 1, looking south  
access road.

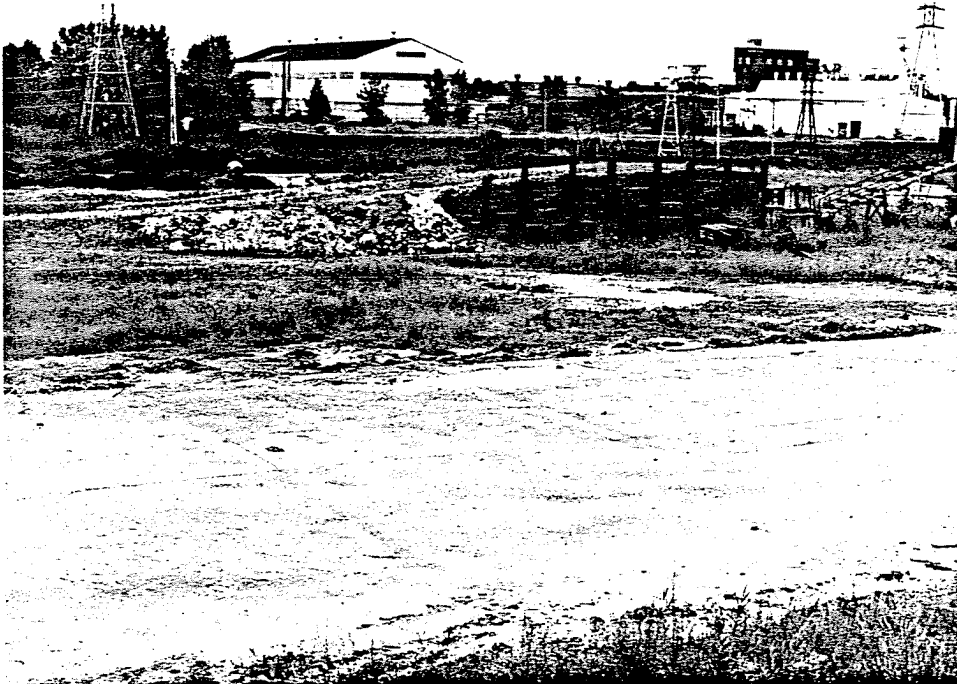
Photographer: D. Sutton  
Date/Time: 8/26/87; 11:48  
Lens: Type:                       
SN:                       
Frame No.: No. 5  
Comments\*: Photo shows old  
Vanadium Corp. building  
foundation and loading ramp.  
Also shows piles of mixed  
spill of raw materials/  
cleanup from facility. Look-  
ing south from road embank-  
ment on disposal cell.

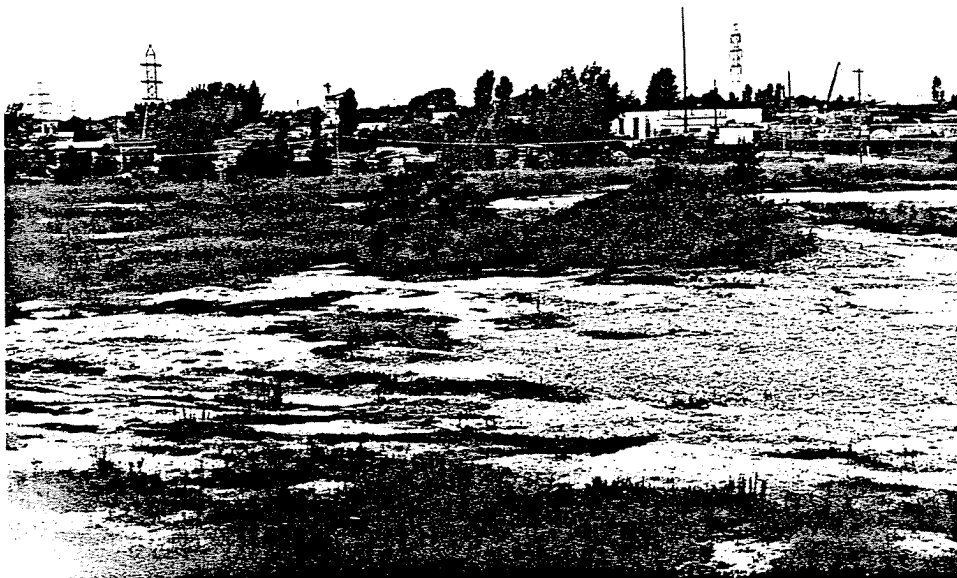
Photographer: D. Sutton  
Date/Time: 8/26/87; 11:55  
Lens: Type:                       
SN:                       
Frame No.: No. 6  
Comments\*: Photo shows low  
area with standing water.  
View looking south from  
access road on disposal cell  
No. 2.

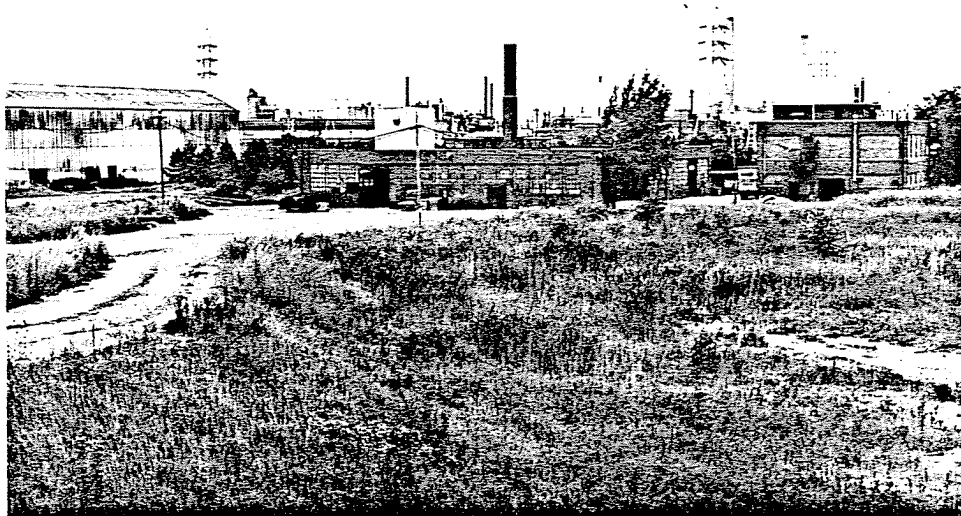
Photographer: D. Sutton  
Date/Time: 8/26/87; 11:58  
Lens: Type: \_\_\_\_\_  
SN: \_\_\_\_\_  
Frame No.: No. 7  
Comments\*: Photo shows  
buildings on site, looking  
south from access road on  
disposal cell No. 2.

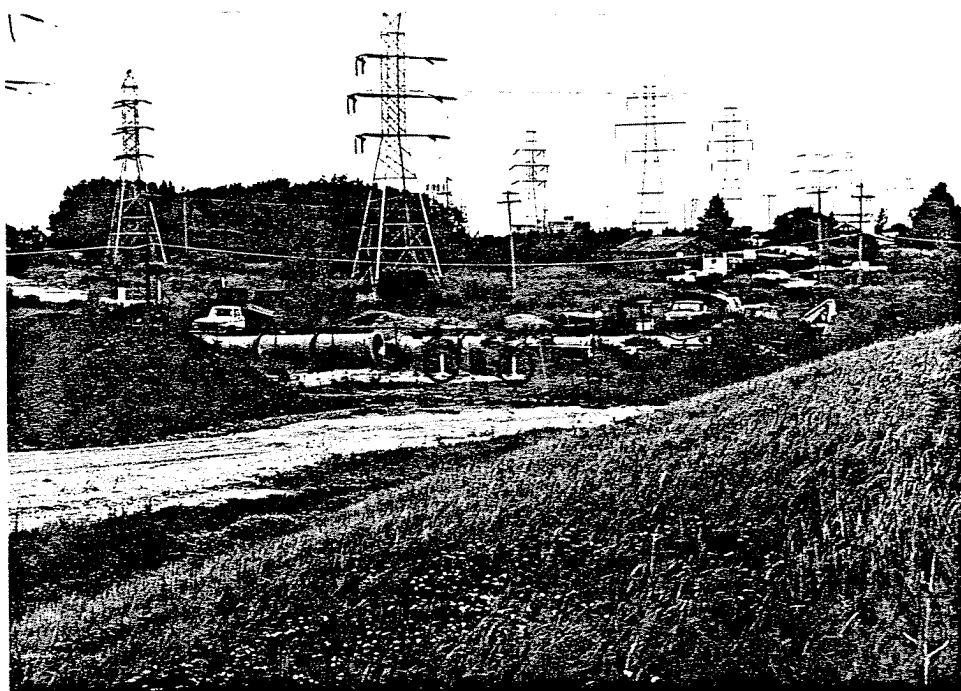
Photographer: D. Sutton  
Date/Time: 8/26/87; 12:10  
Lens: Type: \_\_\_\_\_  
SN: \_\_\_\_\_  
Frame No.: No. 8  
Comments\*: Photo shows two  
monitoring wells on site,  
looking north from access  
road adjacent to disposal  
cell No. 2; also shows waste  
piles.

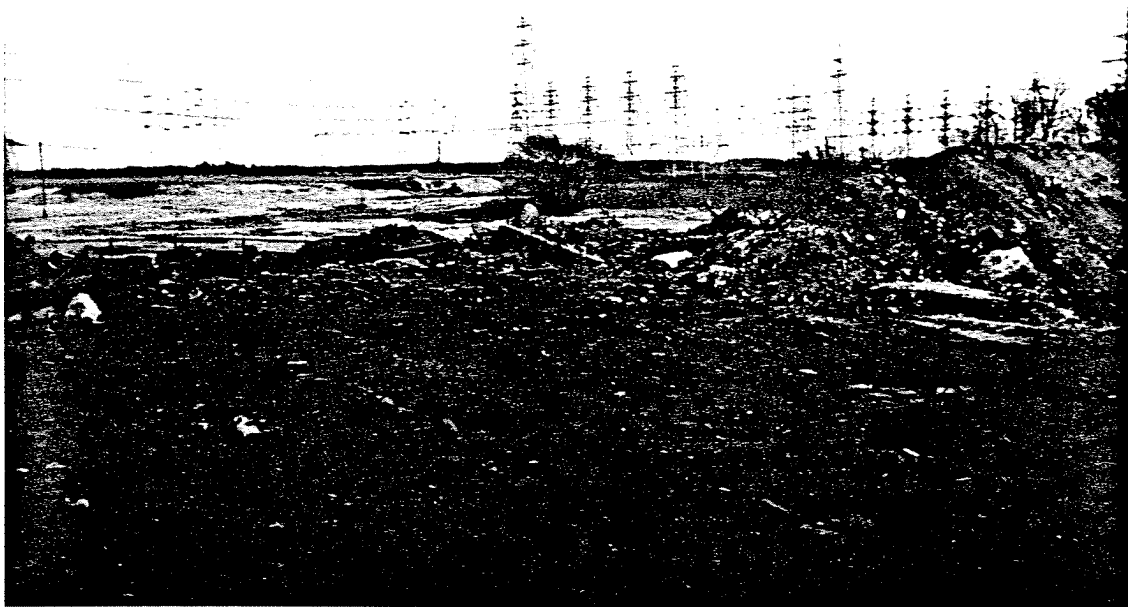
Comments: Photo showing construction debris and carbon waste, facing east from top of landfill area  
on Airco Carbon property.

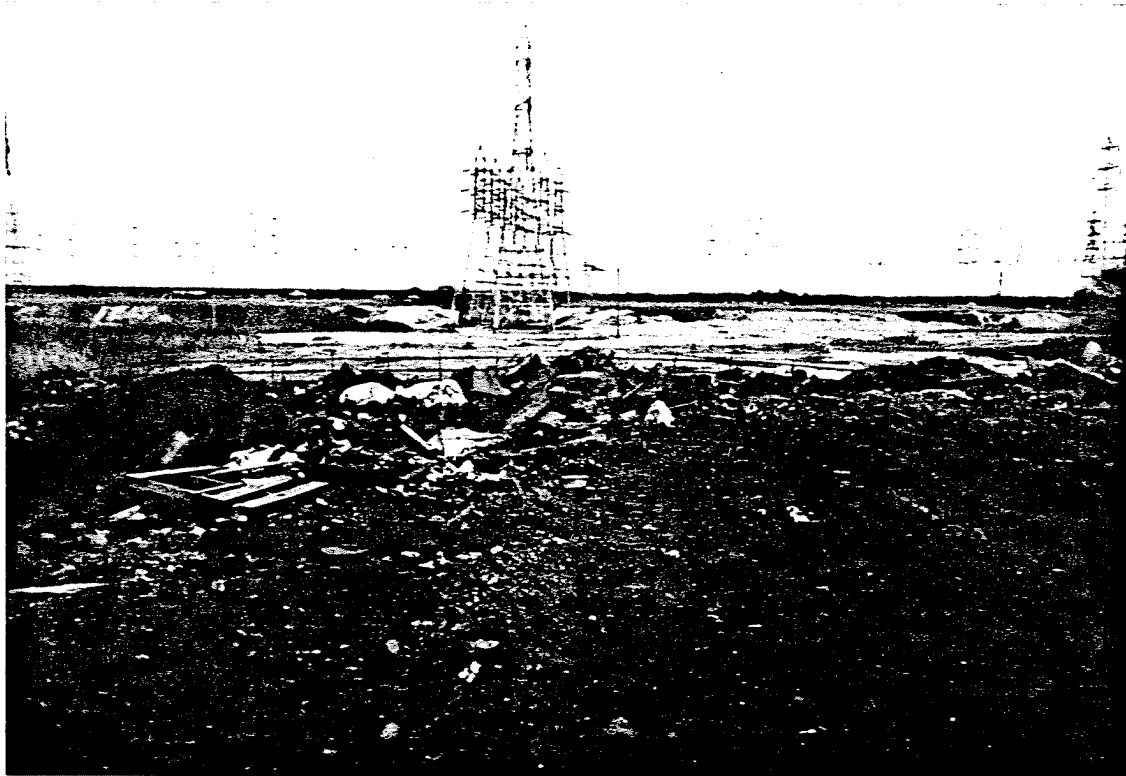
Photographer: D. Sutton Date/Time: 1/25/89 13:50  
Lens: Type \_\_\_\_\_ SN: \_\_\_\_\_ Frame No.: 2  
Comments: Continuation of Frame #1.

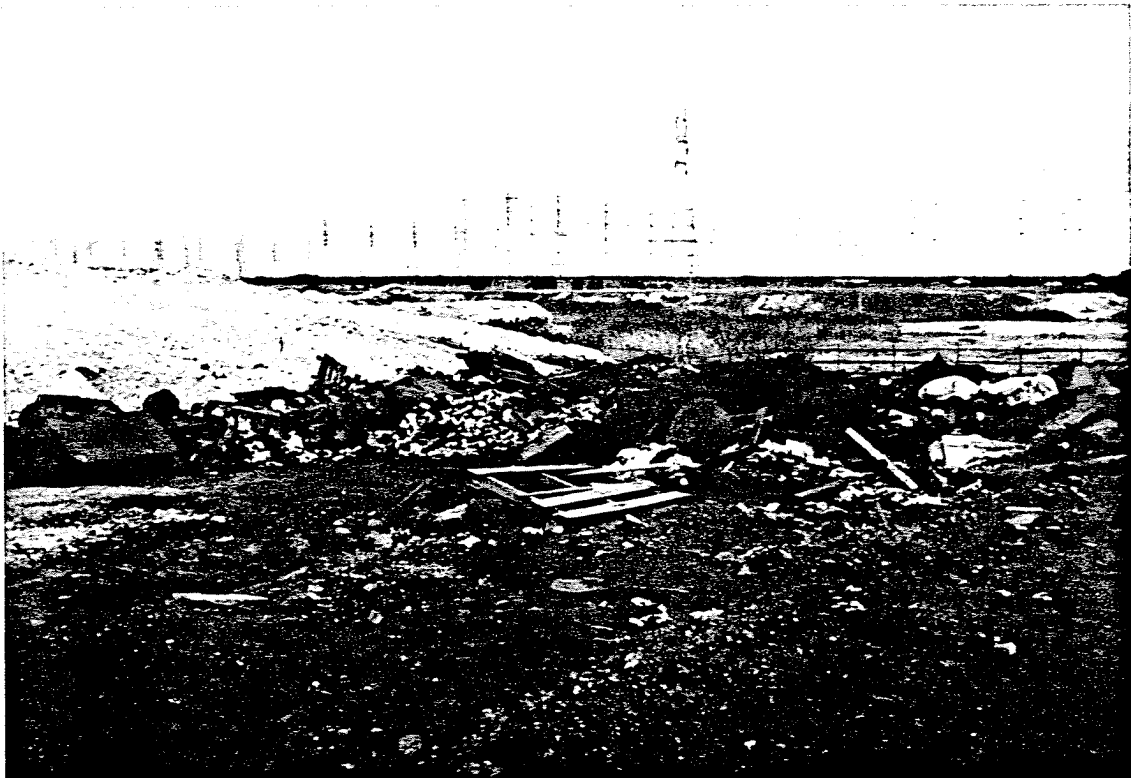
Comments: Continuation of Frame #2, showing lime slag pile.  
\_\_\_\_\_  
\_\_\_\_\_

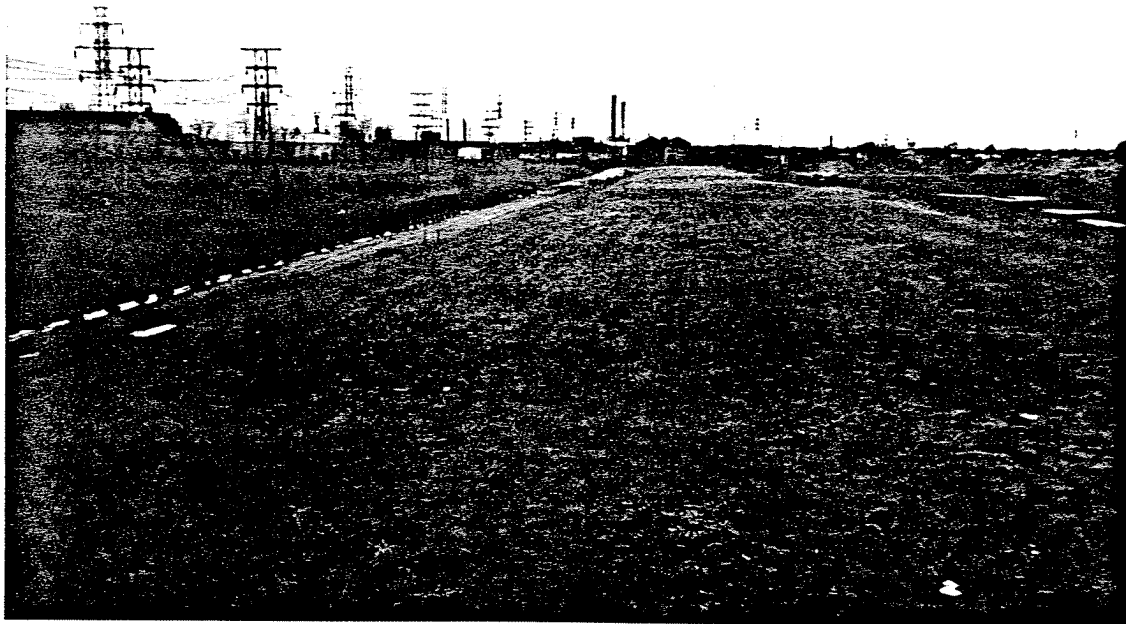
Comments: Looking west from top of closed area, Airco Carbon landfill, showing access road and  
entrance to landfill.

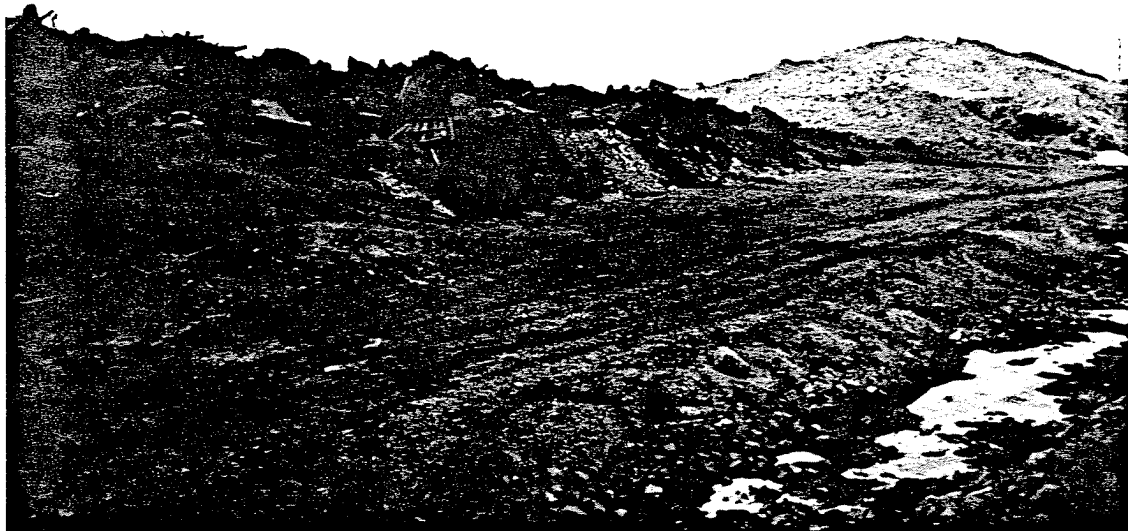
Comments: Photo looking east from Airco Carbon access road showing construction debris and carbon waste in landfill area.

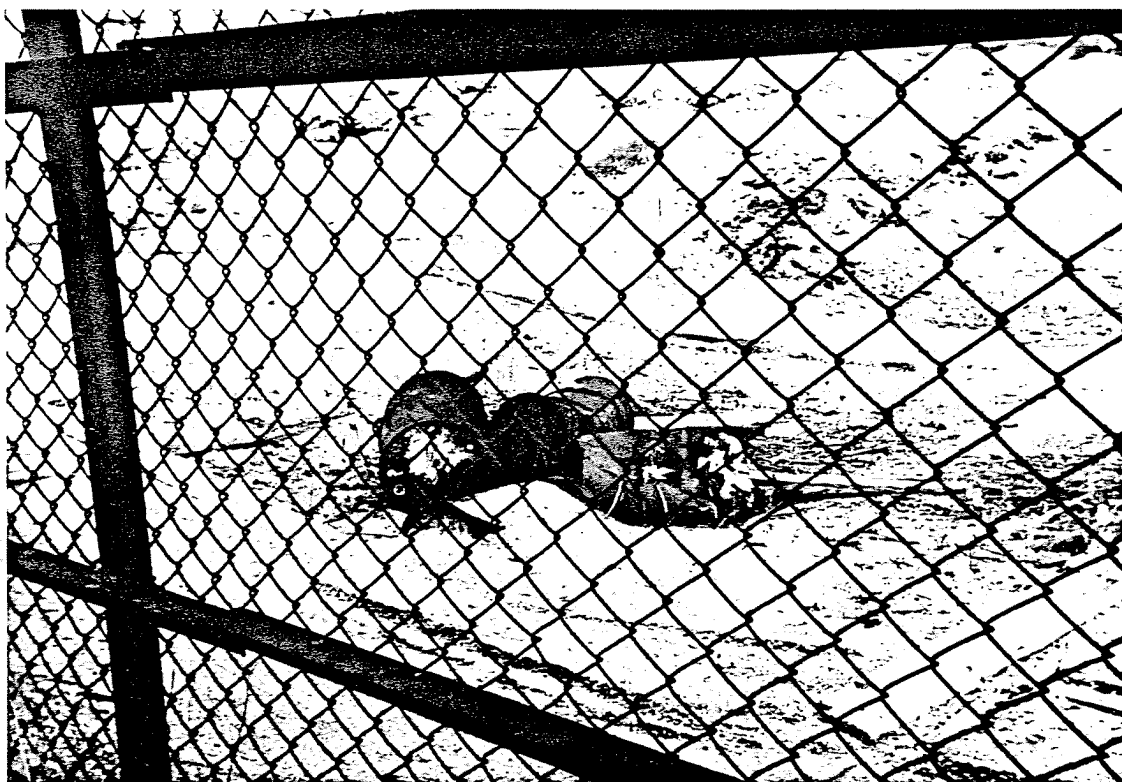
Comments: Photo showing rusty drums on Niagara Mohawk property, facing north from Airco Carbon land-  
fill perimeter road. Note lime slag on ground surface.

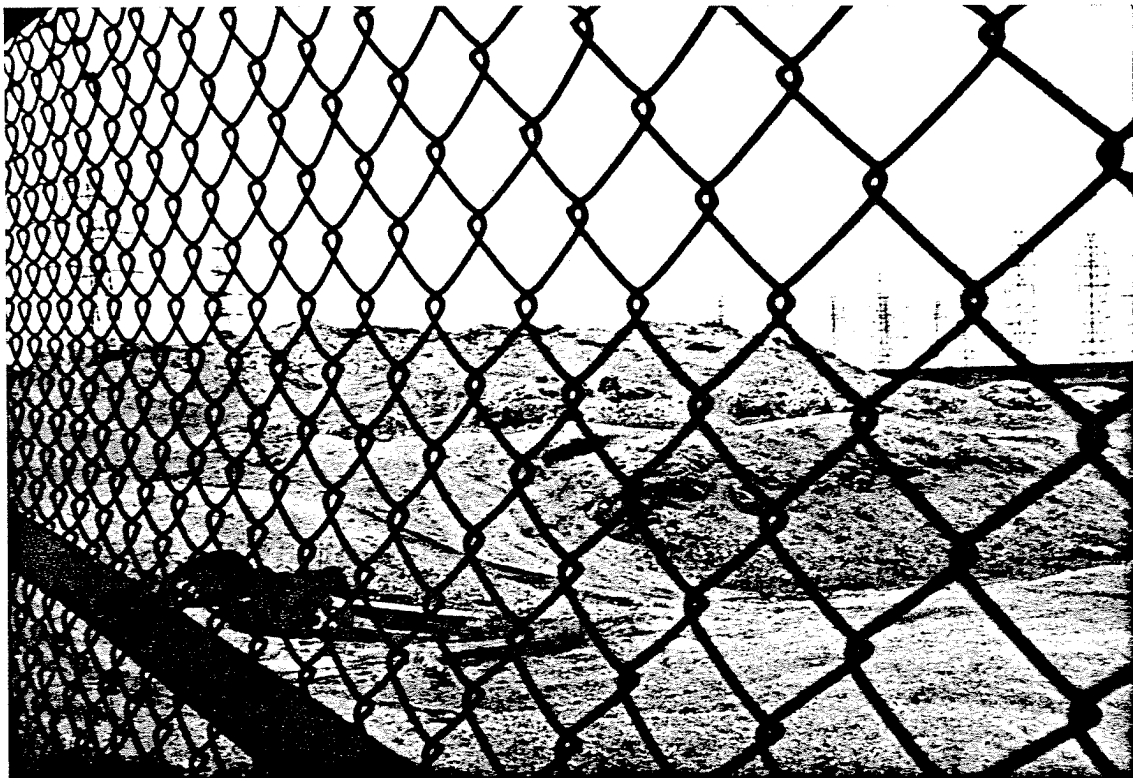
Comments: Photo facing northeast, showing white lime material on Niagara Mohawk property.

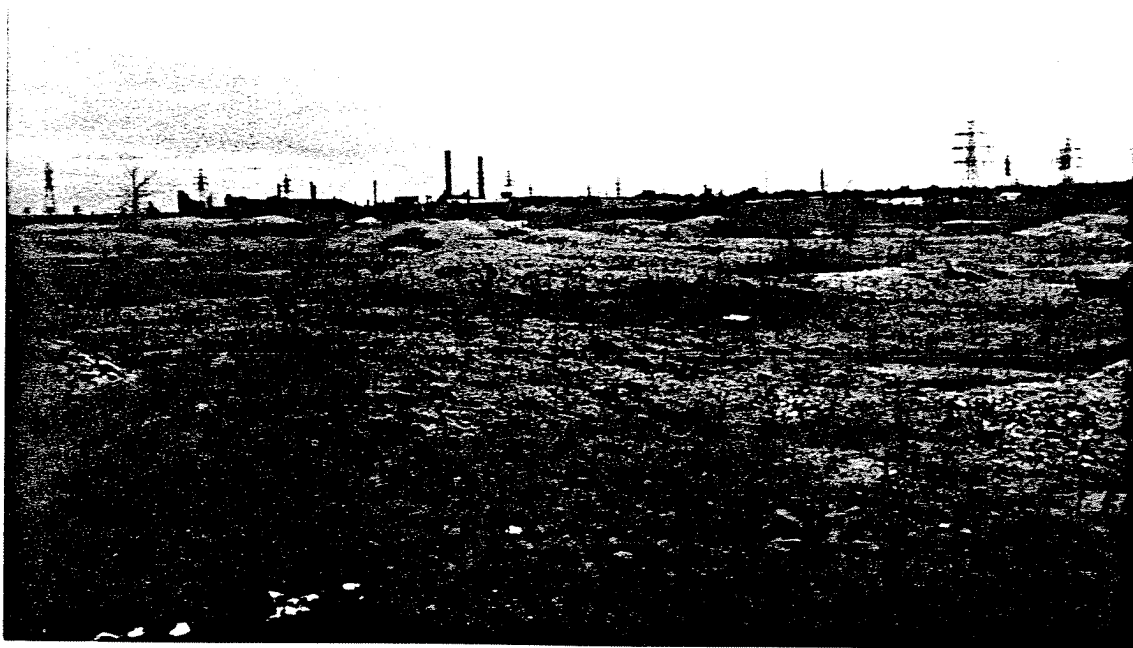
Comments: Photo looking west showing piles of waste on Airco Carbon property, looking toward SKW  
property.

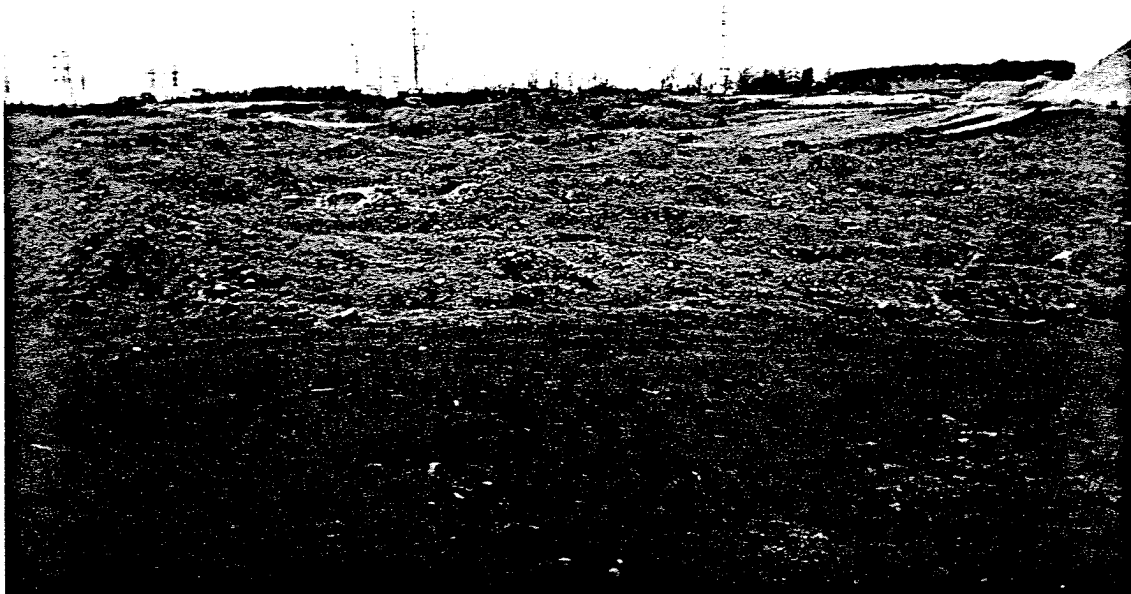
Comments: Photo taken from top of landfill area facing northwest on Arico Carbon property, showing  
waste on top of landfill.

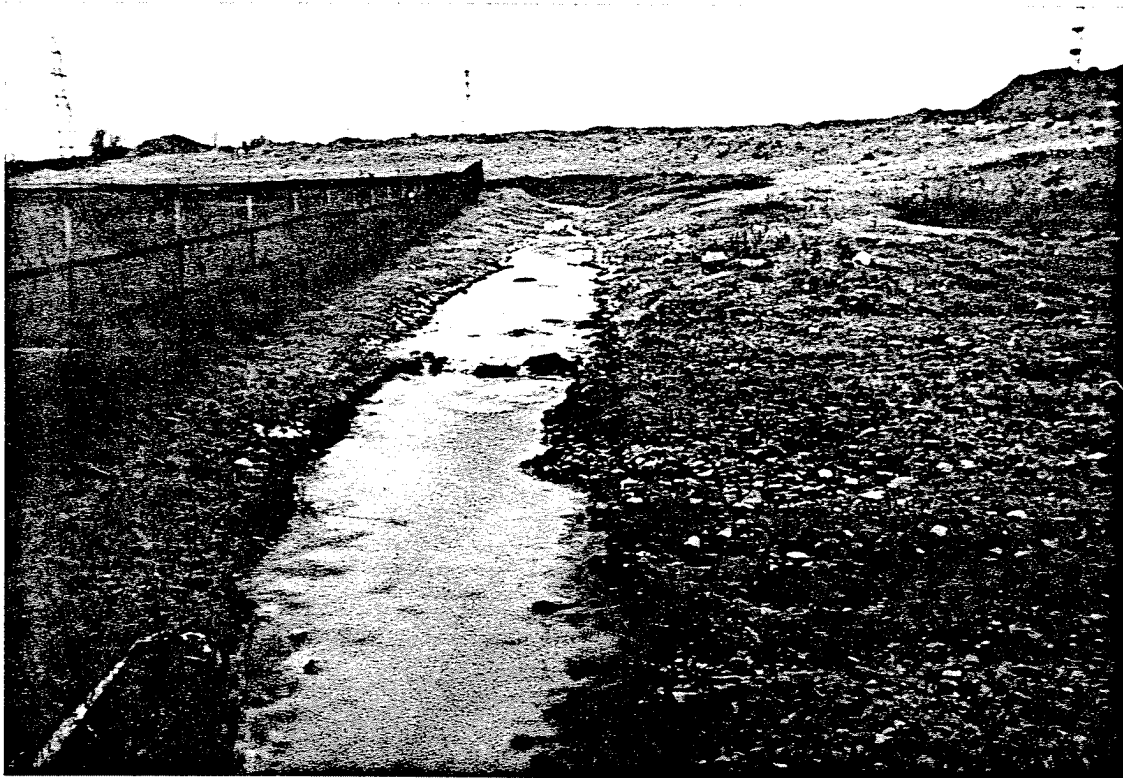
Comments: Photo of drainage ditch between SKW and Airco Carbon property, facing north. Note white  
milky surface water.
