## **Wetland Inspection Report (Spring 2015)**

### **Vanadium Site OU-3 Remedial Action Town of Niagara, New York**

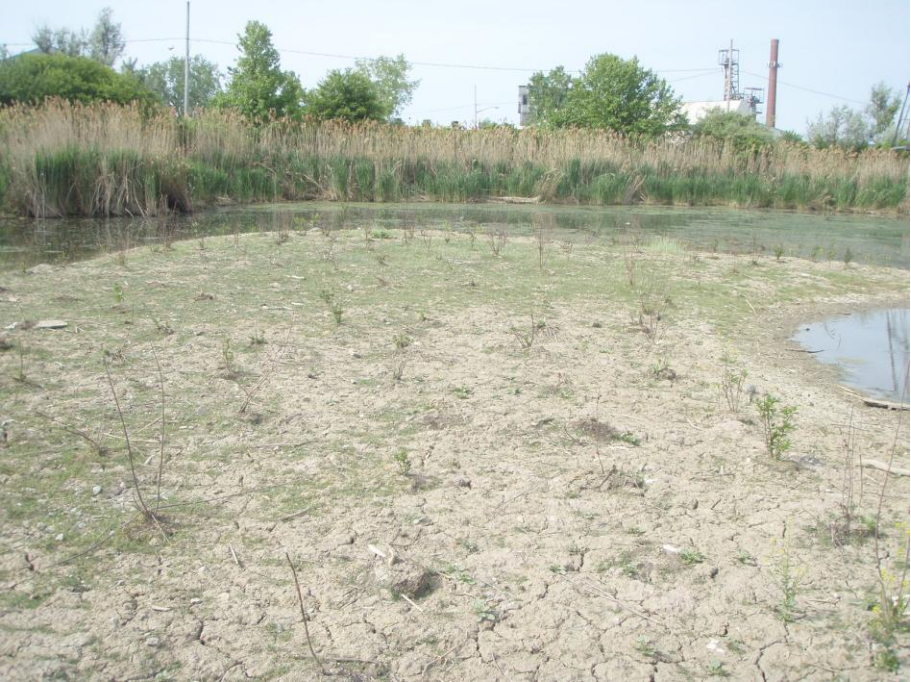
<b>CLIENT NAME:</b> National Grid		<b>SITE LOCATION:</b> Vanadium , Town of Niagara, NY	<b>PROJECT NO.</b> 1118/50443
<b>PHOTO NO.</b> 1	<b>DATE:</b> 5/29/15

<b>DESCRIPTION</b> Looking west at central restoration island and Plot 1			
<b>CLIENT NAME:</b> National Grid		<b>SITE LOCATION:</b> Vanadium, Town of Niagara, NY	<b>PROJECT NO.</b> 1118/50443
<b>PHOTO NO.</b> 2	<b>DATE:</b> 5/29/15

Remarks: (Explain alternative procedures here or in separate report.)  
**108/132 (82%) shrubs appear viable on island. Below average precipitation reported by Severson**  
**Approximately 40% vegetative coverage on island.**

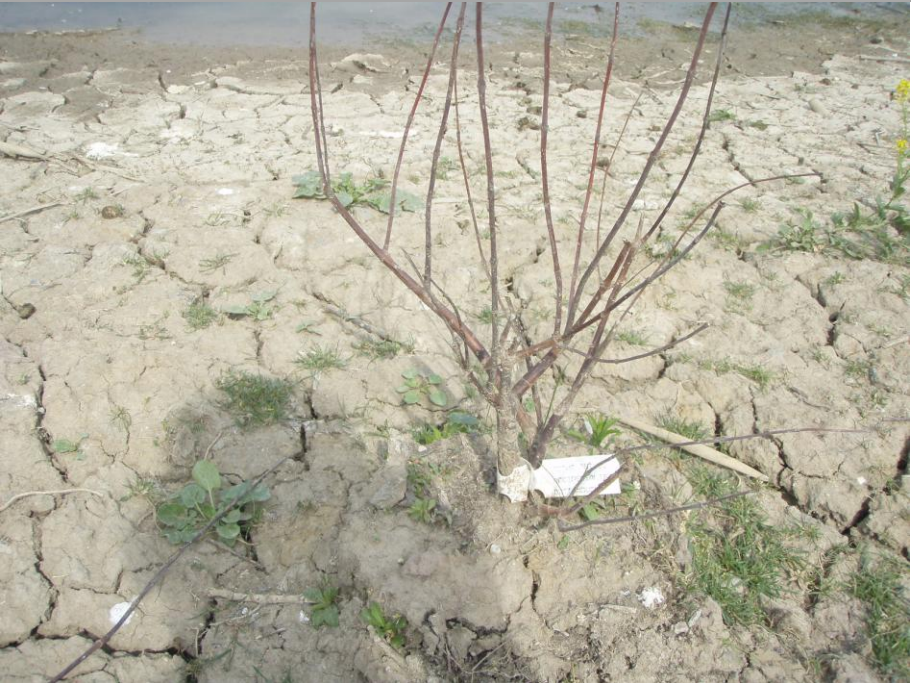
<b>DESCRIPTION</b> Vegetation within Plot 1

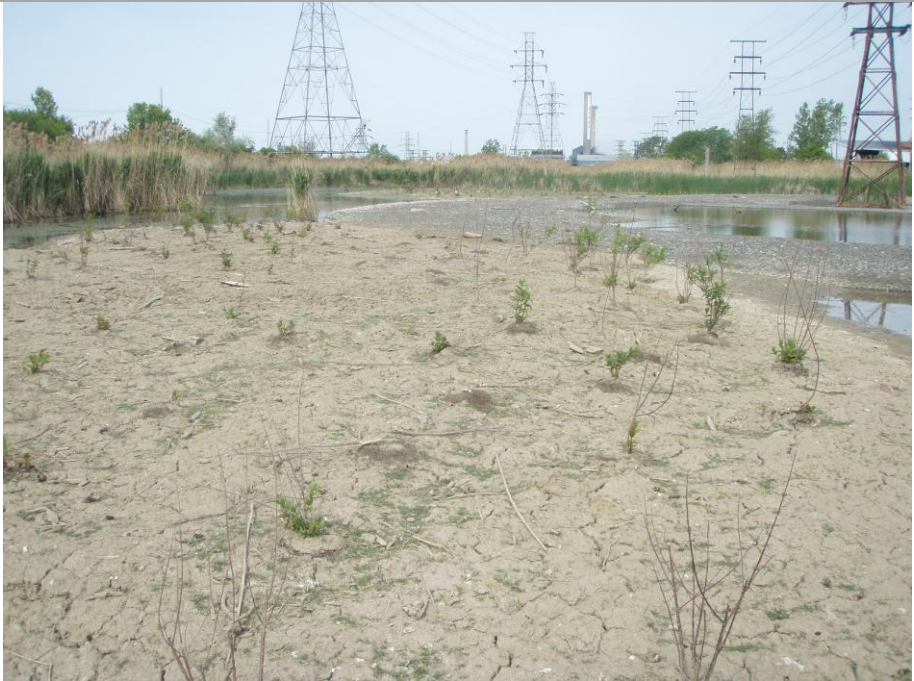
<b>Client Name:</b> National Grid		<b>Site Location:</b> Vanadium , Town of Niagara, NY	<b>Project No.</b> 1118/50443
<b>Photo No.</b> 3	<b>Date:</b> 5/29/15

The west island was observed to have an established ground cover of approximately 80%, while the center and east islands were generally bare (photos attached). The west island had been seeded and planted earlier during 2014, while the other two islands were seeded and planted later during 2014 prior to winter.

<b>Description</b> Looking west at eastern island from Plot 2			
<b>Client Name:</b> National Grid		<b>Site Location:</b> Vanadium, Town of Niagara, NY	<b>Project No.</b> 1118/50443
<b>Photo No.</b> 4	<b>Date:</b> 5/29/15

Remarks: (Explain alternative procedures here or in separate report.)  
**108/140 (77%) shrubs appear viable. Below average precipitation reported by Severson**  
**Approximately 10% vegetative coverage on island.**

During the Site visit, representatives of Sevenson indicated their preference to complete the required re-seeding of the center and east islands during August 2015. Waiting until then is warranted since the Site is presently dry as observed during the Site wide inspection that occurred on May 15, 2015.

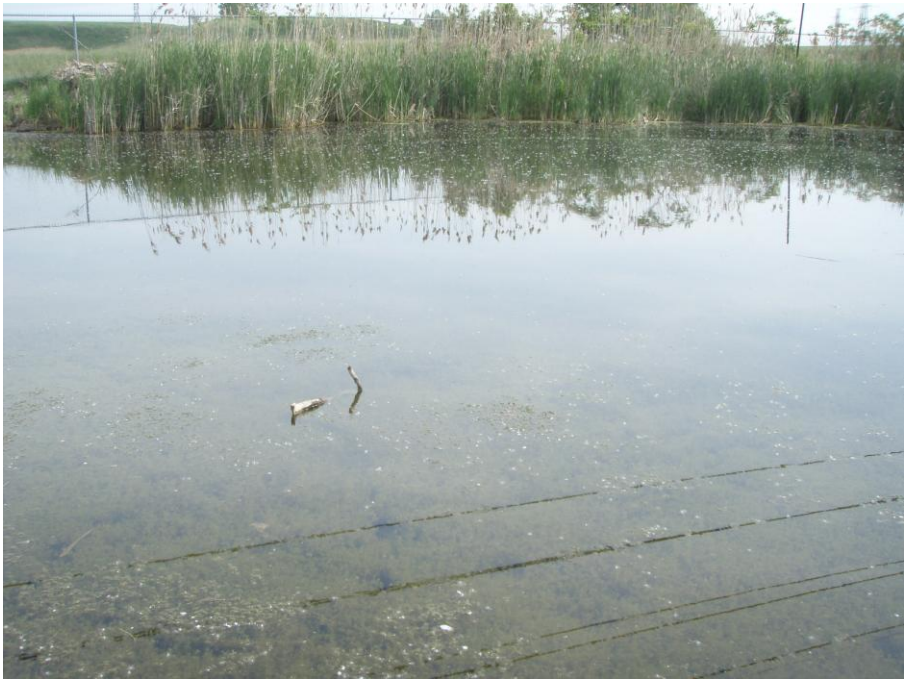
<b>Description</b> Submerged aquatic vegetation – coontail ( <i>Ceratophyllum demersum</i> ) in open water area adjacent to eastern island.

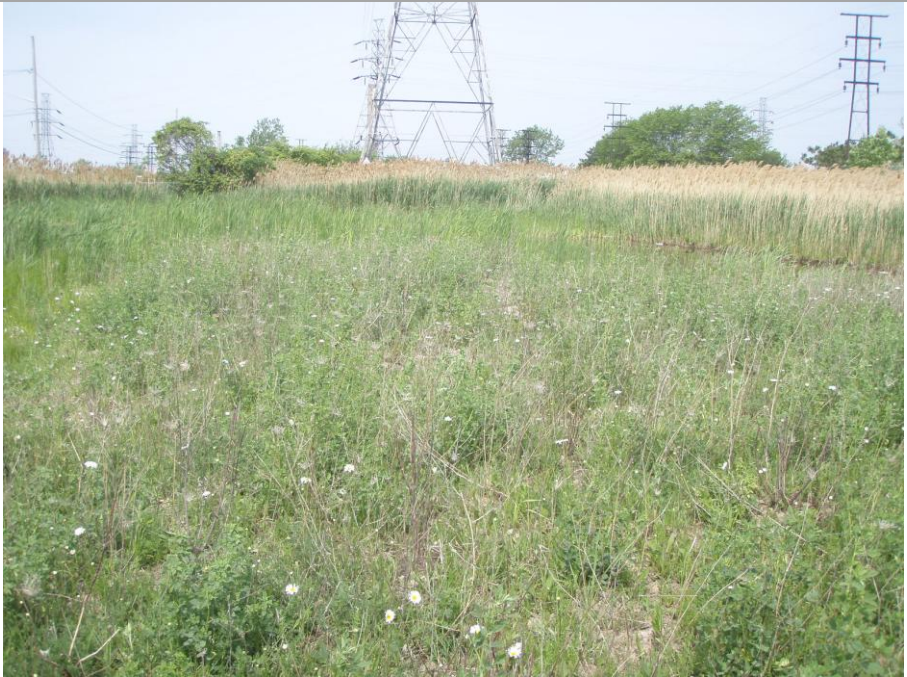
<b>Client Name:</b> National Grid		<b>Site Location:</b> Vanadium , Town of Niagara, NY	<b>Project No.</b> 1118/50443
<b>Photo No.</b> 7	<b>Date:</b> 5/29/15

<b>Description</b> Looking west across western island from Plot 4.			
<b>Client Name:</b> National Grid		<b>Site Location:</b> Vanadium, Town of Niagara, NY	<b>Project No.</b> 1118/50443
<b>Photo No.</b> 8	<b>Date:</b> 5/29/15

213/240 (89%) shrubs appear viable on island. Below average precipitation reported by Severson  
Approximately 80% vegetative coverage on island.

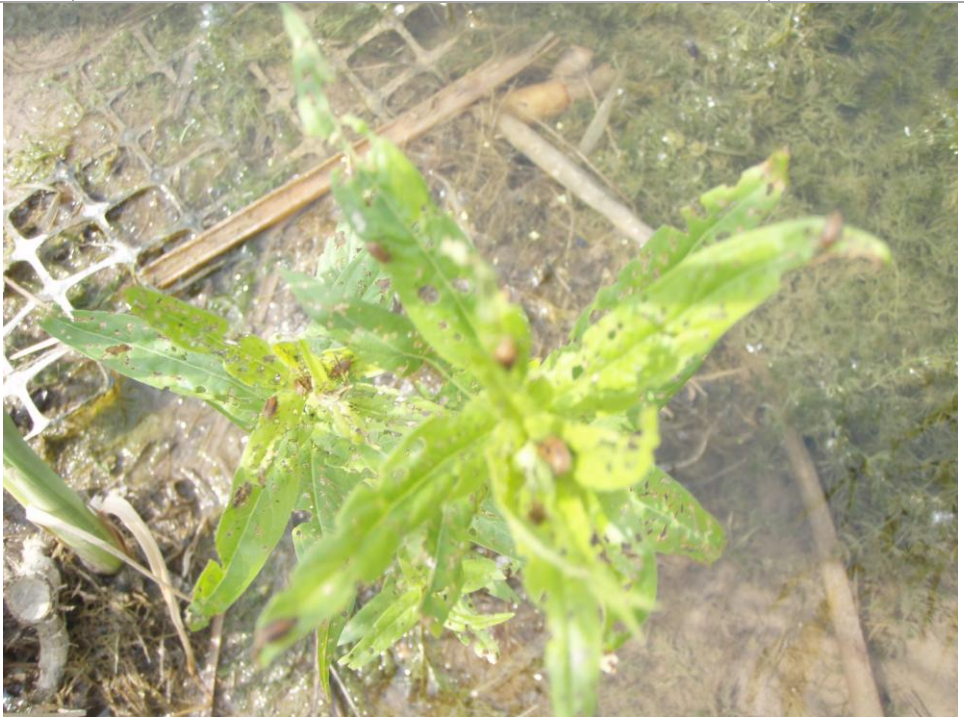
<b>Description</b> Purple loosestrife ( <i>Lythrum salicaria</i> ) plant with <i>Galerucella</i> beetles and evidence of beetle damage to leaves ("shot holes")

213/240 (89%) shrubs appear viable on island. Below average precipitation reported by Severson  
Approximately 80% vegetative coverage on island.  
Galerucella beetles noted on purple loosestrife leaves.
