# ENGINEERING INVESTIGATIONS AT INACTIVE HAZARDOUS WASTE SITES

## PHASE I INVESTIGATION

Airco Speer Carbon  
City of Niagara Falls

Site No. 932002  
Niagara County

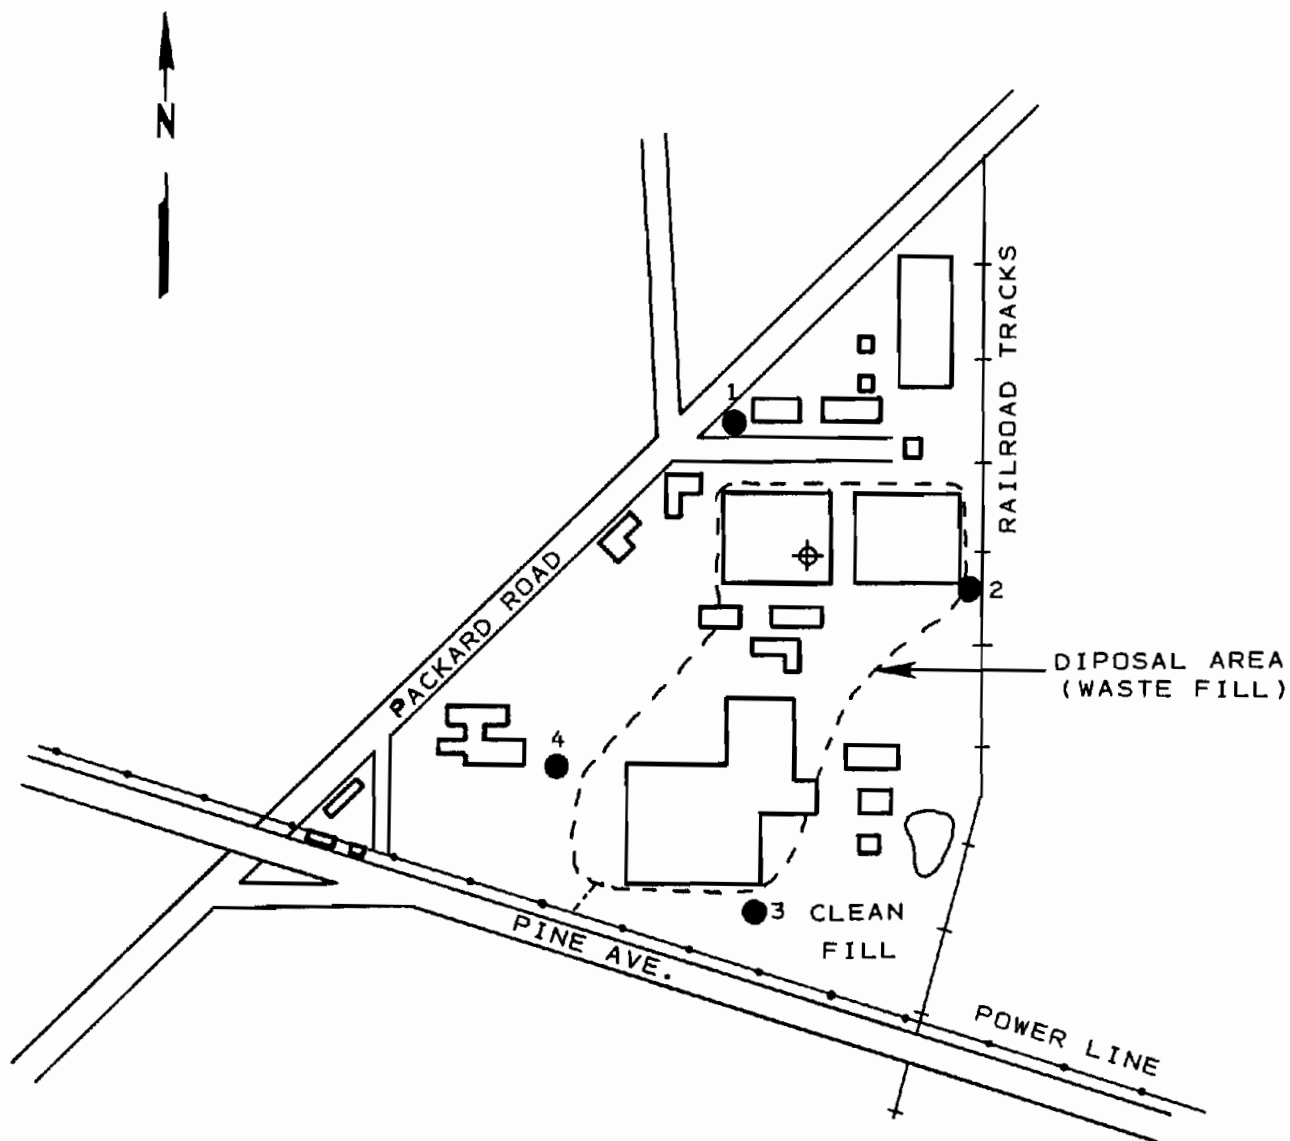
The plant site, approximately 2-acres in size, is owned by the Airco Speer Carbon-Graphite Company (see Figure I-2). Prior to 1920, the site was owned by the International Graphite and Electrode (IGE) Company. In 1930, the Speer Carbon and Exelon Companies each purchased half ownership of the IGE Company. The Speer Carbon Company assumed full ownership of the graphite plant in 1932 (NCHD, 1981). Speer Carbon became a subsidiary of Airco in 1961 and a Division in 1962. In 1978, Airco became a subsidiary of BOC International.

A site inspection conducted by the Niagara County Department of Health (NCDOH) in June 1981, noted that almost all of the previous disposal site was paved with either asphalt or concrete. Furthermore, the plant's buildings, including several of the graphite and bake plants, were located over areas previously used for waste disposal.

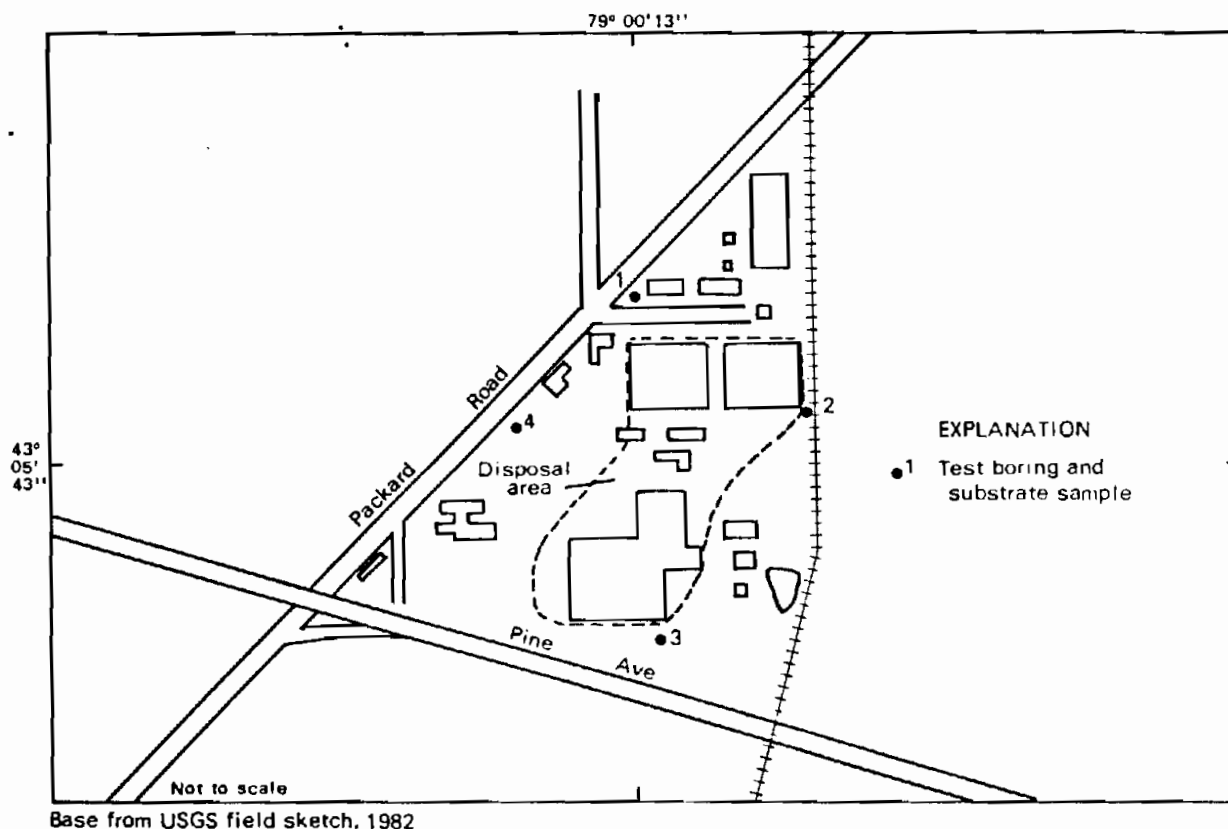
HNU meter readings were taken up and downwind of the site and readings did not indicate an air release.

<u>Boring no.</u>	<u>Depth (ft)</u>	<u>Description</u>
1	0 - 2.0	Topsoil.
	2.0 - 6.2	Clay, reddish, some sand, fairly dry. Sample: 6.2 ft.
2	0 - 4.0	Topsoil, black, gravel fill. Hit bedrock at 4.0 ft. Red clay mixed in. SAMPLE: 4.0 ft.
3	0 - 2.1	Red top soil. Hit bedrock at 2.0 ft. sample: 2.0 ft.
4	0 - 1.5	Top soil, black.
	1.5 - 4.2	Clay, sandy, red, dry. Hit bedrock at 4.2 ft. SAMPLE: 4.0 ft.

Chemical information.--The U.S. Geological Survey collected four soil samples at each test boring for organic compound analyses, but the samples exceeded holding time and were recollected in May 1983. Results are given in table C-1. The samples contained 14 organic priority pollutants, some in concentrations as high as 61,000 ug/kg, and five organic nonpriority pollutants.
