ENGINEERING INVESTIGATIONS AT INACTIVE HAZARDOUS WASTE SITES IN THE STATE OF NEW YORK

PRELIMINARY SITE ASSESSMENT TASK I

Allied Chemical - Elberta Works Site
Site Number 932003
Town of Wilson, Niagara County

August 1991

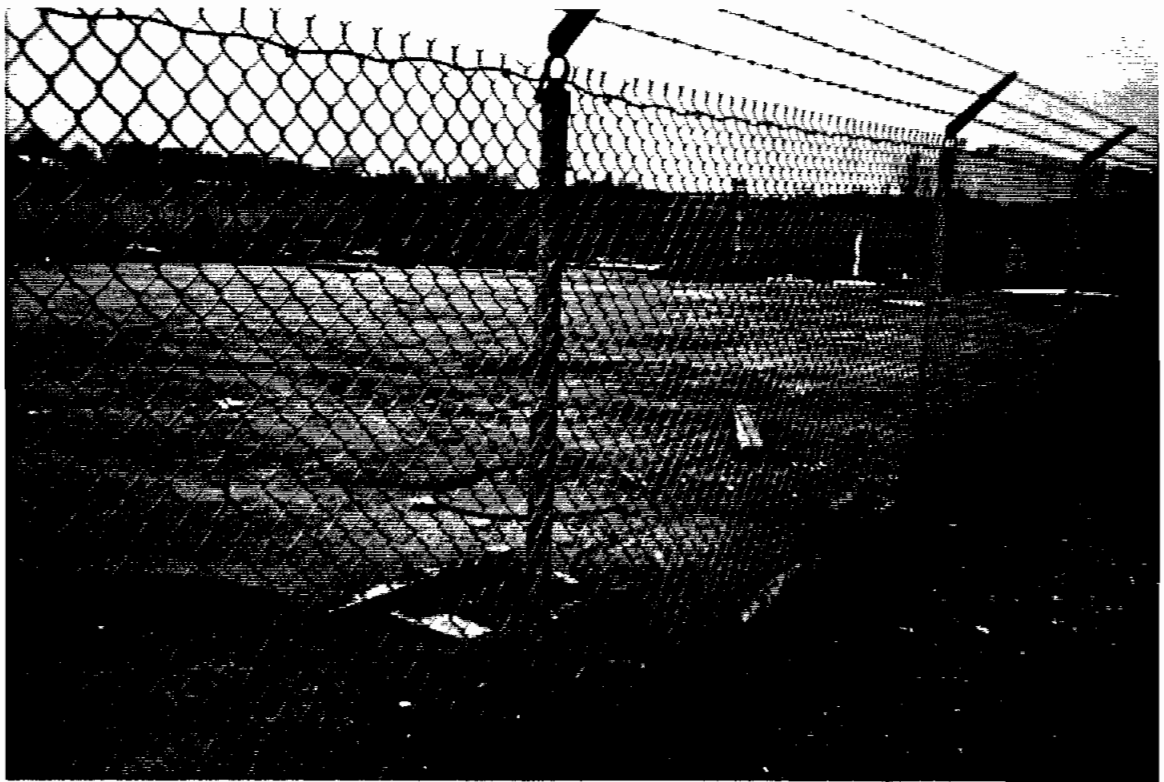
Photographer: Linda Fischer Date: 4/29/91
	Time: 1:30 p.m. Frame No.: 12
	Comments*: Photo taken while standing on the abandoned railroad tracks. Direction north: debris and pallets scattered behind buildings.
*Comments to include location.

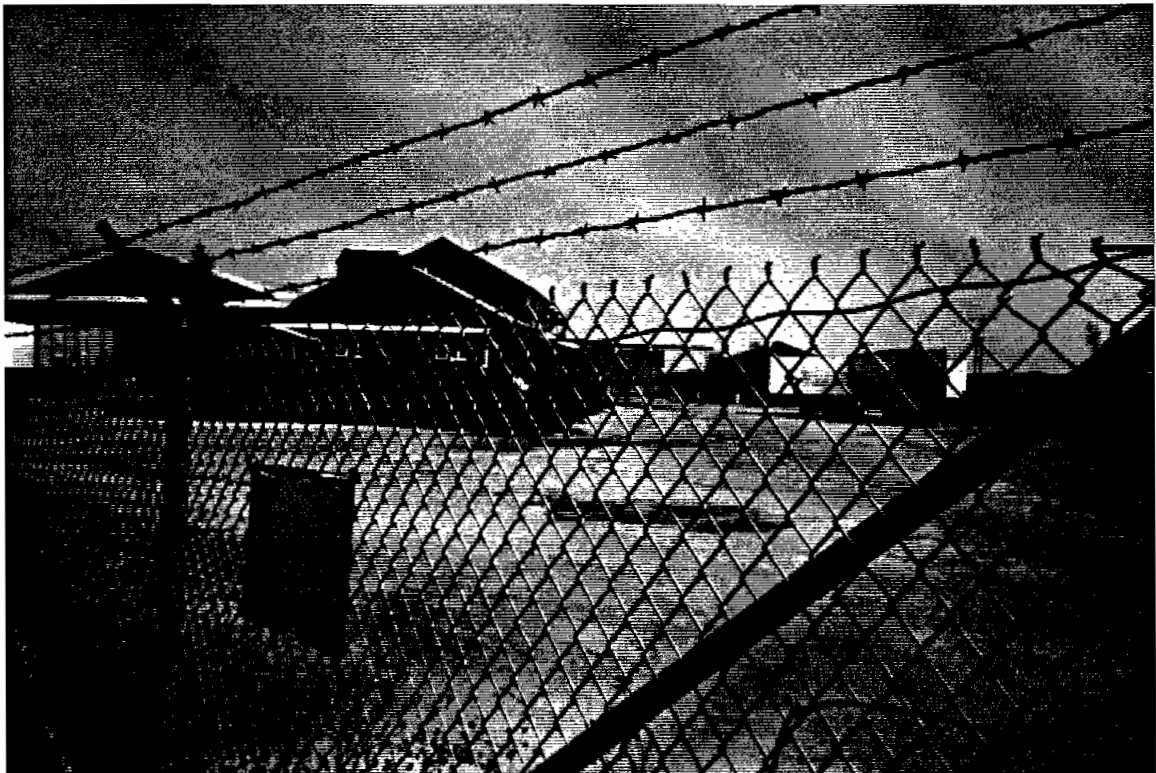
Comments*: Standing on Randall Road, looking east to
corner of property: office building and warehouse.
