ENGINEERING INVESTIGATIONS AT INACTIVE HAZARDOUS WASTE SITES IN THE STATE OF NEW YORK

PRELIMINARY SITE ASSESSMENT Volume 1

**Allied Chemical-Elberta Works Site
Site Number 932003
Town of Wilson, Niagara County**

April 1995

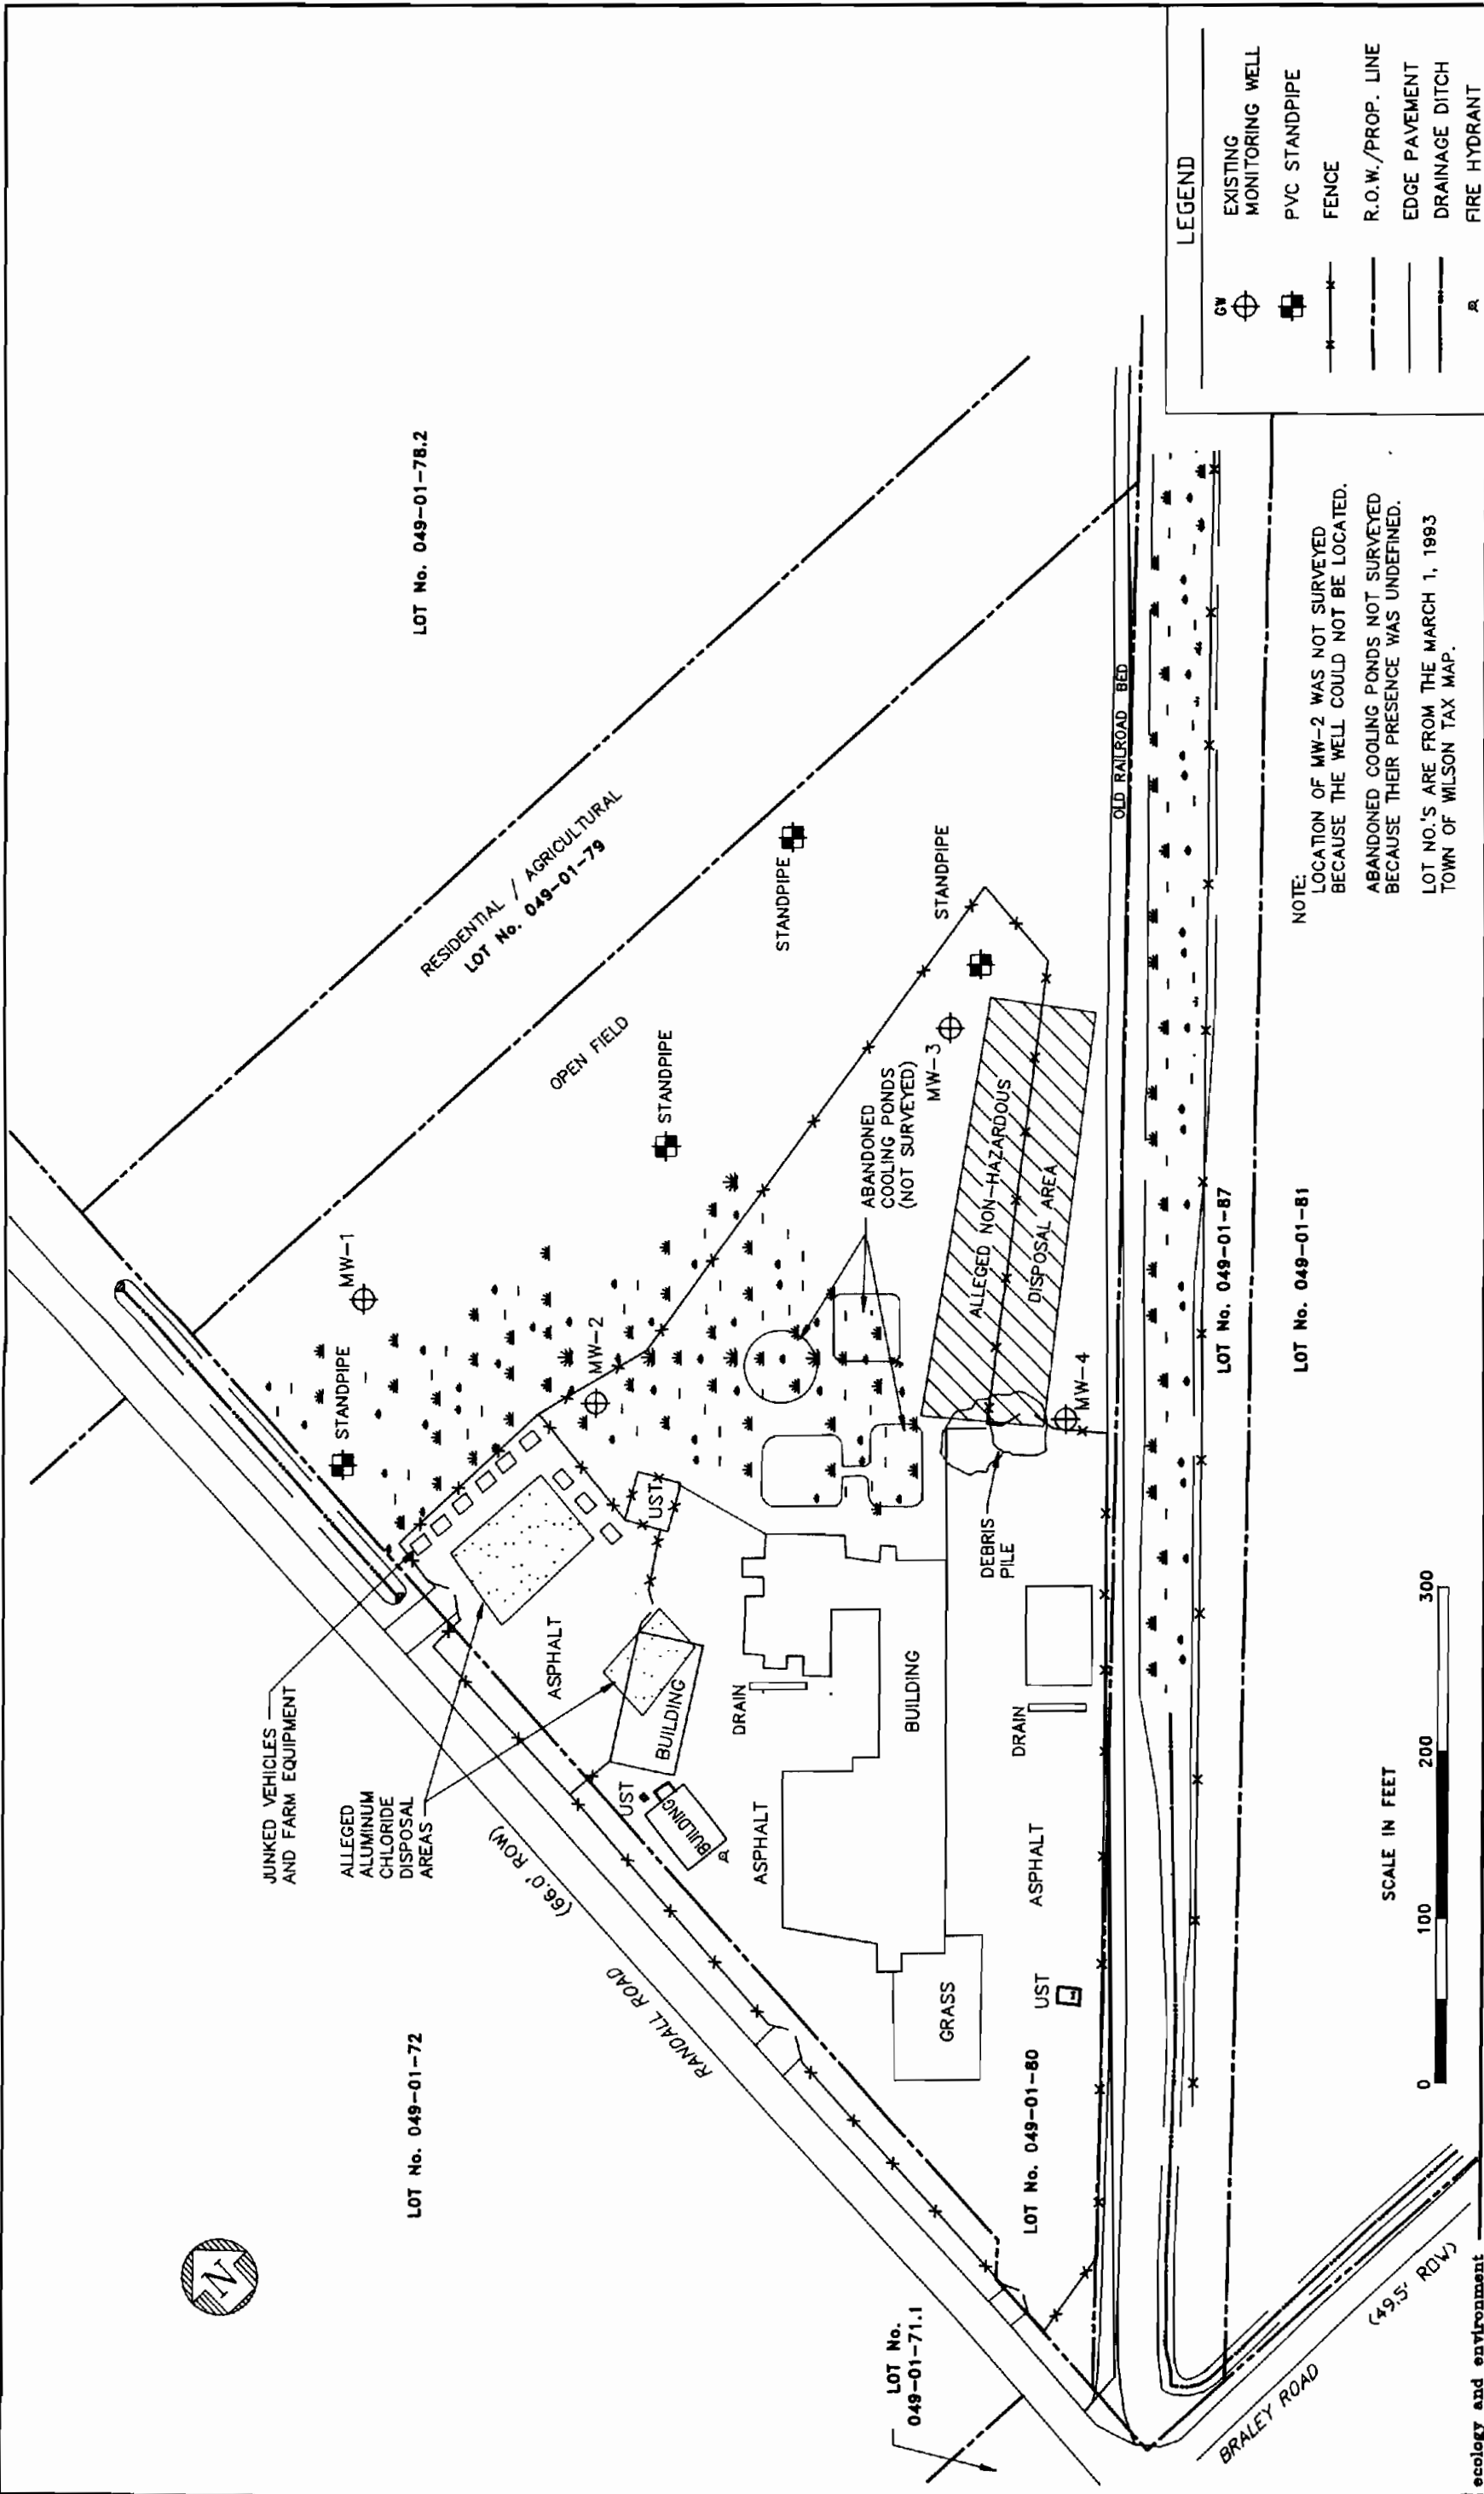
Figure 1-2 ALLIED CHEMICAL - ELBERTA WORKS SITE MAP

NOTE:
LOCATION OF MW-2 WAS NOT SURVEYED
BECAUSE THE WELL COULD NOT BE LOCATED.
ABANDONED COOLING PONDS NOT SURVEYED
BECAUSE THEIR PRESENCE WAS UNDEFINED.
LOT NO.'S ARE FROM THE MARCH 1, 1993
TOWN OF WILSON TAX MAP.

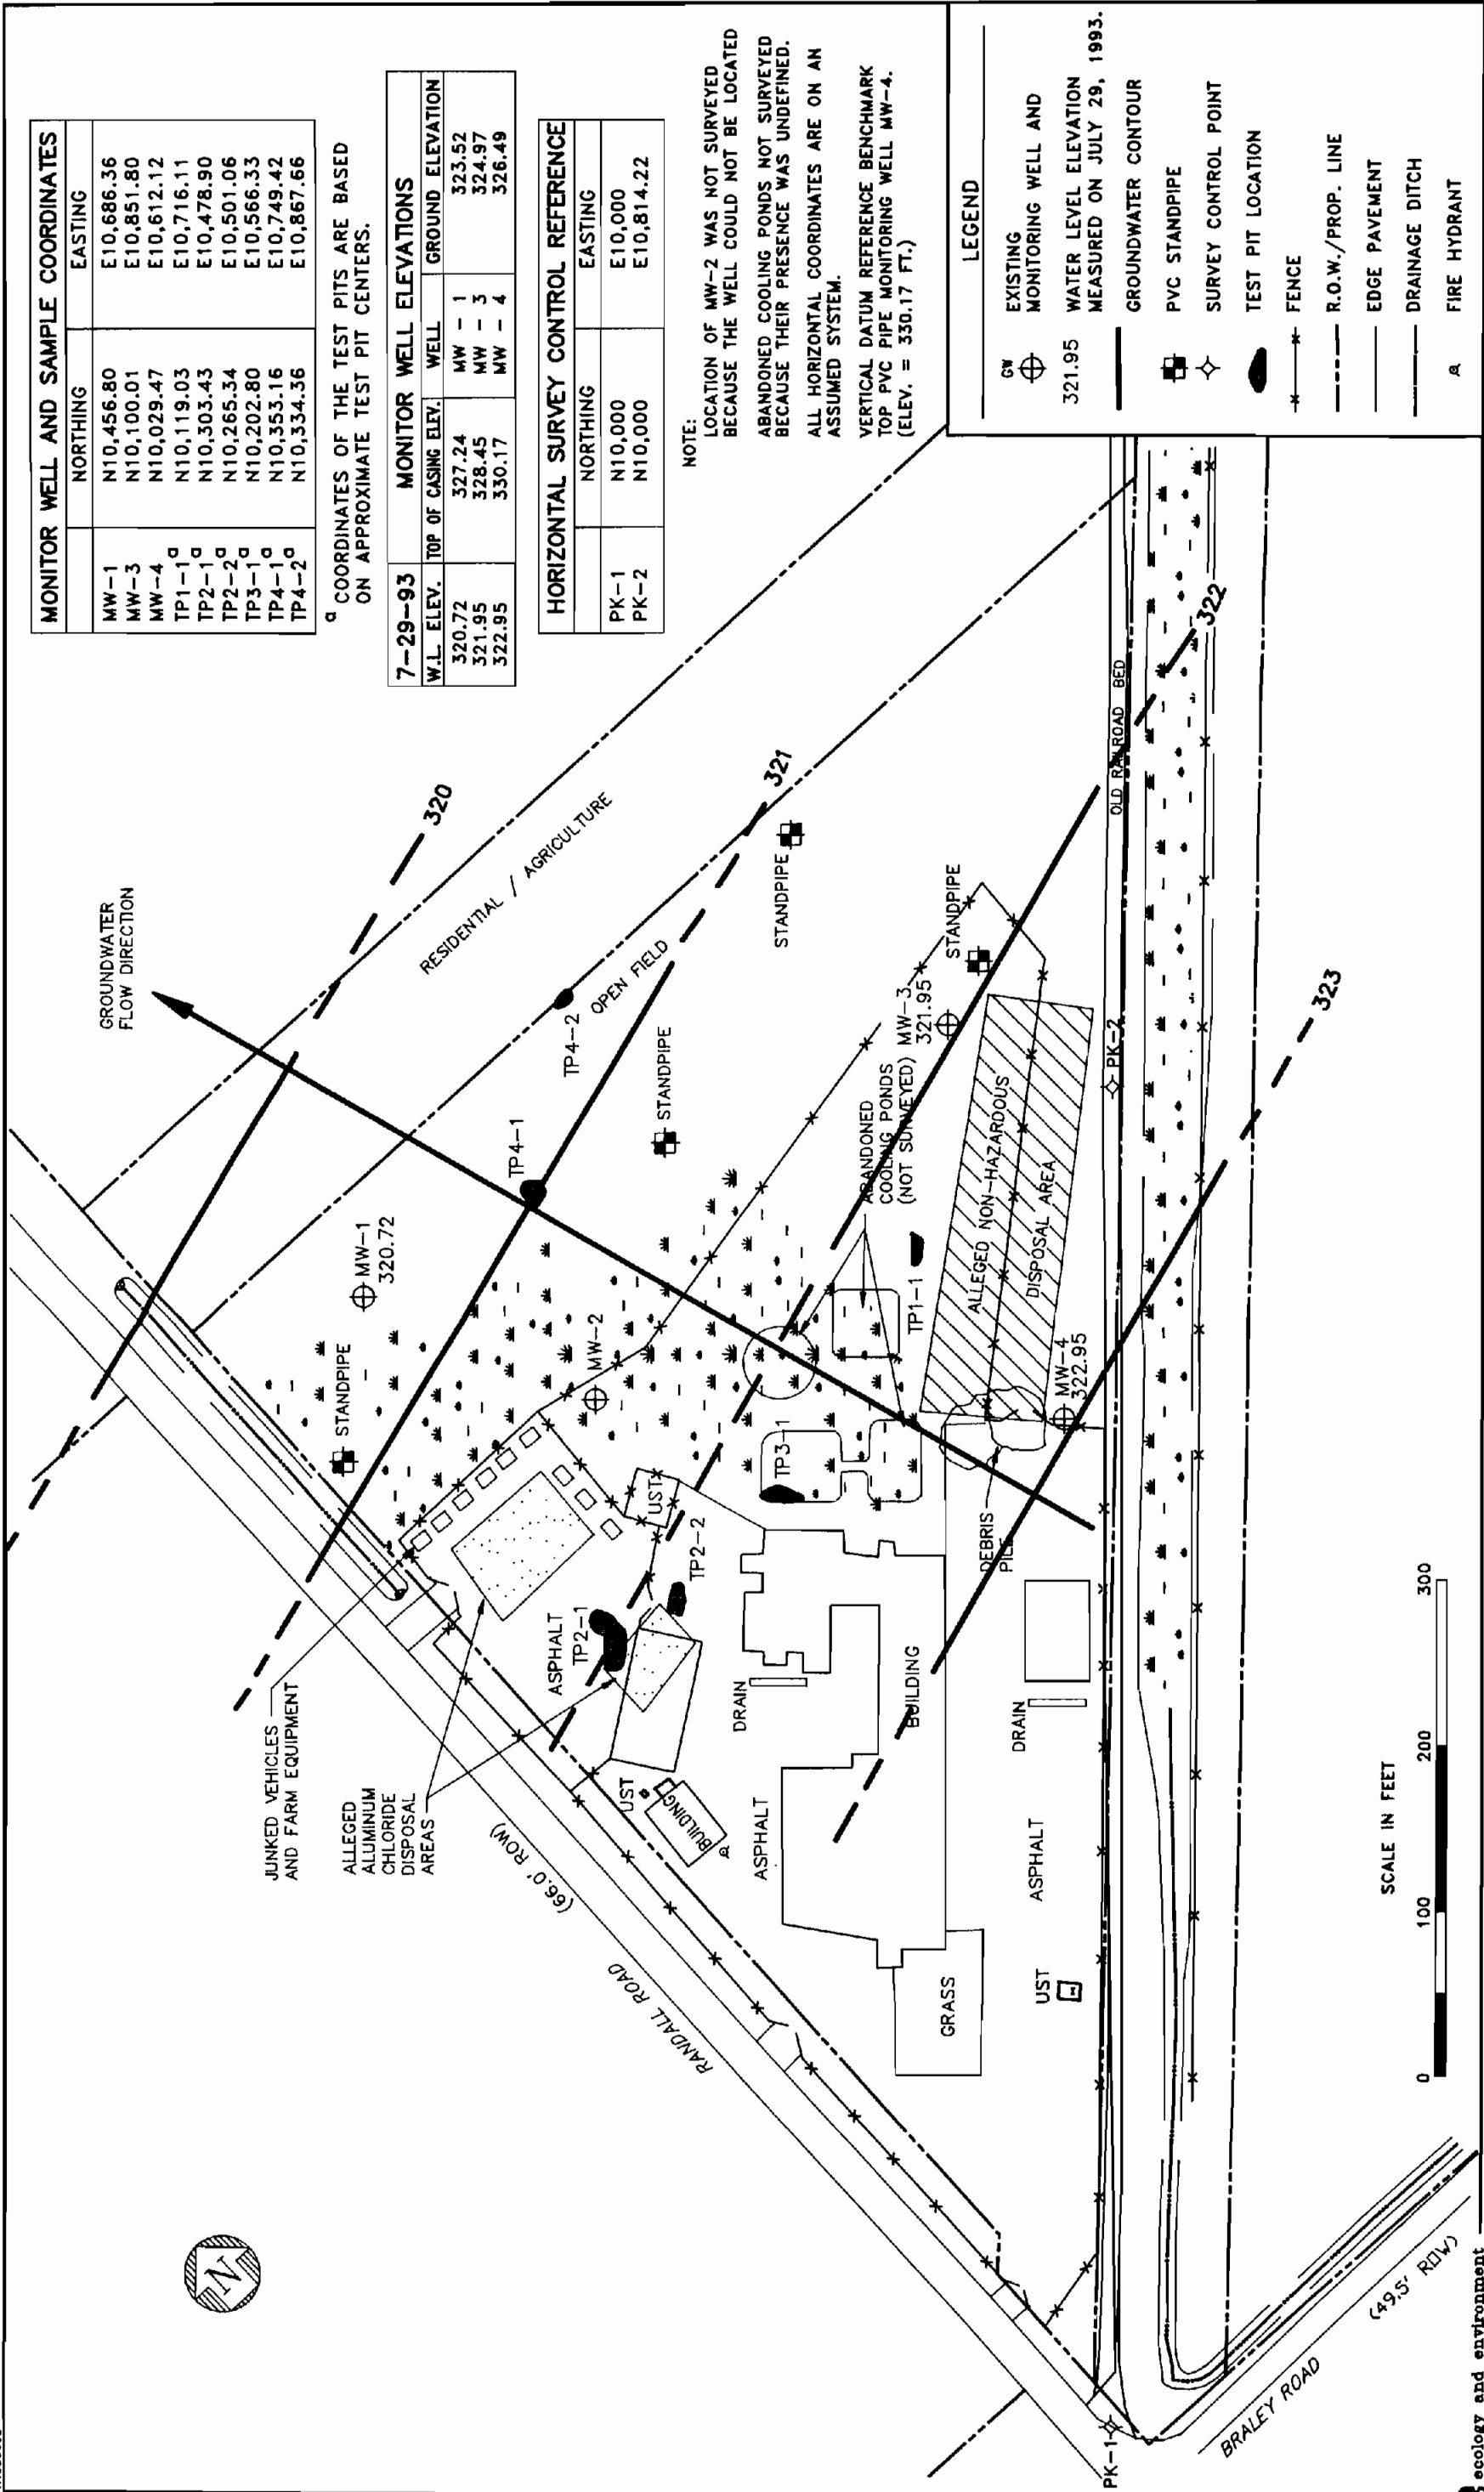
Figure 3-1 SAMPLE LOCATION AND GROUND-
WATER CONTOUR MAP
ALLIED CHEMICAL - ELBERTA WORKS

| 8. Briefly Describe the Site (see Figure 3-1 for site plan) The site consists of approximately 1-acre of fill on a 3-acre parcel located in a rural residential/agricultural area. During disposal the site was a chemical manufacturing facility, primarily producing aluminum chloride. Anhydrous aluminum chloride was disposed of at the site. In that form, it is violently reactive with water, and produces aluminum hydroxide and hydrochloric acid and is considered a hazardous waste. The site is currently used to warehouse pet supplies. a. Area 1 acre b. EPA ID Number NYD002128544 c. Completed <input checked="" type="checkbox"/> Phase I <input type="checkbox"/> Phase II <input checked="" type="checkbox"/> PSA <input type="checkbox"/> RI/FS <input type="checkbox"/> PA/SI <input checked="" type="checkbox"/> Other (SI) | | | |

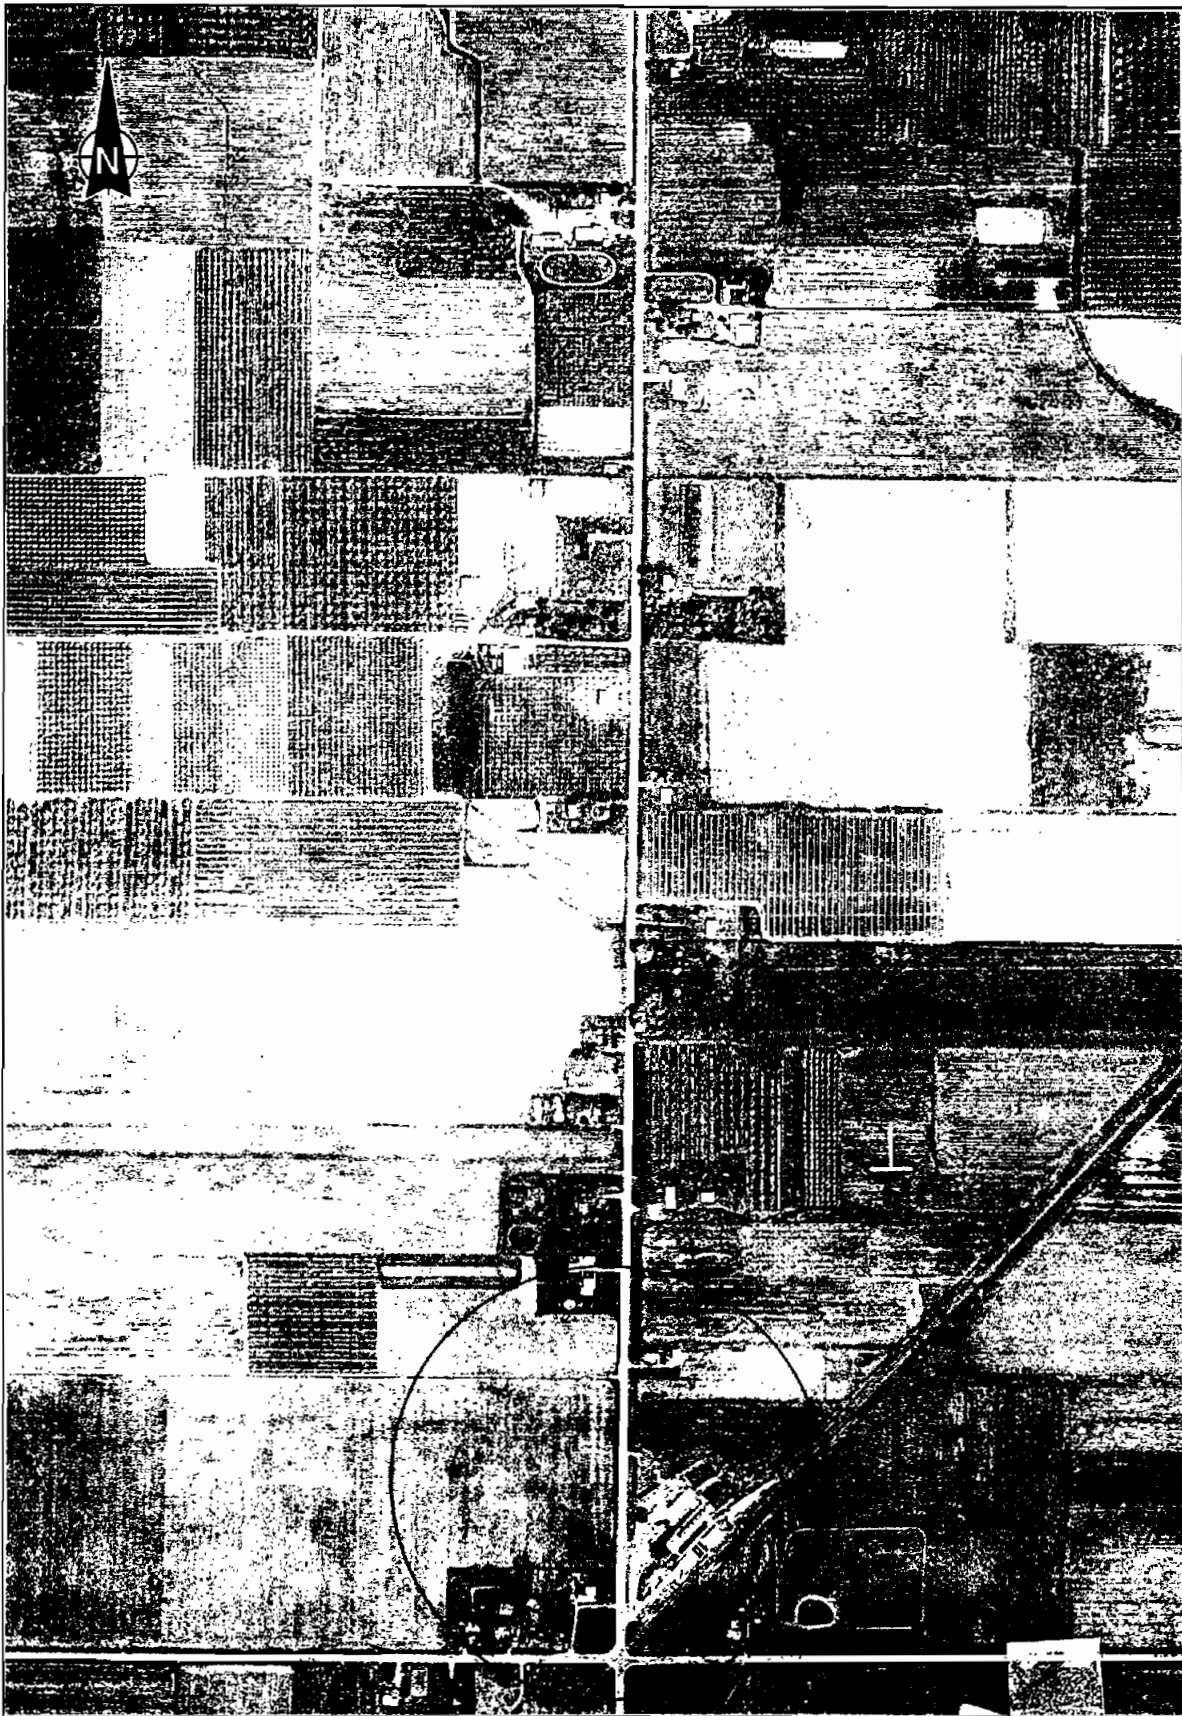
Appendix A AERIAL PHOTOGRAPH 1982 ALLIED-ELBERTA SITE

- The 1982 photo still indicated the presence of the two cooling ponds, along with several additional buildings to the northwest of the previously observed buildings; and

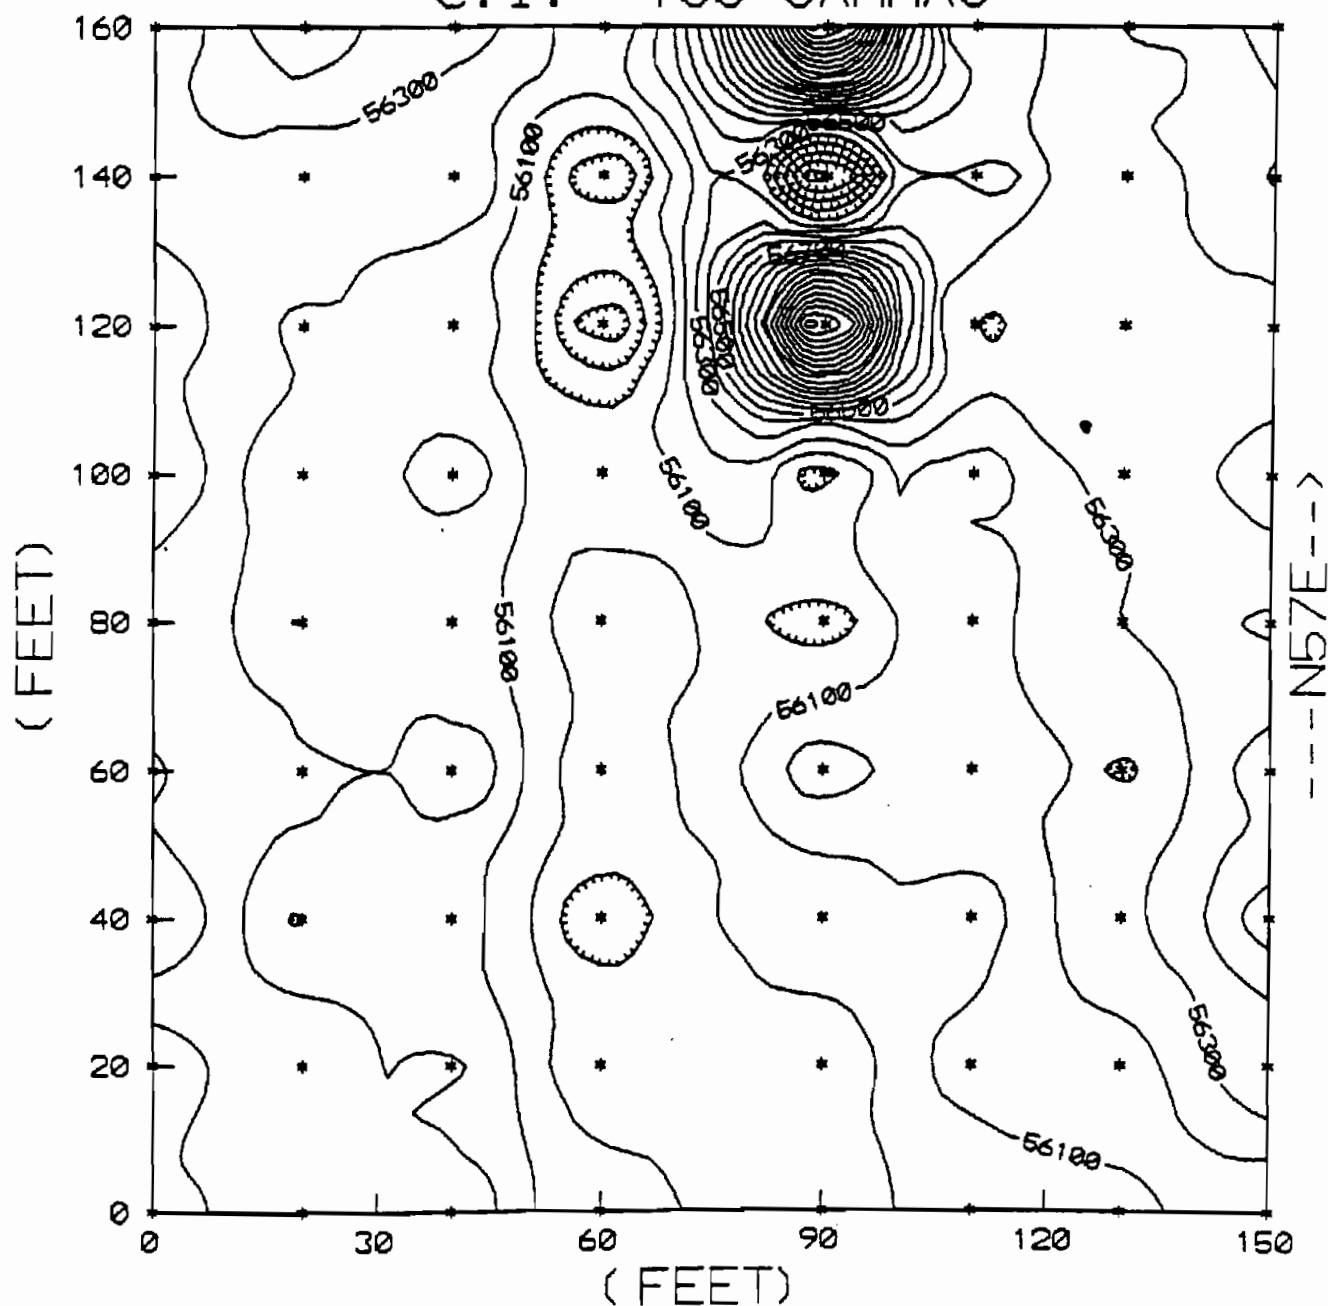
ALLIED MAG GRID 1

In order to confirm the results of the geophysical surveys and identify the source of the more prominent anomalies, test pit excavations were recommended in Grid 1 at X,Y grid coordinate (20,60); Grid 2, between (60,30) to (80,50); Grid 3 at (70,0); and Grid 4 at (200,25), and (275,100) to (300,100). Since Grid 5 was inside the storage building with the concrete slab foundation, no initial investigative work was recommended due to difficult access. If necessary, investigation at grid coordinates (18,40) and (18,50) in Grid 5 is recommended. Review of the data collected in Grid 6 revealed no significant anomalies, therefore, no test pits were recommended. Results of test pit excavations at the above-mentioned anomalies are discussed in Section 3.4.

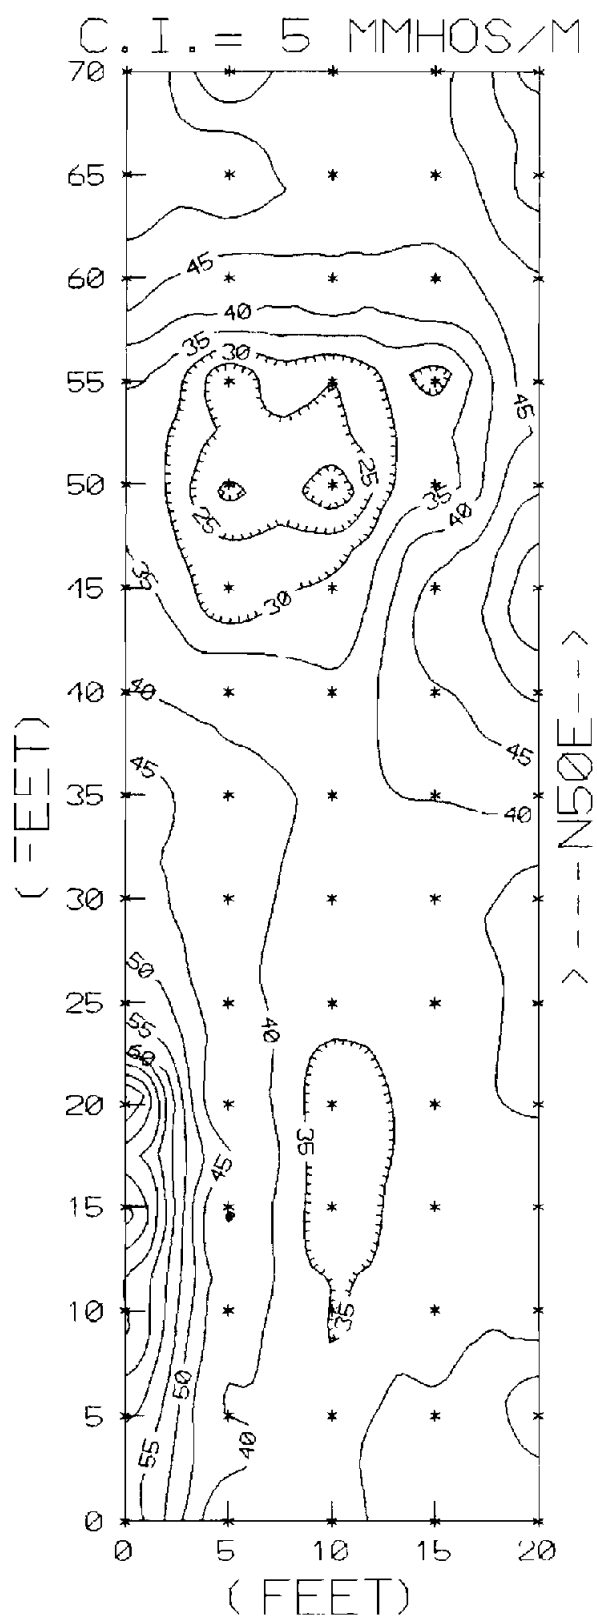
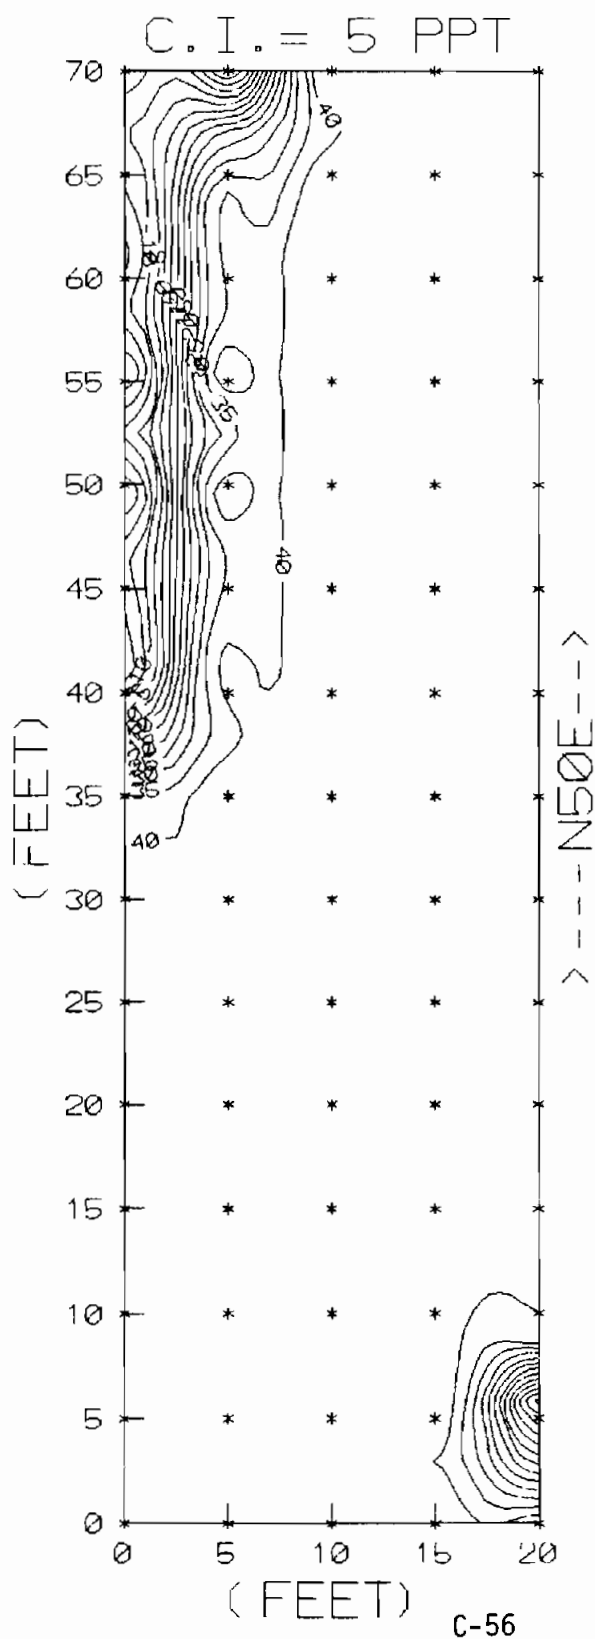
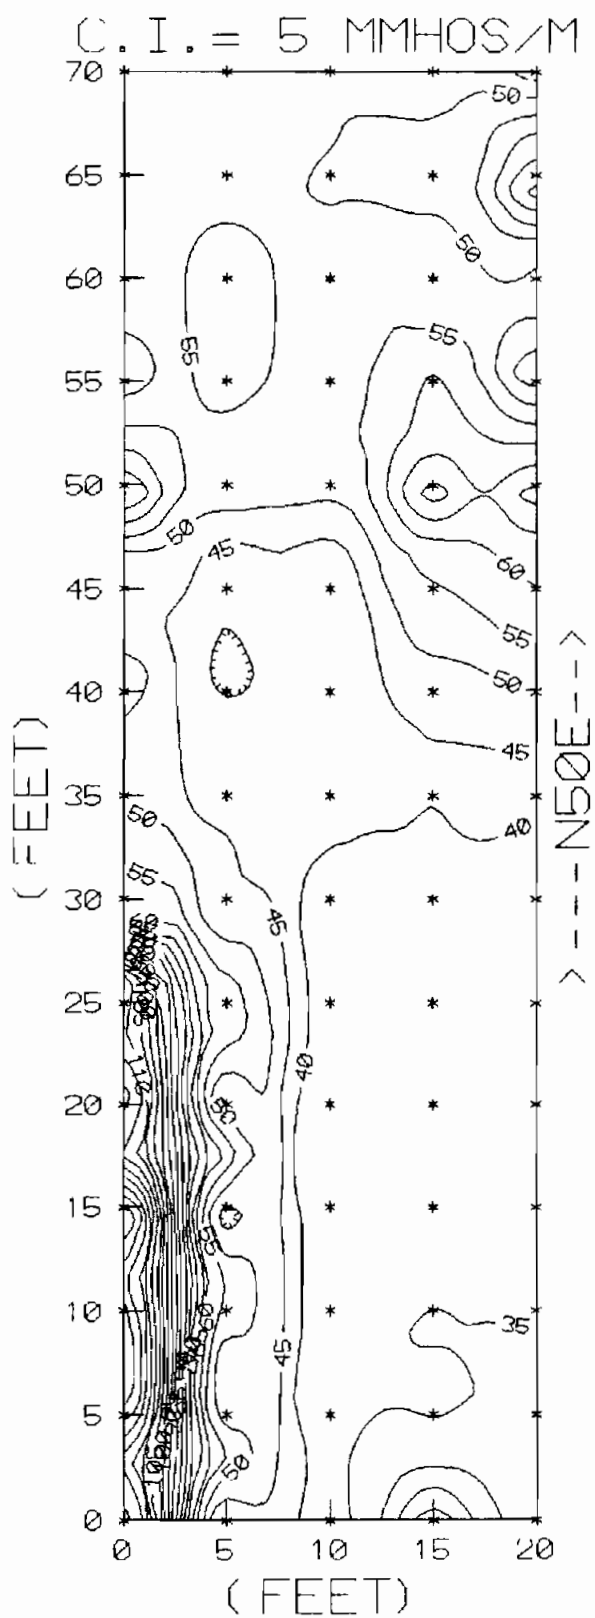
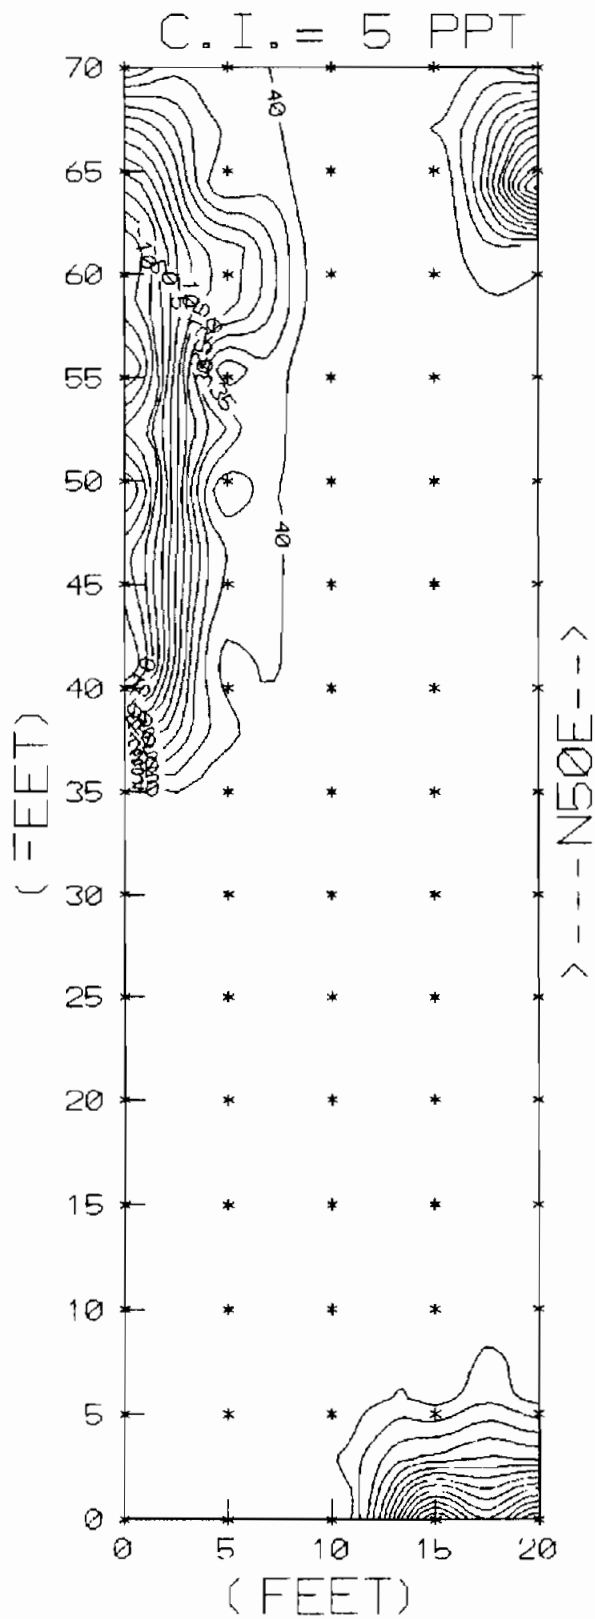
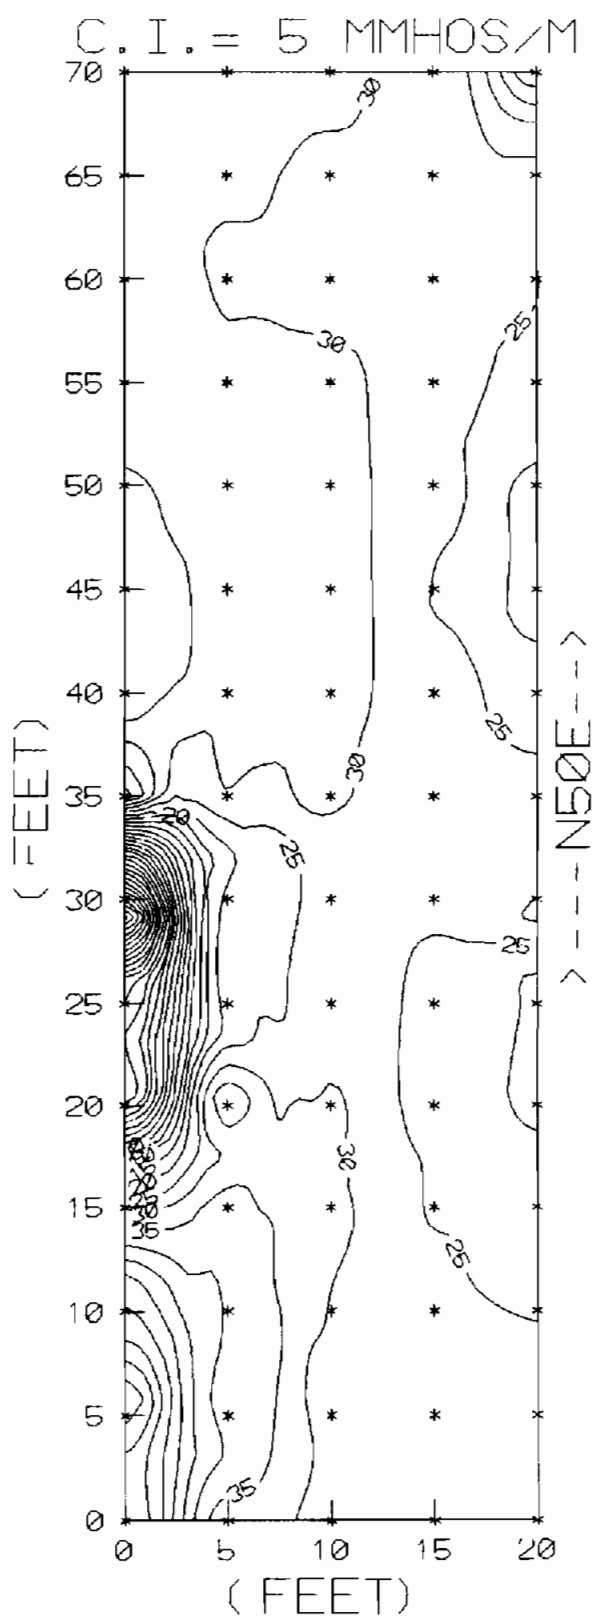
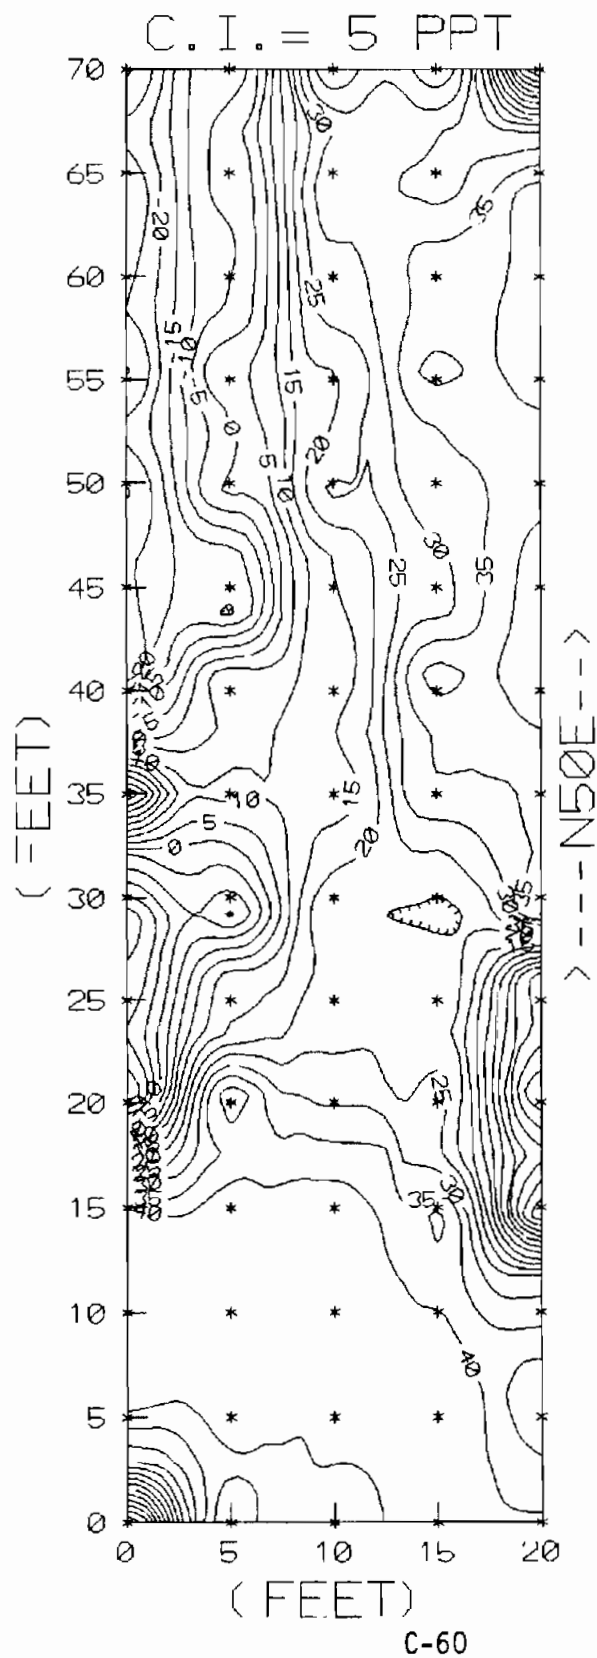
ALLIED V1 CONDUCTIVITY GRID 6

On November 17, 1994, E & E performed an additional geophysical survey (Grid 6) at the Allied-Elberta site, at the request of NYSDEC. The location of Grid 6 is illustrated in the figure on page C-9 of this appendix. The survey was performed with an EM31 ground conductivity meter using the same survey techniques and methods as described in the August 23, 1993 letter report on page C-3 of this appendix. The grid was 70 feet long and 20 feet wide, with a station and line spacing of 5 feet. Because the magnetometer was unavailable at the time of the survey, only the EM31 was initially used for the survey. Based on the preliminary analysis of this data, the magnetometer survey was deemed not necessary for this grid.

The results of the EM31 survey of Grid 6 revealed no significant unexplainable anomalies. The elongated anomaly in the southwest corner of the V1, V2, H1, and H2 conductivity contour plots is due to the presence of a warehouse immediately adjacent to that corner of the grid. The anomaly in the southeast corner of the V1, V2, and H2 in-phase contour plots is due to the presence of a metal grate over a storm sewer. The elongated anomaly in the northwest corner of the V1, V2, H1, and H2 in-phase contour plots is believed to be due to the presence of buried electrical conduit and pipes encountered during the excavation of test pit TP2-2. The poorly defined anomaly in the northeast corner of the V1, V1, and H2 conductivity plots and V1, H1, and H2 in-phase contour plots is due to the presence a portion of the main building. Therefore, there appears to be no significant influence from and subsurface material between the anomalies caused by building interference or known buried utilities. Excavation in this grid area was, therefore, not recommended.
