2019 Periodic Review Report

Carborundum – Abrasive Division Site

NYSDEC Site No. 932007

Saint-Gobain Abrasives, Inc.

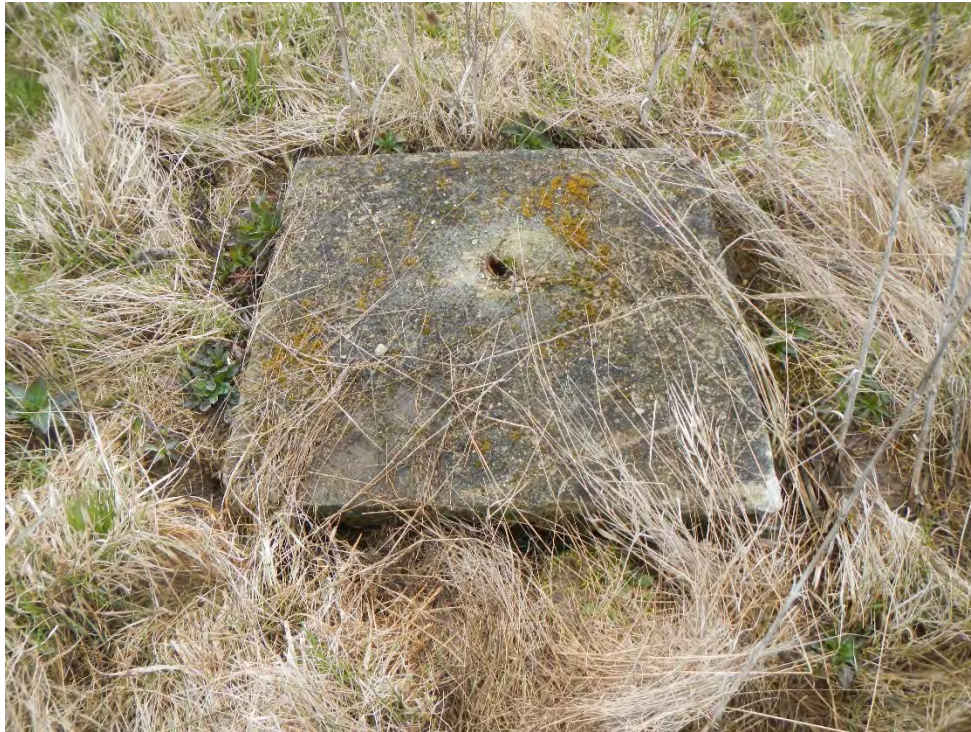
Photo 2 - View of OMW2-81 west of Site on NFTA property

- The riser on OW2-81 is broken off at the concrete slab, leaving the well in an "open" condition (refer to Appendix C, photo 2). This condition requires immediate repair in order to protect the well. A lockable cap and lock will also need to be installed. Following repair of the riser, the top of the riser will need to be surveyed in order to provide a reference elevation for determination of

groundwater elevation. This work will be completed prior to the July 2020 groundwater monitoring event.

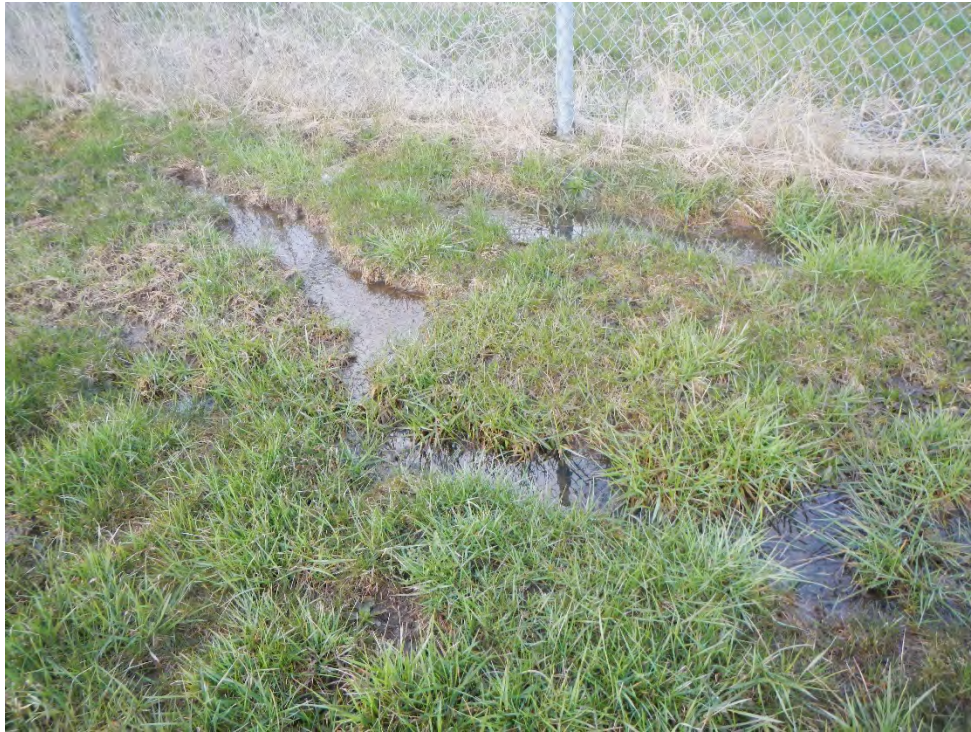
Photo 15 - View of west side of cap (southern end) and ruts from lawnmower

A cap inspection was not completed during the reporting period. A cap inspection was completed during a Site inspection conducted by GHD on April 21, 2020. A completed Site Inspection form is included as Appendix B, and a photographic log of the Site inspection is included as Appendix C. Based on the results of the cap inspection, the cap appears to be in very good condition. No conditions were identified through the visual inspection that would suggest that the integrity of the cap has been compromised. Minor surficial ruts from a lawnmower were observed in an area on the west side of the cap (refer to Appendix C, photo 15). These ruts will be filled with topsoil and reseeded.

Engineering Control	Condition	Maintenance Required or Comments
Clay Landfill Cap	cap in very good condition minor rutting along west fence line from mower	fill ruts; continue to mow vegetative cover on cap.
Monitoring Wells	See below.	See below.

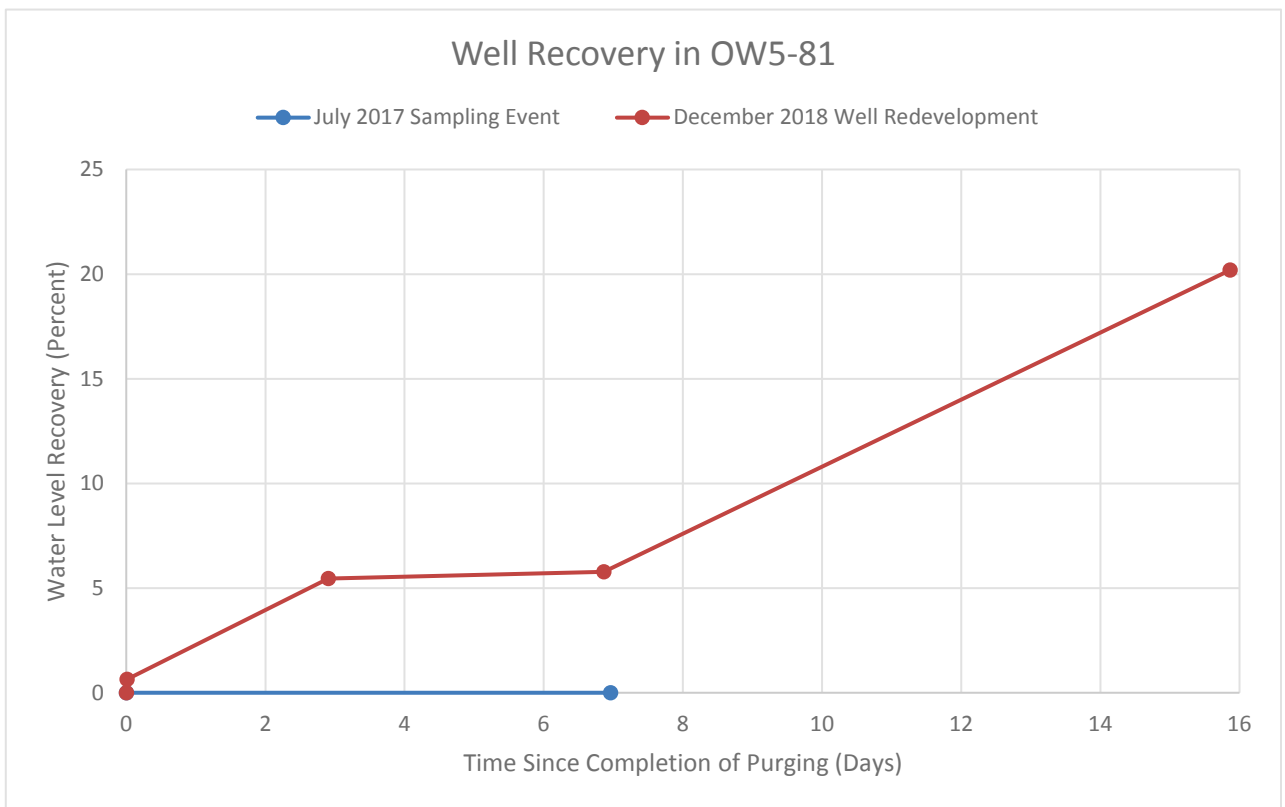
Table 3.3 Water Level Recovery in OW5-81 Following Purging
