2020 Periodic Review Report

Lockport City Landfill
NYSDEC Site No. 932010

City of Lockport, New York
Department of Public Works

GHD | 285 Delaware Avenue Suite 500 Buffalo New York 14202
11137273 | Report No 7 | January 13, 2021

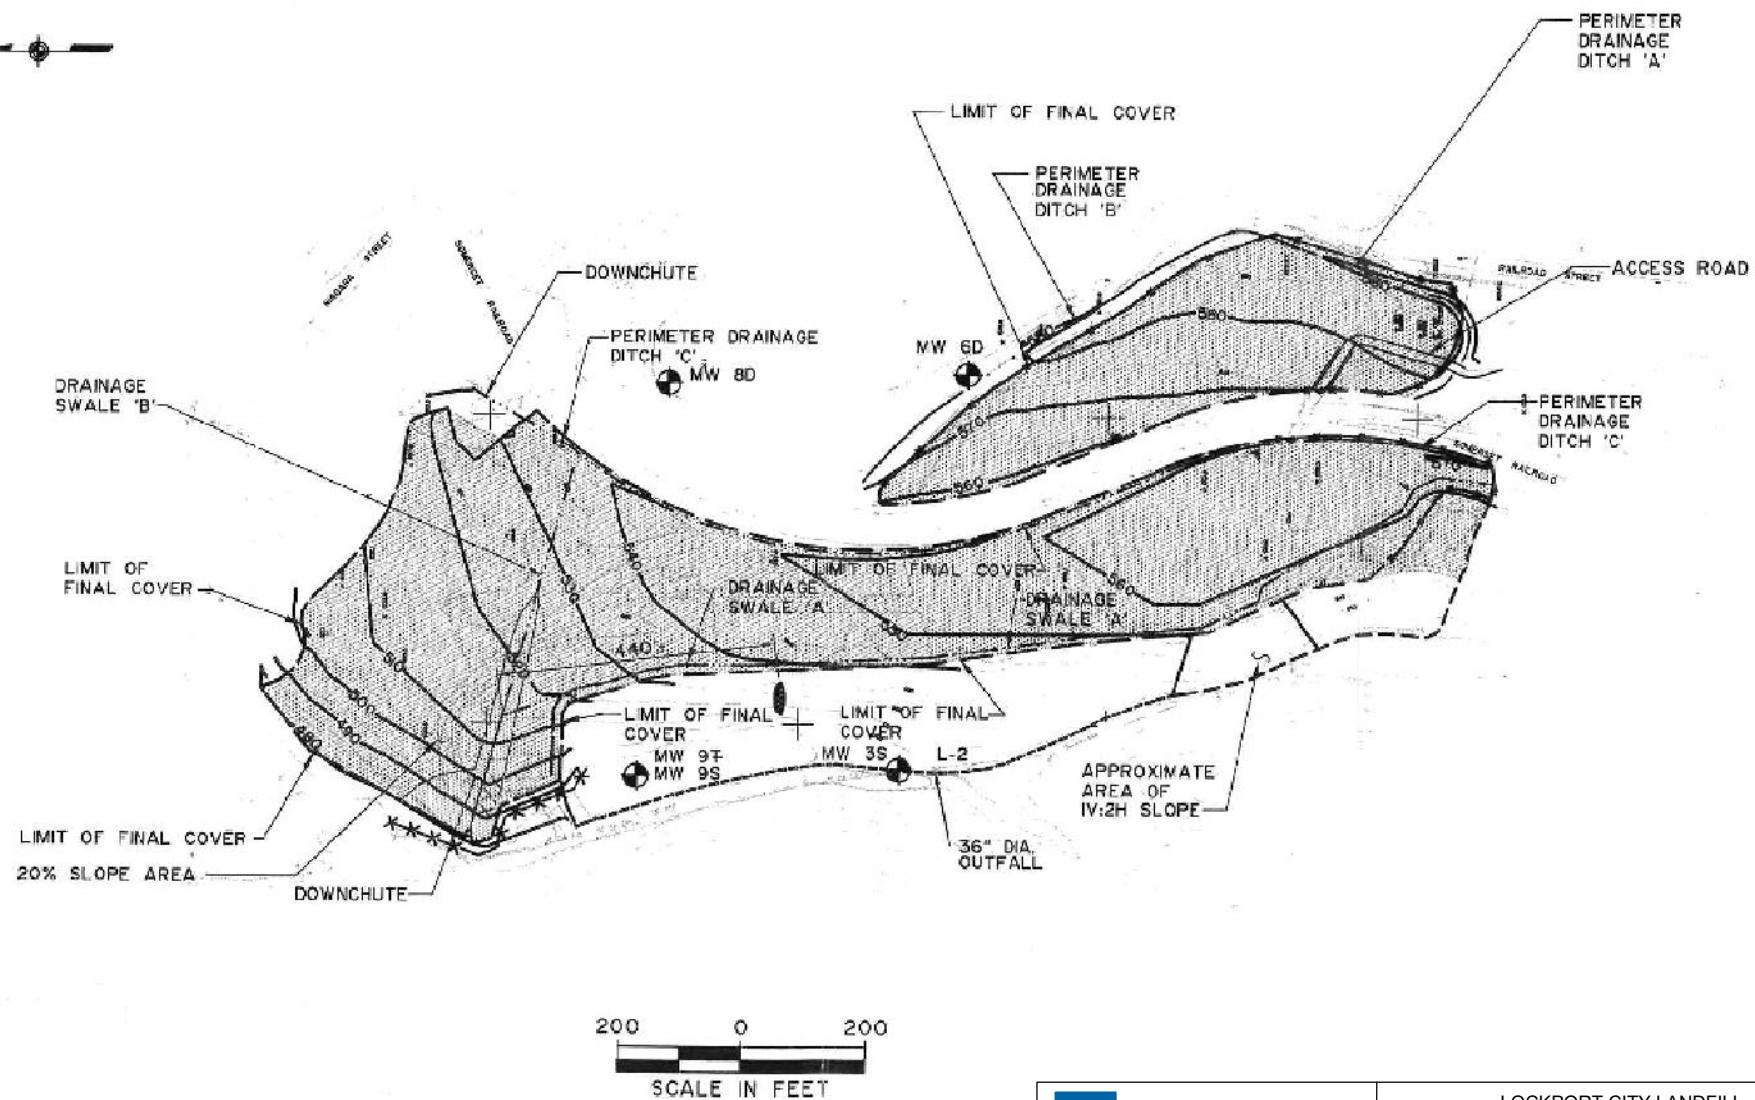
FIGURE 1
SITE PLAN

The Lockport City Landfill (Site) is located on Oakhurst Street in the City of Lockport, Niagara County, New York. This Site is listed on the New York State Department of Environmental Conservation (NYSDEC) Registry of Inactive Hazardous Waste Sites as Site No. 932010. The Remedial Action Design for the site included a Long-Term Monitoring Plan and Operation and Maintenance Plan that were approved by the NYSDEC in March 1994. The purpose of the Long-Term Monitoring Plan is to provide information to evaluate and monitor the long-term effectiveness of the remedial work. The Operation and Maintenance Plan includes site inspections and analytical testing to identify any potential problems at the landfill that are not being adequately addressed by routine maintenance and to document the current condition of the landfill. A site plan of the Lockport City Landfill is presented on Figure 1.
