# **SANITARY SEWER INVESTIGATION AND REMEDICATION**

**COLVIN BOULEVARD AND 96<sup>TH</sup> STREET**

**GLENN SPRINGS HOLDINGS, INC.  
NIAGARA FALLS, NEW YORK**

**MARCH 2011  
REF. NO. 009954 (21)**

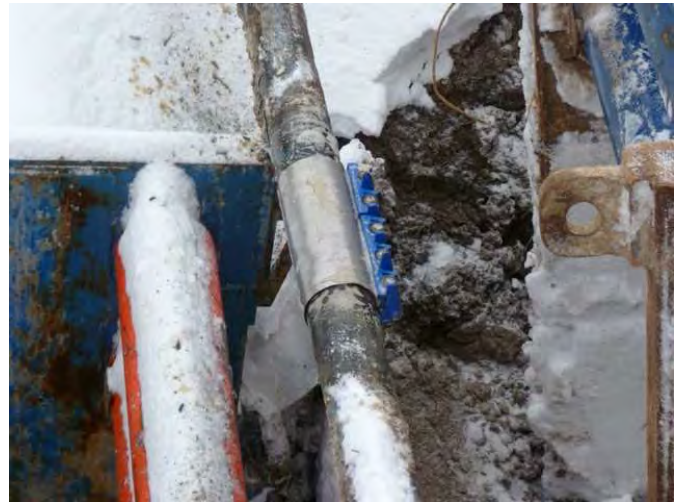
Photo 4: Feb. 02, 2011: Gas line was discovered to be leaking. National Fuel Gas repaired with a sleeve.

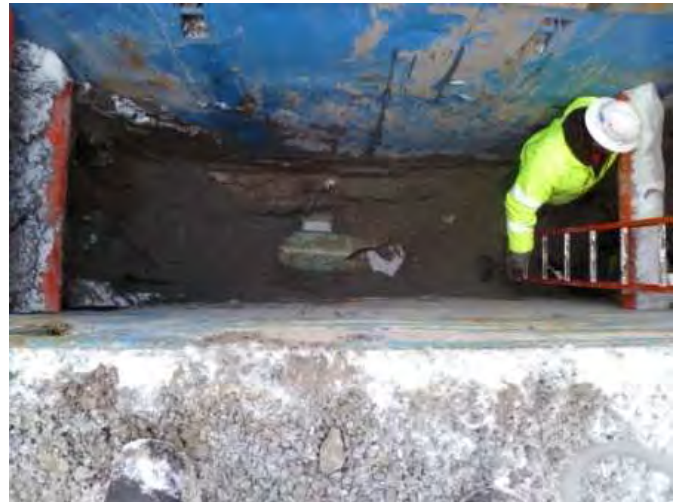
Photo 10: Feb. 03, 2011: Broken PVC sanitary sewer pipe; was supposed to be concrete pipe.

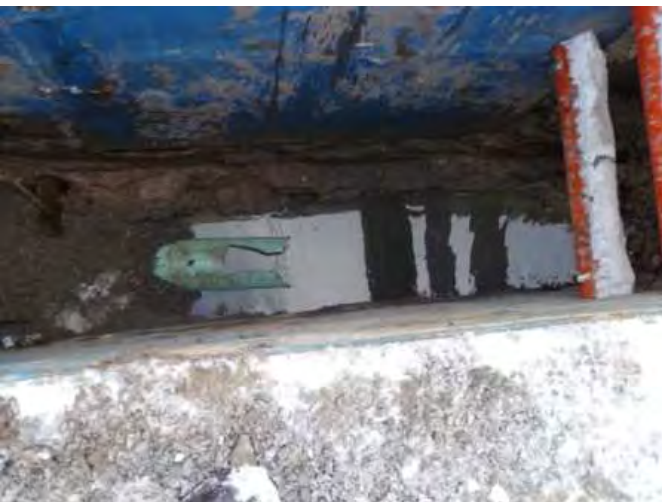
Photo 11: Feb. 03, 2011: Broken PVC pipe and open hole where next section of concrete pipe was removed.

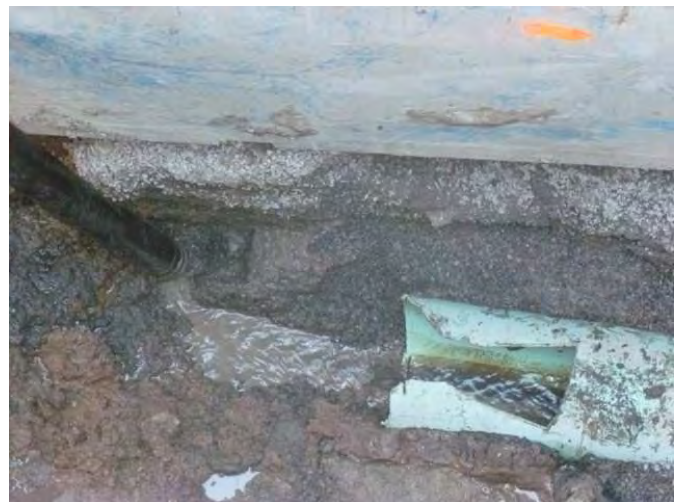
Photo 12: Feb. 04, 2011: Vacuuming water from excavation; water coming from the sanitary sewer pipe.

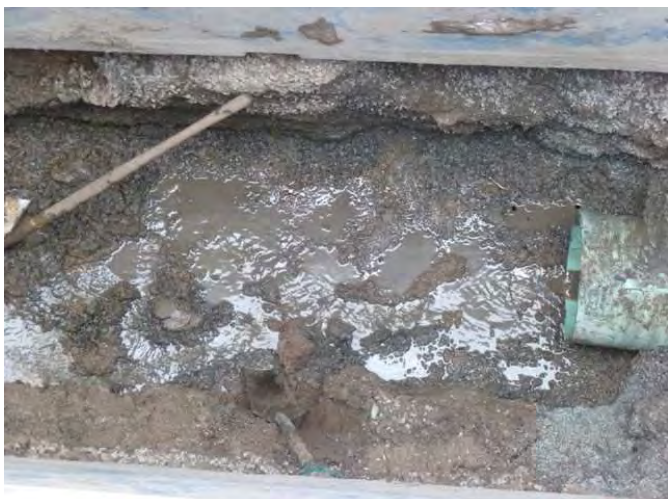
Photo 13: Feb. 04, 2011: Excavation nearly dewatered. Note black dots near pipe end that appears to be a NAPL-like material. Approx. 10 ft west of manhole at 96<sup>th</sup> Street.

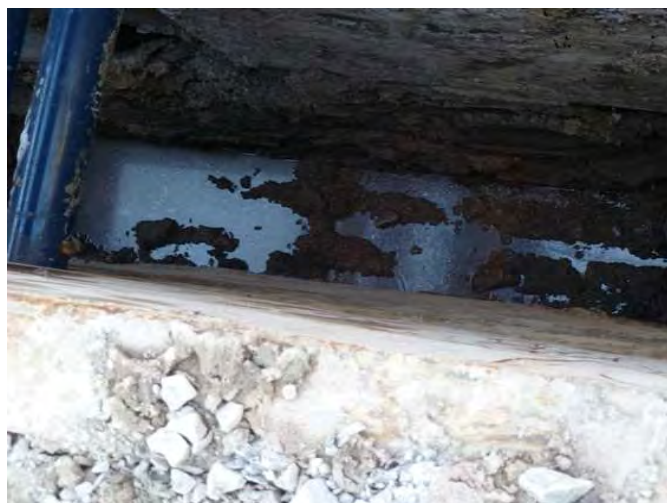
Photo 16: Feb. 04, 2011: Under pipe bedding and clay removed to the extent possible. Approx. 2 ft of material removed below pipe.

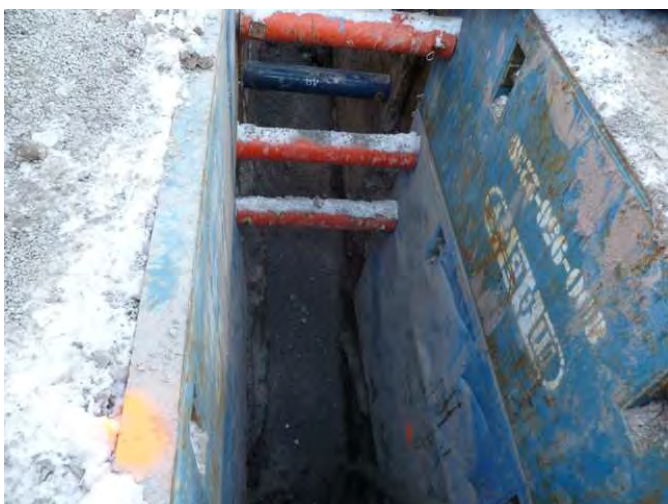
Photo 17: Feb. 04, 2011: Two feet of new bedding installed.

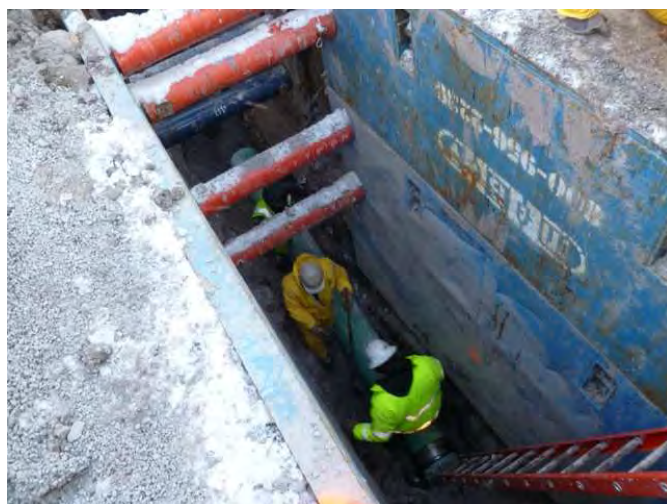
Photo 18: Feb 04, 2011: First 14-ft section of new pipe installed.

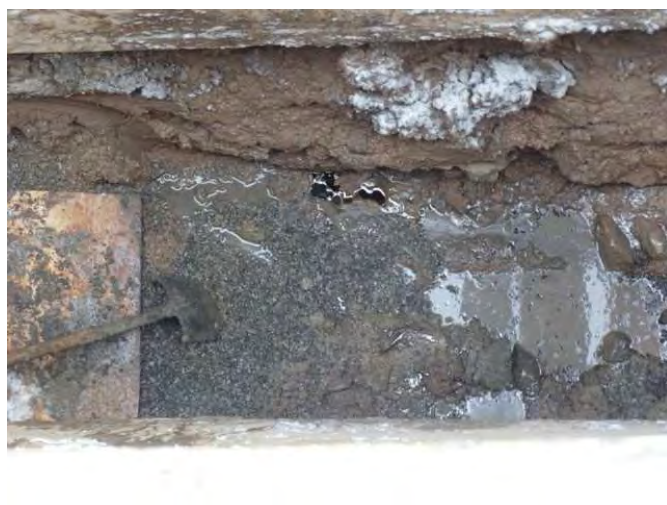
Photo 24: Feb. 08, 2011: Under-bedding and clay removed to extent possible. Note NAPL-like material.

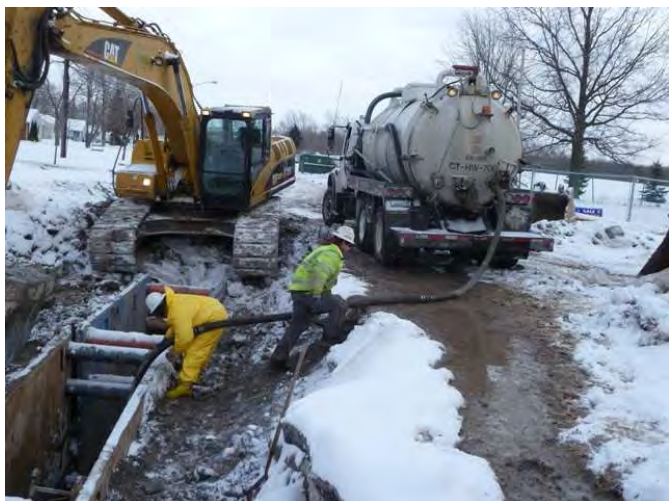
Photo 25: Feb 08, 2011: Vacuuming water and NAPL-like material from excavation.

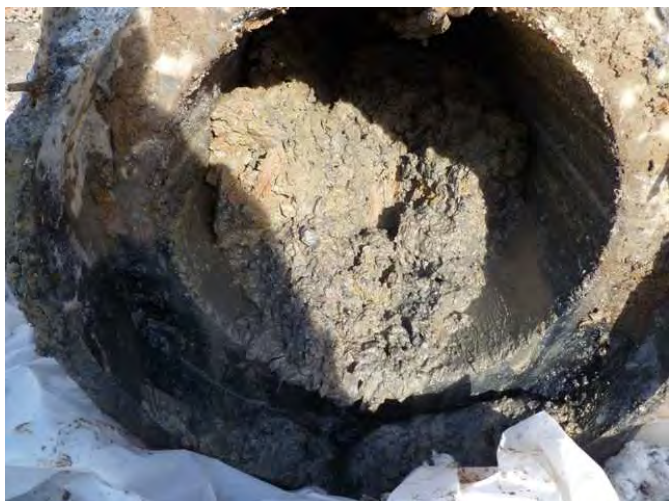
Photo 31: Feb. 09, 2011: Sediments inside of concrete sanitary sewer pipe.

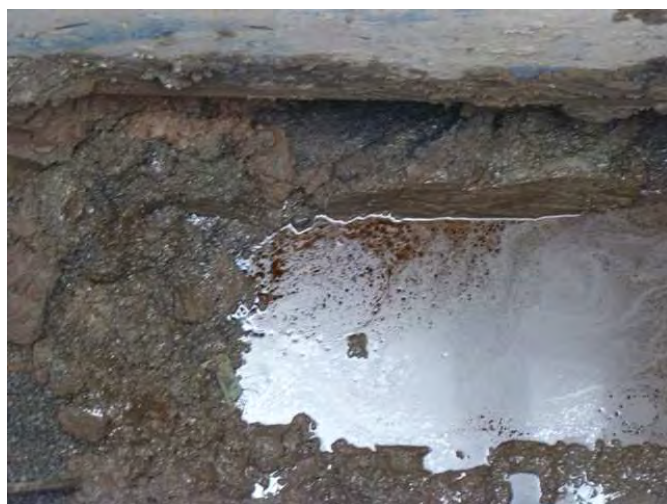
Photo 34: Feb. 10, 2011: Stained gravel and NAPL-like material prior to removal to extent possible. Distance from manhole at 96<sup>th</sup> Street is approximately 38 ft to the east.

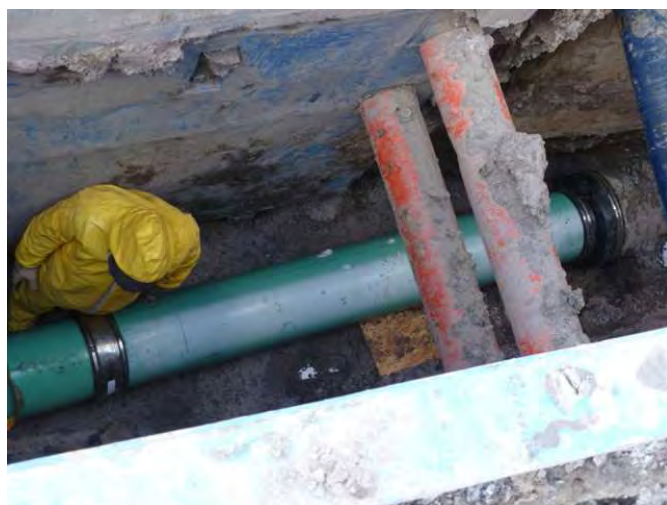
Photo 36: Feb. 10, 2011: Last section of new pipe connected to existing concrete pipe.

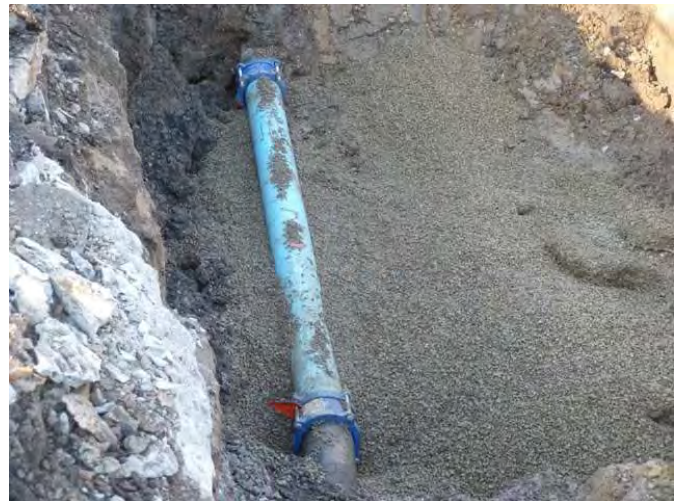
Photo 40: Feb. 15, 2011: Repaired 8-inch water line.

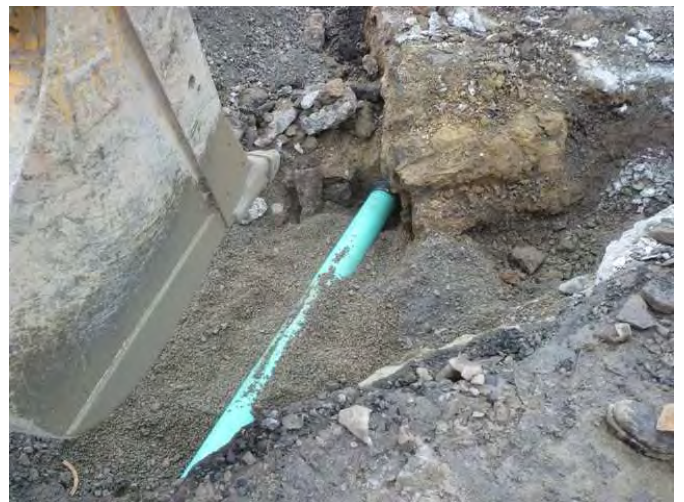
Photo 42: Feb 16, 2011: Repaired storm sewer line.

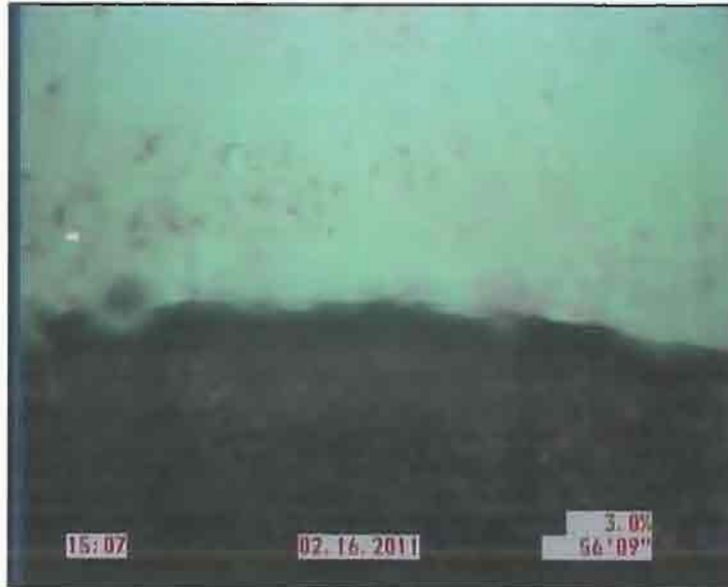
Photo: 4\_1\_2\_17022011\_140929\_A.JPG, VCR No.: X  
56.75FT, Material Change, Concrete pipe (non-reinforced) / PVC (SDR35) to Concrete

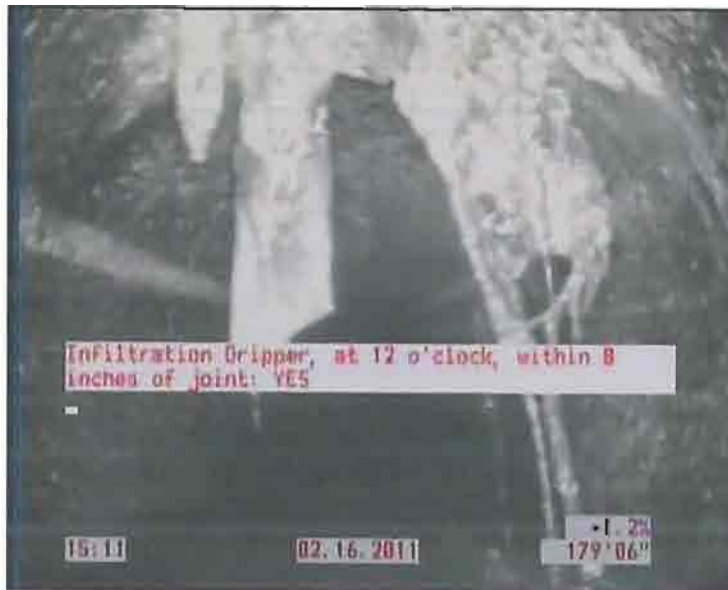
Photo: 4\_1\_3\_17022011\_141402\_A.JPG, VCR No.: X  
179.5FT, Infiltration Dropper, at 12 o'clock, within 8 inches of joint: YES  
/ Infiltration
