# 2019 Annual Periodic Review Report

Hyde Park Landfill  
Niagara Falls, New York  
NYSDEC Site No. 932021

Glenn Springs Holdings, Inc.

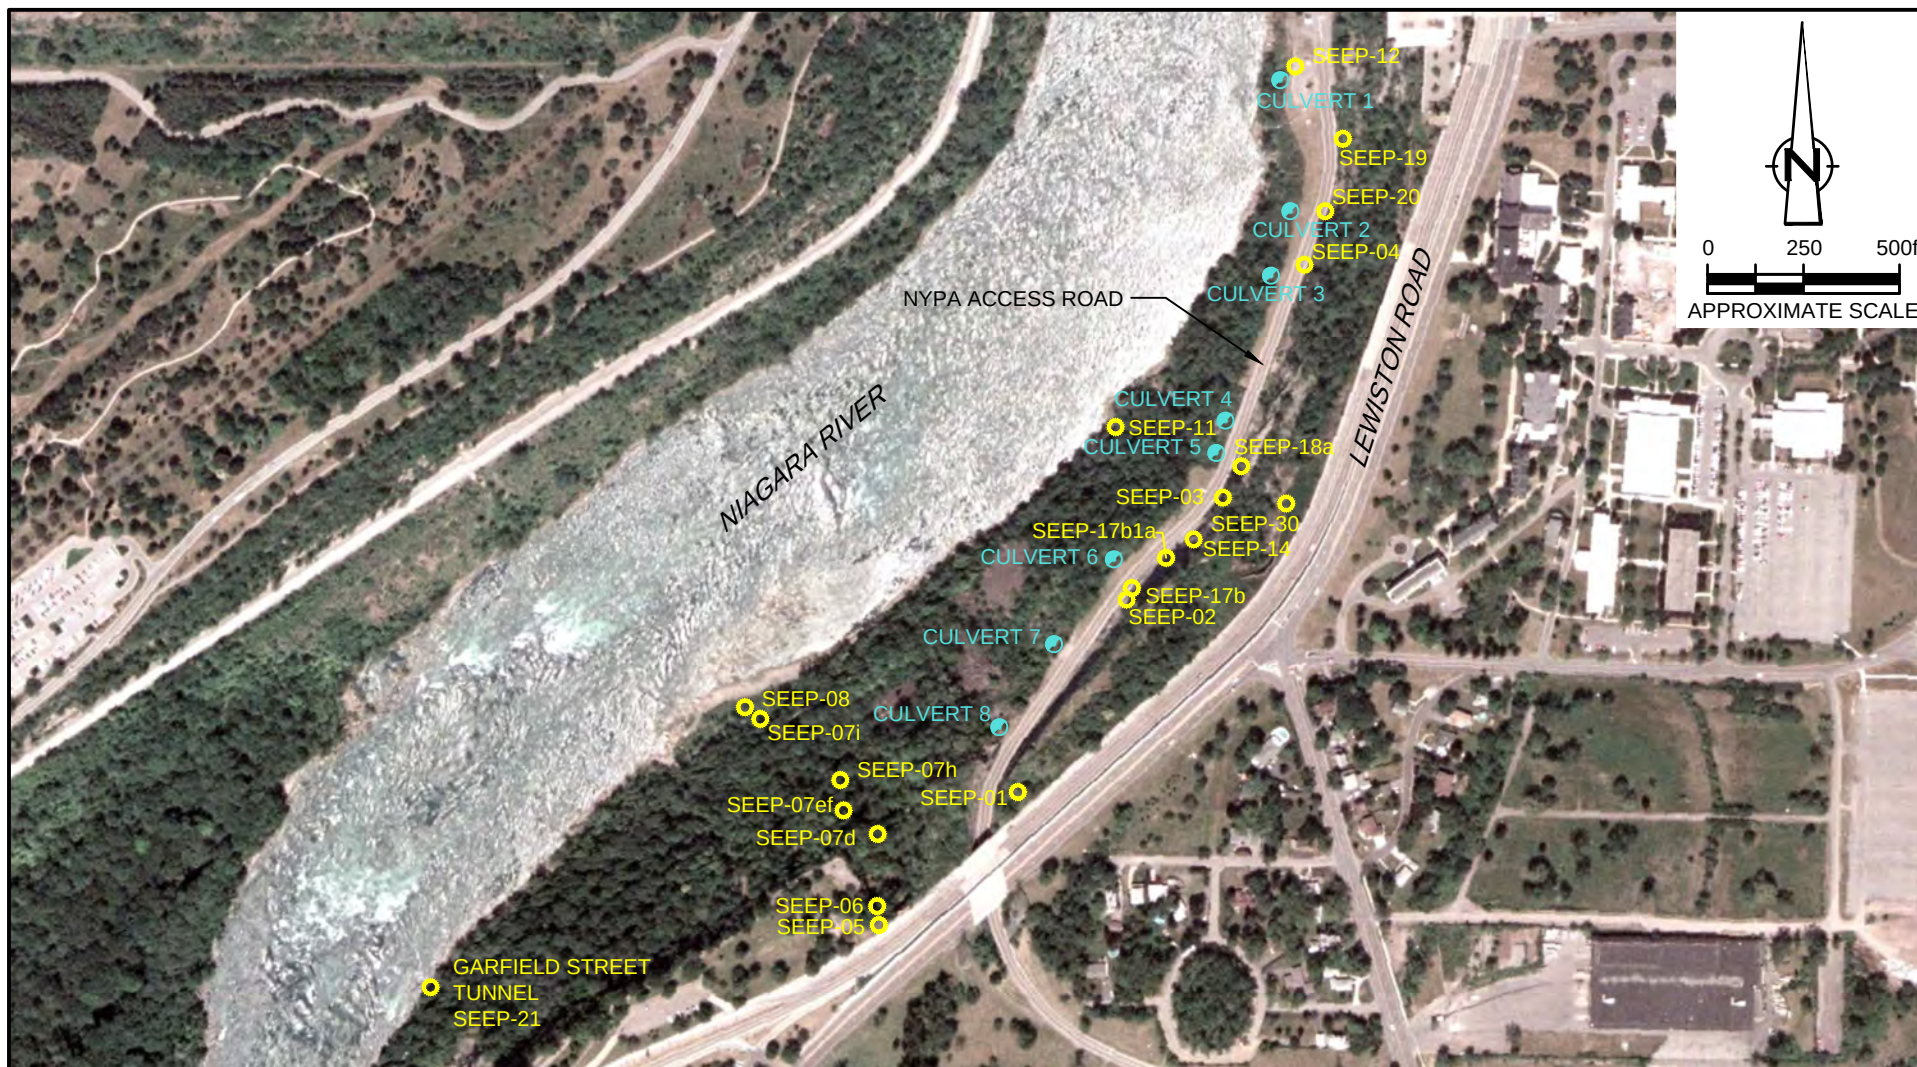
figure B.1

During the survey, all of the accessible seep/wet areas identified during previous surveys were reexamined, and a reevaluation of the proposed remedial action was conducted. The seep locations are presented on Figure B.1. It should be noted that NYPA added slope stability fence fabric along portions of the gorge face in the spring of 2000 to protect the access road.

**SEEP LOCATIONS - OVERVIEW**  
**HYDE PARK LANDFILL SITE**  
**GLENN SPRINGS HOLDINGS, INC.**  
*Niagara Falls, New York*

Based upon the results of the 2019 Biennial Gorge Face Seep Survey, no remedial actions are recommended at this time. The next inspection will be scheduled for fall 2021, unless a change in the frequency of the survey is approved.
