2010 ANNUAL MONITORING REPORT

NIAGARA COUNTY REFUSE DISTRICT SITE

Wheatfield, Niagara County, New York

(NYSDEC Site No. 9-32-026)

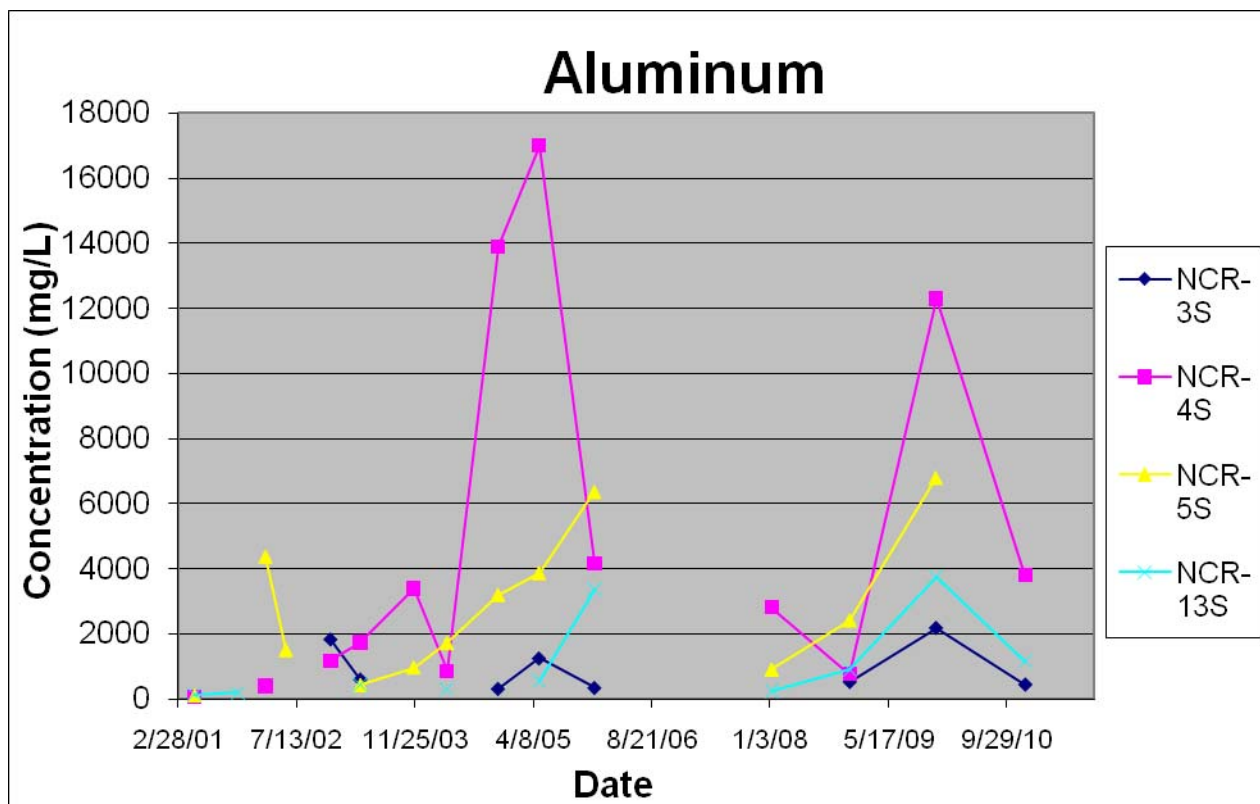
Figure 2.1A: Plot of Historical Aluminum Concentration

Seventeen metals were identified in one or more of the groundwater samples. Five of the detected metals exceeded either the NYSDEC AWQS, NYSDOH MCLs, or USEPA MCLs, which is consistent with previous sampling events. In general the detected values appeared to be consistent with ranges observed in previous sampling events. Two metals, lead and zinc, have detections that are greater than historic high at the site.

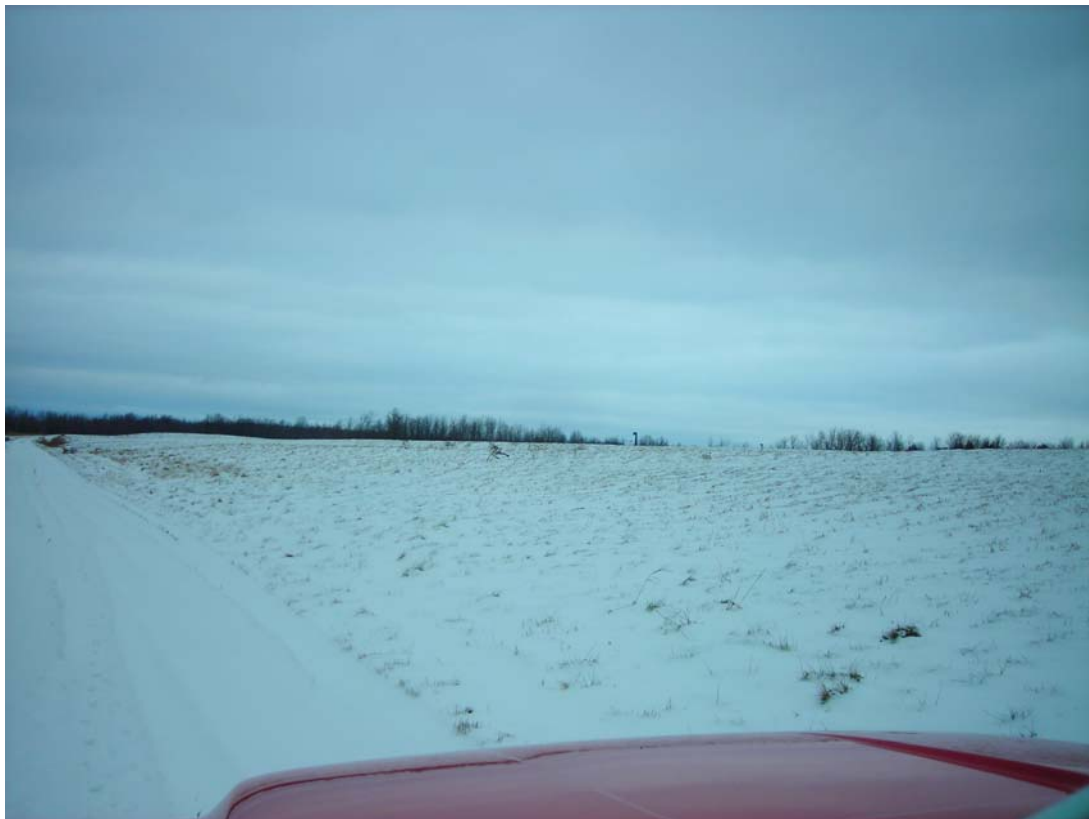
Photo 2: Taken from west side of landfill facing northeast near wet well D.

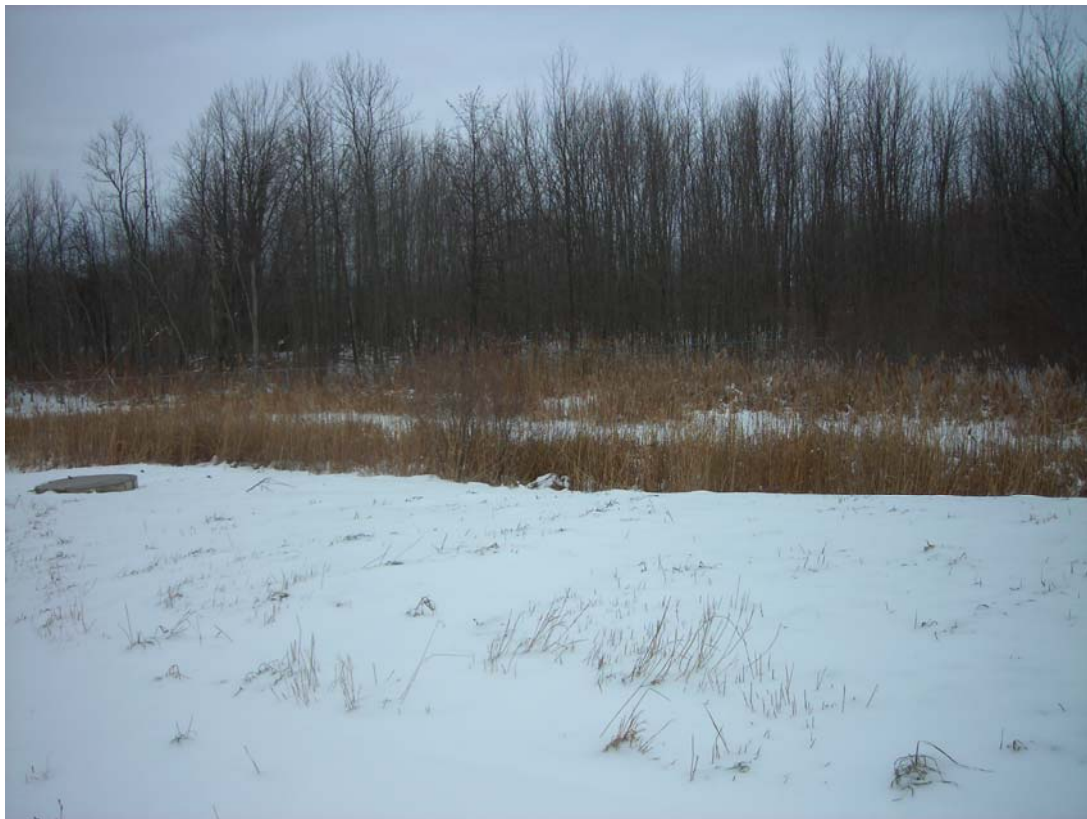
Photo 4: Wet well D and wetlands facing northwest from landfill.
