QUARTERLY DATA SUMMARY REPORT THIRD QUARTER 2014

NIAGARA COUNTY REFUSE DISTRICT SITE

Wheatfield, Niagara County, New York

(NYSDEC Site No. 9-32-026)

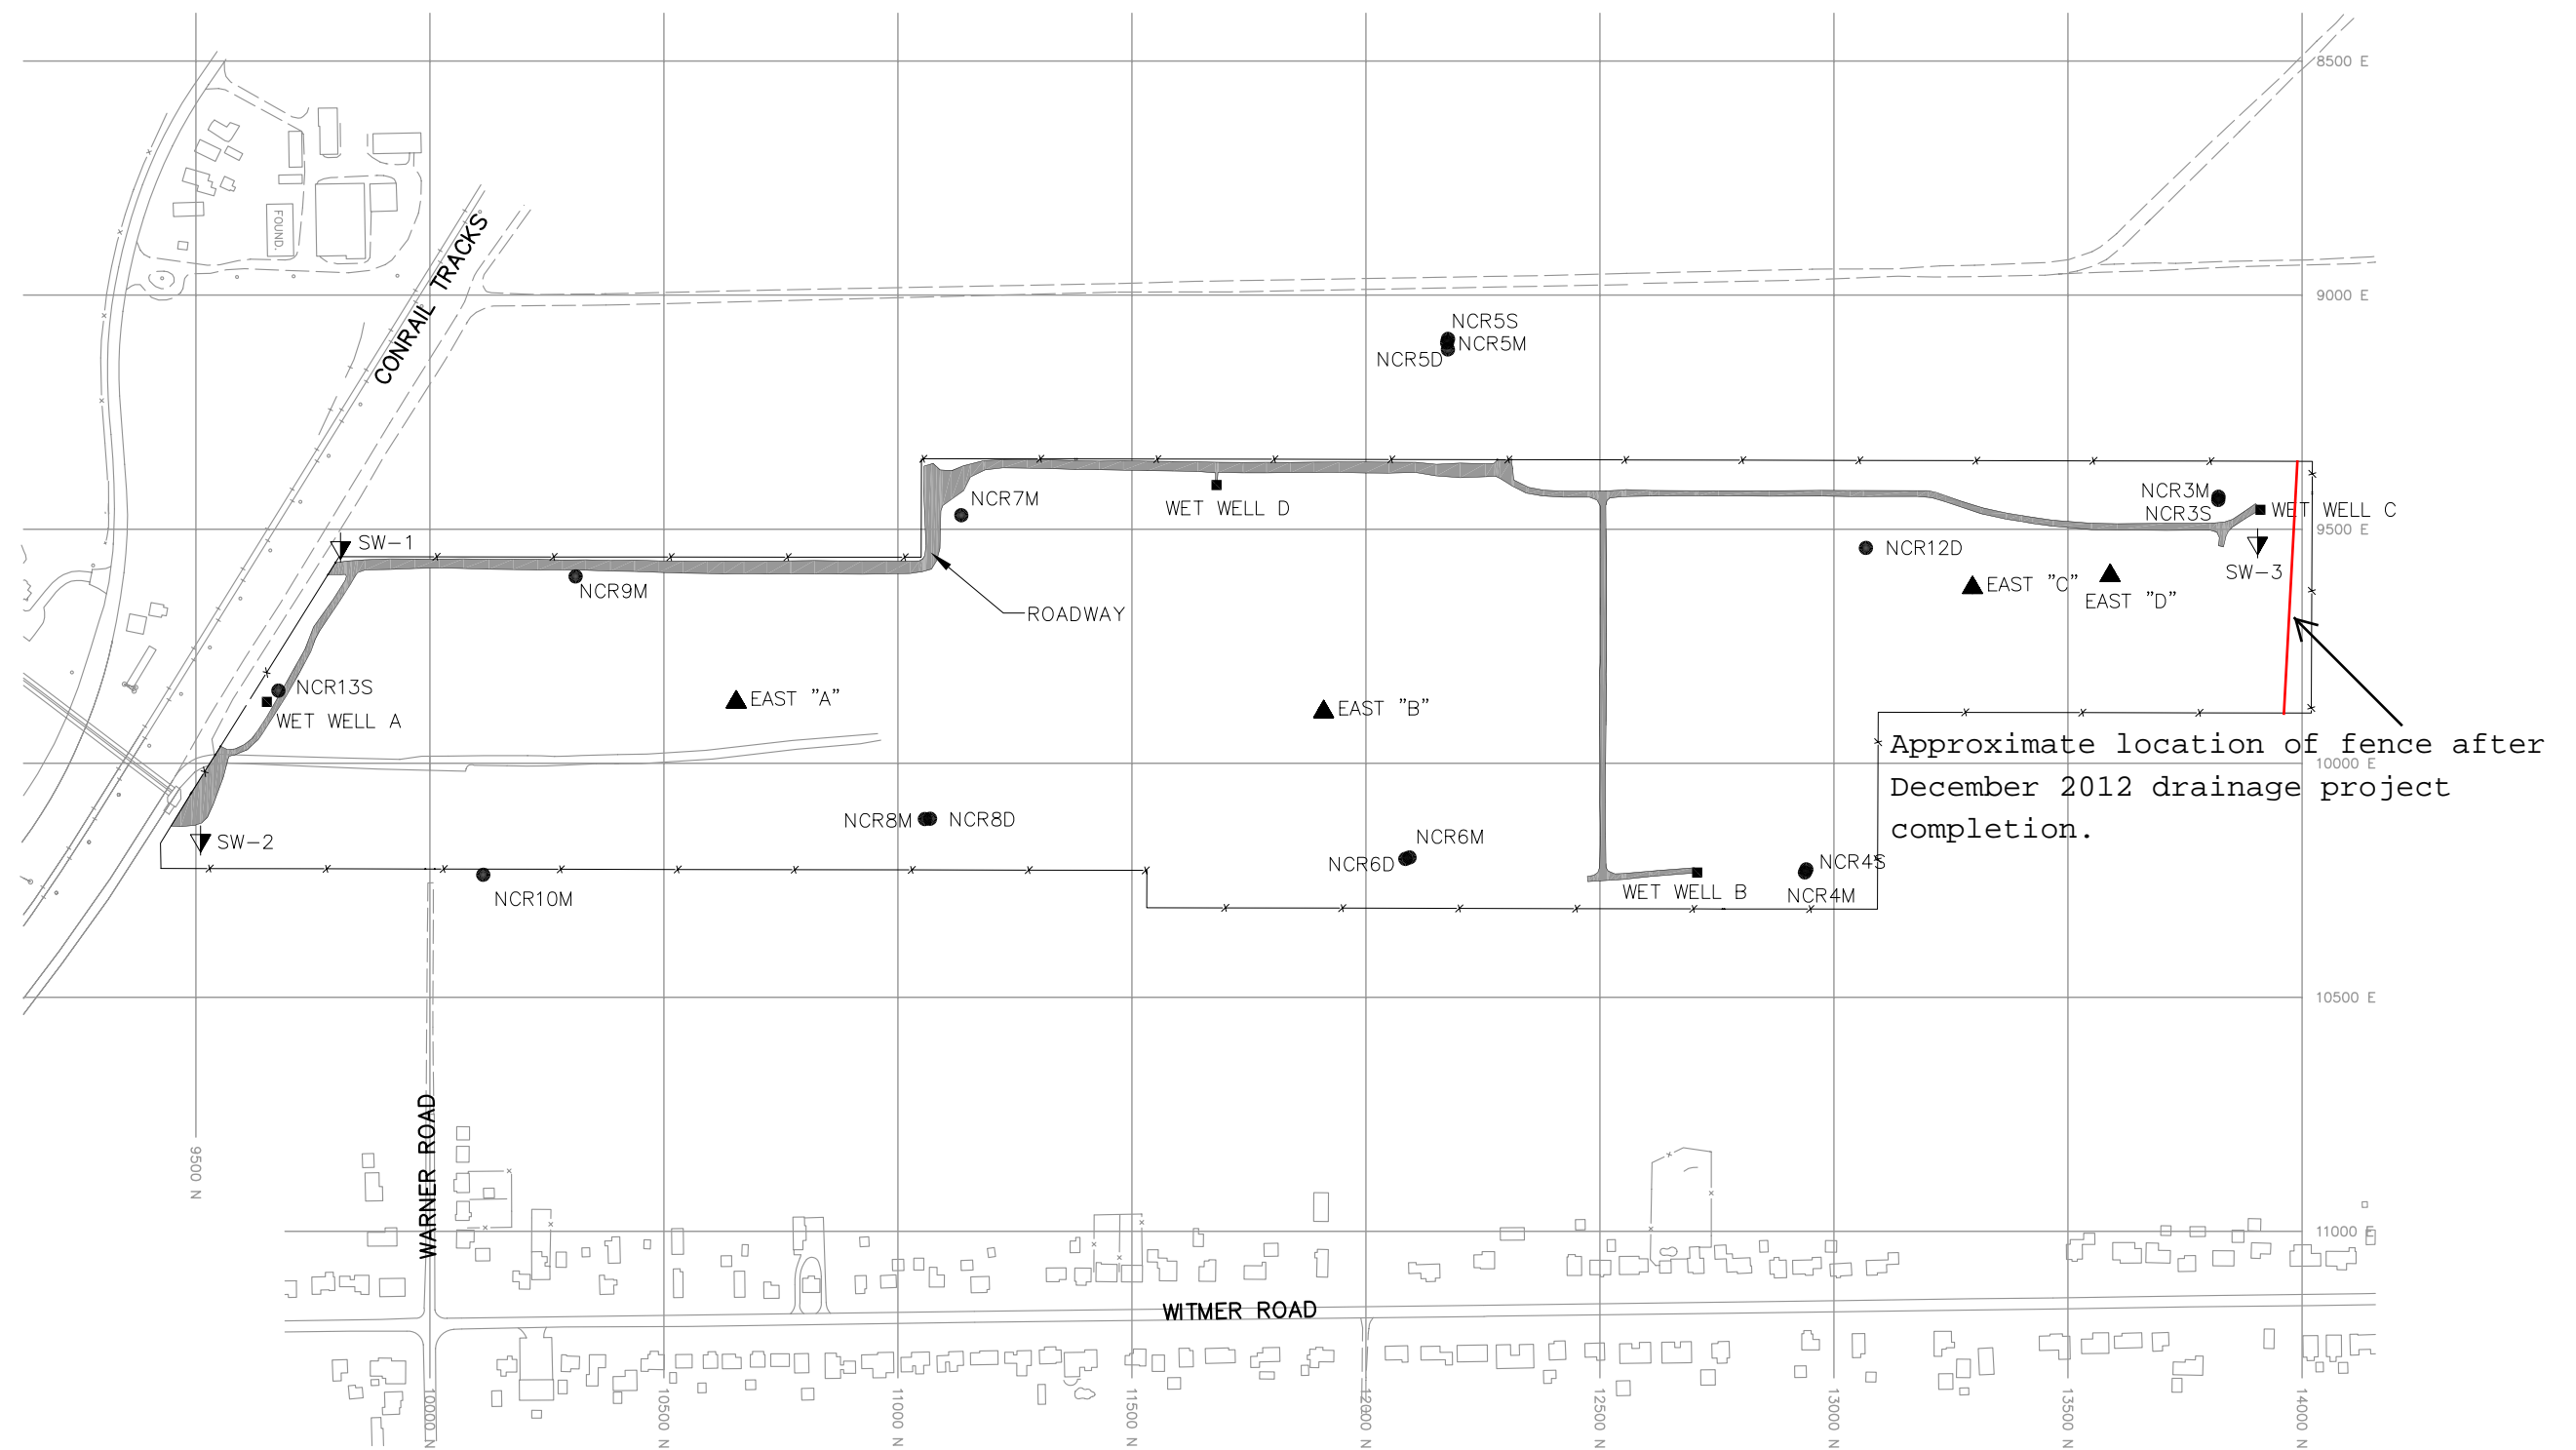
FIGURE 1.1

Water levels were measured during monthly Site inspections in July, August, and September 2014. Water levels were measured from four observation well locations (Piezometers East A, East B, East C, and East D), four effluent monitoring locations (Wet Wells A, B, C, and D), and four monitoring well locations (NCR-3S, NCR-4S, NCR-5S, and NCR-13S). The water levels were measured with an electronic water level indicator, and reported as an elevation above mean sea level. Figure 1.1 shows the locations of the water level monitoring points.

NIAGARA COUNTY REFUSE SITE
WHEATFIELD, NEW YORK
SITE PLAN

Monitoring wells NCR-3S, NCR-4S, NCR-5S, and NCR-13S were not sampled during this reporting quarter, based on the current annual groundwater sampling schedule specified in the OM&M Manual (CRA, 2000). Groundwater sample collection for the above-listed wells is planned for April 2015, assuming groundwater levels are adequate, and sufficient water is available for sampling within the wells. The locations of the monitoring wells are provided in Figure 1.1.
