# 2014 ANNUAL MONITORING REPORT

## NIAGARA COUNTY REFUSE DISTRICT SITE

Wheatfield, Niagara County, New York

(NYSDEC Site No. 9-32-026)

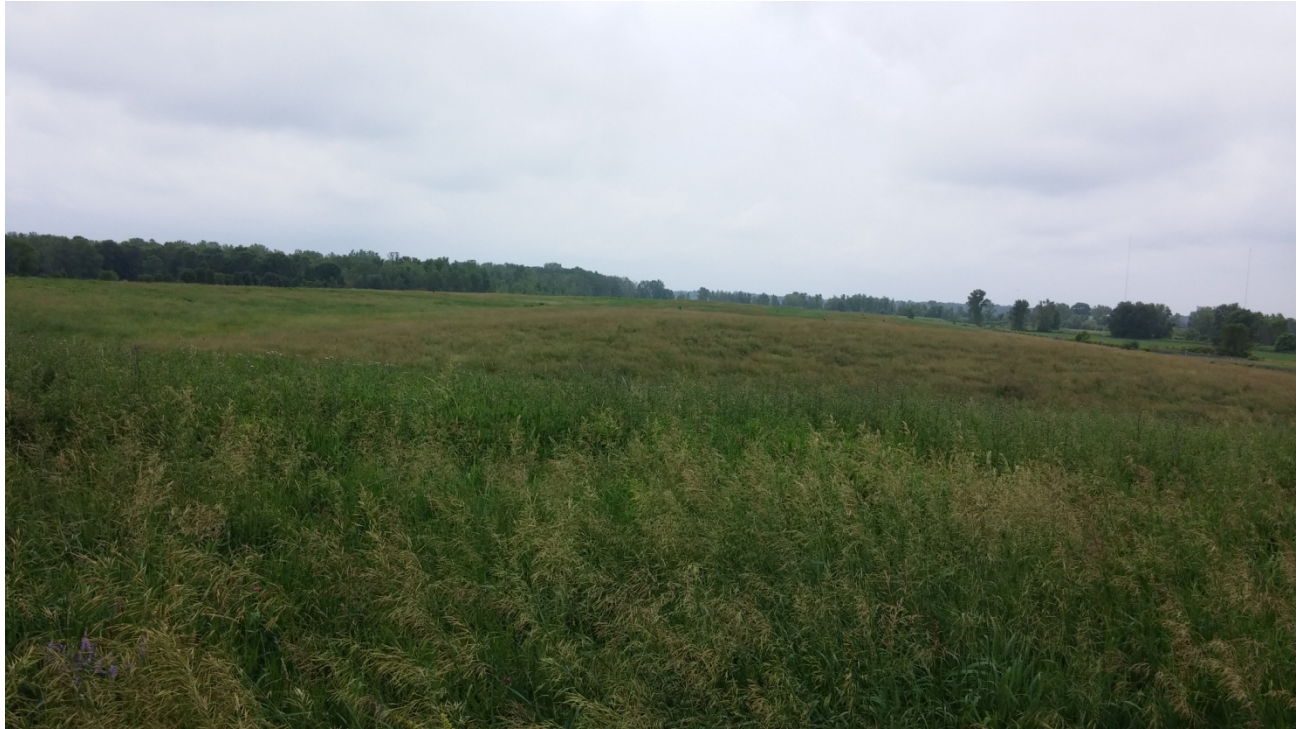
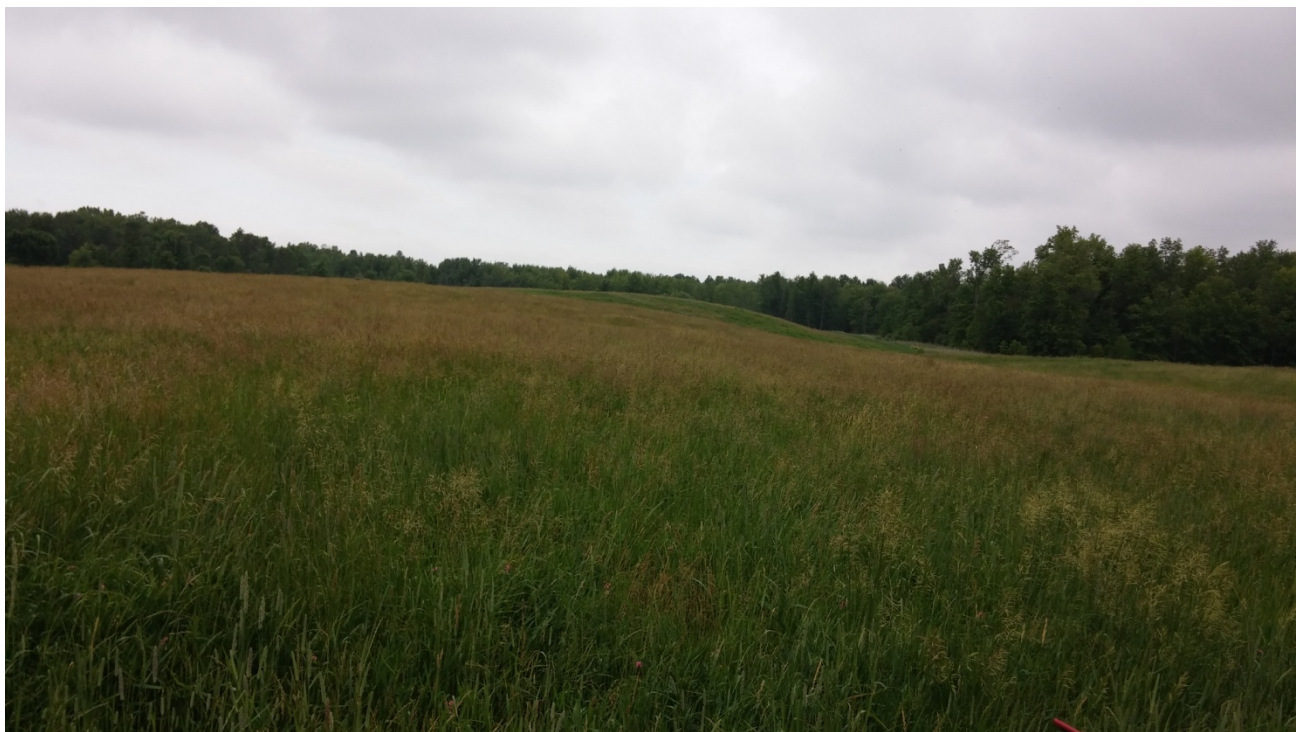
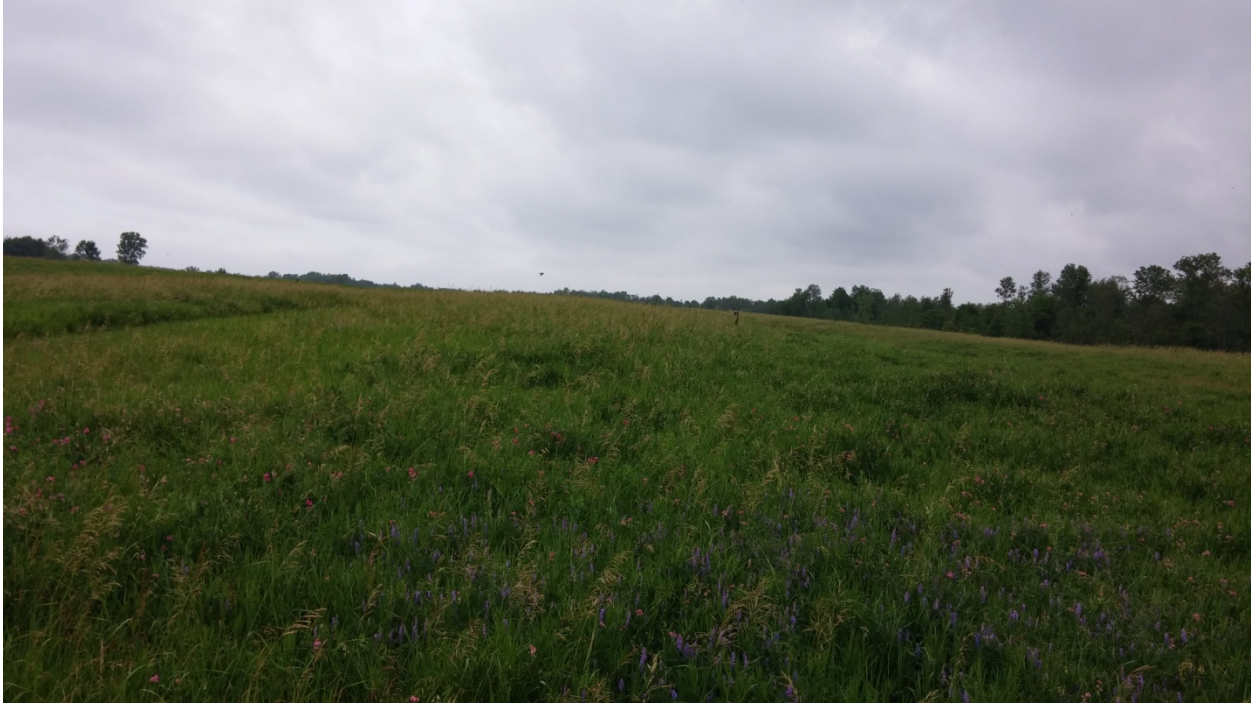
Each of the inspections found the manholes and wet wells to be in good condition. Water levels in the wet wells were measured during each inspection visit (see Table 2.3). Examination of the landfill cap vegetative cover included checking for erosion, bare areas, washouts, leachate seeps, length of vegetation, and dead/dying vegetation. Additionally, during the examination of the landfill cap, the access roads were examined for bare areas, dead/dying vegetation, erosion, potholes/puddles, and obstructions. No surface erosion, bare spots, or leachate seeps were noted. The landfill cap vegetation was noted to be snow covered in January, February, and March, normal for early winter in December, normal in October, short during the April, May, September, and November site inspections, and tall in the June through August inspections. The landfill cap was mowed in September.

June 25, 2014 – Top of landfill facing west from northeastern part of landfill.

June 25, 2014 – Top of landfill facing east from western side of landfill.

June 25, 2014 – Top of landfill facing north from southern end of landfill.
